Waterjet Scaling for Reducing Injuries in Underground Mining

Final Report

by
Mark Kuchta,
Hugh Miller, and
Erik Poeck

Project Sponsor: NIOSH

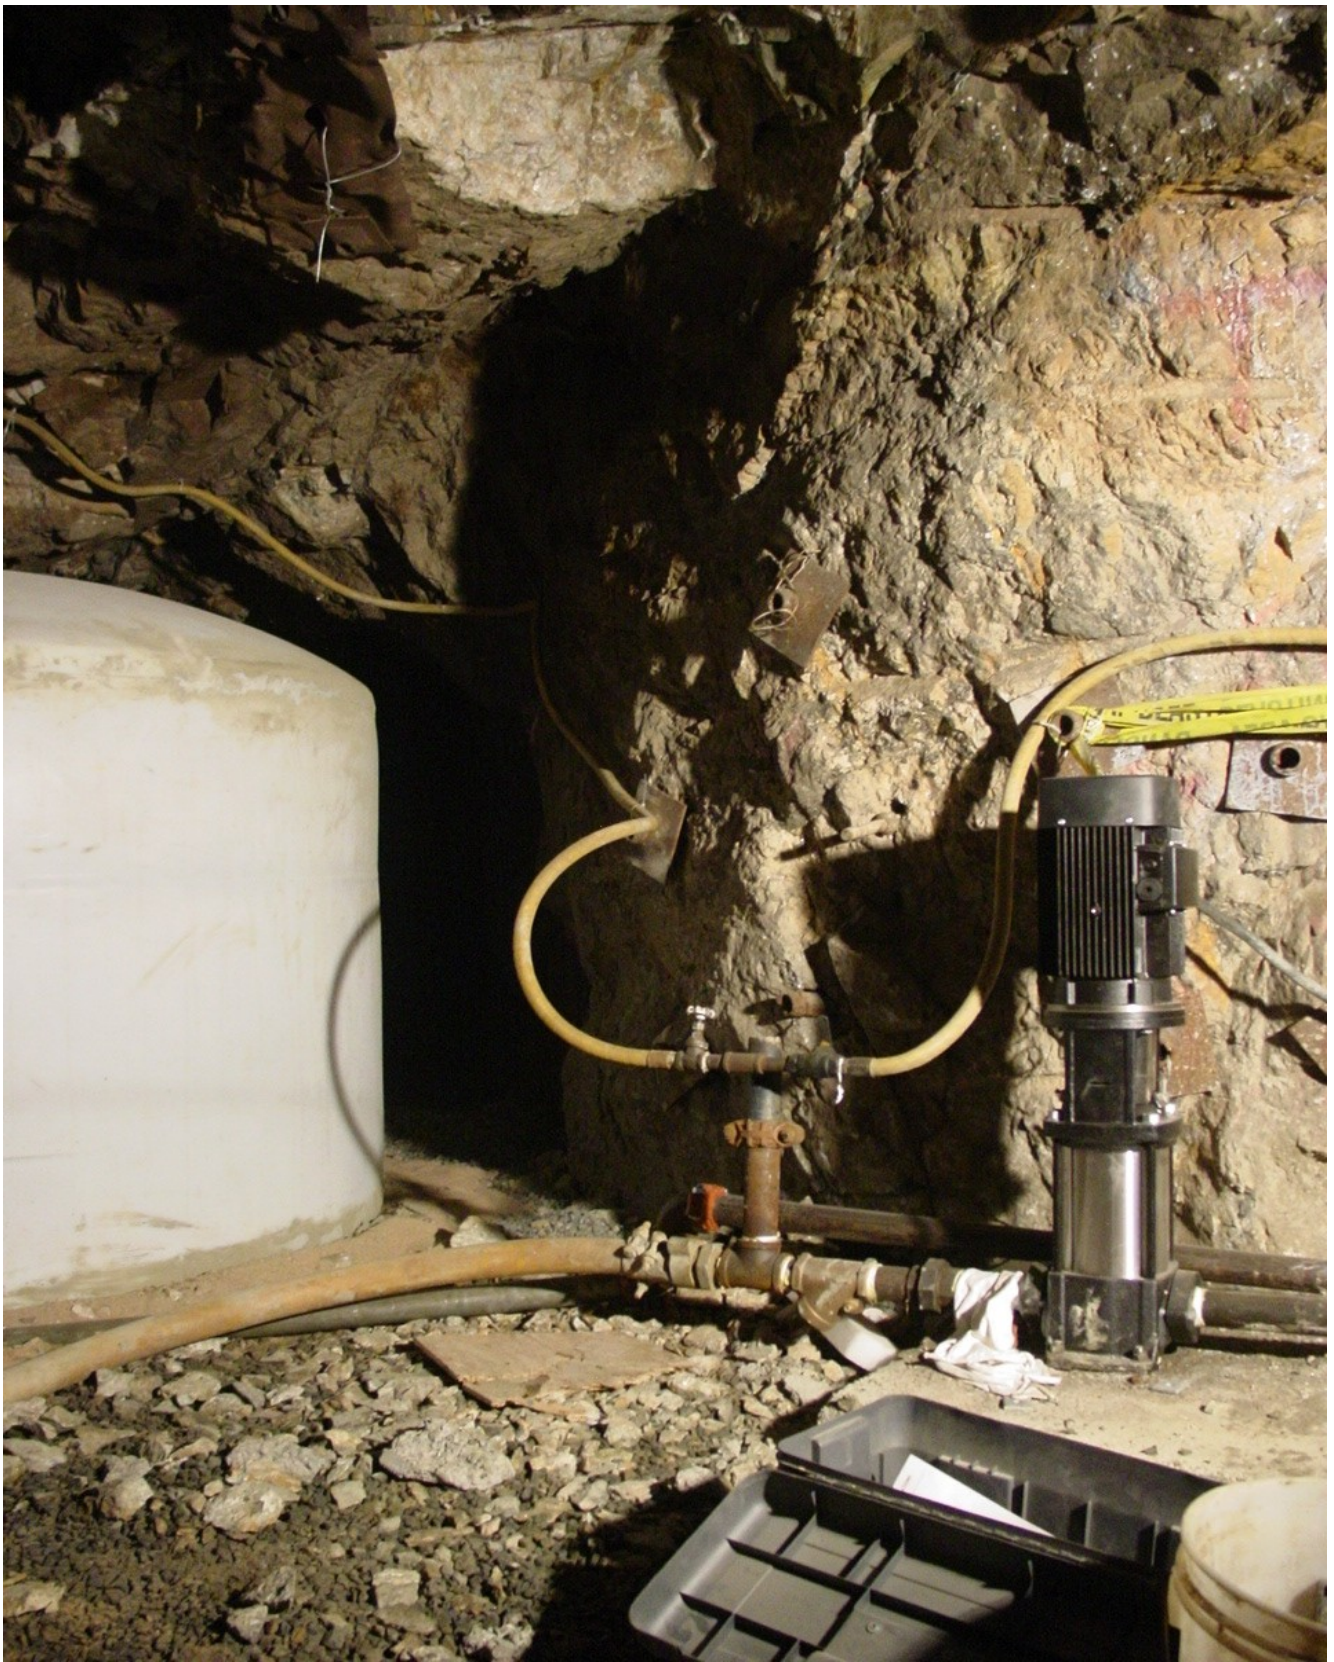
Fig 7.1. Low pressure pump and plastic storage tank that provide water to the high pressure pump.

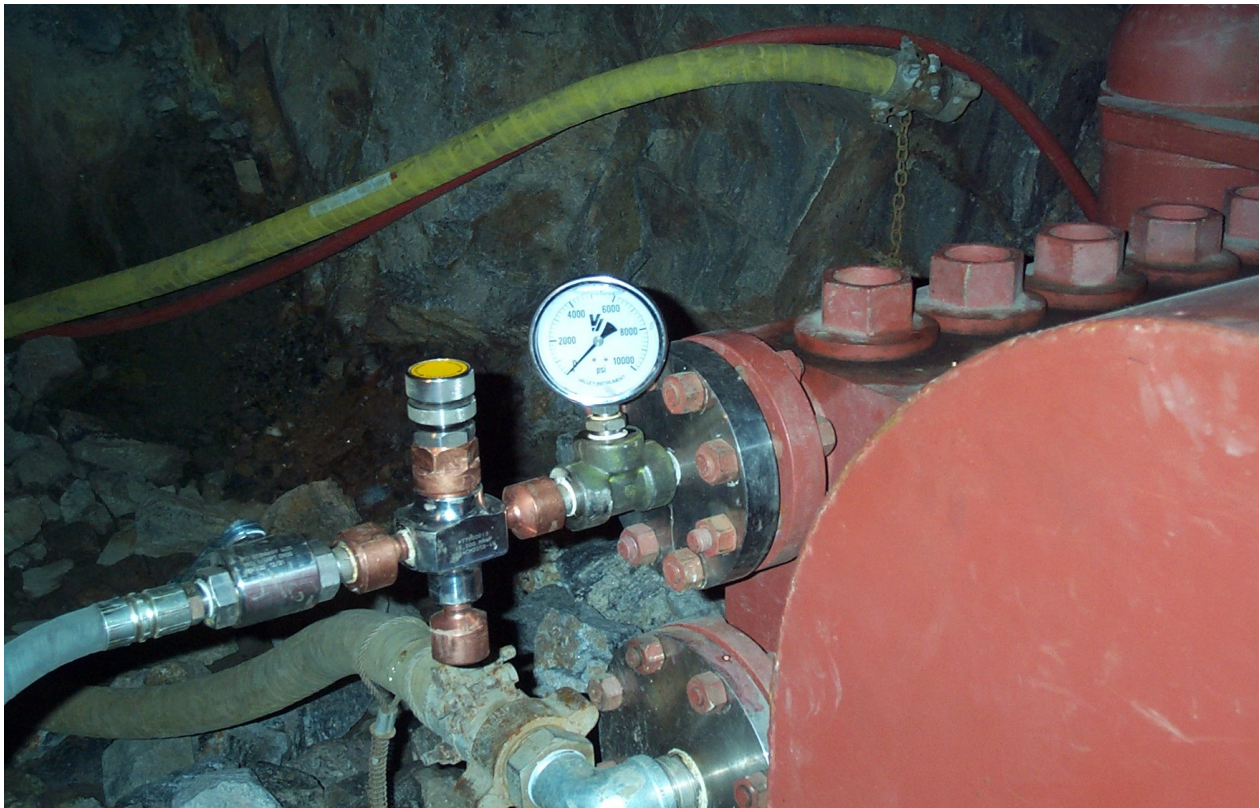
Fig 7.3. The pressure gage, flow control valve, and rupture disc assembly mounted on the Wheatly Quinteplex pump.

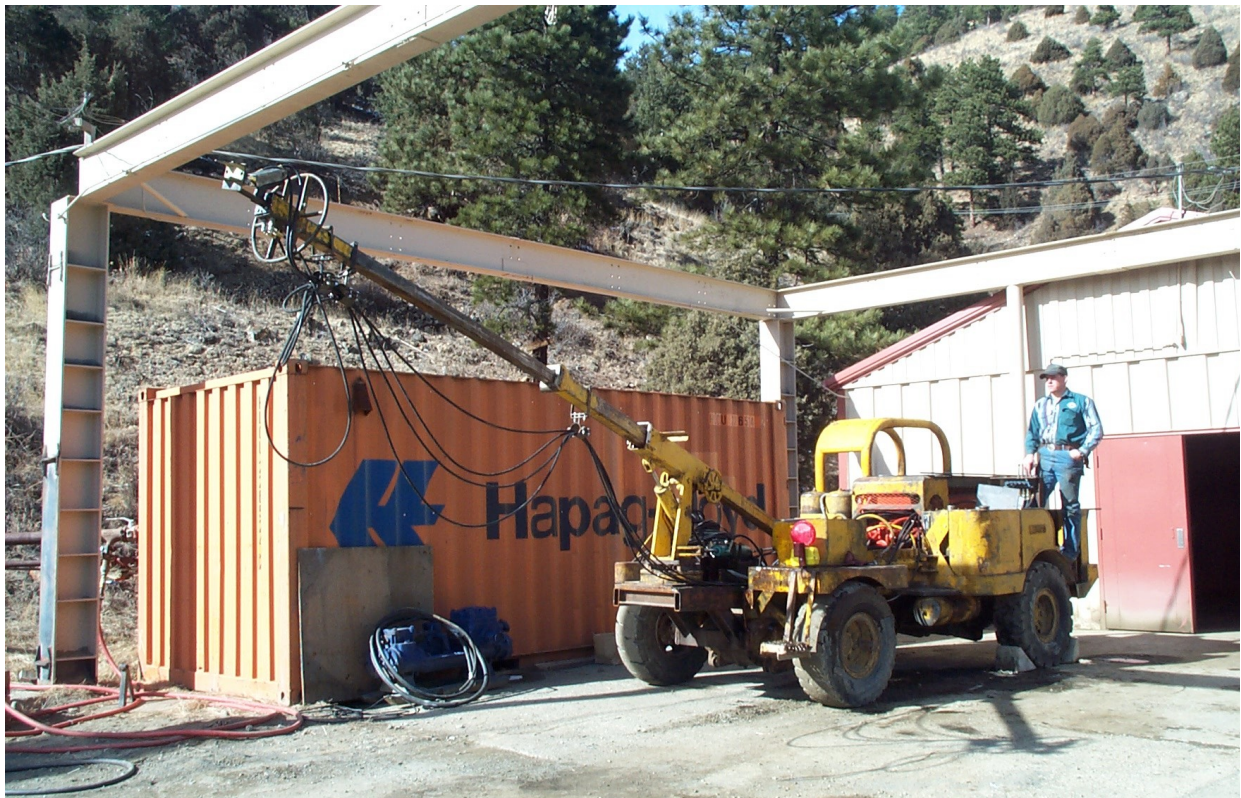
Fig. 7.6. The CSM waterjet scaling carrier vehicle.

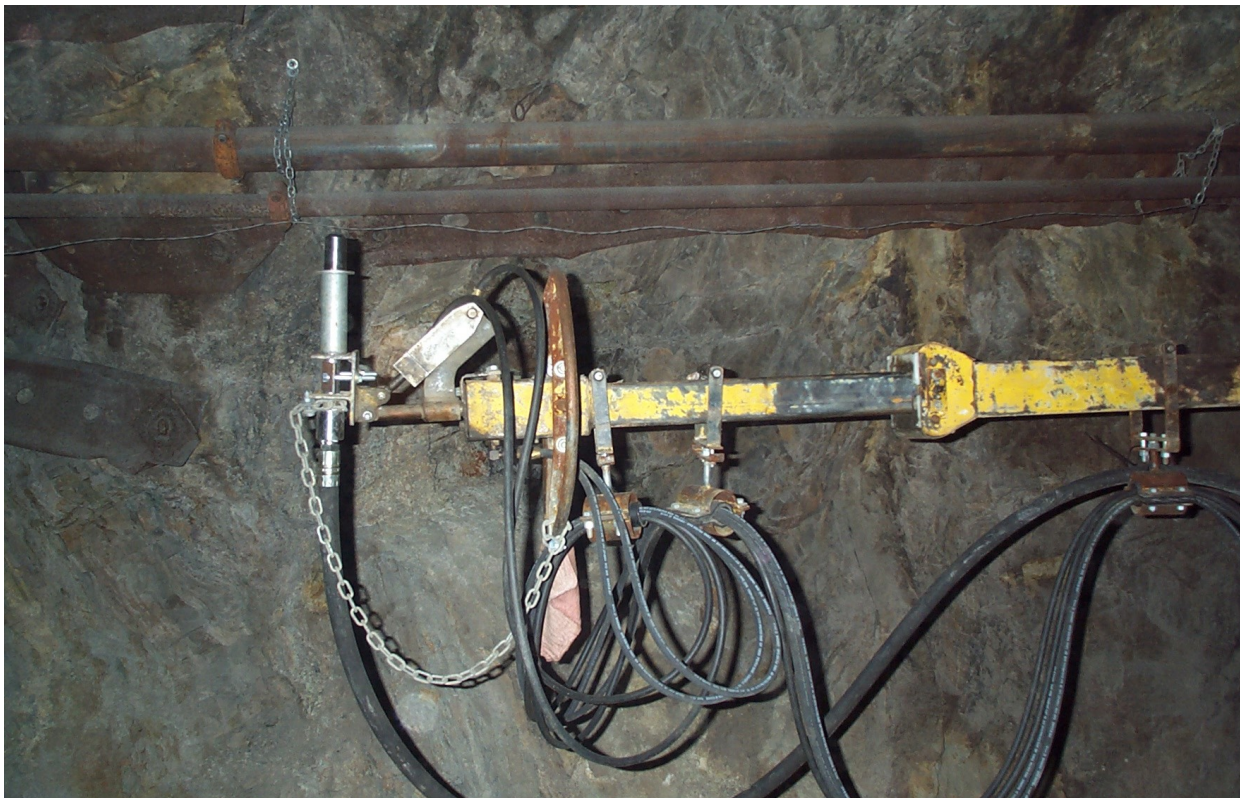
Fig. 7.7. The end of the hydraulic boom showing nozzle assembly mounting on the CSM waterjet scaling carrier vehicle.

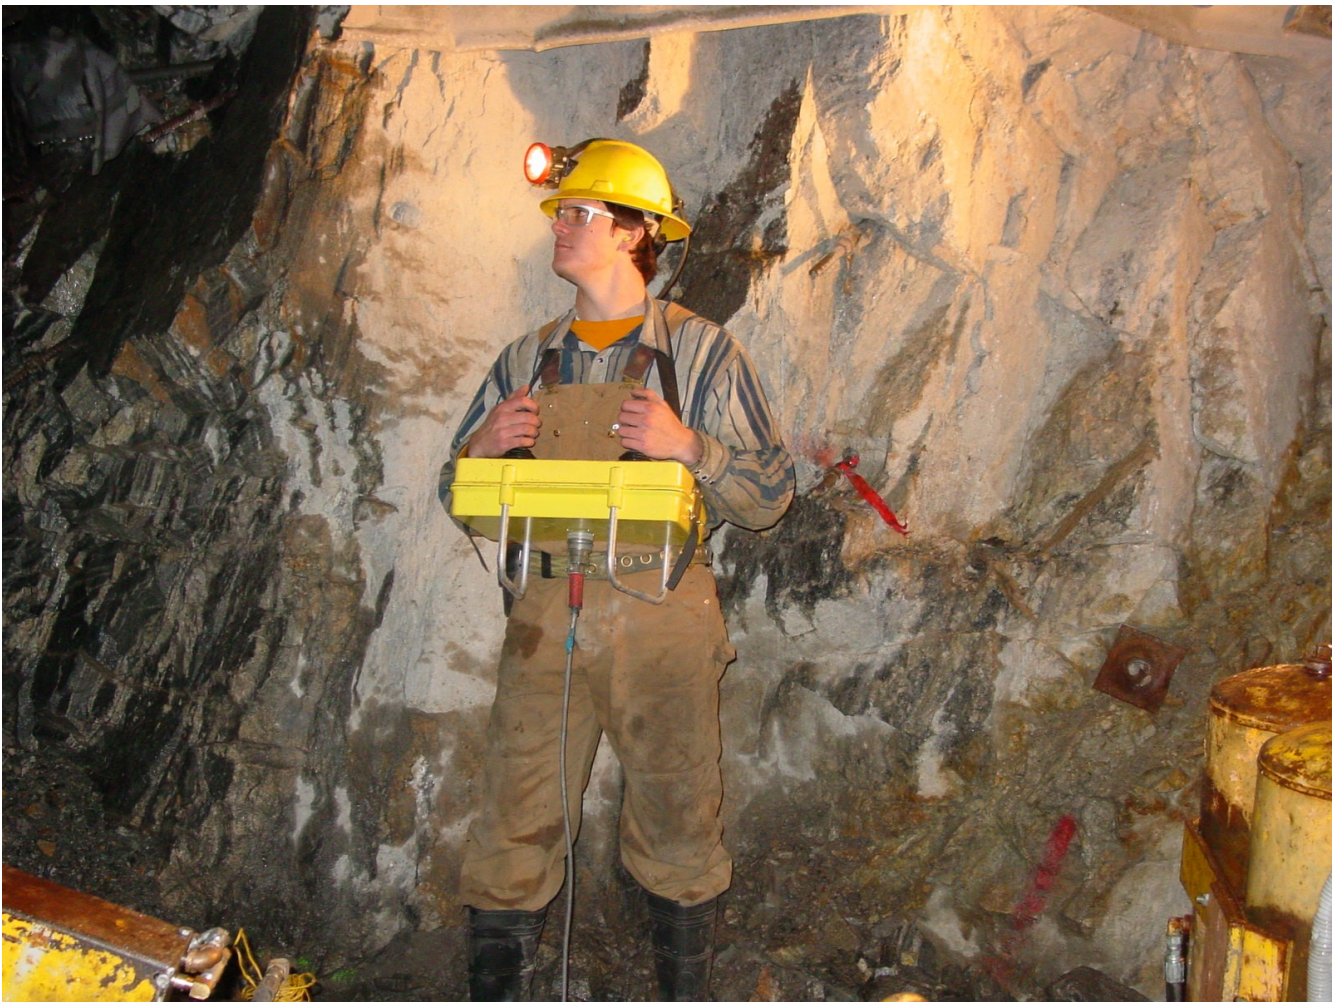
Fig. 7.8. The 12-volt electric joystick control box for controlling the motion of the hydraulic boom on the CSM waterjet scaling rig.

The extendable boom could be operated manually by a series of five hydraulic valves and levers or remotely with a 12-volt electric joystick control box (Fig. 7.8) installed specifically for this research by Shotcrete Technologies of Idaho Springs, Colorado. The electronic valve bank and tether provided a degree of control and operator safety that was a significant improvement over the manually operated boom controls. Functions included tilt, swing, and extension of the main boom, as well as tilt and rotation of the nozzle.

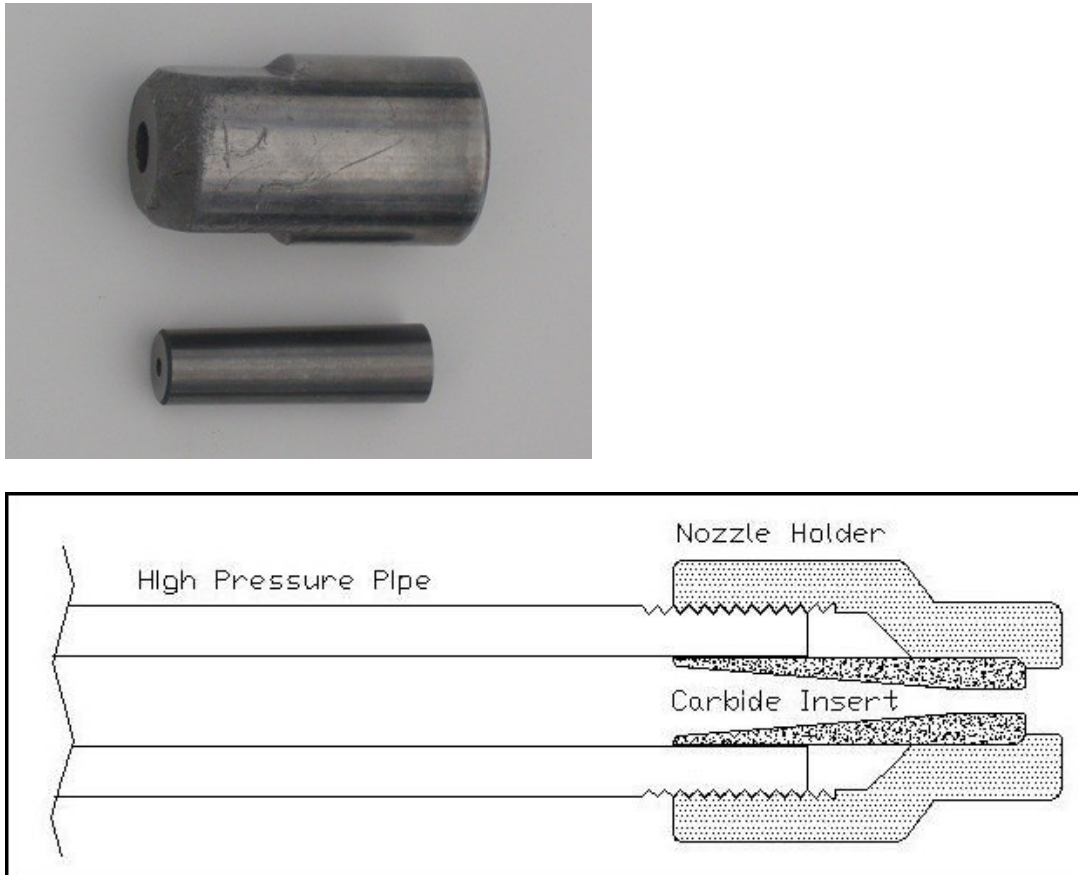
Fig 8.1. Single orifice continuous nozzle with holder.

The single orifice nozzle assembly, (Fig 8.1), consists of a machined carbide 3.56 mm (0.140 in) diameter orifice held in place by a steel outer protective holder. In turn, this assembly was attached to a 250 mm (10 in) long, 19 mm ($\frac{3}{4}$ in) diameter straight section of steel pipe. The assembly was purchased from Stoneage Waterjet Tools Inc. of Durango, Colorado. This nozzle assembly was operated at a pressure of approximately 22 MPa (3200 psi) and a flow rate of approximately 0.106 m³/min (28 gpm).

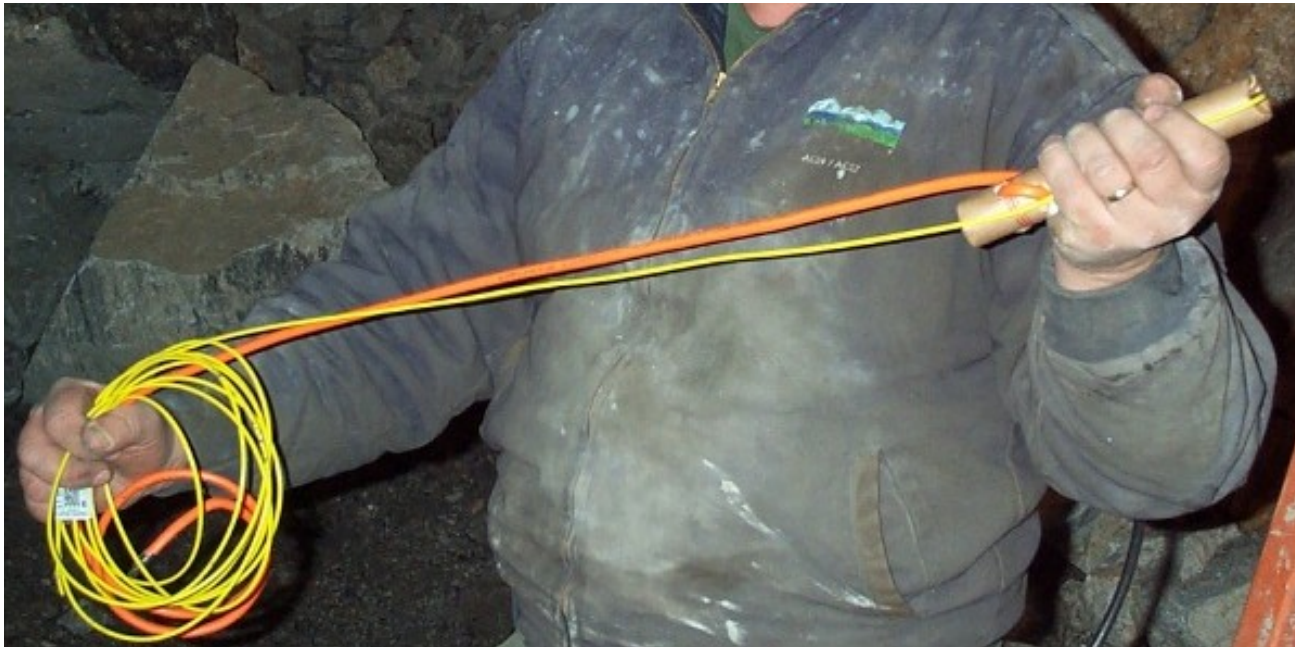
Fig. 9.5. A typical smoothwall blast primer showing 200 grain det-cord (thick orange) inserted into a stick of packaged emulsion explosive.

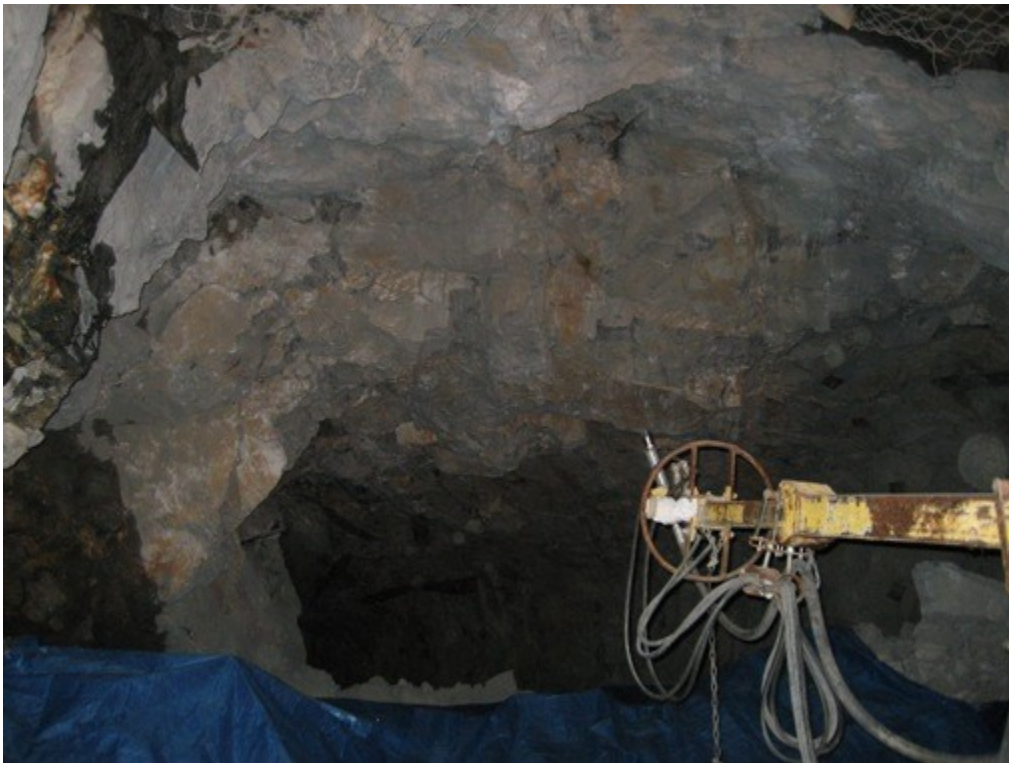
Fig. 10.2 Before Experiment #1

Photographs taken before and after the scaling experiment under the same lighting conditions and from the same physical location illustrate the cleaning effect offered by the waterjet (Figs. 10.2 and 10.3). Also notable in the photograph taken before the experiment is the presence of moisture along the left rib. Although this area was noted for being wet year-round and containing exceptionally soft and weathered material, the formation did not intersect the scaling area. It did, however, indicating the type of groundwater activity present in the rock mass and the effect it has on the materials in contact.

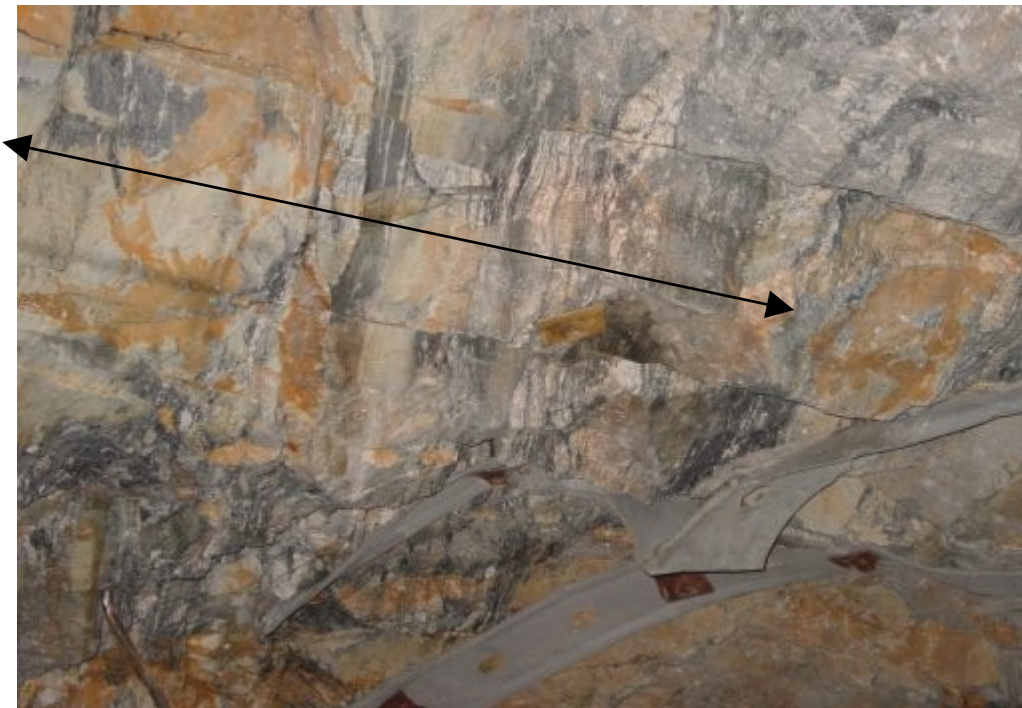
Fig. 10.9 Troubling discontinuities noted before Experiment #2

The most significant feature in the rock mass was the presence of several near-vertical, parallel discontinuities. Some of them had 2-3 mm gaps, and some of them were intersected by perpendicular discontinuities creating conditions favorable for large rock fall. Before the start of the waterjet test, a photograph was taken of the discontinuities that posed the greatest danger. The photograph is shown in Fig. 10.9 with an arrow to indicate the trend of the joint set.

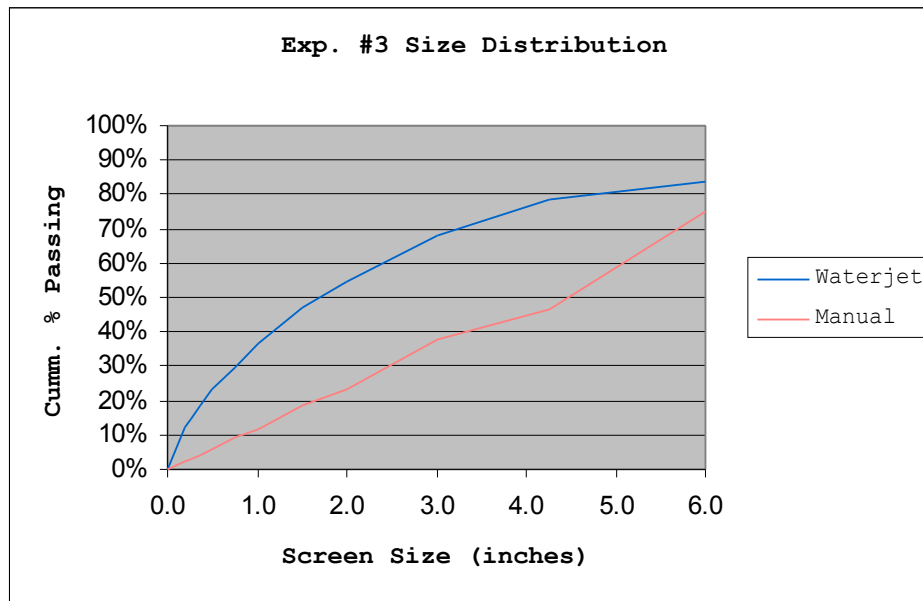
Fig. 10.20 Experiment #3 particle size distribution

The particle size distribution illustrates that only 15% of the waterjet-scaled material and 25% of the manually scaled material was larger than six inches. These statistics, along with visual evidence in the photographs, suggest that there was a general scarcity of large blocks to be scaled. The curve also indicates that nearly 55% of the material scaled by waterjet is two inches or smaller in size. Though such evidence is encouraging for the cleaning effect of waterjets, the highly fractured shear zone undoubtedly contributed to the statistics for small sized particles. It is difficult to determine whether the pulsed single orifice nozzle had any necessary effect on the results.

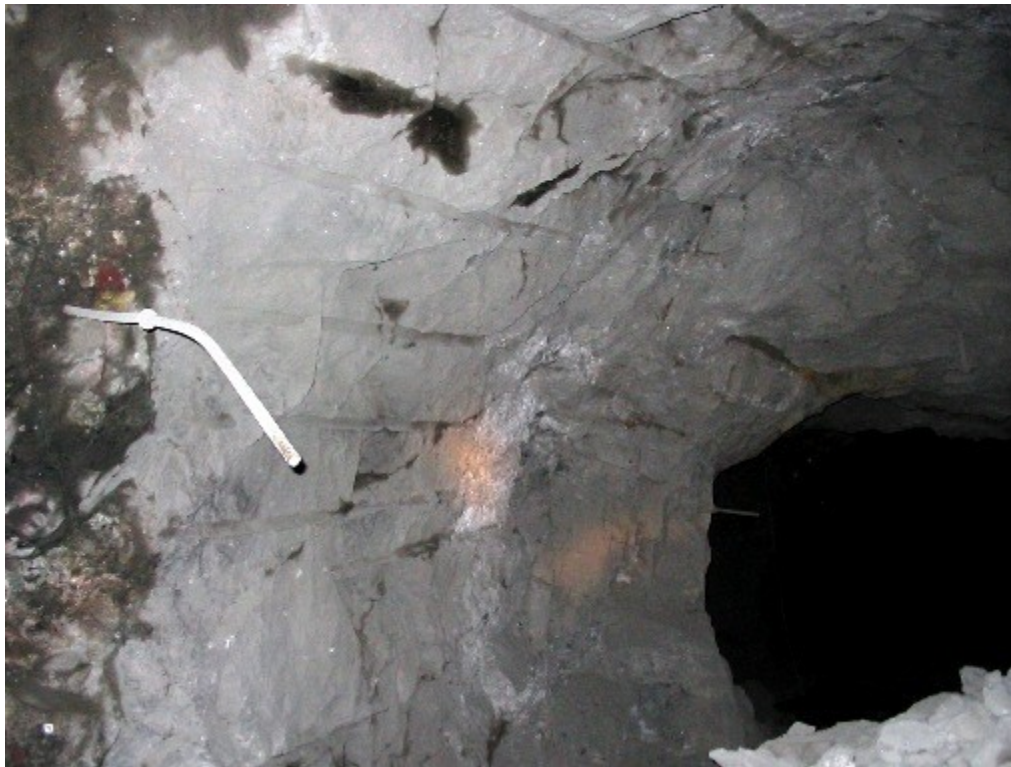
Fig. 10.29 Half-cast drill holes visible after blast

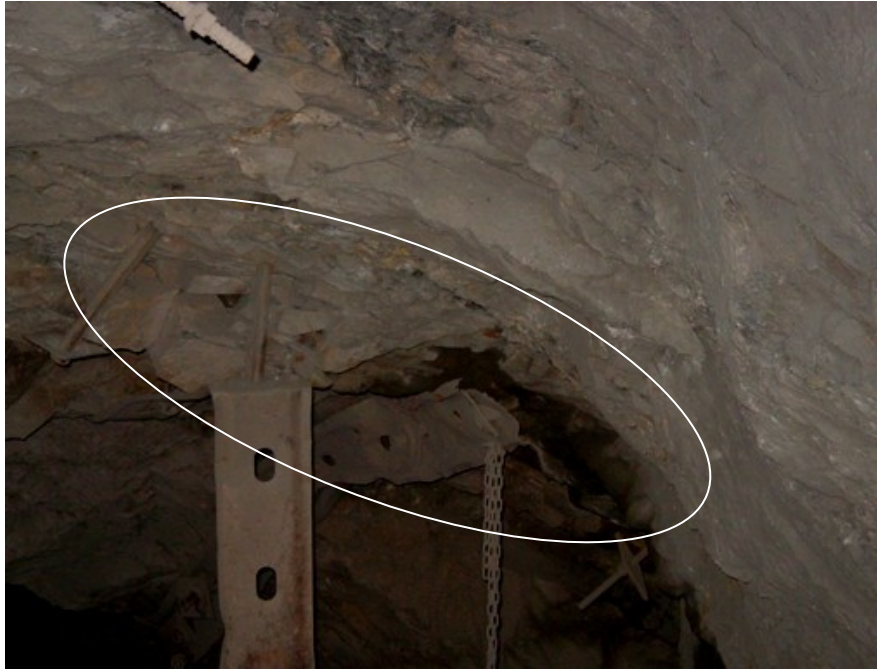
Fig. 10.34 Fractured material in north east corner

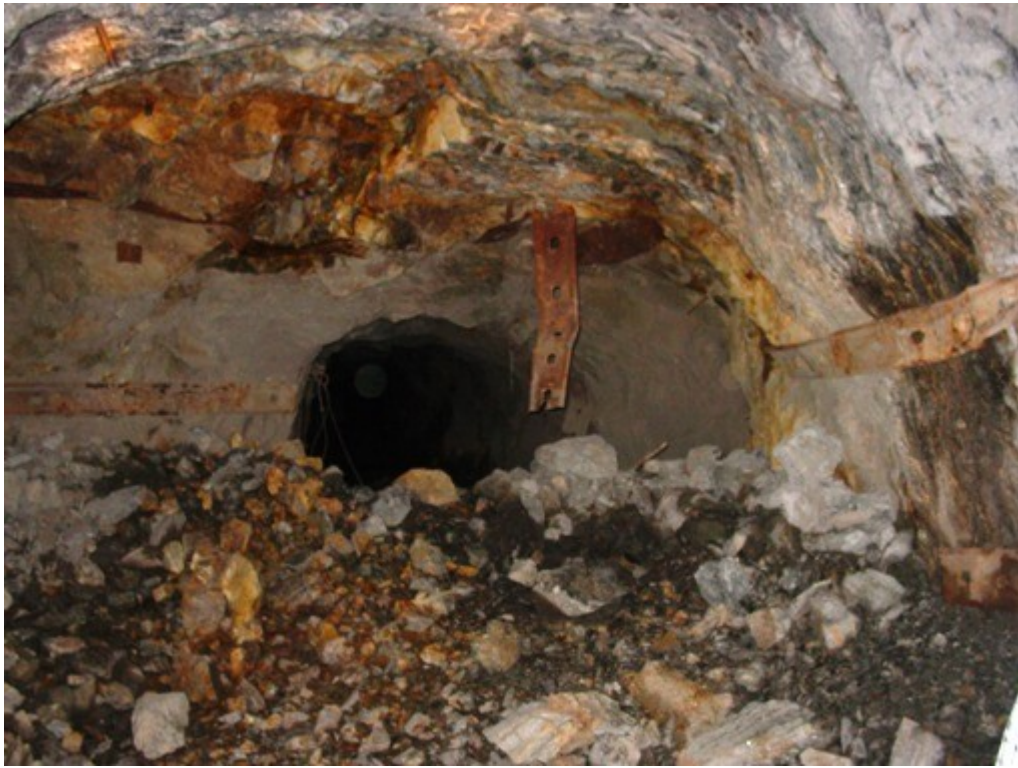
Fig. 10.38 Fractured and weathered weak zone in Experiment #8

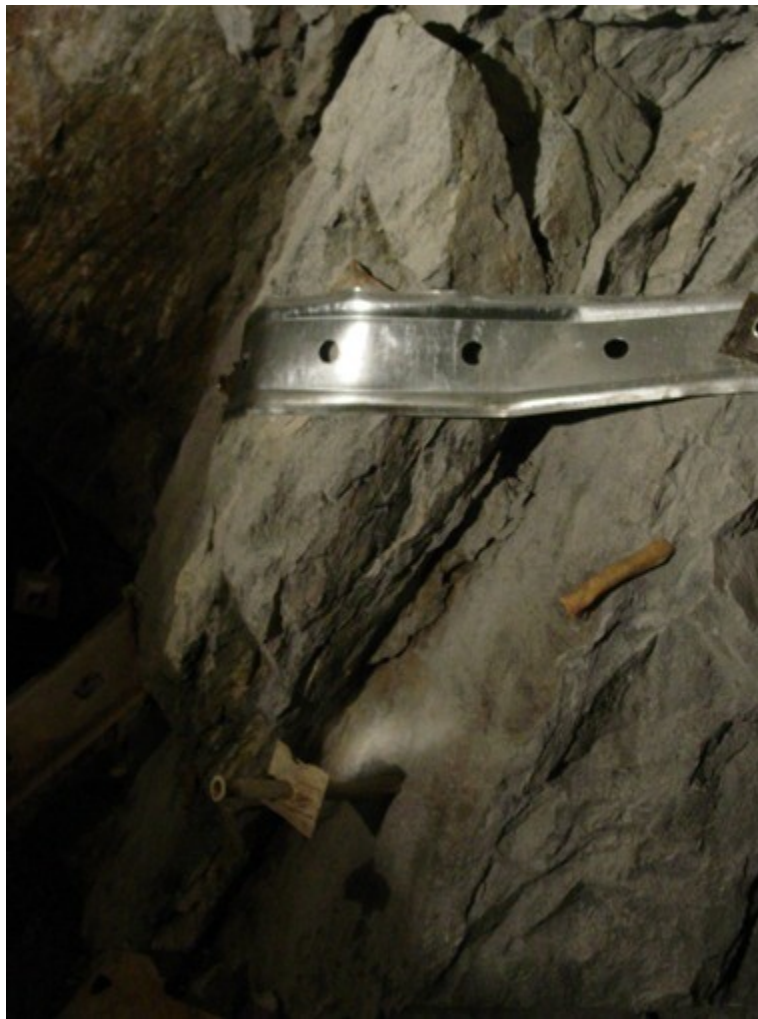
Fig. 10.39 Large slab bound by open discontinuities

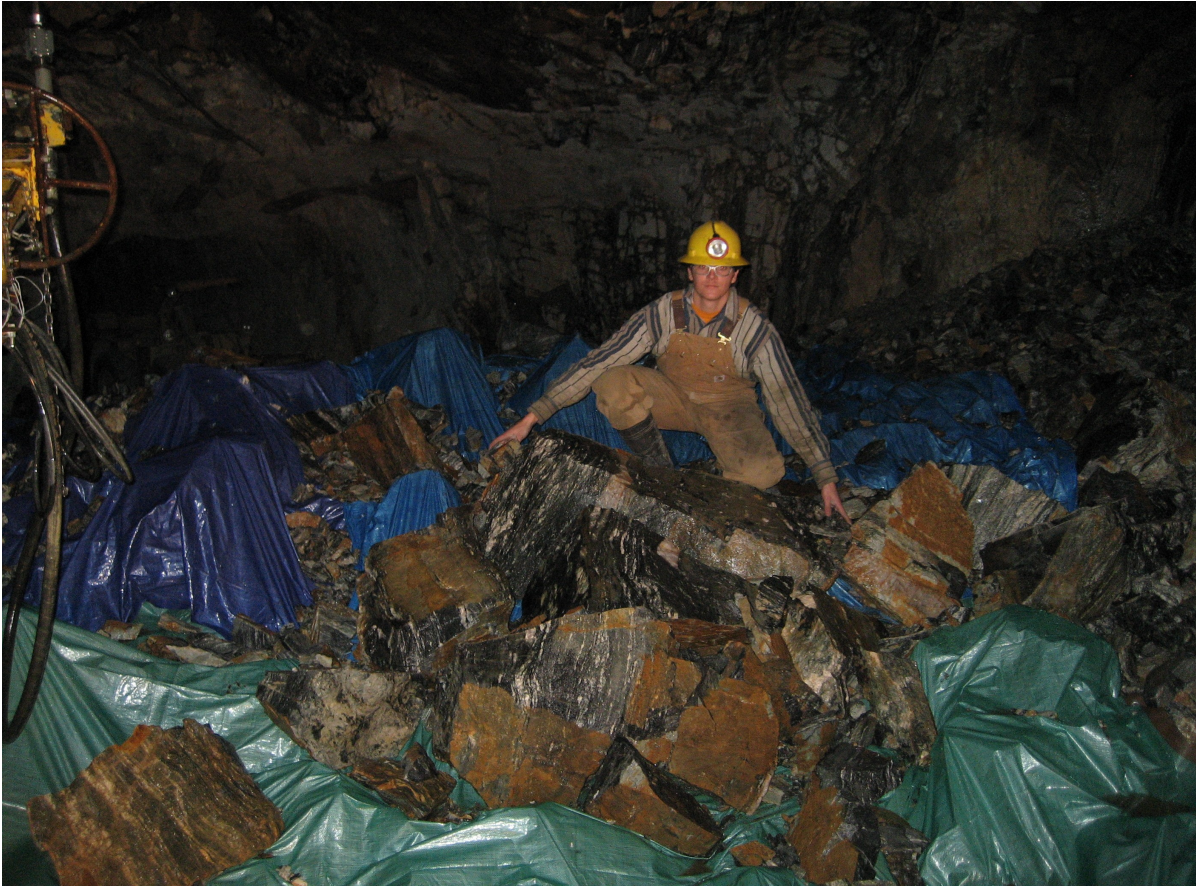
Fig. 11.4. The approximately four-ton slab scaled by the waterjet during experiment two.

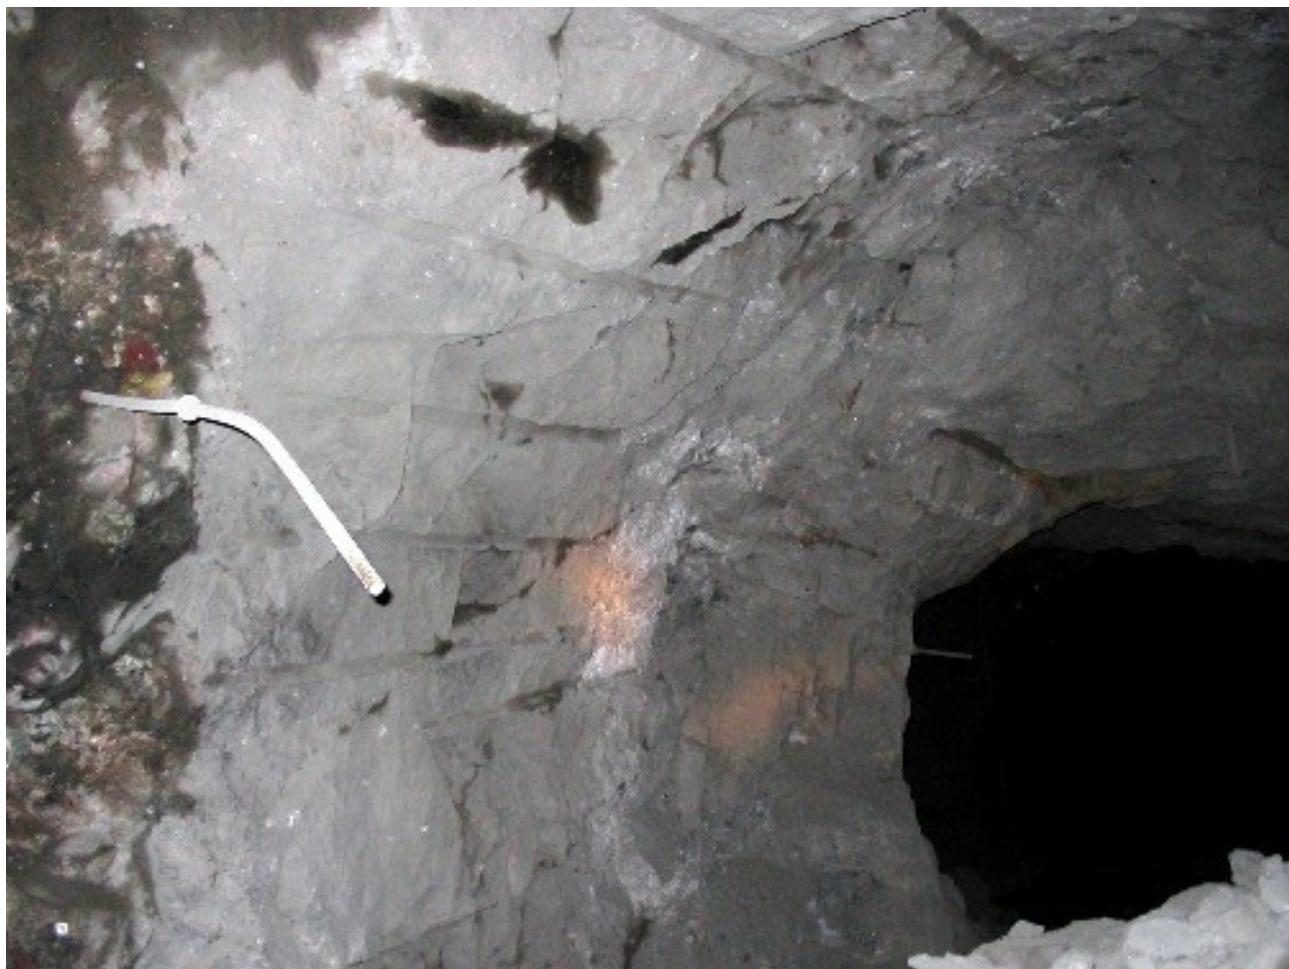
Fig. 11.5. Half-cast drill holes visible after a smoothwall blasting in experiment six.

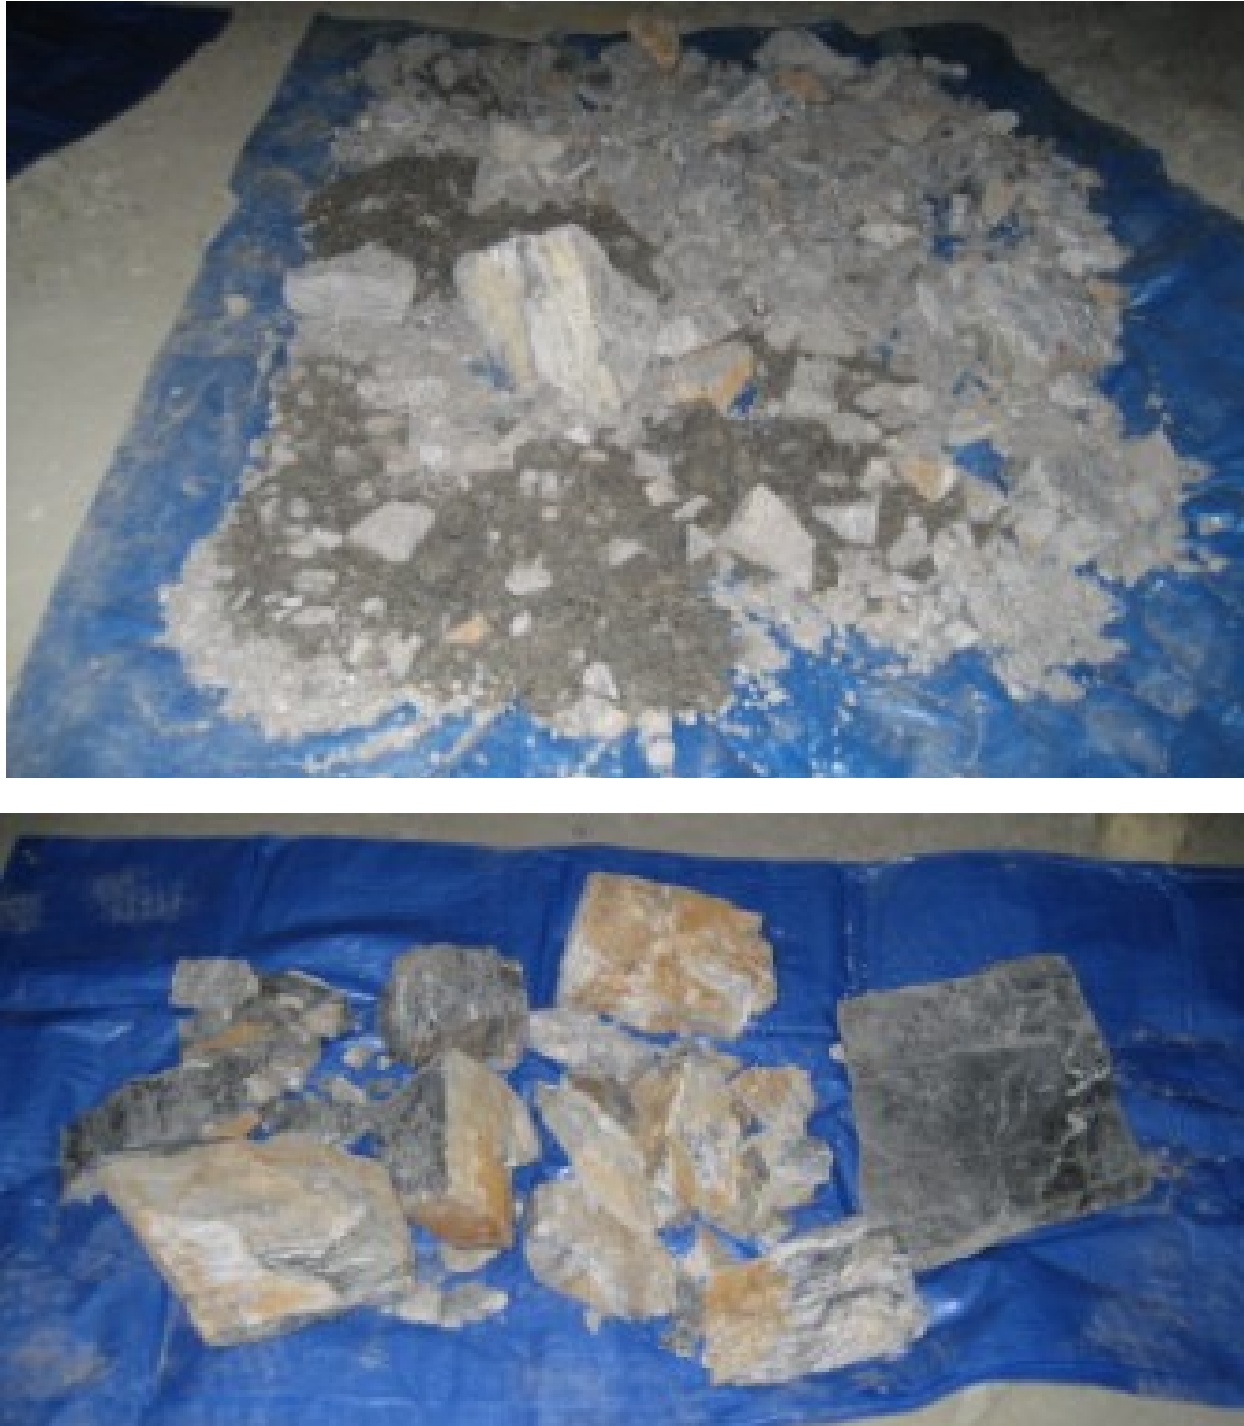
Fig. 11..9. Typical size distribution of material scaled by waterjet (upper) and a hand held scaling bar (lower).
