**TECHNOLOGY FOR THE EARLY DETECTION AND  
WARNING OF IMPENDING UNDERGROUND MINE  
ROOF FALL**

**FINAL PROGRESS REPORT**

**Grant Number:** 1R43OH9679

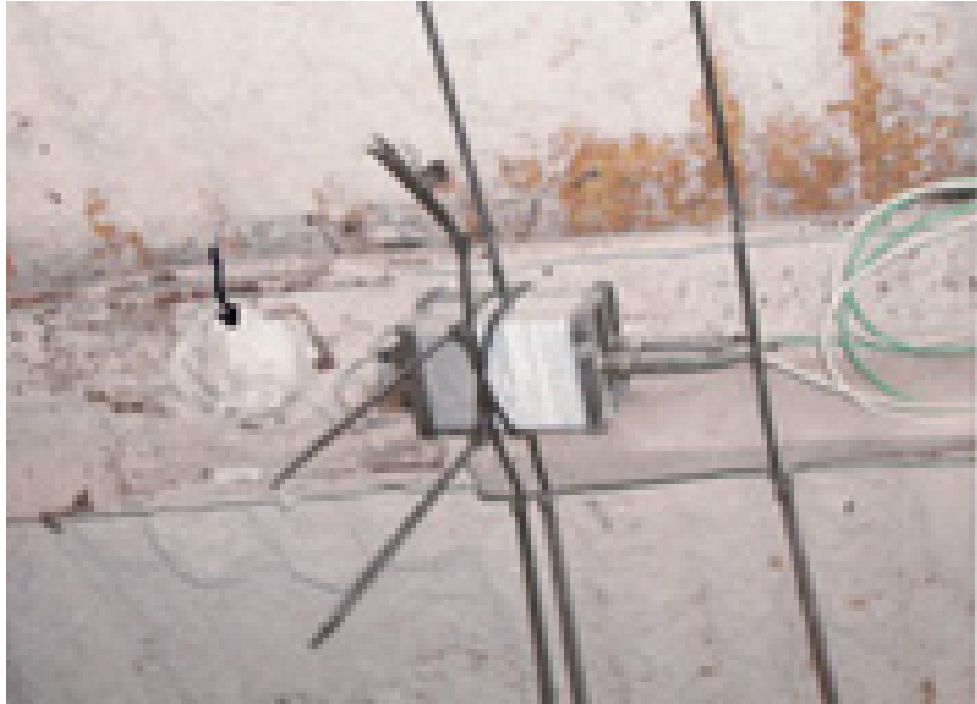
Fig. 1 Sensor and Signal Processing Electronics Package

The original sensor was housed in a separate package and the signal conditioning and processing electronics was assembled into a 4 inch X 3 inch X 1 inch enclosure. Figure 1, on the next page, shows the sensor and electronic package mounted on the roof of an underground coalmine next to the cutting face of a long-wall.

The sensor, shown on the left side, is attached to a metal bolt strap on the roof. It is protected with white epoxy. The electronics (center) is connected with a cable to the sensor and it is strapped to the roof. To the right is an optic fiber carrying the output of the electronic package to the monitoring equipment in a fresh-air area 1,000 feet away. The monitoring equipment is shown in Figure 2 below.

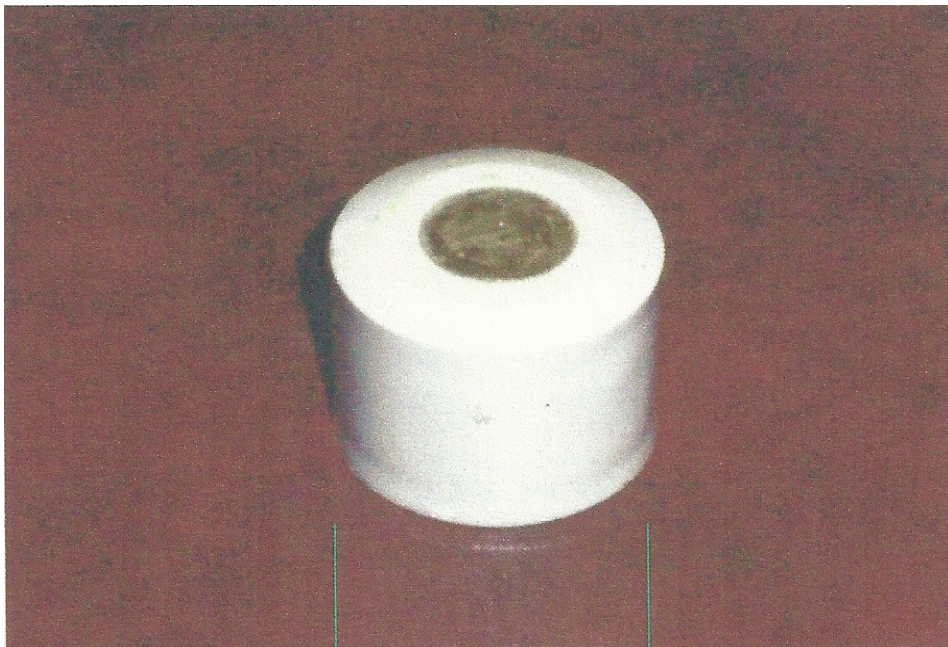
Fig. 5 Sensor/Alarm Module Housing

Figure 5 below shows the Sensor/Alarm module housing.

A module, one inch in diameter and three quarters of an inch long, using the new technology has been built and tested. The product will be market-ready as soon as it receives MSHA certification and undergoes beta-site verification. Discussions with a
