# Rock Mechanics Study of a Longwall Panel

Lewis V. Wade and Peter J. Conroy

**Abstract**—Old Ben Coal Co. successfully completed the first longwall panel in Illinois. The panel was mined using shield supports and was part of a cooperative agreement with the US Bureau of Mines. This paper describes the rock mechanics studies which were performed to monitor: the performance of the supports, the stress changes in the coal and floor, convergence in entries, and caving mechanism of the roof. From this study, maximum support loads were obtained as well as the stress distribution in the panel, floor and adjacent pillars.

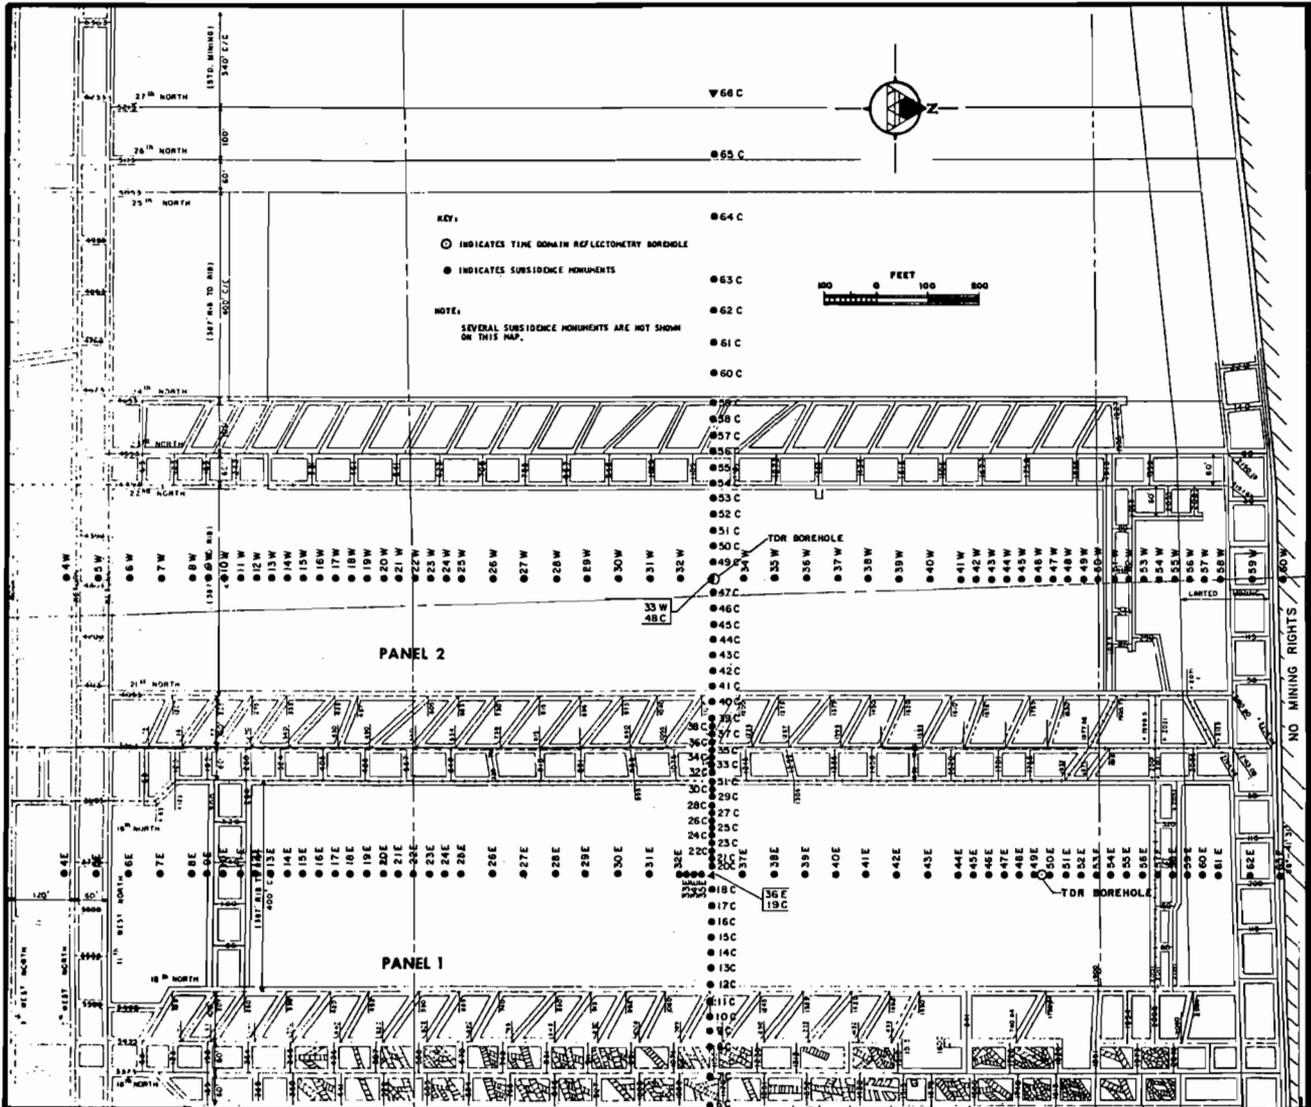
Fig. 1— Surface subsidence monument locations.

in a borehole drilled at the location shown in Fig. 1. The cable extended from the surface to the bottom of the boring, 15.2 m (50 ft) below the top of the No. 6 coal. The cable was then securely grouted into place with a cement grout.

Surface subsidence was measured by installing 197 survey monuments in three lines over the panels as shown in Fig. 1. These monuments were installed by Old Ben personnel with direction and assistance from USBM. Each monument consisted of a 1.5-m (5-ft) length of 50.9-mm (2-in.) diam pipe driven 0.9 m (3 ft) into the soil. A 3.0-m (10-ft) length of 25.4-mm (1-in.) diam pipe was driven through the large pipe into the soil and used as the monument reference. The space between the pipes was packed with silicon grease to allow the smaller pipe to move freely within the larger protective pipe. These monumented survey lines were used to evaluate the rates and amounts of subsidence which resulted from mining operations.

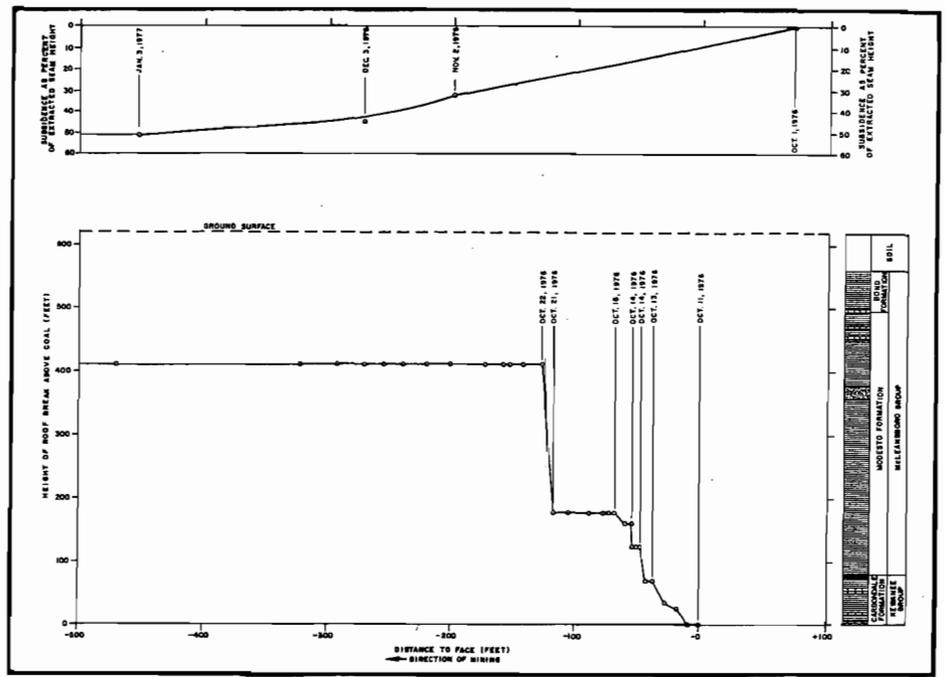
Fig. 2— Roof break vs. face advance.

When the coal was mined the cable was cut and the termination of the cable was observed on the TDR record. At that time, the schedule of readings was changed to twice each day. The collapse of the mine roof after mining and the successive failure of strata above the mine caused breaks in the cable which could be observed in the TDR records. Fig. 2 shows a plot of the height of strata separation above the coal vs. the distance to the face.

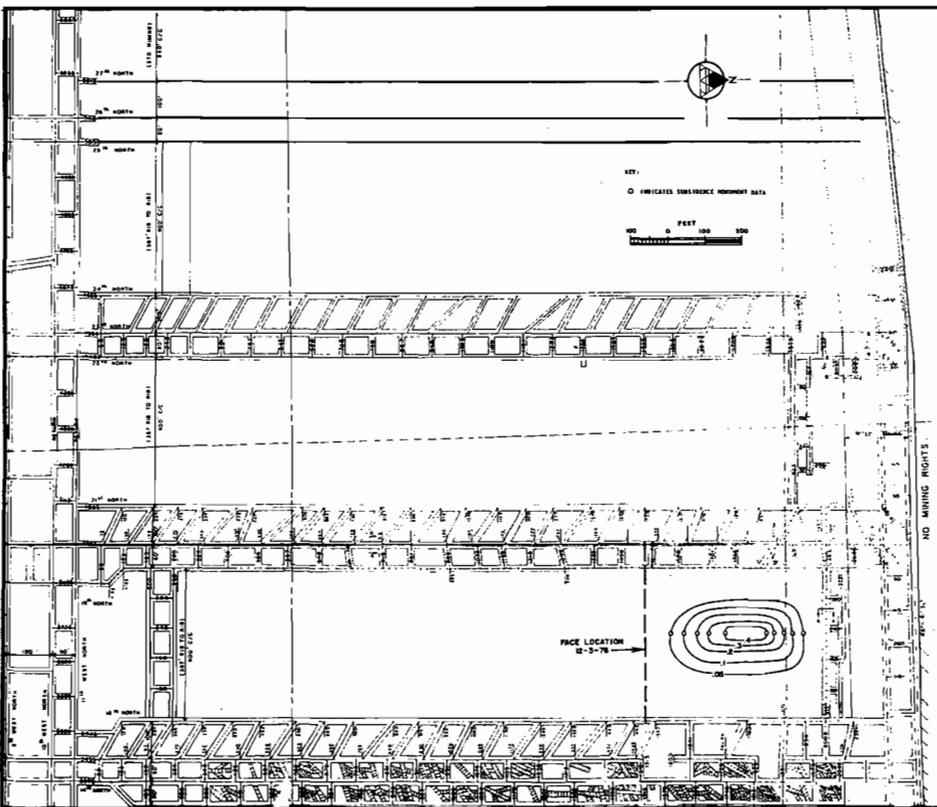
Fig. 3— Surface subsidence contours, Dec. 3, 1976.

Subsidence contours were drawn for three different face positions as shown in Figs. 3, 4, and 5. The contour ratios are the measured subsidence over the average extracted seam height which is 2.1 m (7 ft). Multiplying the contour ratio by 7.0 will give the actual subsidence for the contour line.

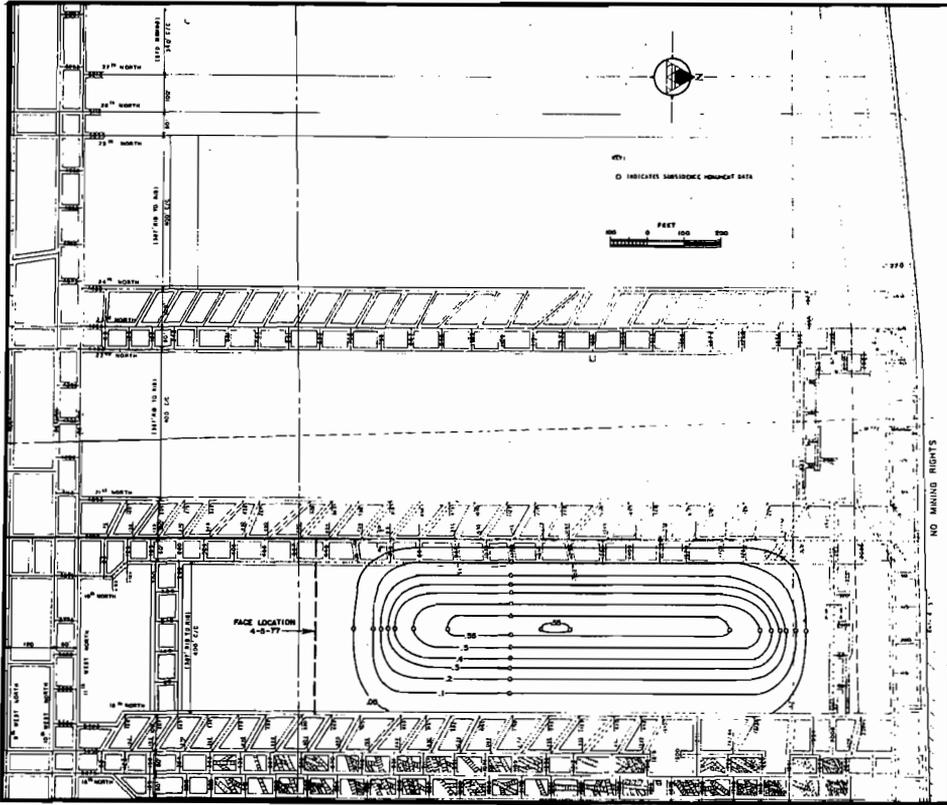
Fig. 4— Surface subsidence contours, April 5, 1977.

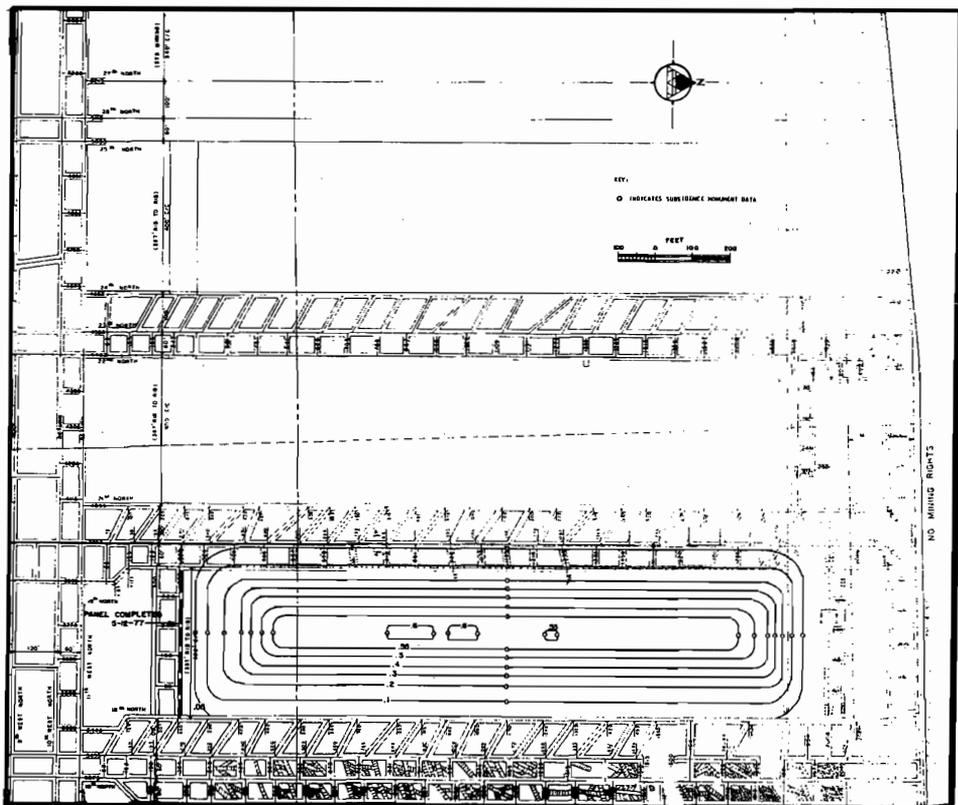
Fig. 5— Surface subsidence contours, May 31, 1977.

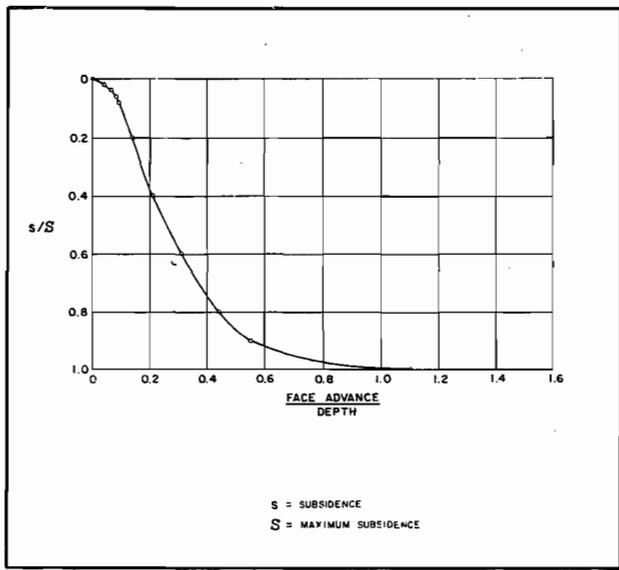
Fig. 6— Generalized subsidence development curve.

A generalized subsidence development curve was constructed using representative development curves from several monument locations. This development curve shown in Fig. 6 indicates that 100% subsidence occurs at a distance approximately equal to overburden depth.

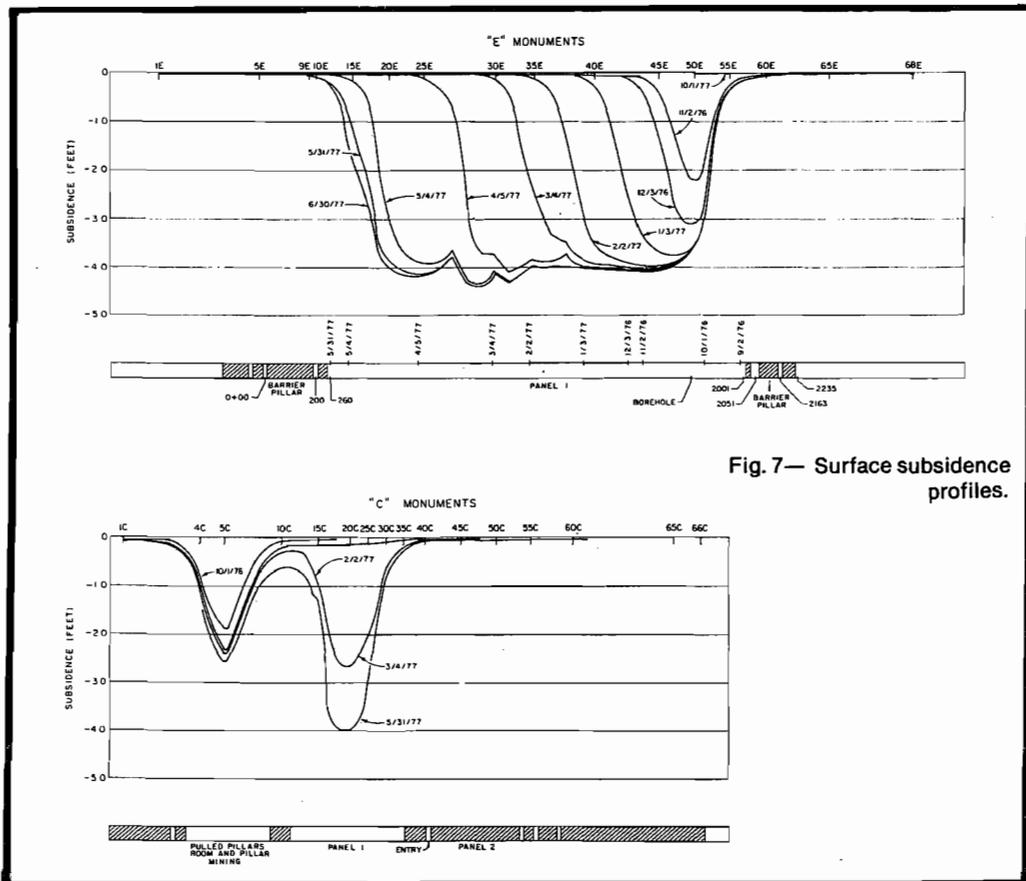
Fig. 7— Surface subsidence profiles.

Subsidence profiles were plotted using the line of monuments running north-south over panel 1 and the line of monuments that runs east-west. These profiles are shown in Fig. 7. The mining with pillar extraction east of Panel 1 has contributed to the subsidence in that area.

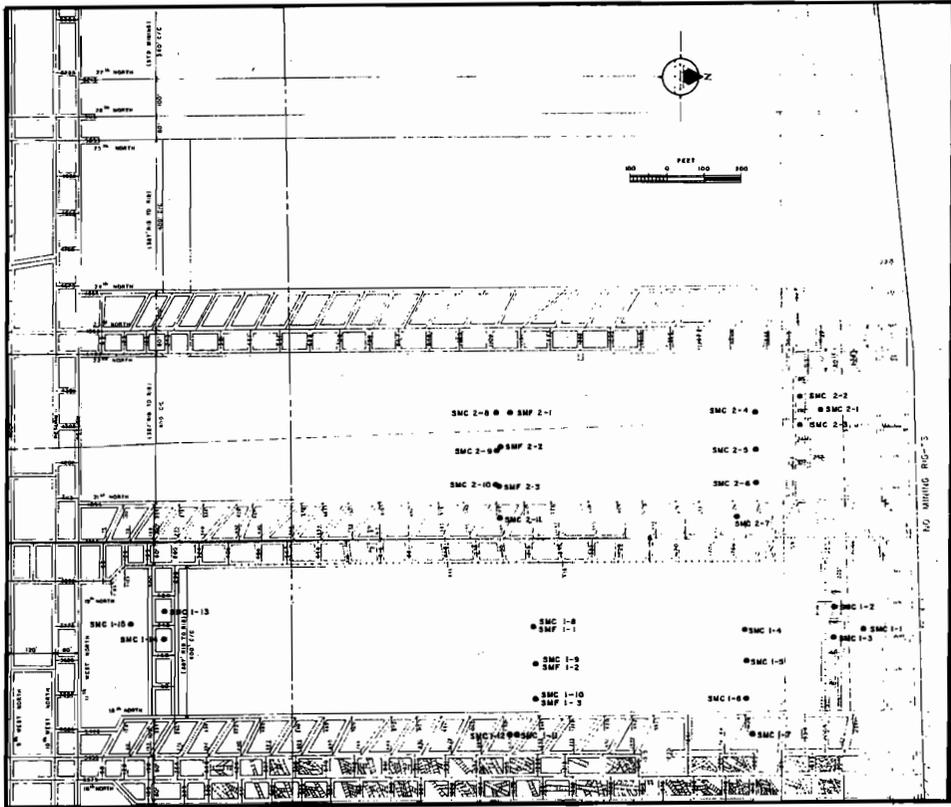
Fig. 8— Stressmeter locations.

The stressmeters were used to monitor pressure changes in the coal seam, in the longwall panel and the pillars surrounding the panel, and in the siltstone floor under the longwall panel. The stressmeters were placed in 38.1-mm (1½-in) diam boreholes drilled both horizontally and at an incline into, around and under panel 1. The setting distances ranged from 7.3 to 84.7 m (24 to 278 ft). The locations of the stressmeter installations are shown in Fig. 8.

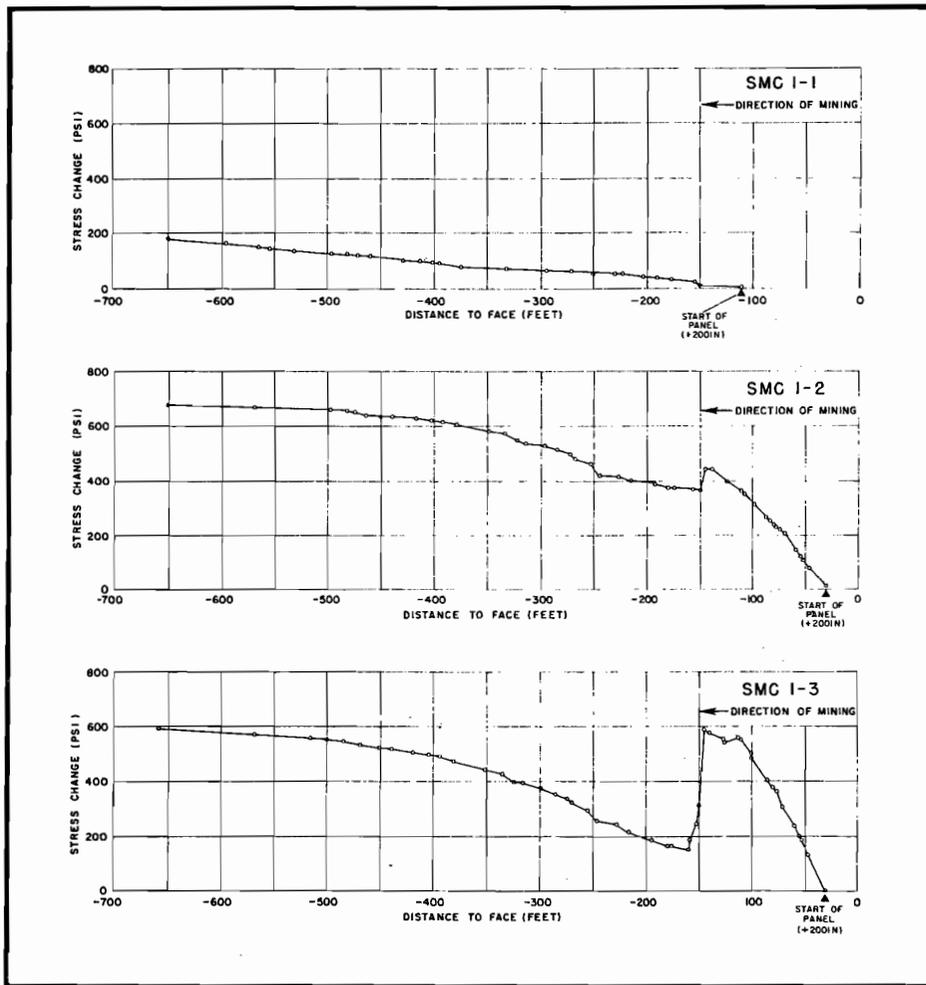
Fig. 9— Stress change vs. distance to face stressmeters, SMC 1-1, 1-2, and 1-3.

Representative plots of stress change as a function of face advancement are shown in Figs. 9 and 10.

Stressmeters (SMC 1-2 and SMC 1-3) installed in pillars at the bleeder entries showed a marked increase in stress  $2.7 \times 10^6$  to  $4.1 \times 10^6$  Pa (400 to 600 psi) when the face was advanced to approximately 45.7 m (150 ft). At that point, stress reduced sharply and then increased to exceed  $4.1 \times 10^6$  Pa (600 psi) above initial stress. The sharp stress reduction was accompanied by large roof falls behind the shield and by failure of the underclay beneath the bleeder entry pillars. A similar failure of the underclay was observed at pillars in the recovery area when pillar stresses reached  $4.1 \times 10^6$  to  $5.5 \times 10^6$  Pa (600 to 800 psi) above overburden stress.

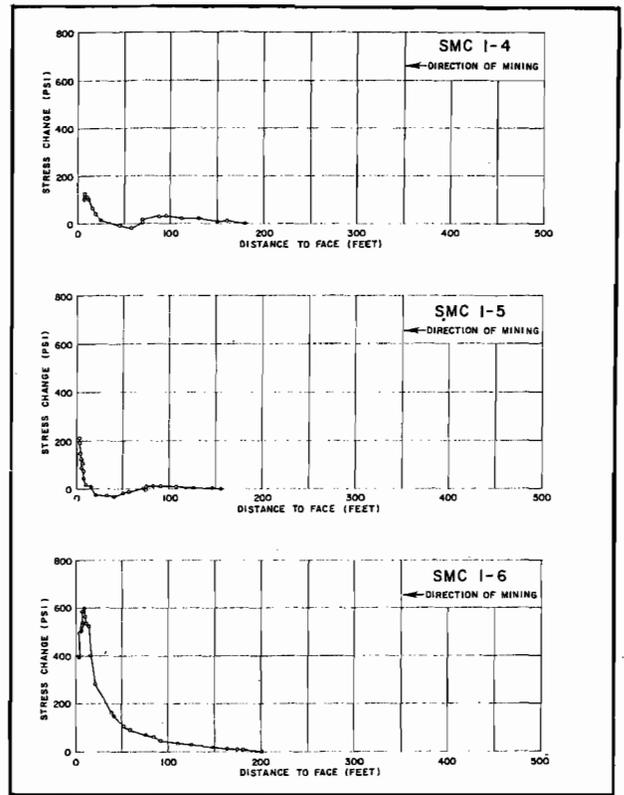
Fig. 10— Stress change vs. distance to face stressmeters SMC 1-4, 1-5, and 1-6.

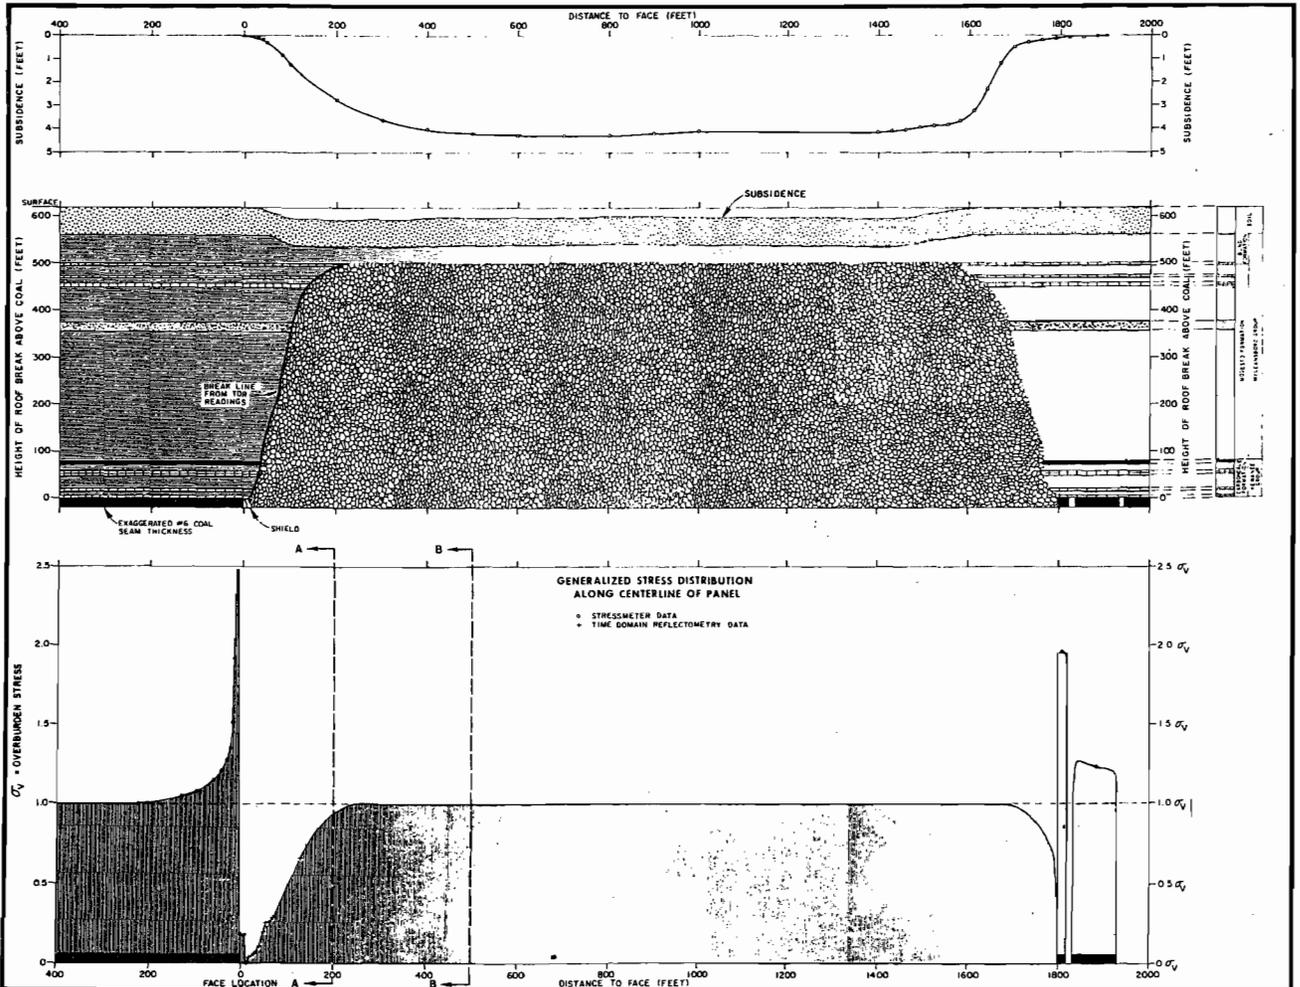
Fig. 11— Generalized stress distribution along panel center-line.

Fig. 11 was developed from stressmeter, TDR, and subsidence data to show generalized stress distribution along the panel centerline. This figure shows that at a distance of approximately 76.2 m (250 ft) loading on the gob has resumed overburden pressures. At a distance of approximately 91.44 m (300 ft), most of the subsidence is the result of consolidation of the gob. Fig. 12 was developed from stressmeter data and shows the generalized distribution of stresses in the panel and adjacent pillars.

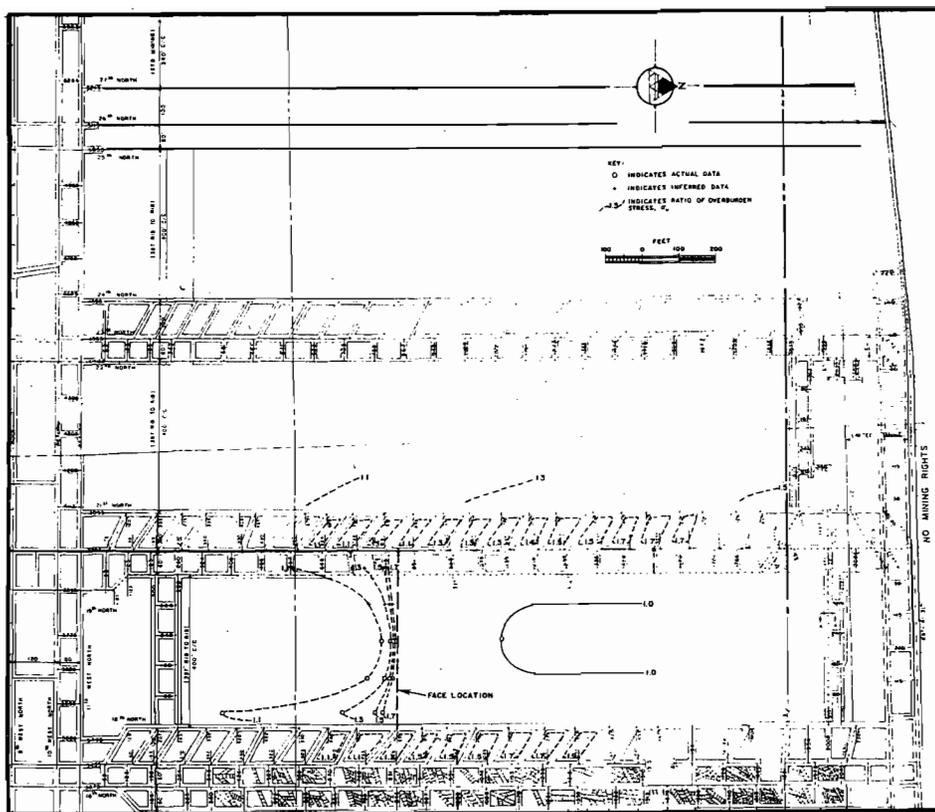
Fig. 12— Generalized stress contours.

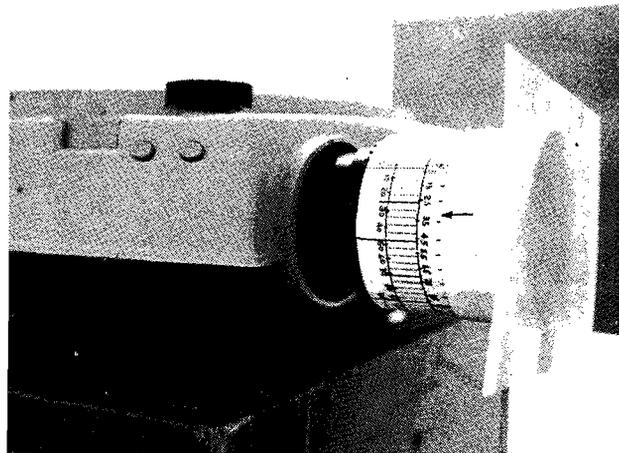
Fig. 1— Photograph of Ronchi grating and indexing device. The index is divided into four 90° quadrants and labelled according to compass directions.
