DEMONSTRATION OF SHIELD - TYPE LONGWALL SUPPORTS  
AT YORK CANYON MINE OF KAISER STEEL CORPORATION

Final Technical Report A  
Contractor - Kaiser Steel Corporation

Date Published - April 1980

Contract No. - U.S.D.O.E. EF-74 - C - 01 - 9067  
(Formerly U.S.B.M. S0144066)

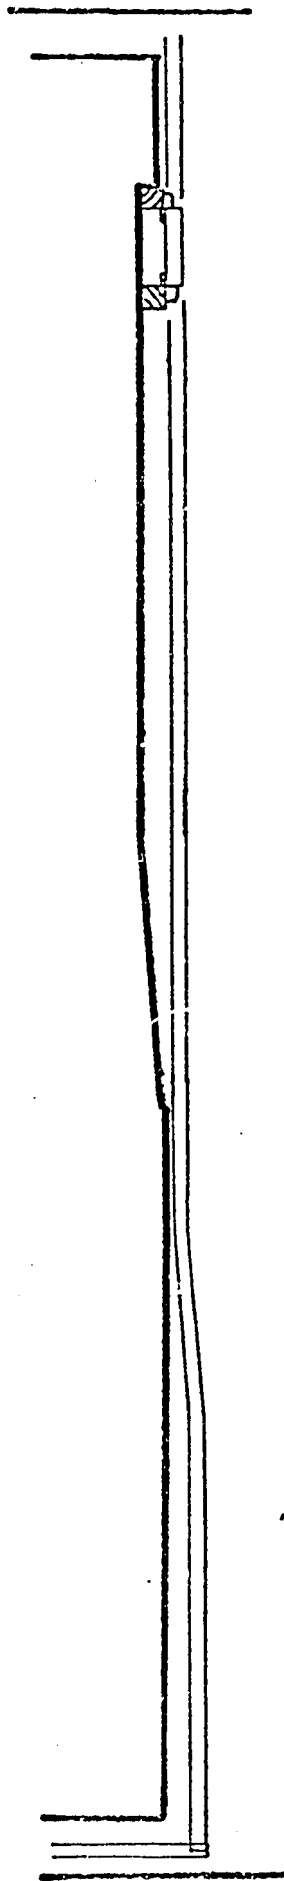
FIGURE 21A

Shearing machine is ready to start cycle. The face conveyor is away from the face for the first half of the face and is pushed against the face on the last half of the face.

The shearing machine flits to the center of the face without cutting coal. the shearing machine is then sumped in at the center of the face. It is then ready to cut coal toward the tailgate.

The shearing machine cuts toward the tailgate. The face conveyor is pushed forward from the center of the face to the headgate to prepare for the return cut.

The shearing machine breaks through the tailgate and flips the cowl. The face conveyor has been pushed over on the first half of the face for the return cut. The shearing machine will now flit to the center of the face without cutting coal.

The shearing machine flits to the center of the face.

The shearing machine cuts coal from the center of the face towards the headgate. The face conveyor is pushed over from the tailgate to the center of the face to prepare for the next cycle.

The cycle is completed when the shearing machine breaks through to the headgate entry. The face conveyor has been pushed over on the tailgate half of the face so that the next cycle is ready to start.

With the half face method, the shearing machine travels from the headgate to the center of the panel and then cuts to the tailgate. It then travels back to the center of the face and cuts to the headgate to complete the cycle. After the shearing machine passes, the shields which were originally in the one web back position are brought in tight against the face conveyor. The face conveyor must be left back from the face until the shearer returns to the center of the panel. This is necessary since the shearer cannot travel along the face with the conveyor pushed forward without cutting coal. When the face conveyor is pushed forward, the shields are left in the one web back position. When this method is used, half of the shields are tight against the face conveyor and half are in the one web back position at all times. The distance from the shield canopies to the face is the same as if all shields were in the one web back position. Figure 21 illustrates the half face method.

Because half of the shields are tight against the face conveyor at all times this method results in poorer working conditions for half of the face. This method is also limited to areas with good roof since all the shields are never tight against the face.
