17th CONFERENCE ON GROUND CONTROL IN MINING

A Case Study of Bolt Performance in a Two-entry Gateroad

ABSTRACT

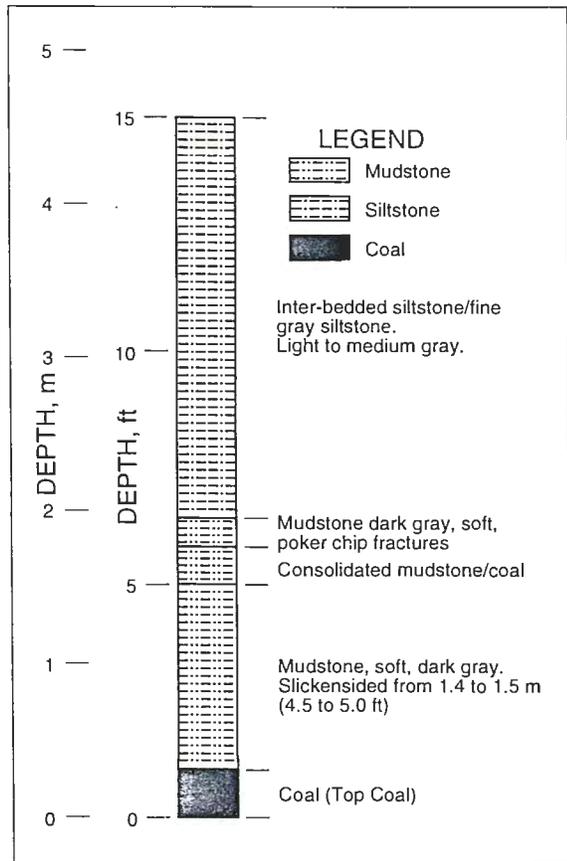
Figure 1.—Core log near crosscut 59

Geology may have been a significant factor in the localized roof degradation. Several 2.7- to 4.6-m (9- to 15-ft) deep core-holes were drilled, and AX core was removed and tested to assist in a geological assessment of the roof. The immediate roof in the bad areas had layers of very weak mudstone, carbonaceous mudstone, and coal. Immediately above these weak layers was a very strong siltstone-sandstone member that had an average compressive strength of 179 MPa (24,600 psi). The mudstone was too weak to allow recovery of a sample large enough to test. The core log near crosscut 59.5 is shown in figure 1.

All data showed that enough movement was taking place within the bolted zone to load the supports past ultimate strength. Behavior of the strain gages indicated that shear forces added to axial loading caused bolt failure. The weak mudstone layer and the very strong siltstone-sandstone layer were significant factors because of their great difference in rock strength. By itself, the weight of the material was not enough to produce the bolt loads measured. However, weak material could dilate over the pillars and cause horizontal forces that would exceed the strength of the weaker material. This could have produced tensile failures in the rock that created shear forces on the supports.

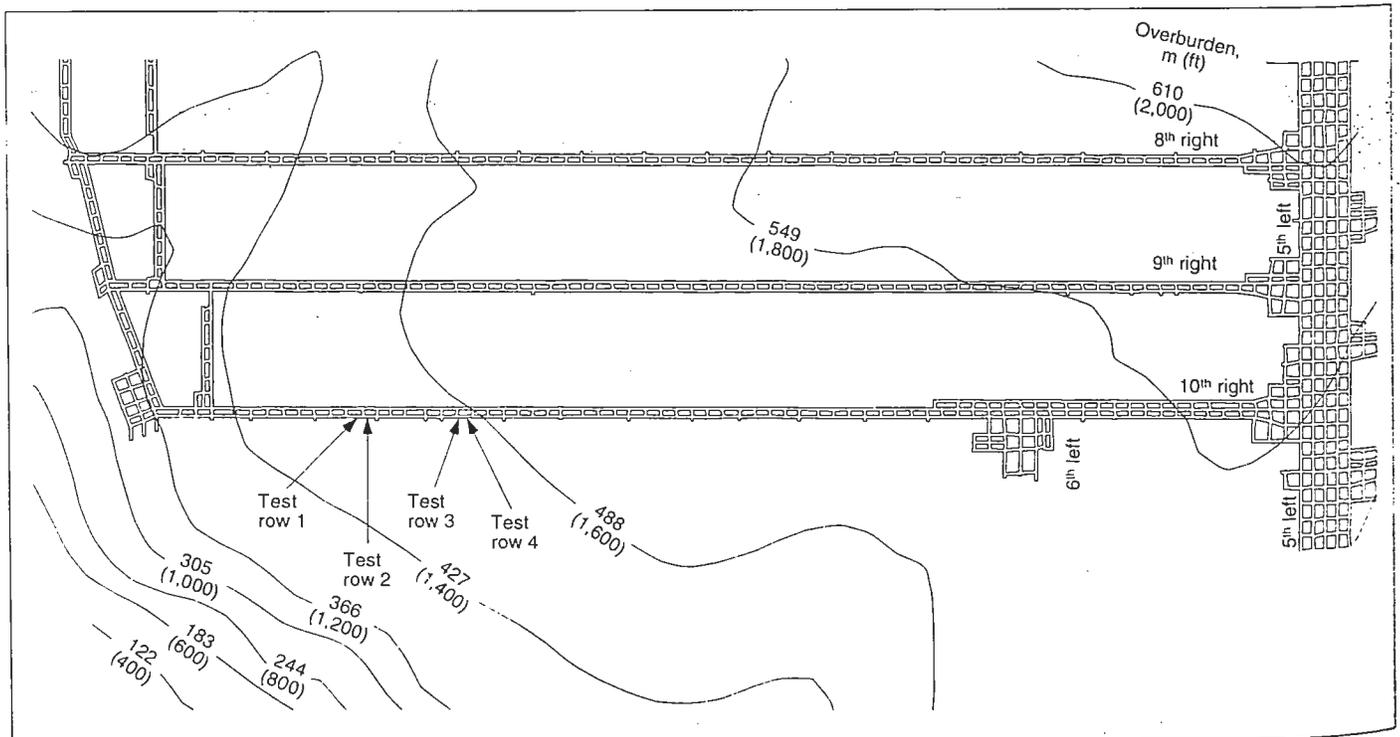
Figure 2.—Plan view of test areas

Sixteen instrumented, fully grouted bolts, as well as sagmeters and pressure pads, were installed on-cycle in three test areas in the 10th Right gateroad to measure loading on bolts in the existing support pattern and to determine if cable bolts could be used to improve roof stability. This gateroad was the last in a sequence of longwall panels (figure 2).

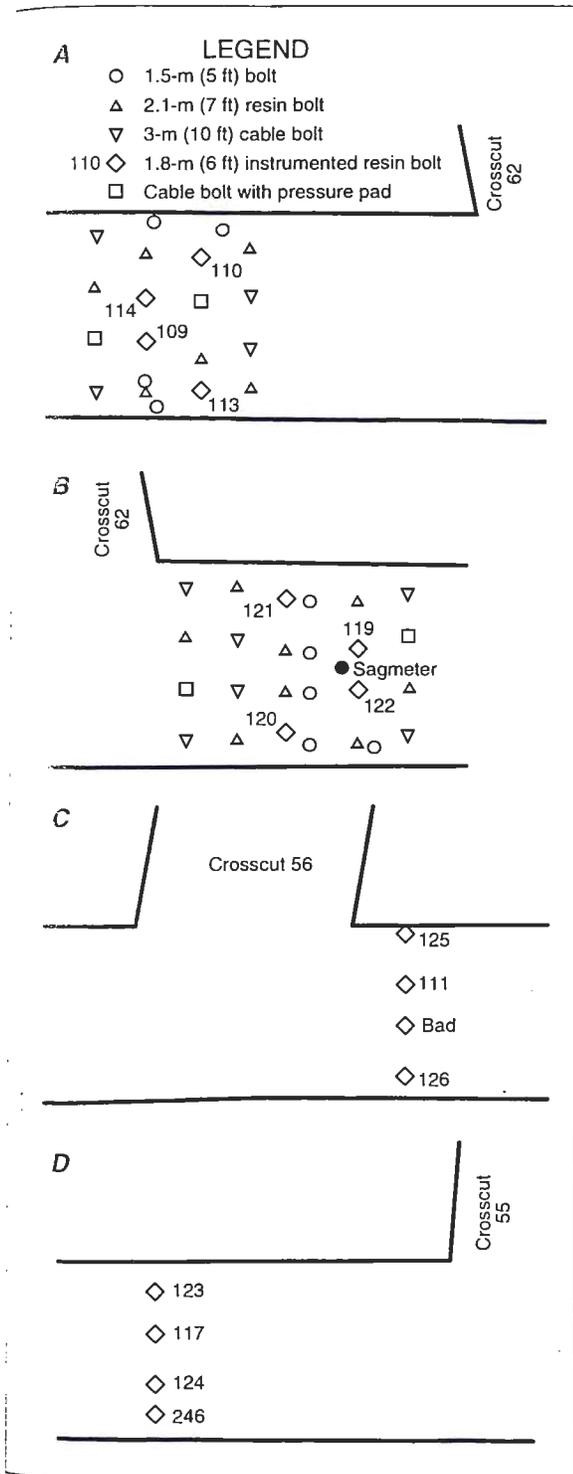
Figure 3.—Test rows. A, Fully grouted bolts; B, partly grouted bolts; C, resin bolts, row 3; D, resin bolts, row 4.

In the first test area, a combination of fully grouted cable bolts and resin bolts was used (table 1). Two rows of instruments were located approximately 12 m (40 ft) outby from the center of crosscut 62. The resin bolts and cable bolts were alternated as shown in figure 3A.

In the second test area, a combination of partly grouted cable bolts and resin bolts was used (table 1). Two rows of instruments were located approximately 8 m (27 ft) inby from the center of crosscut 62 (figure 3B).

Two rows of instrumented No. 7, grade-60, 6-ft-long resin bolts were installed in the third test area as the primary support. The first row was 4.9 m (16 ft) inby the center of crosscut 56, and the second row was 19.8 m (65 ft) inby the center of crosscut 56 (figure 3C-D). The connector to an instrumented bolt in this test area was severed during installation. The uninstrumented resin bolts were 2.1-m (7-ft) long and were No. 6, grade 60. Entry development and longwall pass of the test rows are shown in table 2. This gateroad had only one longwall panel pass.

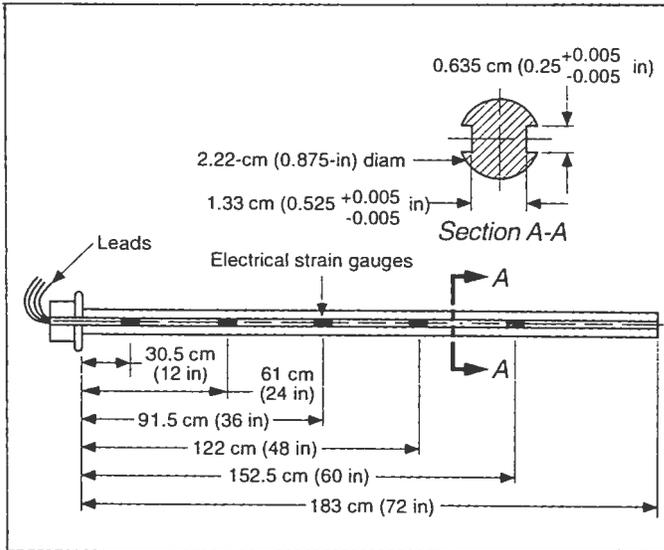
Figure 4.—Instrumented bolt

The resin bolts were modified by milling a slot 6.4 mm (1/4 in) wide and 3.2 mm (1/8 in) deep. Five strain gages were attached on both sides, as shown in figure 4. Because these bolts were used for primary support, No. 7 bolts were used in place of the No. 6 bolts. Table 3 describes the properties of the two bolts. Note that the No. 7 bolt has an increased capacity of approximately 28%.

An Omnidata Polyrecorder data acquisition system (DAS) was used to measure load on the instrumented bolts. Readings were taken immediately after installation and then periodically as mining-induced stresses changed. The strain gages on the bolts were wired into a Wheatstone bridge configuration using 350-ohm resistors and a 5-V excitation. The accuracy of the system is ± 0.445 kN (100 lb).

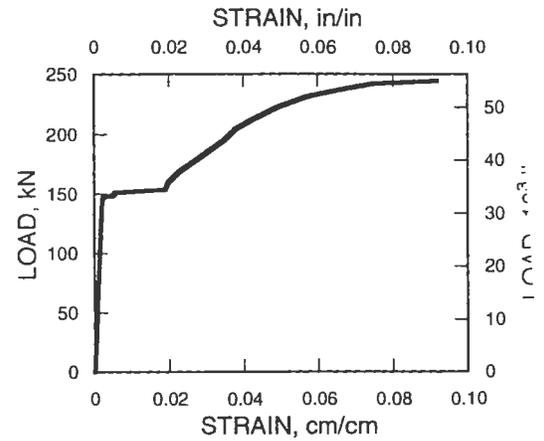
Figure 5.—Load strain plot for No. 7, grade 60, slotted bolt

Another, equally important, aspect of selecting bolts for roof support is the evaluation of strain levels in the bolt (figure 5). Typical engineering design limits strain to a percentage of the yield point. Previous evaluations of strain measured on roof bolts show that, in many cases, the yield point of the steel bolt is exceeded where the roof remains stable. Fully grouted roof bolts are a stiff support system in which loads increase quickly as the bolted strata move. Rebar bolts are made from a ductile steel that can reach strain levels of 100,000 to 160,000 microstrain at ultimate load. Yielding occurs at approximately 2,000 microstrain on grade 60 rebar. Immediately after yielding, the bolt will continue to stretch, with very little increase in load until the steel begins to work harden. Thus, design strain limits should take bolt loading mechanisms (i.e., axial, bending, and/or shear) into consideration. Bolts loaded axially with little bending or shear

Data from each instrumented bolt were evaluated in several different ways. Each bolt was calibrated in a uniaxial test machine to correlate voltage change to load change. A calibration factor was used below the steel yield point to convert voltage data to load at each of the 10 strain gages. If a bolt section exceeded the steel yield point, the strain was calculated and load estimated from the stress-strain relationship shown in figure 5.

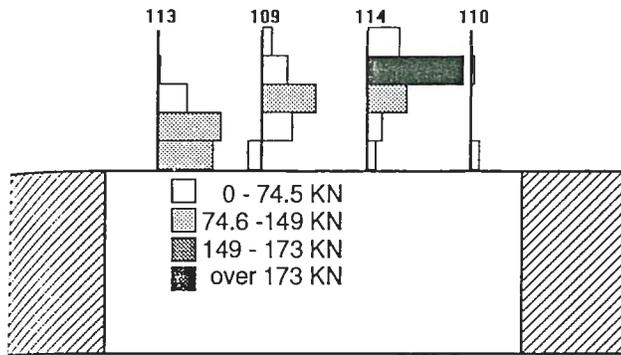
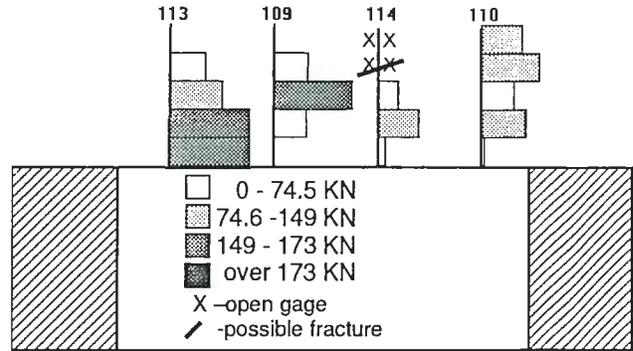
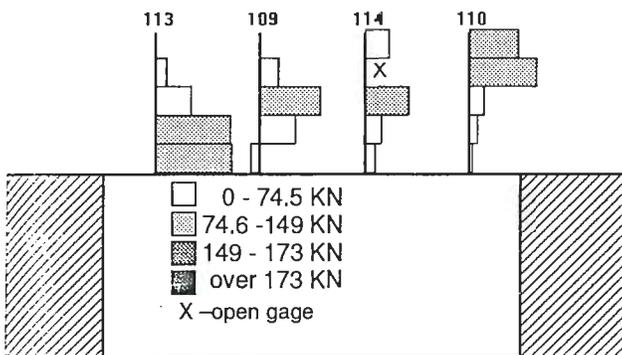
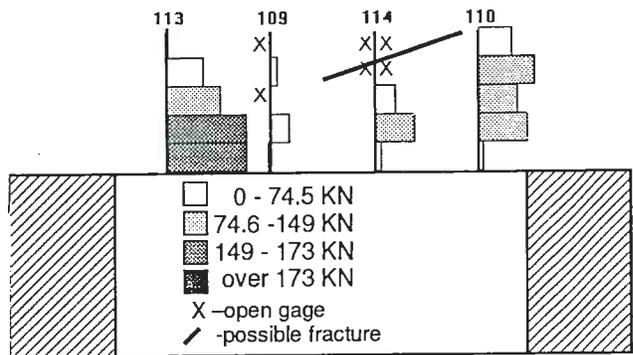
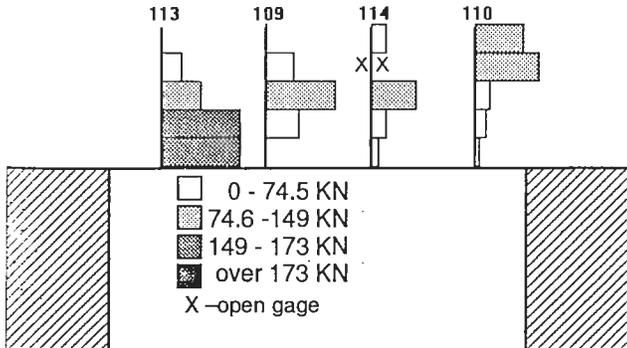
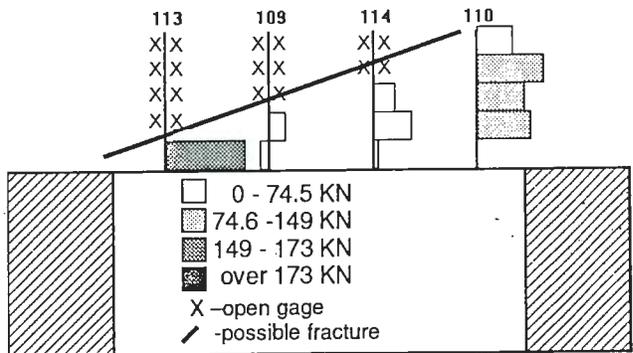
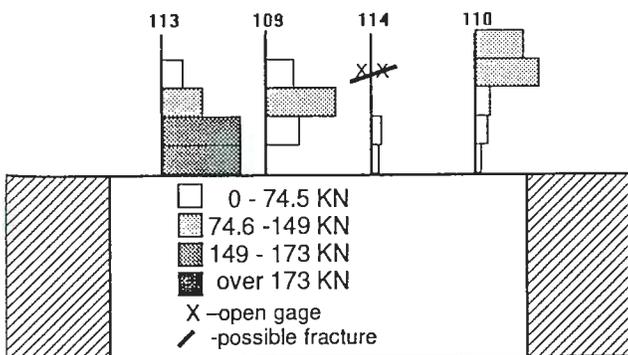
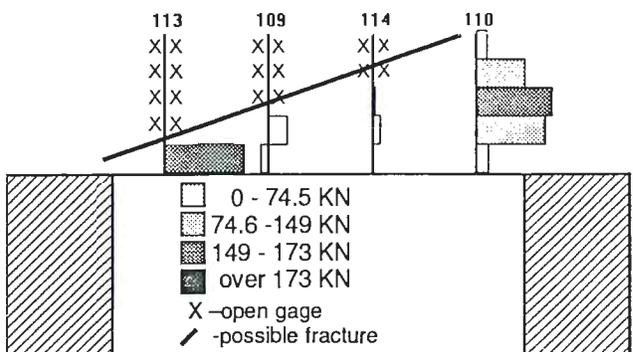
Bolt loading is shown in figures 6 through 22 as a cross-sectional view. Each test row is shown at various time intervals. Figures 6 through 13 show the development of axial loading in the row of fully grouted cable bolts. On December 12, gage 4 on bolt 114 had reached 43,000 microstrain, well into the strain hardening phase of the steel. When that bolt was read again 10 days later, that gage had an open reading and axial loading on the adjacent bolts had increased. Three weeks later, the strain gage

opposite gage 4 had an open reading. Six days later, the load level in bolt 114 dropped significantly, which may indicate that the bolt was beginning to break. On April 19, the last four gages were open, and loading increased in the adjacent bolts. Two days later, loading on adjacent bolt 109 dropped significantly and two open gages were recorded. Then on April 23, many of the strain gages had an open reading, which could have been caused by shear movement along a possible fracture plane (figure 13).

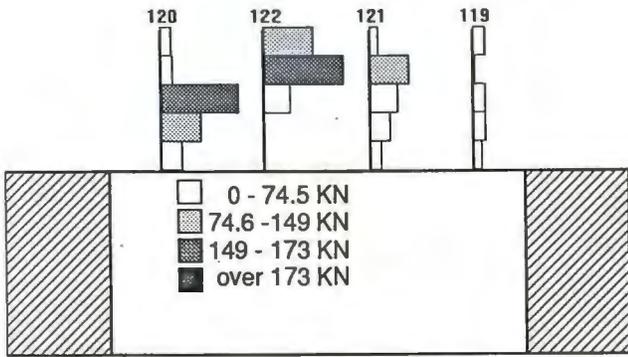
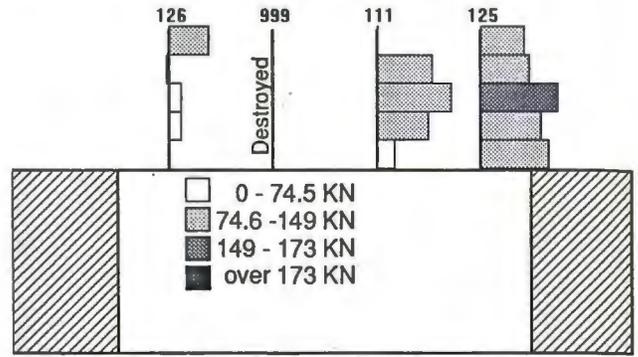
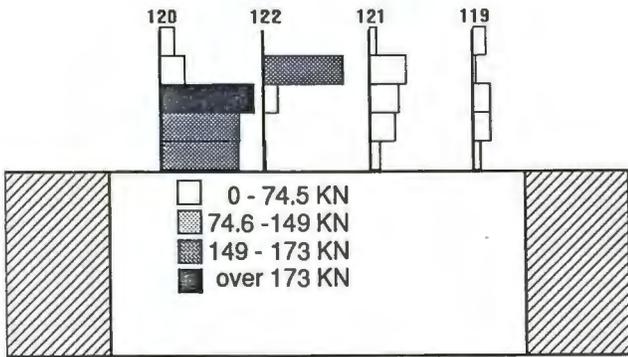
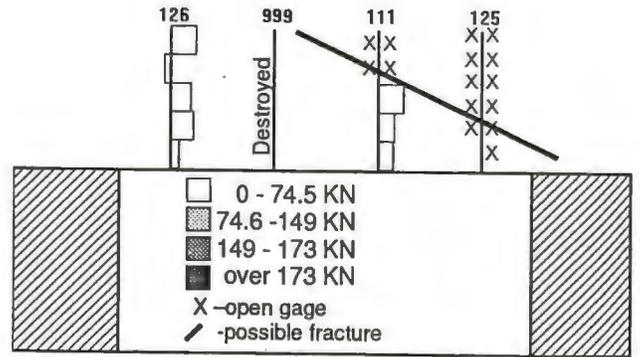
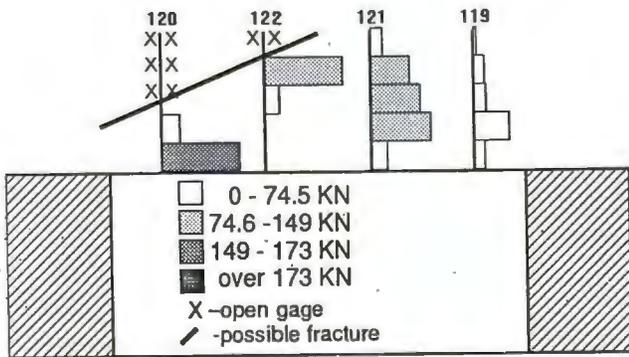
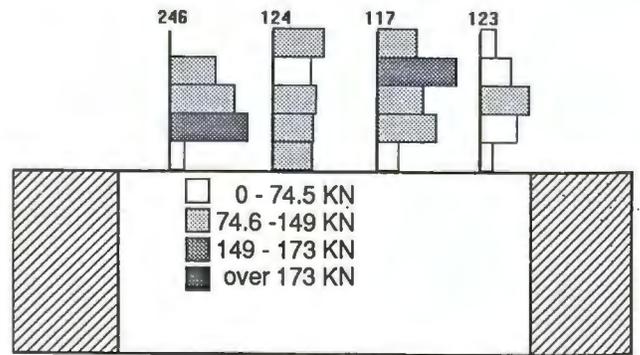
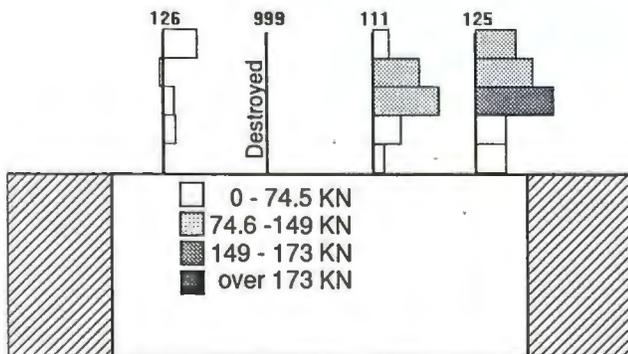
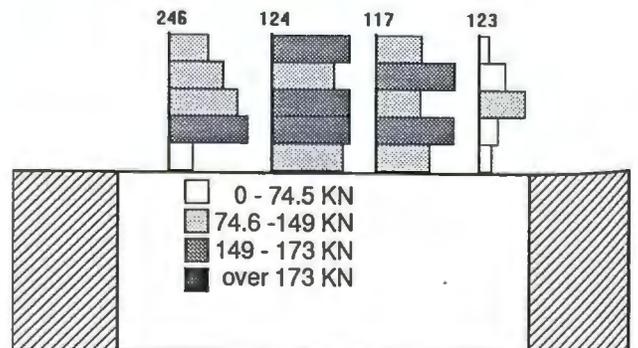
This sequence was repeated at test row 2, but only three time shots are shown. At this test site, the possible fracture plane was higher in the roof and affected only two instrumented bolts. A similar sequence was repeated at test row 3, but this time on the other side of the entry. In this test row, bolt 125 broke and was recovered on the mine floor. Test row 4 did not show any strain gage failures, and loading was more evenly distributed along the length of the bolts.

When a strain gage indicated an open reading, axial loading is not shown at that location because axial loading is an average of load on each side of the bolt. Open strain gages can be a result of either excessive loading or wire failure. Under axial loading, most lead wires maintain continuity until bolt failure. Recent shear tests on instrumented bolts show that lead wires are severed well in advance of bolt failure, and bending moments dissipate quickly from a shear joint. There are several indications that a bolt has broken: (1) high loads prior to failure, (2) loss of continuity to strain gages past the break, and (3) drop offs in

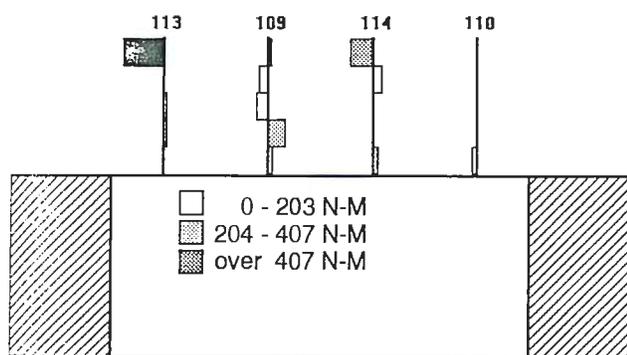
Figure 23.—Bending moments on test row 1 on 12/12/97

A typical plot of the bending moments is shown in figure 23. If shear forces caused by joint planes were the primary means of bolt failure, then the bending moments would be very localized and might not be detected because of the large spacing of the strain gages. Resin bolts will not fail under pure bending because of the high ductility of the steel. For this reason, axial loads are a better indicator of bolt failure.

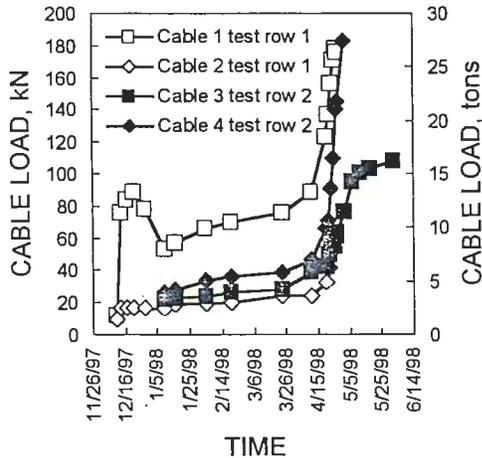
Figure 24.—Cable bolt loads

Loading on the cable bolts in test rows 1 and 2 is shown in figure 24. Loading was fairly low until the abutment stress from the longwall panel approached the test areas, at which time the load increased rapidly and the pressure pads failed to work on all but cable 3. Several uninstrumented cables broke in both test areas along with instrumented cable 4.
