SUMMARY OF FIELD MEASUREMENTS OF ROOF BOLT PERFORMANCE

By Christopher Mark, Ph.D.,¹ Dennis Dolinar,² and Thomas P. Mucho³

Proceedings: New Technology For Coal Mine Roof Support

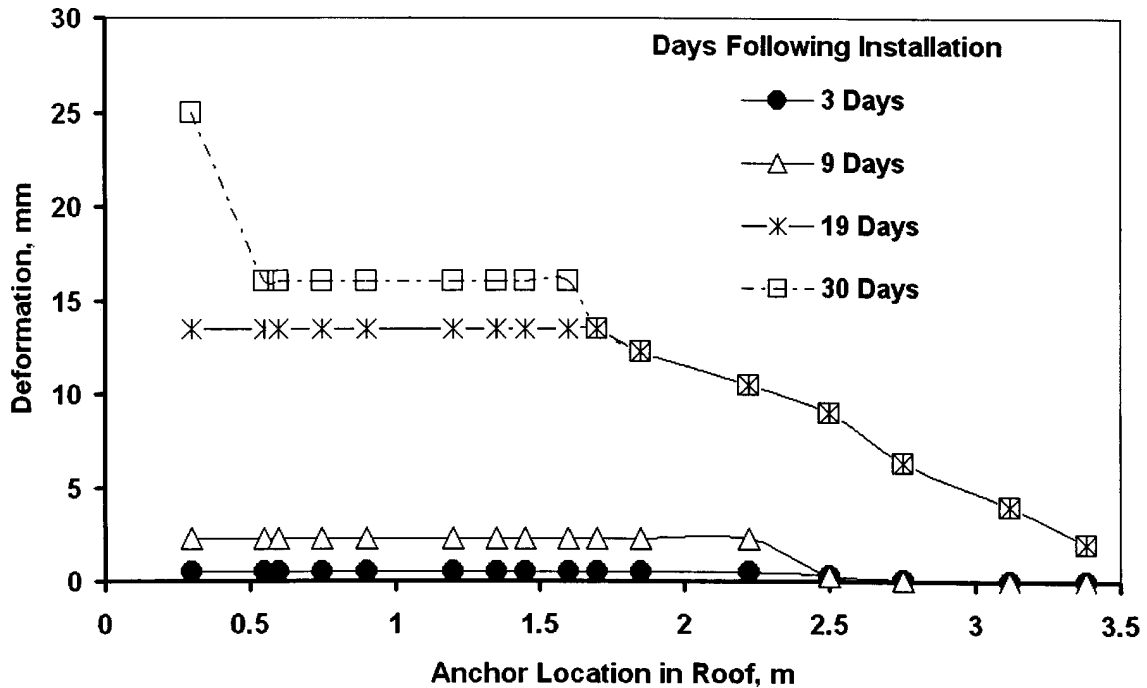
Figure A-2.—Roof deformations measured at mine A.

As shown in figure A-1, a roof cutter (rock shear failure) formed along the left (panel side) rib coincident with mining and prior to the instrumentation or other supports being installed. Very little roof movement was measured initially, however. Nine days after installation there had only been a few millimeters of movement slightly above the bolts. After several weeks, however, the roof within the development section began to "work" (audible noise, dripping, etc.), and workers had to be called to the mine to set supplemental supports throughout the section, including the instrumented area, to prevent possible roof collapse. The extensometer showed that a movement of slightly over 13 mm (0.5 in) had occurred above the bolts and near the bolt top anchorage zone at the shale/sandstone interface (figure A-2).

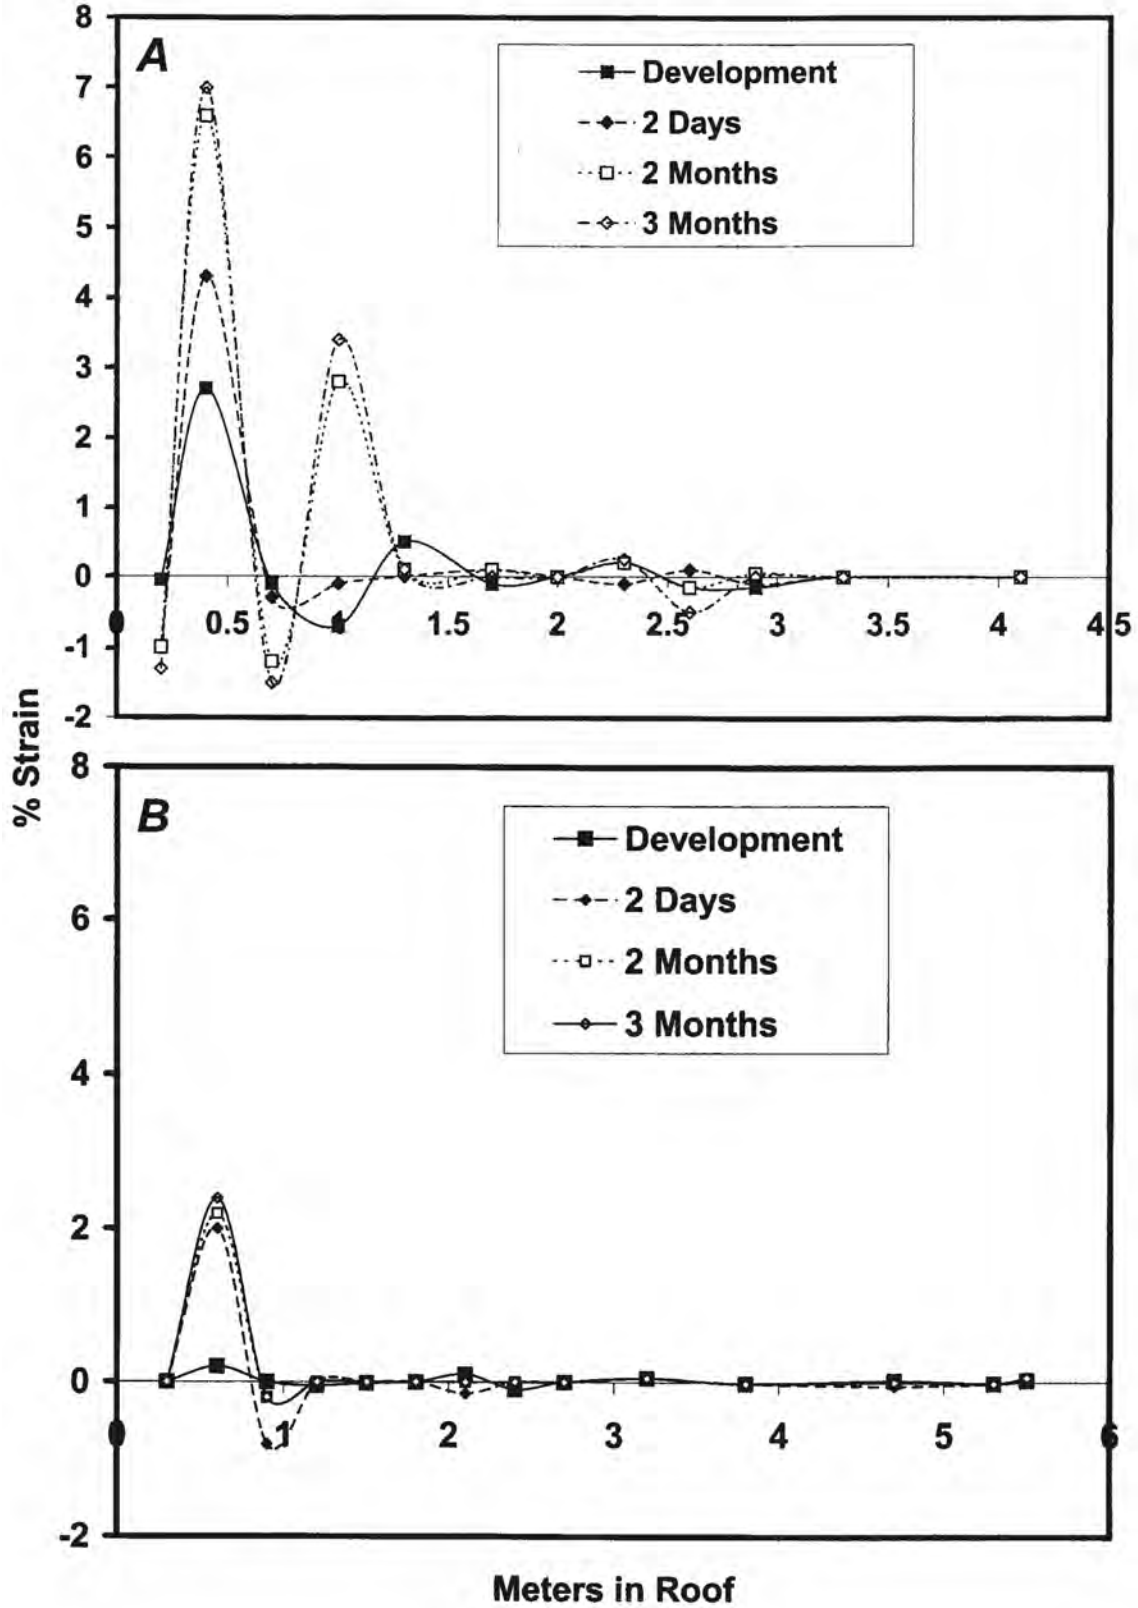
Figure A-5.—Roof strains measured at mine C. A, Resin bolt site; B, torque-tension bolt site.

A roof cutter developed coincident with mining in the No. 4 entry (the resin bolt area), and a similar cutter developed soon after mining in the No. 2 entry. The extensometers in the resin bolted No. 4 entry detected roof movements within 3 hr of installation. During the next 3 weeks, major roof movements (as much as 7% strain) were recorded within the bolted horizon (figure A-5). Since the cutter developed later in the tensioned rebar area, the roof movements occurred later following mining. The magnitudes of the movements in the tensioned rebar area were also less than the nontensioned fully grouted bolt area, ranging between 1% to 2% strain in the lowest 1.5 m (5 ft) of the roof. Like the fully grouted nontensioned area, no movement was observed above the bolted horizon during the study period.

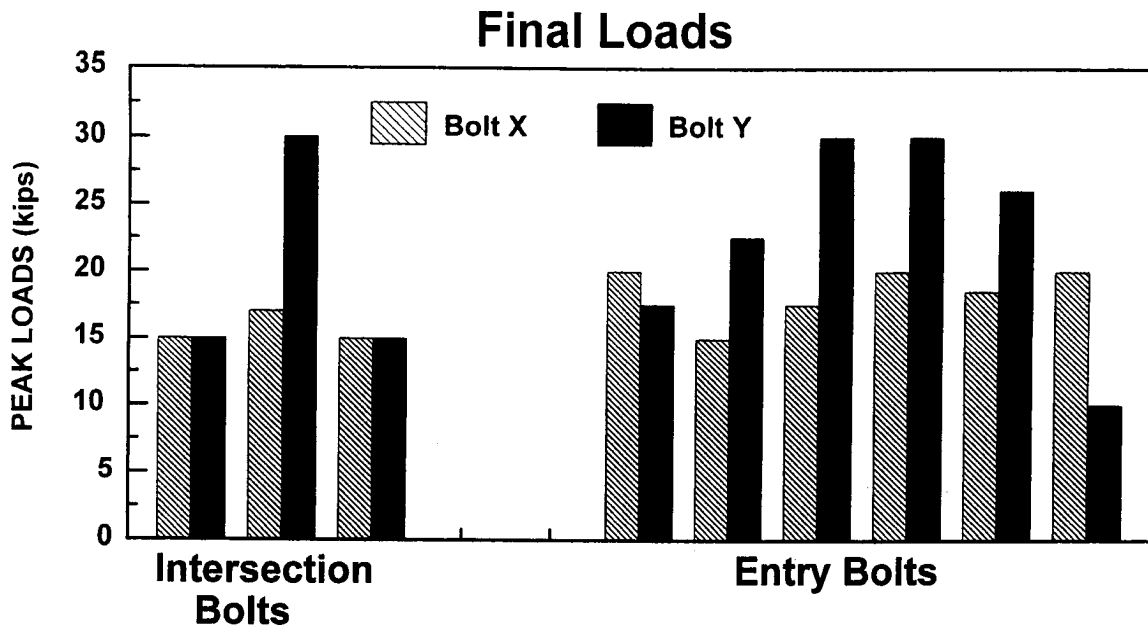
Figure A-7.—Roof bolt loads measured at mine D. Bolts are paired by location (i.e., the first pair shows the intersection right-hand X bolt compared to the intersection right-hand Y bolt).

The maximum load achieved by the short-anchor X bolts averaged 84.5 kN (19,000 lb), but in many cases the load was dropping as the longwall approached. Several Y bolts achieved the yield limit of the steel of 150 kN (33,000 lb), and most continued to increase their load up until the final reading as the longwall face passed (figure A-7). Since the maximum load achieved by the short-anchor bolts was well below the strength of the steel, it appears that the anchors must have been slipping. The most likely explanation is that 0.3 m (1 ft) of resin was insufficient to maintain anchorage in this particular roof rock.

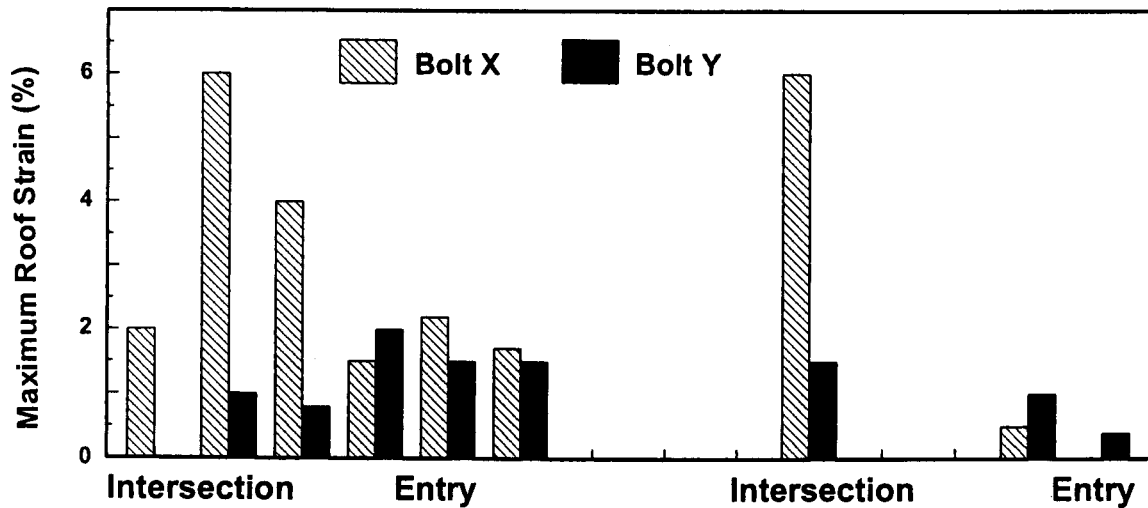
Figure A-8.—Roof strains measured at mine D. The right-hand data show strains measured within the bolted horizon; the left-hand data show strains measured above the tops of the bolts.

Roof strains measured during the approach of the longwall are shown in figure A-8. At the X bolt stations, roof strains >2% were measured at four locations within the bolted horizon. At one intersection location, a roof strain of 6 was measured *above the bolts*. The X bolts apparently began to lose control of the ground as the horizontal stress concentration developed.

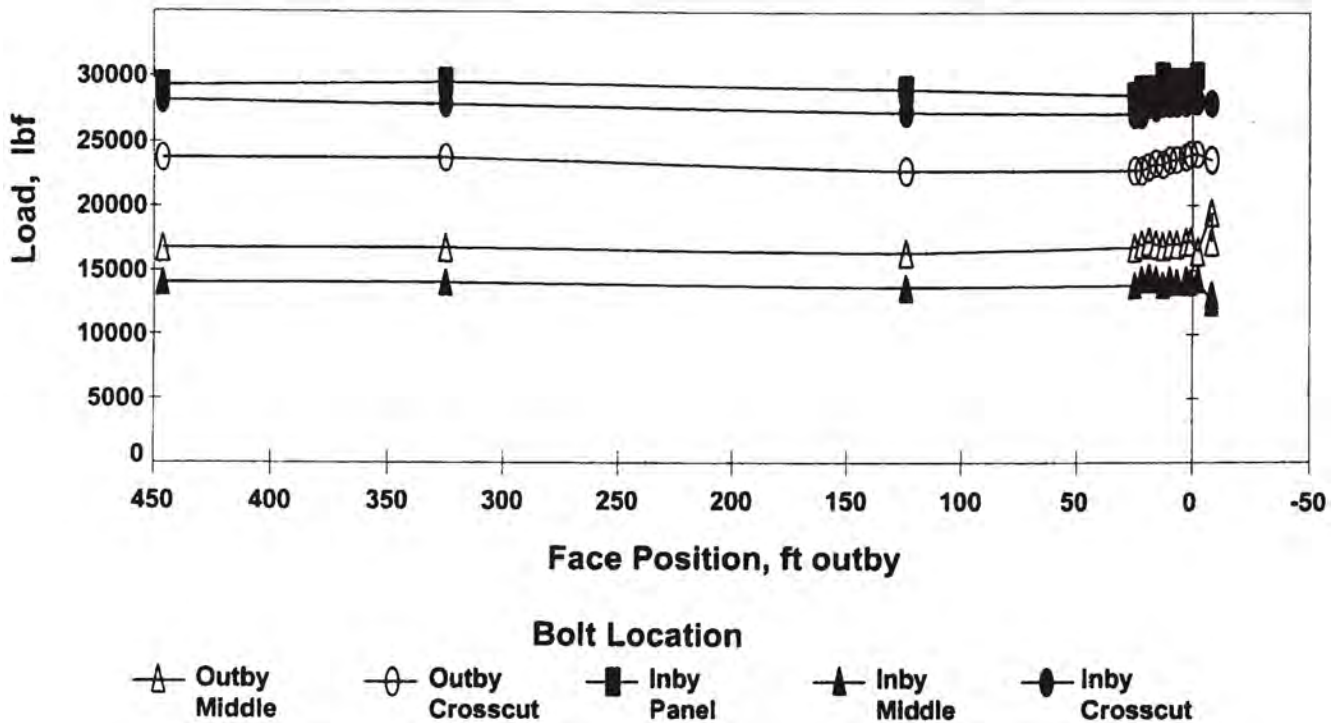
Figure A-9.—Bolt loads at mine E during the approach of the longwall.

Very little change in roof deformation and almost no change in bolt load was observed at any of the four sites as the longwall approached. The maximum increase in roof strain averaged a mere 0.2%, and all of this occurred below the bolt horizon. Final loads on the tensioned bolts ranged between 75 and 135 kN (8 and 15 tons), considerably less than their 150-kN (16.5-ton) yield strength. As the longwall approached, some bolts even decreased load slightly (figure A-9). It appears that relief of the horizontal stress may actually have *enhanced* roof stability!

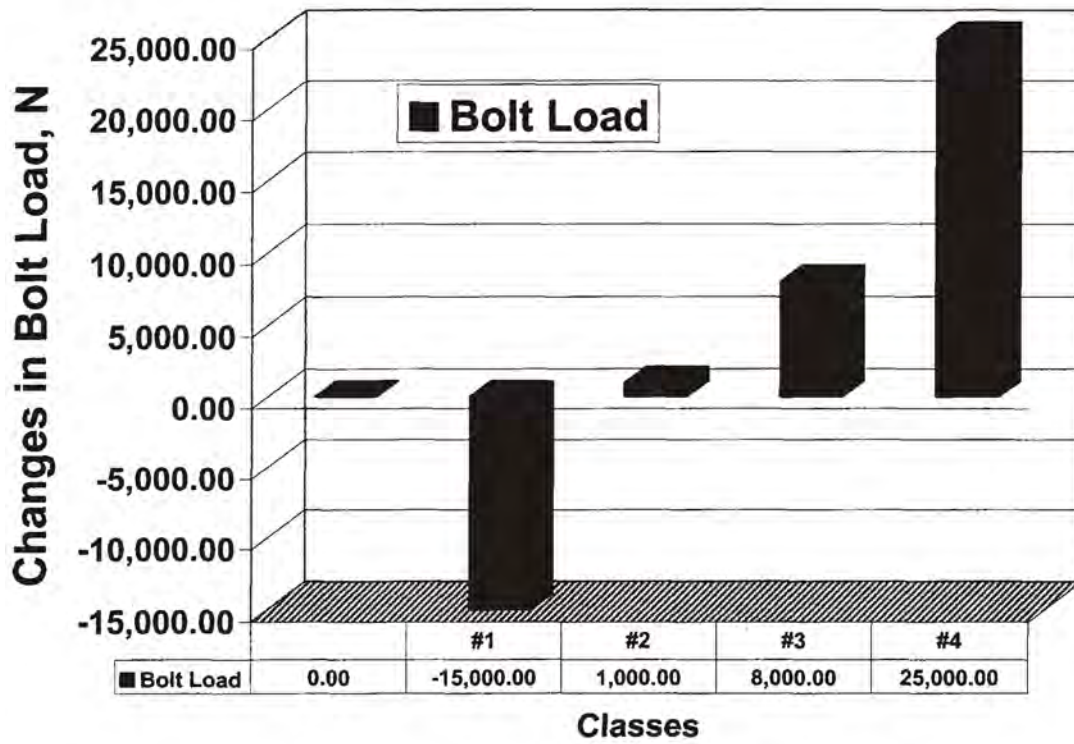
Figure A-14.—Changes in roof bolt loads measured at mine G. Bolt No. 4 is nearest a cutter; bolt No. 1 is nearest a solid rib.

The bolt loading increased systematically from the No. 1 bolt to the No. 4 bolt. The No. 4 bolt, which was farthest from the coal pillar and near a "cutterlike" feature, saw a load of 100 kN (23,000 lb), which is near its yield point (figure A-14). The bolt loadings did not change significantly over time even when the pillars were recovered.
