# 19th CONFERENCE ON GROUND CONTROL IN MINING

## Utilizing the "Advance and Relieve" Method to Reduce Horizontal Stress Affects on the Mine Roof, A Case Study

*Dennis R. Dolinar*, Mining Engineer  
*Thomas P. Mucho*, Branch Chief  
*David C. Oyler*, Mechanical Engineer  
NIOSH - Pittsburgh Research Laboratory  
Pittsburgh, PA

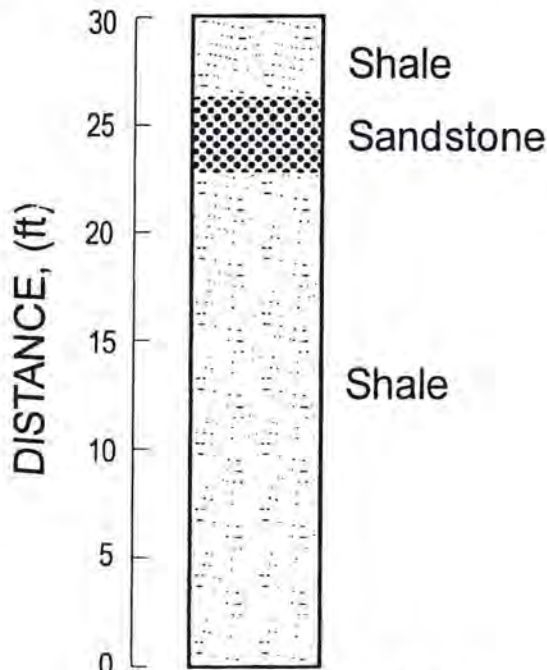
Figure 2. Roof geology in the E-mains and panels

The Tanoma Mine is in the Lower Kittanning or B seam and has a coal height of 46 in. The geology of the immediate roof in the E mains and panels consists of a gray or black shale to a depth of about 20 ft. This shale is overlain by a competent sandstone that is generally 2 to 3 ft thick. In areas, the shale will become silty especially above a depth of 15 feet in the roof and near the sandstone. However, at times the sandstone may be within 10 to 15 ft or closer to the seam. Figure 2 shows a typical geologic section of the mine roof.

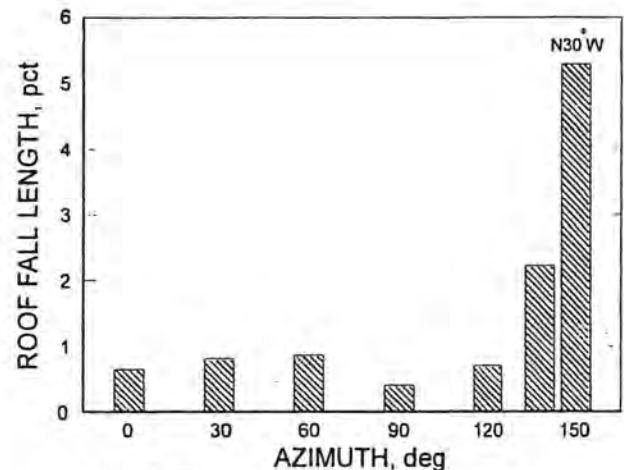
Figure 3. Direction of failed roof normalized by drivage in a given direction

In the E mains and panels, the mine has experienced directional roof control problems that are related to horizontal stress. The stress damage includes long running roof falls and cutters. Roof falls as long as 2,000 ft and up to 30 to 35 ft high have occurred generally in the northwest or southeast direction (figure 1). About 95 pct of the fallen roof is in the N 30° W orientation. Figure 3 shows the amount of fallen roof normalized by the drivage in a given direction. In the N 30° W direction, over 5 pct of the drivage has failed while a little over 2 pct of the drivage has fallen in the N 40° W direction. In the other mining directions, less than 1 pct of the roof has fallen. These roof falls have occurred on both development and during retreat mining where falls occur just outby the cave. When the roof falls occurred during retreat mining, the panels or portions of the panels would often be abandoned. A little over 40 pct of the drivage is in the N 30° W direction while about 20 pct of the drivage is in both the east-west and N 30° E direction.

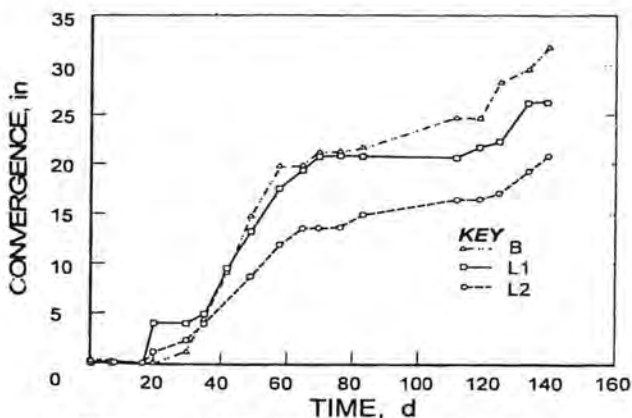
Figure 13. Floor heave rates across E17 panel

The maximum floor heave occurred in both panels during the first 800 ft of "advance and relieve" pillaring. In E15 the average heave rate in this panel section was 0.24 in/day, while in E17 the average rate was 0.38 in/day. These rates were maintained for periods of up to 40 to 60 days before leveling off. In places, 20 to 30 in of floor heave resulted. This floor heave occurred across the panel width and was not confined to the area adjacent to the cave. Figure 13 shows the pattern of floor heave over time across the E17 panel 200 ft inby the start of pillaring. The accelerated rate of floor heave shown in figure 13 after 115 days is the result of retreat mining in the panel. The variable initial rates between 20 and 30 days may reflect the failure of the hard shale layer.
