## Case studies of cable bolts using instrumented King Wires

Instrumented cable bolts developed at the Spokane Research Laboratory of the National Institute for Occupational Safety and Health were used in conjunction with existing ground control to monitor rock mass loads at various field sites (FMC Granger, Getchell, Meikle, SSX, K-2, and Stillwater). Axial and shear loads were determined by strain gauges to levels of instrument accuracy of  $\pm 5$  N or  $\pm 5$  microstrain as these loads were transferred to the instrumented cable bolts. These gauges were 12.5 mm long and embedded into a remanufactured king wire that replaced the conventional king wire. Cable bolt performance, quality of grout, and installation techniques were also assessed. By using instrumented cables, a mine operator can determine axial load along the cable at predefined gauge locations. By monitoring load on and displacement of the rock mass, more effective ground support can be selected and installed, which will lead to safer working conditions for miners.

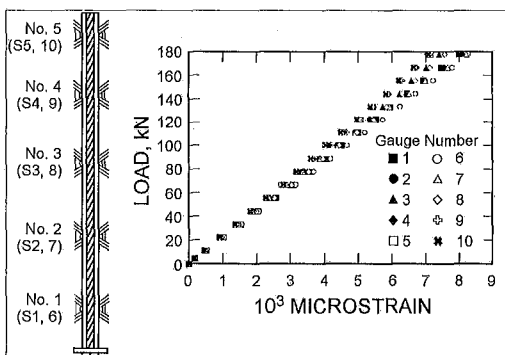
The instrumented king wire cable bolt has 12.5-mm-long strain gauges embedded in the king wire at positions defined by the mine operator. Presently, 10 gauges can be installed along a resin-grouted bolt up to 5 m long or a cement-grouted bolt up to 7 m long. These constraints are largely due to current manufacturing processes and not to limits on the system. The gauges can either be set in pairs to detect shear load in the same plane or the flat stock can be set at 90° angles to detect loads in three directions. The cables are capable of sustaining an ultimate load of 251 kN and can produce reliable readings to 179 kN, as shown by the calibration curve in figure 1.

Figure 1.—Calibrated curve for instrumented king wire cable bolt.

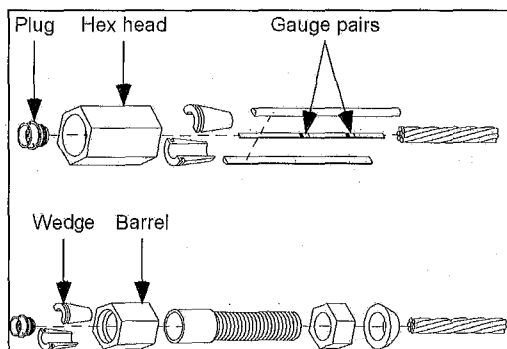
To create an instrumented king wire cable bolt, strain gauges are first installed on both sides of an 8- by 2.4-mm metal strip at various user-specified positions on the bolt (figure 2). The individual strain gauges are connected to an instrument plug by 30-awg wire. This apparatus is then placed in a steel mold and injected the total specified length of the bolt with a two-part epoxy. This new king wire measures 8.3 mm in diameter.

Figure 2.—Instrumented cable bolt assembly with and without pretension head.

The original cable is uncoiled strand by strand, the original center wire is replaced by the new epoxy-filled king wire, and the outer six strands are rewound around it, resulting in an instrumented cable bolt. The gauge wires protruding from the center are then inserted into a 12-pin connector. This connector is recessed into a 4.4-cm hex head attached to the cable by means of a barrel-and-wedge assembly (figure 2).

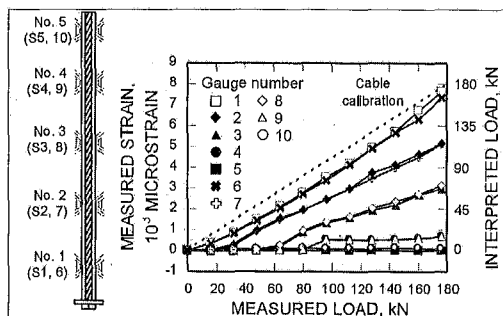
Laboratory tests were conducted on instrumented king wire cable bolts embedded in concrete blocks to obtain calibration curves for converting microstrain to load in kilonewtons. Pull tests were also conducted to determine the load-carrying characteristics of the bolts. The strain gauges were mounted 0.15, 0.35, 0.61, 0.91 and 1.22 m from the head of the bolt (figure 1). The cables were loaded to 179 kN using hydraulic pull test equipment. A strain-to-load curve is shown in figure 3 and is typical of what Goris et al. (1994) observed in pull tests with conventional cable bolts.

Figure 3.—Calculated load and strain on grouted cable bolt with instrumented king wire.

These tests aid in explaining how load on cable bolts is transferred from the cable to the grout and then into the rock mass. A “shelling” effect is shown whereby the grout-cable interface breaks down and the gauge becomes unbonded as load is increased and is taken fully by the cable. Figure 3 shows results of the pull tests as a load profile along the cable length. The curve shows that a 128-kN (~12.8-tonne) pull load on the collar of the cable resulted in measured strain loads of 123 kN along gauges 1 and 6 at a distance of 0.15 m from the collar. Researchers interpreted this measurement (5 kN) as the amount of load the cable was not sensing 0.15 m from the collar. At 1.22 m from the collar, the cable did not sense any load, which indicates critical bond length. Other researchers (e.g., Goris et al. 1994), have reported critical bond length to be approximately 1 m for standard cable. This load capability enables an operator to measure failure in real time as debonding of the grout-cable interface is initiated. In addition, the difference between cable load and applied load indicates grout quality, which can be a better field test of the quality of cable bolt installations than field pull tests.

- Bolt 4 shows a load shelling profile similar to that shown in the laboratory (see figure 3). The greatest load was recorded 3.1 m above the back by gauges 3 and 8. The ungrouted length (2.8 m) shows a low load primarily because load was distributed over a large distance, as discussed previously. It must be noted that loads were lower on the gauges on either side of the bolt at 3.1 m, implying that a crack was close by.

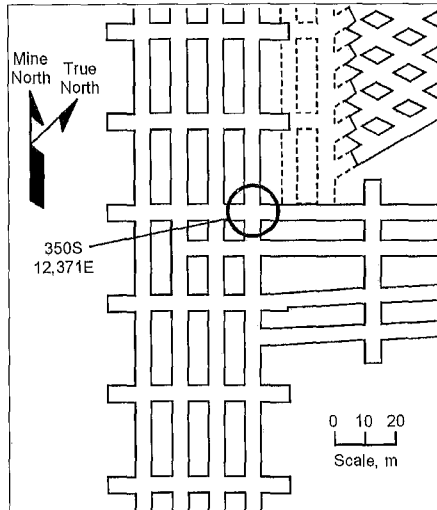
Cable bolts were installed in the roof of FMC Grangers’s trona mine, a room-and-pillar operation in Wyoming, to measure roof loads in the intersection of 350S and 12371E (figures 4 and 5). This location was chosen because of drill access ahead of the mining cycle and because loads would be induced in the cable bolts as ore was extracted toward the intersection. Mine personnel were interested in determining the potential for instability in the back and the extent of any unwedged blocks.

Figure 4.—Instrument locations in trona mine.

Loads on the cable bolts were measured from April 29 through July 11, 1999. Mining activities influencing the intersection were progressing from northeast of the site to the south (figure 4). On June 9, mining reached a point one pillar width from the intersection (8 m). Figure 7 shows all load profiles measured by the 4.27-m-long bolts (bolts 1, 2, 4, and 5) and the 3.66-m-long bolts (bolts 6, 8, 9, and 11). Approximately the last 1.5 m of the bolt was bonded with resin grout.

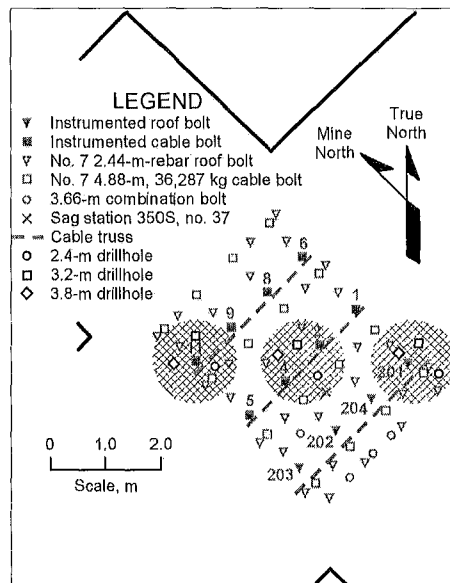
Figure 5.—Bolt and sagmeter locations.

rebar bolts was highest. Sagmeter stations were set at three locations in the intersection (figure 5), and holes were drilled to depths of 2.4, 3.2 and 3.8 m. These sagmeter depths were chosen to correspond with the bolt gauge profiles (figure 6), allowing correlations to be made between deformation recorded by the strain gauges to deformation recorded by the sagmeter stations. This is important because slip expected to occur between the cable-grout-rock interface can be compared to actual rock deformation.

Three sagmeter stations were installed at three different depths (2.4, 3.2, and 3.8 m) at the intersection of 350S and 12,371E (figure 5). Figure 8 shows that sagmeters at the three stations generated similar curves with displacements ranging from 0.5 to 2.0 cm. In general, the most centrally located station had the greatest displacements at all three depths. Generally, the north-northwest and south-southwest sagmeter stations, which were near the boundary pillars, showed the least amount of deformation. Delamination was observed throughout all horizons with the largest amount of movement between 2.4 and 3.8 m of the back. This roof movement corresponded with data collected from the strain gauges, showing that delamination was generally 3 m above the back. Sagmeter readings from the 3.2-m-deep hole at the center of the intersection would be comparable to readings from a 4.3-m-long cable bolt with 1.5 m of resin embedment. This would mean 2.8 m of unbonded cable length.

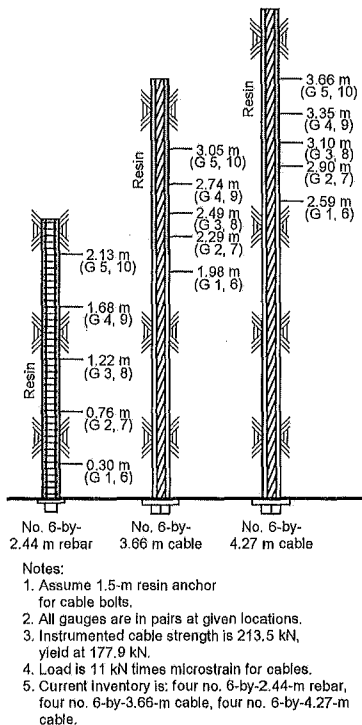
Ground support was installed after development and during rehabilitation. Strain gauges were positioned along rebar and cable bolts at depths that would ensure that loads in the resin grout would be measured. In addition, a set of gauges was mounted at an ungrouted section to measure dead weight loads in the rock mass. Figure 6 shows the position of the

strain gauges with respect to the collar. The longest cable bolts were installed at the center of the intersection because these bolts would receive the greatest loads, while shorter cable bolts were installed north of the intersection closer to the pillar front. Resin-grouted rebar bolts were placed in the south part of the intersection to measure loads where the density of

Figure 6.—Positions of strain gauges on bolts (note two at each position).

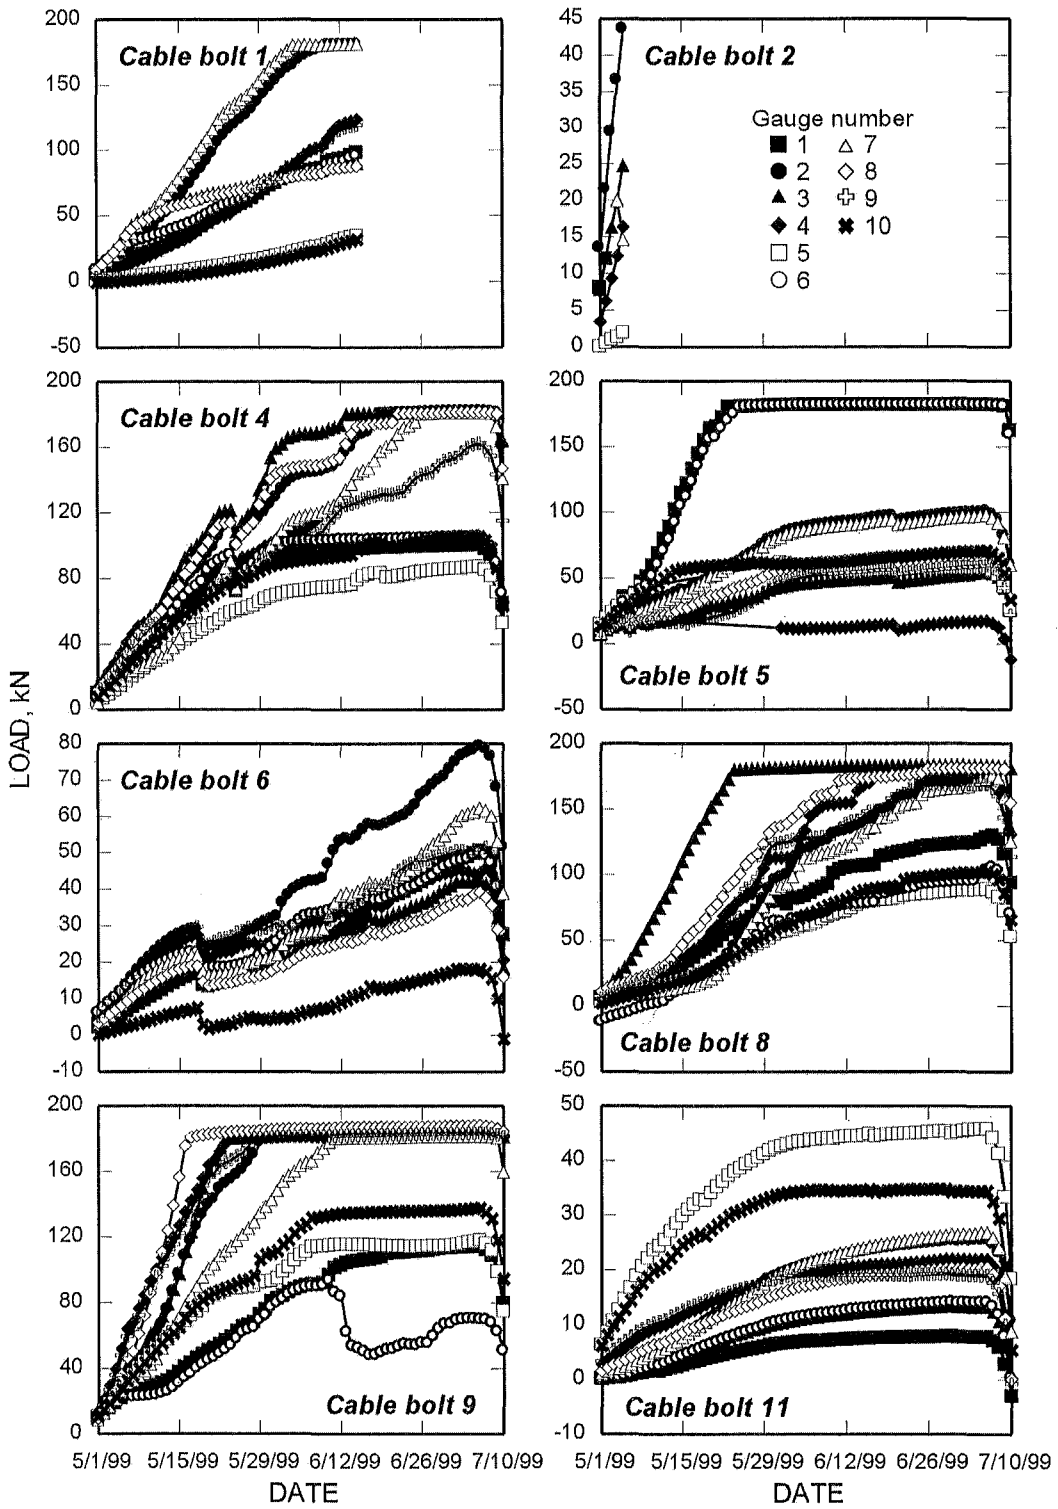
Figure 7.—Load profile versus time on 4.27-m-long bolts (1, 2, 4, and 5) and 3.66-m-long bolts (6, 8, 9, and 11).

- Gauges 2 and 7 on bolt 1 were indicating loads up to the yield limit of the steel. These loads were higher than the axial dead weight loads on the ungrouted section of the bolt and loads on the grouted gauges, indicating that some delamination was occurring close to the gauge. The higher readings were most likely a result of the fact that concentrated load is measured over the gauge length by a strain gauge, whereas an ungrouted gauge measures the sum of all delamination cracks over the length of the ungrouted section, which was 2.8 m. The result is an average load much lower than that of a bonded cable over a given distance.

- Bolt 5 shows the classic load shelling profile. The highest load was recorded in the ungrouted section within 2.8 m of the back. The next highest load was at the bonded gauge 2.9 m from the back. Readings again indicate that delamination was largely controlled by cracks within 3 m of the back.

- Loads on bolt 6 were uniform, with an average of 40 kN, excepting for gauges 2 and 10, which were located 2.3 m above the back. This implies that delamination may have been occurring at this location. Note that this bolt was close to the pillar boundary and therefore the depth of cracking would be less.

- Gauge sets 2 and 7 (2.3 m deep), 3 and 8 (2.5 m deep), and 4 and 9 (2.7 m deep) on bolts 8 and 9 showed a load profile approaching, and in most cases reaching, the yield strength of the bolt. This reading indicates that delamination was occurring throughout the horizon or that rock mass loading was higher. These two bolts were placed in the north-center section of the site, which experienced high loads such

as those on bolt 4, which had also been placed in the center of the intersection. The deepest gauges (5 and 10) at 3.1 m in the back recorded low values, indicating that the bond at depths between 2.7 and 3.1 m was sufficient to absorb most of the load.

- Bolt 11 was located at a pillar boundary and therefore was receiving more support from the mine rock, resulting in less delamination. Therefore, loads were lower. Representative load curves for the 3.1-m-deep gauge resulted in the greatest amount of load. The second set of gauges, at 2.3 m deep, showed the next highest load, and the first set of gauges, at 2.59 m deep, had the lowest loads. Delamination was, however, occurring, albeit at low loads, approximately 3 m above the back.

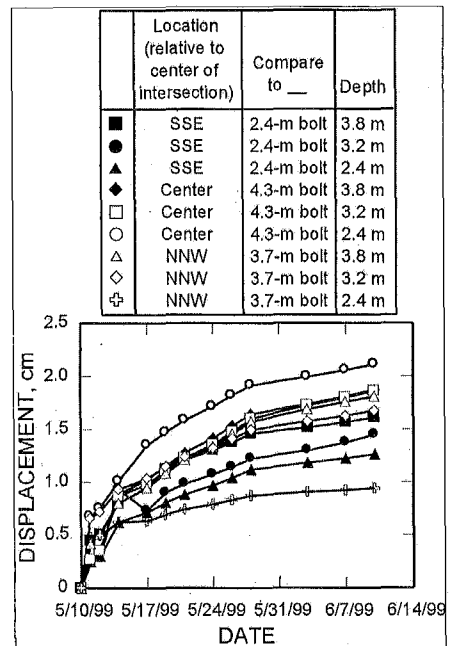
Figure 8.—Displacement of back over time.

Hook's law as applied to a cable with a steel modulus (E) equaling  $2.3 \times 10^{11}$  N/m<sup>2</sup> and a cable area of 0.00011 m<sup>2</sup> would yield an elongation of 2 cm over 2.8 m. The calculated force would be approximately about 180 kN. This force correlates with data from the cable bolt for the unbonded section of bolt 5, gauges 1 and 6 (figure 7), and bolt 4, gauges 2 and 7. Based on this information, it is likely that the resin bond was destroyed as a result of loading.

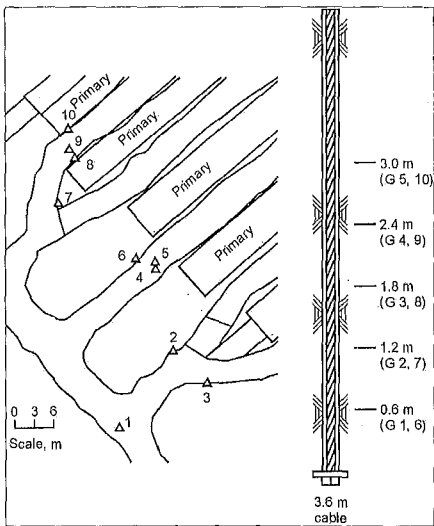
Ten 3.6-m-long instrumented cable bolts were installed at the Getchell Mine, which is a transverse, open-stopping operation in Nevada. Gauges were spaced 0.6 m apart at five positions on the cable bolt. A tensionable head was placed on the bolt (figure 9), and the bolts were grouted with a cement-based grout into the back and ribs at the locations shown in figure 9. The bolts were then tensioned 10 kN on the cables and bearing plates. The instruments were placed after the primary cuts had been backfilled and the secondary drifts to the ore were about to be mined. This enabled analysis of the effects of secondary and tertiary mining effects.

Figure 9.—Plan view of 4950 stope showing locations and depths of strain gauges.

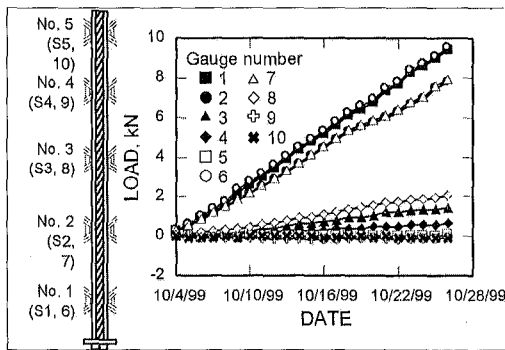
Preliminary data indicate that bolt 4 in the stope is showing a load higher than 10 kN (figure 10) while

Figure 10.—Load on bolt 4 at Getchell Mine.

the rest of the bolts are not showing any significant loading (under 1 kN). Loading on bolt 4 suggests that a crack is most likely developing between gauges 1 and 6 (0.6 m deep) and gauges 2 and 7 (1.2 m deep). A borescope survey was conducted as part of this study and located a crack 0.9 m above the back. Based on a 1.2- by 1.2-m bolting pattern and a depth of 0.9 m (specific gravity = 2.6), a dead load of 38 kN is likely. Measurements and interpretations of the strain data were reinforced by subsequent visual observations intended to provide a higher level of safety for the operator. This area of the mine was reinforced.

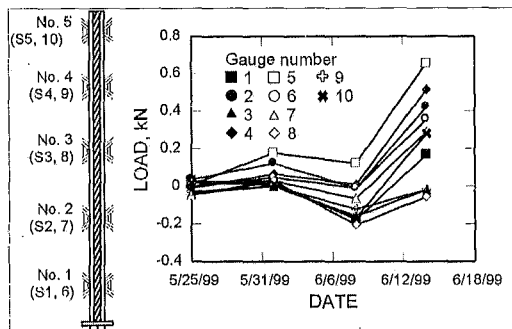
The cable bolt was placed into the mine back directly above the sublevel open stope. Preliminary data show low loads on all gauges along the bolt (figure 11). The cable is approaching yield at gauge 5 (3 m deep), and delamination appears to be occurring close to 3 m above the back. The immediate back exhibits minor loading (gauge 1 at 0.6 m deep). The area where the cable bolt is installed is inaccessible since the open stope has yet to be backfilled. There is no concern for personnel because the stope below is nonentry.

Figure 11.—Load on bolt 14 at K-2 Mine.
