Application of Radar to Detect Pedestrian Workers Near Mining Equipment

Todd M. Ruff

Office for Mining Safety and Health Research, Spokane Research Laboratory, National Institute for Occupational Safety and Health, Spokane, Washington

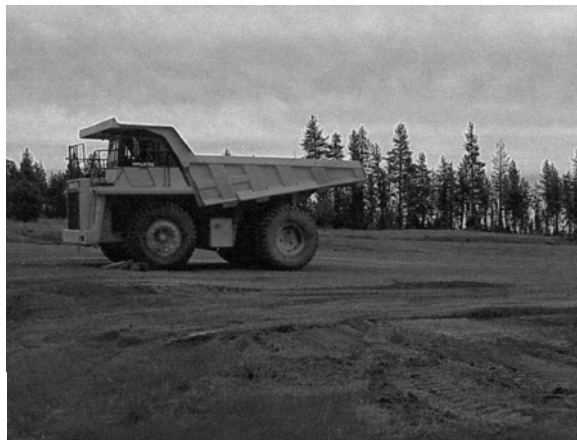
FIGURE 1
Komatsu 210M parked in the test field.

Test of the collision warning systems were designed based on experience gained from previous tests, from portions of the Society of Automotive Engineers (SAE) standard J1741,⁽⁴⁾ and from input from MSHA. The tests were conducted on a rigid frame, off-highway, large-capacity dump truck that represented those used in the mining industry. Because of time constraints, most of the tests were conducted at a NIOSH site using a Komatsu 210M 50-ton-capacity dump truck (Figure 1). However, two radar systems were also tested on a Caterpillar 793B 240-ton-capacity truck at the Phelps Dodge Morenci mine (Figure 2). Table I lists general specifications for each truck so that

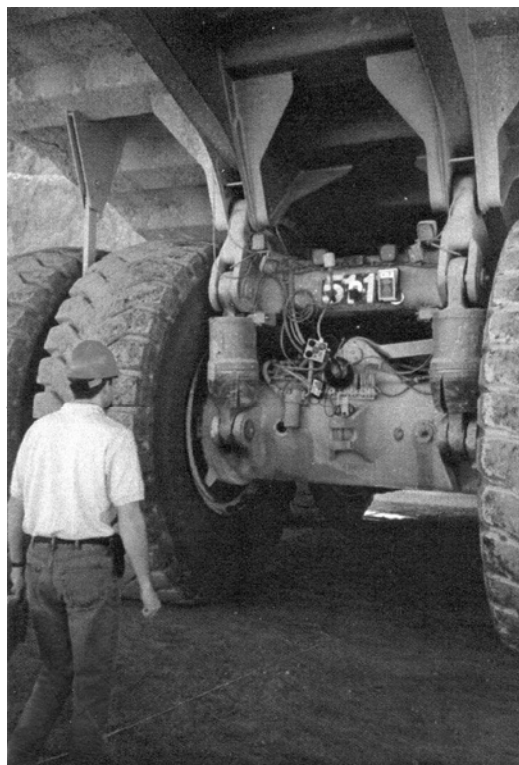
FIGURE 2
Caterpillar 793B at the Phelps Dodge Morenci mine.

Common accidents involve a dump truck colliding with a smaller vehicle, such as a pickup, or with a pedestrian worker. Other accidents involve collisions with stationary objects, such as mine buildings or pit structures. Information presented here applies to pedestrian workers at the rear of the dump truck only. For test results involving pickup trucks and front detection zones refer to NIOSH *Report of Investigation 9652*.⁽³⁾ To determine the reliable detection zones for each system, a human subject, with a height of 75 in and weight of 190 pounds, stood within the potential detection area of the system (Figures 2 and 3). The subject was wearing a hard hat, cotton shirt and jeans, and steel-toe boots.

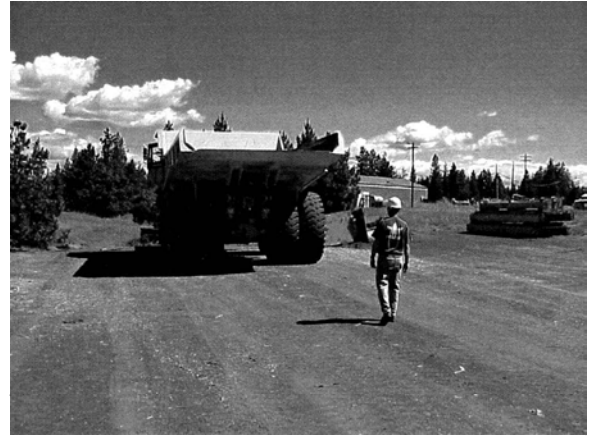
FIGURE 3
Determining the detection zone for a person.

The reliable detection zone for a person was recorded by standing on the points of a grid with 2.5 ft spacing that was marked in the sensor's potential detection area. For the rear blind spot, the dump truck was moved slowly (<5 mph) in reverse

and the state of the alarm was monitored. If the alarm turned on immediately (<200 ms) and consistently after the truck moved, then that point was recorded as a reliable detection point. The recorded points on the grid were then joined to form an outline of the reliable detection zone. A second zone was recorded as needed and labeled "sporadic" if obstacle detection occurred some of the time, but not always (less than 100% detection, but more than 10%). Note that in certain areas near the dump truck, it is not safe to move the truck toward a stationary person. In these cases, the dump truck was kept stationary and the person moved toward the sensor. The reliable detection zone was recorded using the same subject and procedures for each collision warning system and for each truck type.
