## AN EXAMINATION OF THE LOYALHANNA LIMESTONE'S STRUCTURAL FEATURES AND THEIR IMPACT ON MINING AND GROUND CONTROL PRACTICES

Anthony T. Iannacchione, Senior Scientist

National Institute for Occupational Safety and Health

# 21st International Conference on Ground Control in Mining

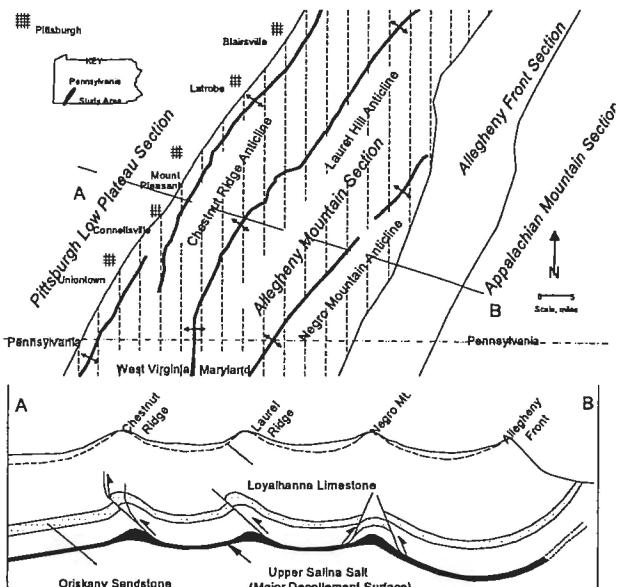
Figure 1. Location of major anticlinal structures and a generalized cross-section through the Allegheny Mountain Section of the Appalachian Plateaus Province.

(figure 1). These outcrops have historically been the sites for commercial aggregate mining, especially those closest to the population centers in and around Pittsburgh, Pennsylvania. Currently nine quarries mine the Loyalhanna through underground and surface operations in Monongalia Co., West Virginia, and Fayette and Westmoreland Counties, Pennsylvania, (table 1) along the linear trace of Chestnut Ridge.

Apparently the Loyalhanna and surrounding strata in the Allegheny Mountain Section have moved some distance along the Salina detachment horizon (figure 1). In addition, the overlying Middle Devonian rocks are intensely faulted. The faults originate within the Salina and quickly rise into a series of branching splay thrust faults under the limbs of the anticline. The complicated nature of the stiffer rock units between the Salina and the Tully Limestone is shown in figure 5 where these units are either stacked in an imbricate fashion by ramping thrust faults (5) or flexurally bent by an overturned fold with imbricate faulting (11). Gwinn explained the stacking at depth as caused by shortening of the detached strata above the Salina Salt. This produced a depressed zone along the anticlinal crest which has helped to create Chestnut Ridge's broad fold at the surface. Shumaker indicates that the highly deformed Salina has thickened into a salt core under some parts of Chestnut Ridge. The overlying Middle Devonian rocks are overturned in relatively tight folds with large splay faults emanating from the base of the overturned limb.

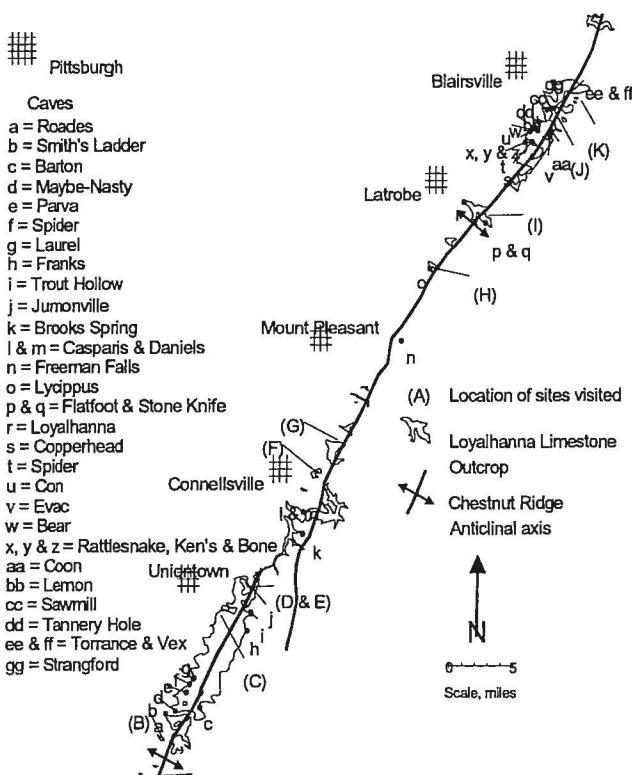
Figure 2. Location of Loyalhanna Limestone outcrop, caves, and sites visited during this study. Capital letters A, B, D, E, F, G, H, I, and J are quarries; C is a highway outcrop; and K is an abandoned coal strip mine.

1. The first fault is exposed along Rt. 40 (Site C, figure 2) where it climbs the western flank of Chestnut Ridge at an altitude of about

The Summit and Griffin Domes have extensive caves developed in the limestone. Caves occur when existing joints open as the confining stresses are relieved by erosion, uncovering the limestone. These unconfined joints are then widened as flowing water dissolves the limestone over extended periods of time. The residual fine-grained material that is left in place can be easily carried away by the small streams of flowing water. Under these conditions, whatever locked-in stresses that once existed are released. Quarries that clearly have low stress conditions (Site D and J, figure 2) are located within the Summit and Griffin Domes.

Despite the low stresses discussed above at two quarries, the level of horizontal stress is, in general, considered to be excessive. Mines with excessive levels of horizontal stresses (Sites F and I, figure 2) are located in saddle structures and are close to either an inferred cross-strike slip fault or a projected lineament that may form the boundary of a large ramp structure. At both of these mines a significant number of joints with low dip angles were observed. Additional research is required to fully understand the important structural factors that either diminish or concentrate stresses in this area.

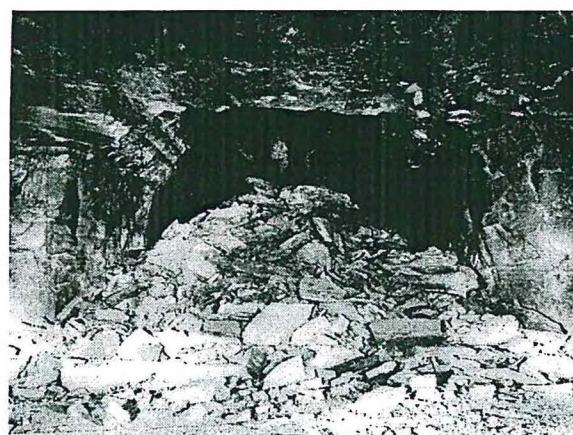
Figure 3. Massive roof fall measuring 45 ft wide by 20 to 30 ft high and extending for approximately 200 hundred feet.

Mines along Chestnut Ridge have experienced roof and rib falls with some falls resulting in injuries to mine workers. One quarry with a workforce of approximately 30-miners experienced 7-injuries from ground falls over a 30-month period from March 1993, until September 1995 (table 2). A second mine had vehicles struck by falling rocks approximately a dozen times during a 12-month period. A third mine reported 9 roof falls to the Mine Safety and Health Administration (MSHA) during an 18-month period from April 1999, until November 2000 (4). Ground falls range in volume from boulder size rocks, falling from the roof or rib, to massive roof falls measuring 45 ft wide by 20 to 30 ft high and extending as far as 500 ft (figure 3). Many of the ground falls were, in part, due to the unique and complex structural environment of the Loyalhanna. The primary reason for initiating this National Institute for Occupational Safety and Health (NIOSH) study is to increase knowledge of the root causes of these hazards and promote the use of timely ground control measures so that miner safety can be improved.

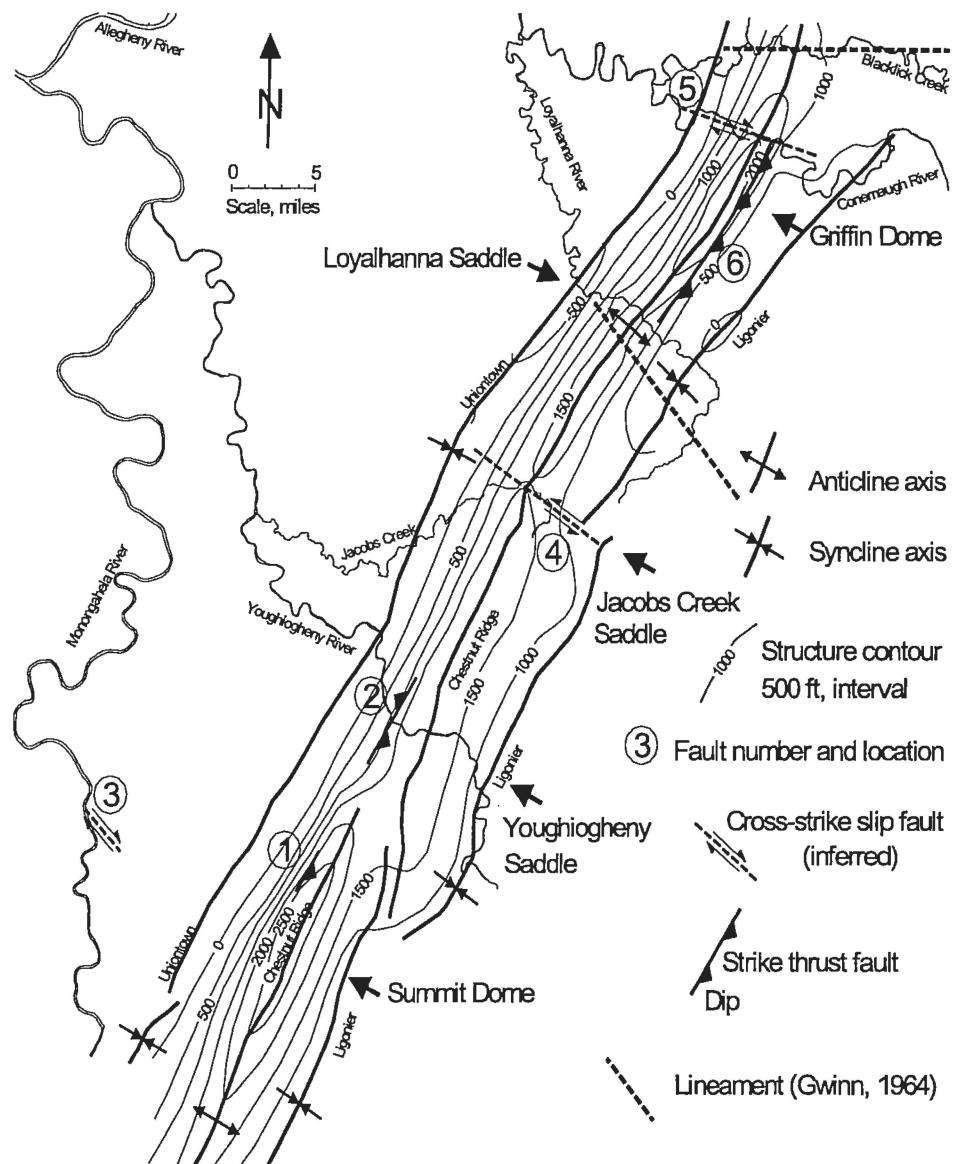
Figure 4. Structure contour map on the top of the Loyalhanna with major fold structures, surface faults, lineaments, and rivers and streams.

areas form enclosed contour elevations called domes. The Summit Dome (figure 4) lies midway between the Cheat River Gorge to the southwest and the Youghiogheny River Gorge to the northeast. The Griffin Dome (figure 4) lies further to the northeast between the Loyalhanna and Blacklick Creeks.

Six major faults have been previously recognized within the study area as shown in figure 4. Three of the faults were reported by Hickok and Moyer (7) and three were reported by Shaffner (8, 9). Two were observed on the western flank of Chestnut Ridge (Fault No. 1 and No. 2), a third along the Monongahela River (Fault No. 3), a fourth and fifth inferred slip faults transecting Chestnut Ridge (Fault No. 4 and No. 5), and a sixth was observed along the eastern flank of Chestnut Ridge (Fault No. 6). These faults can be classified as either strike thrust faults or cross-strike slip faults. The strike thrust faults, in general, have bearings along the strike of the anticlinal structure and dip at a relatively low angle. The cross-strike slip faults (Faults No. 4 and No. 5) were never actually seen by Shaffner although he speculated that they must exist in order to explain the topographic and structural anomalies in this area. The inferred strike of these faults is perpendicular to the anticlinal structure with dips of approximately 90°. These trends are consistent with those expected in response to the formation of the Appalachian Mountain System. A summary of the characteristics of each fault shown on figure 4 follows:

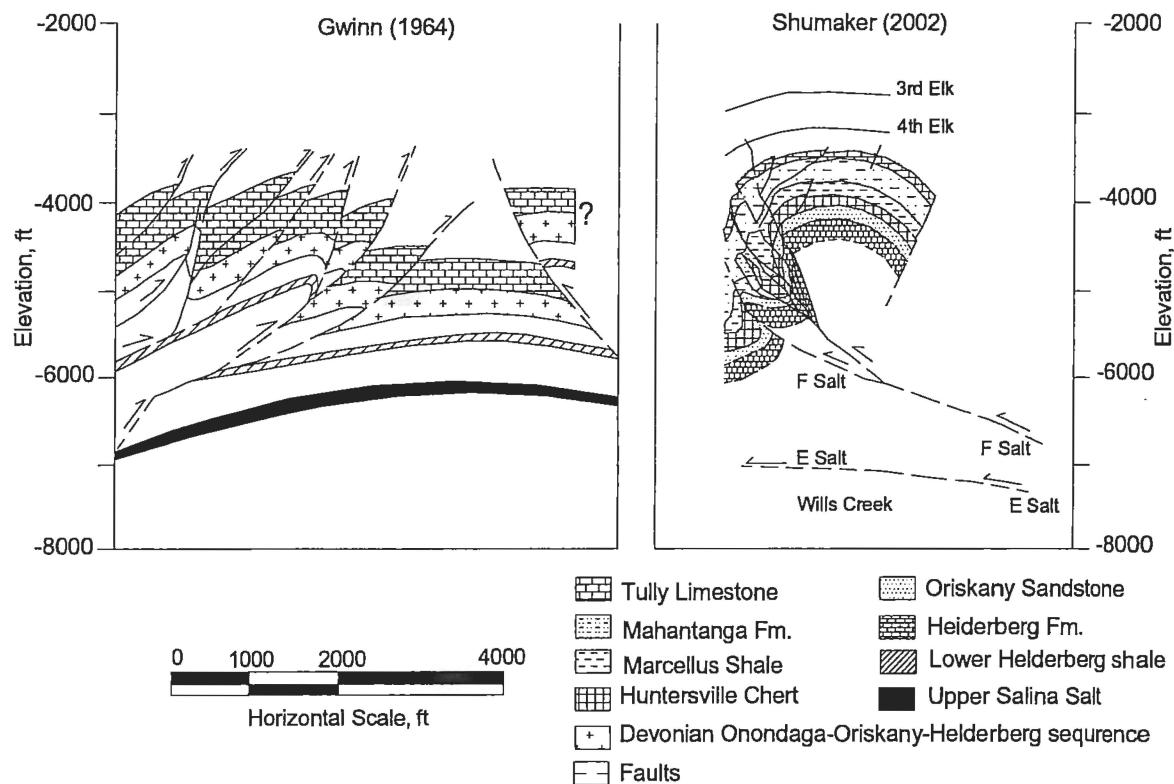
Figure 5. Complex structure under Chestnut Ridge at depths of -2,000 to -8,000 ft below sea level (5, 11).

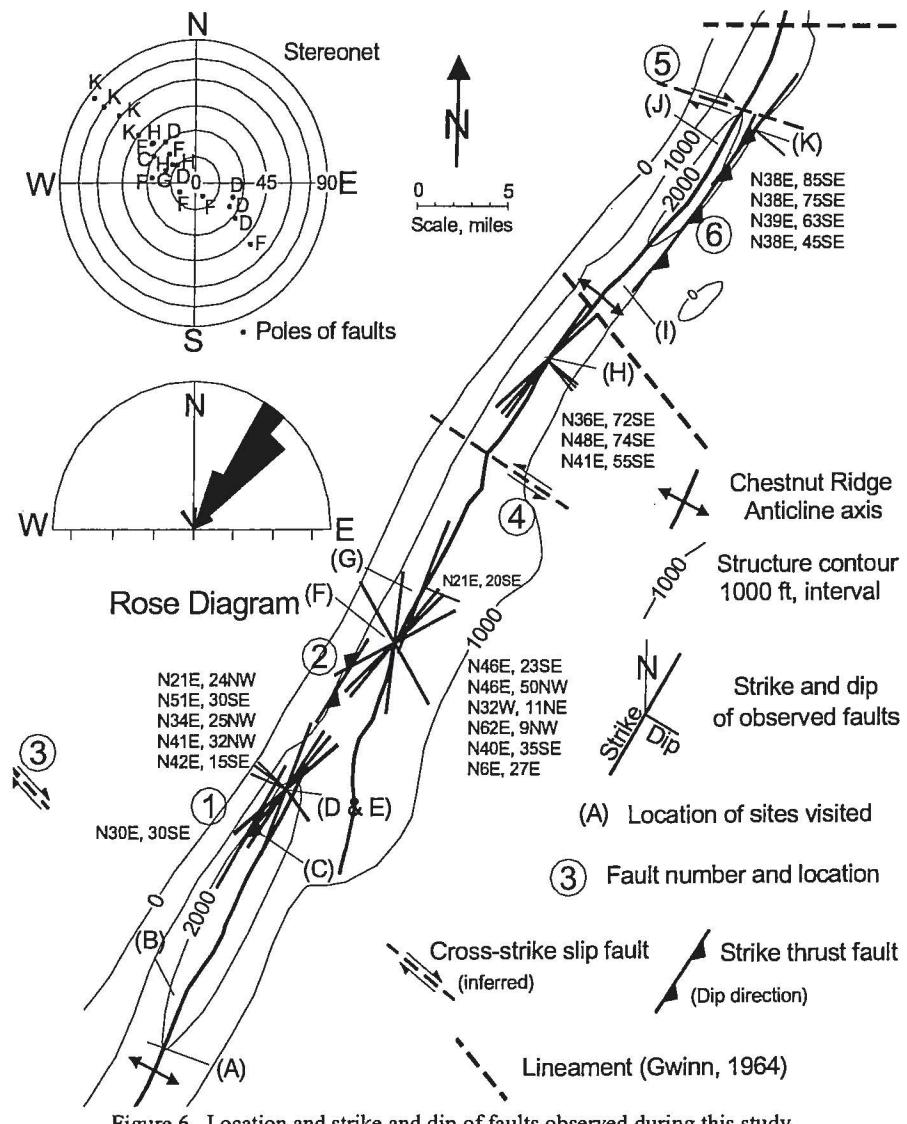
Figure 6. Location and strike and dip of faults observed during this study.

- In addition to these known and inferred faults, numerous other faults were observed during visits to several quarries. Figure 6 shows the location, bearing, and dip of these faults in various formats. First, the location, strike, and dip of each fault are displayed in conjunction with the structure contour map on the Loyalhanna. Second, a stereonet projection is provided which locates the poles of the fault planes. Two important facts are revealed in the stereonet: (1) the faults align along a consistent orientation of N 40° E, and (2) the dips of these faults vary widely from approximately 60° to the northwest through 80° to the southeast. The consistent strike is further illustrated with the associated rose diagram. The strike of N 40° E, observed at all quarries with the exception of Site F (figure 6), aligns closely with the general bearing of Chestnut Ridge. While the dips vary widely, some consistencies can be observed. For example, all the faults from sites G, H, and K dip to the southeast, whereas the majority of the faults from site D dip to the northwest. Site F shows both northwest and southeast dipping faults.

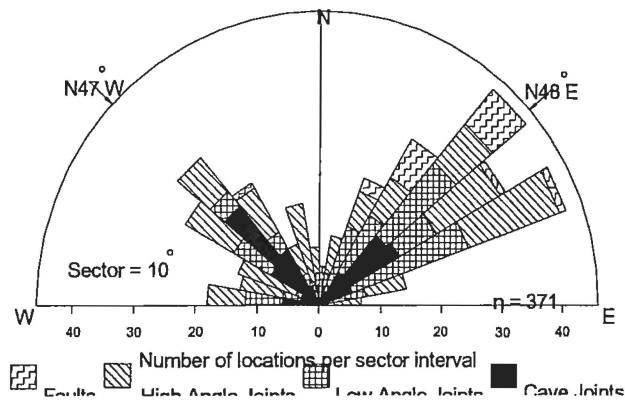
Figure 8. Rose diagram of fault and joint data from study area. 371 measurements were grouped into two clusters. Northwest quadrant data had a mean resultant direction of N 47° W (left arrow). Northeast quadrant data had a mean resultant direction of N 48° E (right arrow).

Jointing was observed throughout the study area and was found to have two distinct trends. A total of 371 joint bearings and dips were measured and plotted on a rose diagram shown in figure 8. These measurements were grouped into two clusters: 1) northwest quadrant data with a mean resultant direction of N 47°W of mostly vertical joints; and 2) northeast quadrant data with a mean resultant direction of N 48° E with varying dips. The N 47° W joint trend strikes across Chestnut Ridge and the N 48° E trend roughly parallel the strike of Chestnut Ridge. These trends are coincident with the orientation of local folding and faulting and are thought to be caused by the same processes.

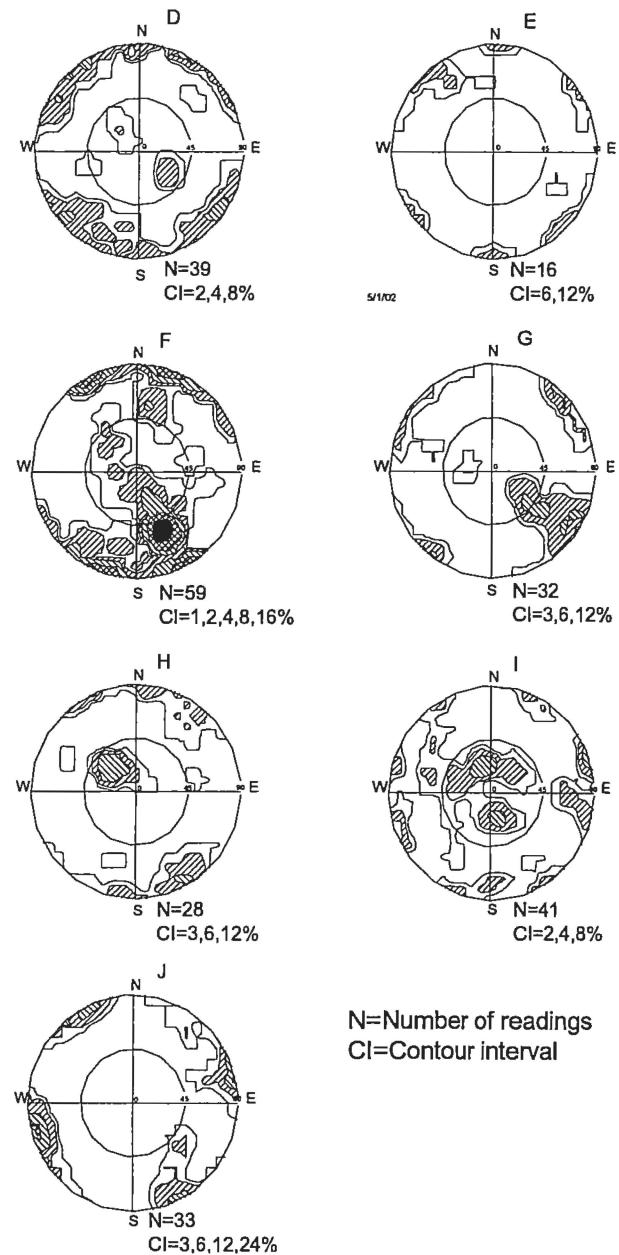
Figure 9. Stereonet projections for seven of the sites visited during this study.

The joint bearings and dips become more significant when the measurements from individual sites within the study area are analyzed (figure 9). For example, at site D (figure 2) most of the joints are vertical with a modest concentration of joints dipping from 10 to 45° to the northwest and lesser concentration of joints dipping from 0 to 45° to the southwest. Site E and J are composed almost exclusively of vertical joints. Sites F and G are dominated by joints dipping from 0 to 90° to the northwest. Site H has a strong concentration of joints

dipping from 0 to 45° to the southeast. Sites F and H have a significant number of joints dipping from 0 to 45° oriented over a wide range of bearings. The spacing of most joint sets ranges from a few feet to tens-of-feet. Displacements along vertical joints were not observed, however, lateral displacements along joints dipping from 0 to 45° were observed at Sites F and I.

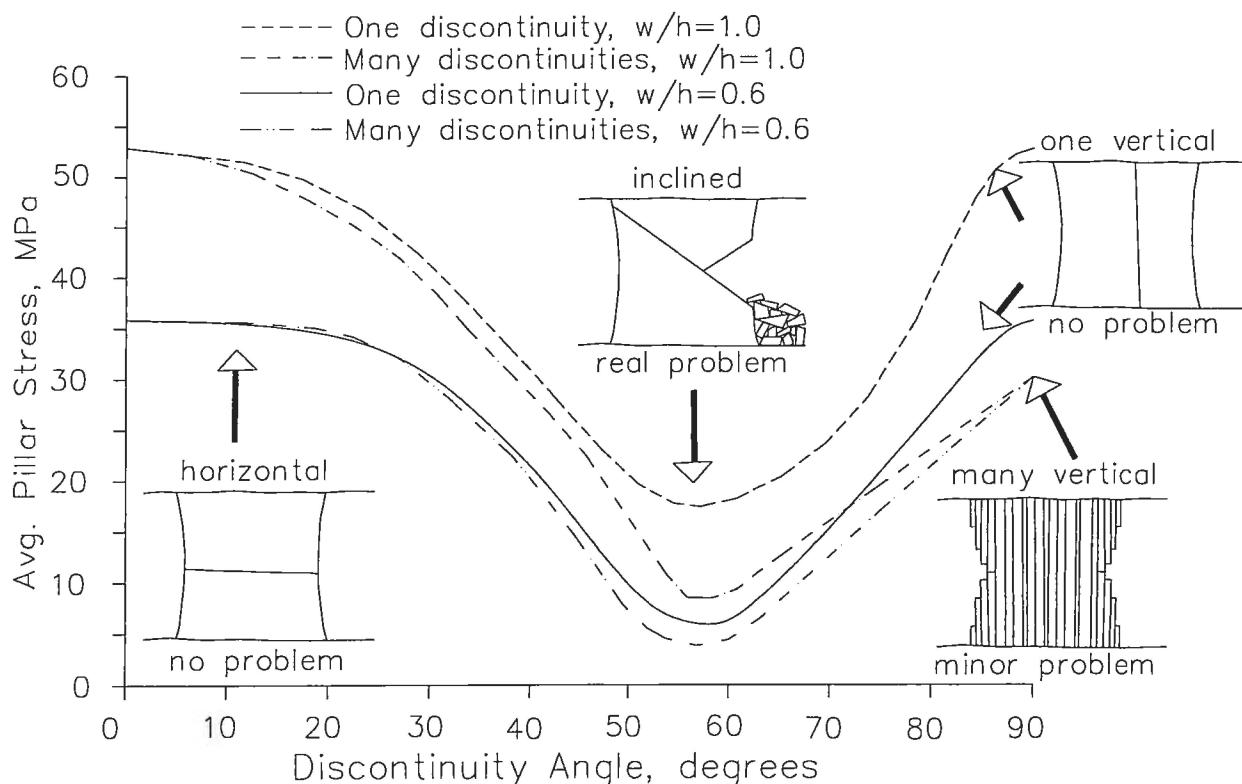
Figure 10. Changes in average vertical peak stress as the dips of discontinuities are varied from 0 to 90° for two different width-to-height ratio pillars.

To illustrate some of these concepts, a model with very closely spaced joints, relatively low joint strength, and variable joint dip was presented by Iannacchione (18). The highest pillar strength occurred with a discontinuity dip of 0° and gradually decreased as discontinuity dip angle increased (figure 10). As the discontinuity dip angle increased above 60°, pillar strength began to increase again, although the original starting strength was never achieved. This result could be expected when near vertical joints are closely spaced, allowing buckling at the edges of the pillar and producing a strain-softening material behavior. Conversely, a near vertical through-going discontinuities with a dip approaching 90° could allow a pillar to regain almost of its strength (figure 10).

pillars took on the appearance of the "real problem" pillars shown in figure 10. Because of the significant percentage of joints within the critical dip range of 30 to 75°, pillar stability is expected to be an important safety issue, especially when pillar width-to-height ratios fall below 1.0 (18, 19). Width-to-height ratios above one are more desirable because there is less chance for the discontinuity to pass entirely through the pillar.
