Ground Control in Mining

21st International Conference

DEVELOPMENTS IN SEALANT SUPPORT SYSTEMS FOR GROUND CONTROL

National Institute for Occupational Safety and Health

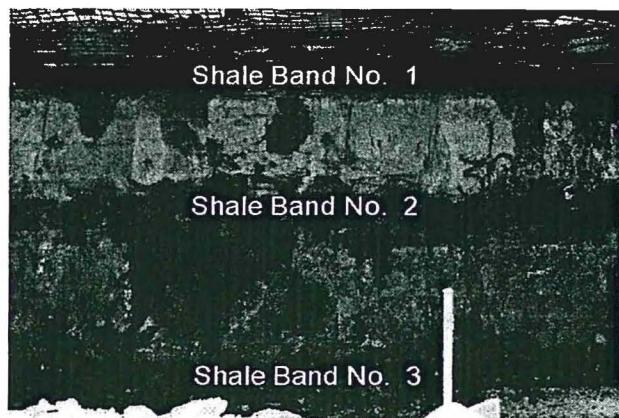
Figure 1. Shale bands dividing the limestone formation at LLEM.

Bedded Shale Effects. The limestone strata within the LLEM is divided by several bedded shale layers and these shale layers were significantly susceptible to the original weathering problem. To determine if there is a change in shotcrete strengths between the shale and limestone sites, a representative sample of hammer sites that had shotcrete applied were located in the shale and limestone areas. The preliminary short-term results, as shown in figure 10, do not reveal any significant difference in the shotcrete strength, which appears to indicate that the shotcrete adheres equally well to the bedded shale as it does to the limestone. If the shale binder did not provide a good bond or had detached from the shotcrete, the hammer results would have been significantly lower.

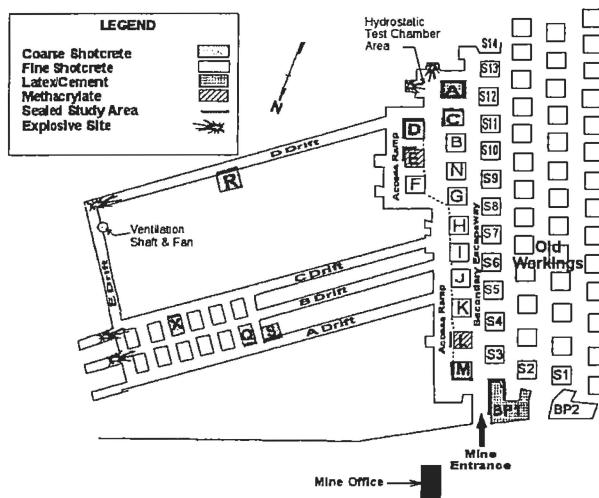
Figure 2. Diagram of LLEM.

- Coarse shotcrete - contains cement, sand, "BB-sized" gravel aggregate, micro silica fume and 0.5-in acid resistant glass fibers. The shotcrete is applied using dry process equipment primarily composed of a large rotary barrel gun. As with all dry process shotcrete machines, the shotcrete is conveyed dry through the hose and water is added to the dry shotcrete at the nozzle. The nozzleman controls the amount of water to obtain the proper consistency which can vary depending on the particular application. Due to the LLEM entry size (6.5 ft high by 18-20 ft wide), the compressed air valve on the pneumatic gun is set at a lower adjustment level to minimize rebound. The coarse shotcrete was installed at sites C, D, M, R, S, and X as shown in figure 2.

- Fine shotcrete - contains cement, well graded silica aggregate, micro silica fume and 0.5-in acid resistant glass fibers. The same dry process shotcrete machine used to apply the coarse shotcrete was used to apply the fine shotcrete. The fine shotcrete was installed at site Q as shown in figure 2.

The latex/cement membrane was also applied on a 250 ft section of the large barrier pillar (BP1) near the entrance portal (figure 2). This area of the mine is subject to frequent freeze thaw cycles and large changes in temperature and humidity (figure 6). A double coating of sealant 0.31 in (8 mm) thick was applied around a corner area and on the unmeshed areas of the adjacent roof. The membrane at this site has also performed well, with the exception of three small patches (approximately 36 ft² total area) that have detached from the rib. These patches represent less than 1% of the total area covered. Upon close observation, it appeared the cause of failure was more

The methacrylate membrane was installed at sites L and E (figure 2) in January, March and September 2001. Pump problems produced incorrect mixing ratios and viscosity which resulted in inadequate application thickness and material composition. Possibly, operator inexperience may have also contributed to the improper application. The inadequate thickness and the improper mixing resulted in not generating sufficient exotherm to cure the membrane. Consequently, the material did not set properly or bond to the limestone, and after several months it began to split and peel off the rib and roof. However, the sealant appeared to bond adequately in the areas where both the pump was providing the correct mixing ratios and the operator applied the sealant at the required coating thickness. Unfortunately, during this particular application at the LLEM the combination of correct mixing ratios and proper sealant thickness was only achieved over a very limited area.

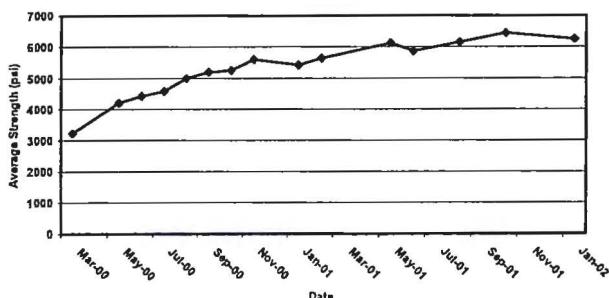
Figure 3 shows a 70% increase in the coarse shotcrete average compressive strength over the two year period. Technically shotcrete reaches its design strength in 28 days but may increase in strength another 5-10% after 56 days (14). The coarse shotcrete was installed between November 1999 and early February 2000, so the shotcrete should have reached at least its 56 days strength by the time the hammer tests were started. Consequently, most of the strength increase may be attributed to other factors, perhaps the high humidity levels present during the time in question. Typically, the humidity levels at the LLEM during the summer months are 100% which produces condensation on the rib and roof of the mine. Possibly the continual presence of moisture, prolonged the curing process of the shotcrete and resulted in the large increase in shotcrete strength. This seems to indicate that spraying the shotcrete with water, in dry mines or dry winter months, may help cure the shotcrete and allow it to reach its full strength.

Figure 3. Schmidt Hammer averaged coarse shotcrete results - time versus estimated compressive strength.

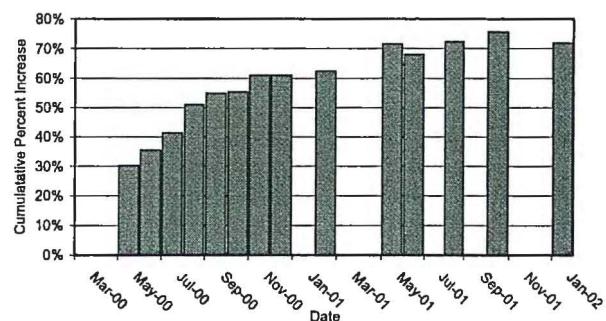
Weather Effects. There appears to be a considerable lag time in reaching the maximum strength of the in situ coarse shotcrete. Examining the cumulative rate of strength increase from the averaged hammer test results for all the test sites, as shown in figure 4, indicates a higher rate of strength increase during the spring and summer of 2000. However, by the fall of 2000, the rate of increase had lessened. Further analyses of the data by test sites (figure 5) shows that study sites C, M, and R had the greatest cumulative increase in strength, especially during the spring and

Figure 4. Schmidt Hammer coarse shotcrete results - time versus cumulative percent increase in strength.

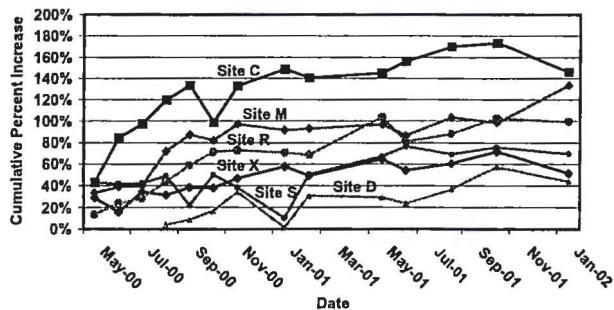
Figure 5. Schmidt Hammer coarse shotcrete results - time versus cumulative percent increase in strength by test site.

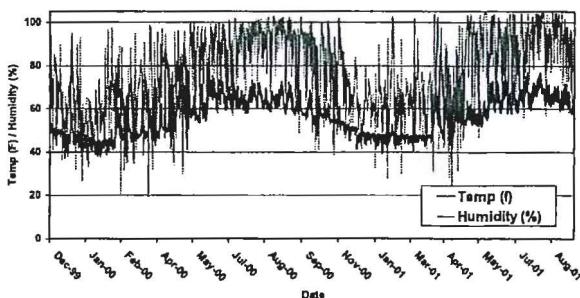
Figure 6. Weather station data at BP-1 site -temperature and humidity versus time.

summer of 2000. Weather data from these sites (figures 6-8), shows that during the late spring and early summer the humidity levels rapidly increase and reach a 100% saturation level by mid summer. Perhaps the added moisture at these sites may have assisted in fully curing the shotcrete on the mine ribs. Site M is located near the entrance portal where there are frequent changes in temperature and humidity which mirror the exterior daily weather cycles. However, site C is located 1,000 ft from the portal where the temperature and humidity cycles are significantly less than Site M, although humidity is still high. Site R is located in the D drift near the ventilation fan. Frequently the fan is operating during the night, in the blowing mode, to ventilate the mine after fire or explosion experiments. During this mode, the D drift experiences frequent temperature and humidity cycles due to exterior climate changes.

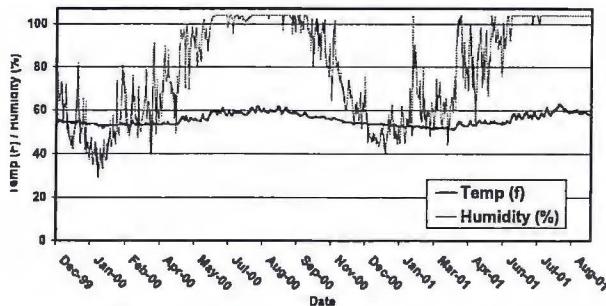
Figure 7. Weather station data near Pillar C site - temperature and humidity versus time.

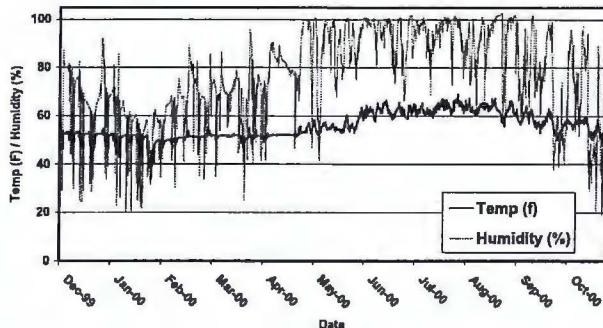
Figure 8. Weather station data near R site - temperature and humidity versus time.

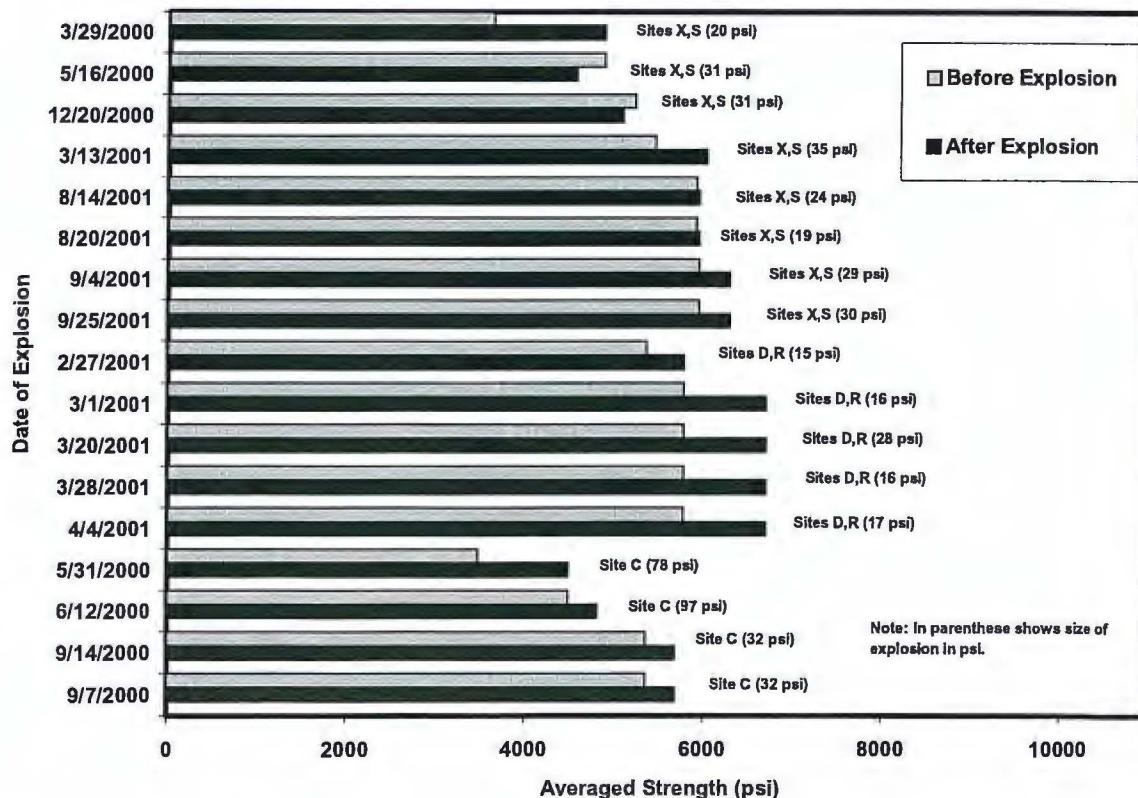
Explosion Effects. The effects of the frequent mine explosion tests conducted within the LLEM were evaluated by comparing the average hammer strength of the shotcrete before and after each test. As can be seen in figure 9, there is no significant decrease in the shotcrete strength. In addition, examinations of the sites before and after each mine explosion test did not reveal any effects on the physical integrity of the shotcrete. Increases in the shotcrete strength after the mine tests is probably due to the long-term curing of the shotcrete. It was apparent after the explosion tests, that the shotcrete had maintained its integrity and stayed completely intact. No fallen roof or rib debris was detected in the areas that were shotcreted.

Figure 9. Comparison of coarse shotcrete strength before and after explosion tests - estimated compressive strength versus time.

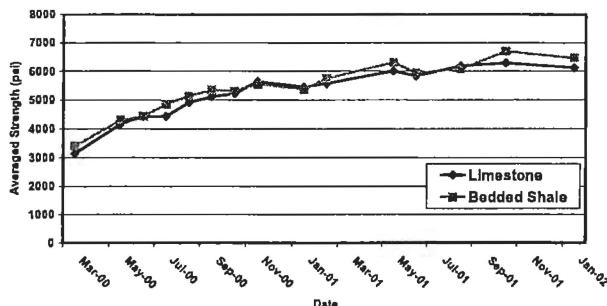
Figure 10. Comparison of coarse shotcrete strength in the limestone and bedded shale - time versus estimated compressive strength.

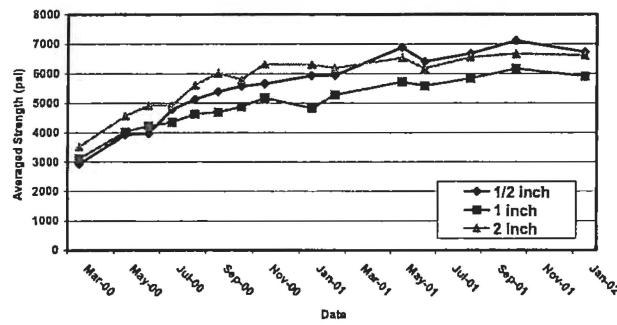
Thickness Effects. Although it is difficult to maintain a consistent thickness with shotcrete, three thickness variations were evaluated. Protruding nails were used as a guide by the nozzleman to measure the desired shotcrete thickness during the application process. Since

one inch is a common thickness for non-structural shotcrete, half the common thickness ($\frac{1}{2}$ in) and twice the common thickness (2 in) were selected along with the 1 in thickness for this study. A series of hammer tests were conducted at each of the sites with the three different shotcrete thicknesses to evaluate the strength of the shotcrete as a function of thickness. The data shown in figure 11 indicates that there are some differences in the shotcrete compressive strength based on its thickness, however, these differences are random and not consistent. Technically the thickness of the shotcrete should not produce different strengths. However, the differences may have been related to test variability and effects of the hammer blows penetrating the thin shotcrete layers into the rock.

Figure 11. Comparison of coarse shotcrete strength by thickness - time versus estimated compressive strength.

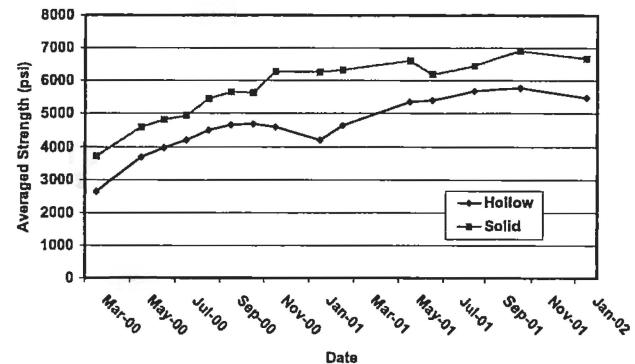
Bonding Effects. Following the shotcrete cure period (greater than 56 days), the shotcrete was sounded with a geologist's hammer to indicate isolated areas in the shotcrete that produced a hollow sound compared to the solid sound elsewhere. This hollow sound may be the result of an air cavity behind the shotcrete, probably due to the shotcrete not properly bonding to the underlying rock. To determine if cavities behind the shotcrete effects its strength, a representative sample of hollow and solid sounding areas were evaluated. Figure 12 shows that the hollow cavity areas have 25% lower strength than the solid areas. This trend is fairly consistent through the two year study period.

Figure 12. Comparison of coarse shotcrete strength by bond effects - time versus estimated compressive strength.
