22nd International Conference on Ground Control in Mining

CONSIDERATIONS FOR USING ROOF MONITORS IN UNDERGROUND LIMESTONE MINES IN THE USA

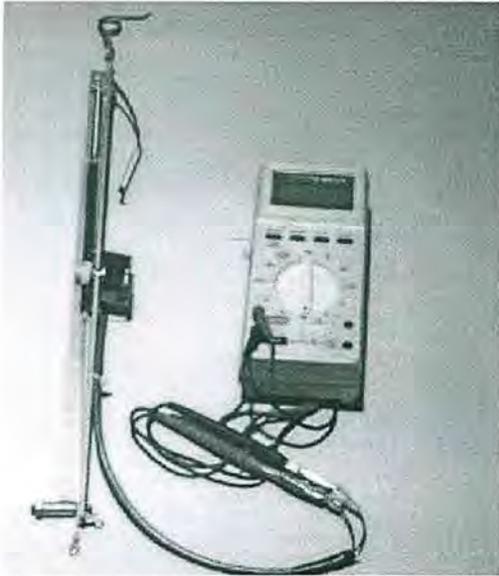
Figure 1. Initial design of RMSS and volt meter.

The basic premise for the RMSS was to provide a simple design combined with easy installation and use. Figure 1 shows the original design used during initial field trials. The open structure of the monitor created a problem with moisture and water. Installation also proved to be somewhat cumbersome. A revised enclosed design corrected both shortcomings and is shown in figure 2. These modifications provided simple construction and easy installation; two key criteria for use in the underground mine environment.

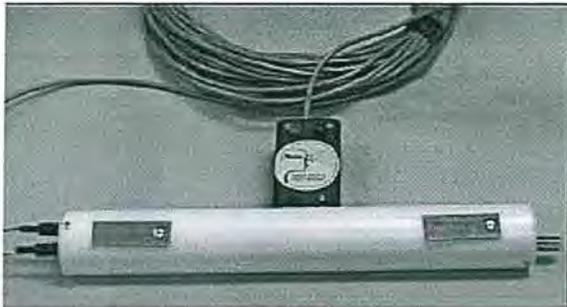
Figure 2. Revised design of RMSS.

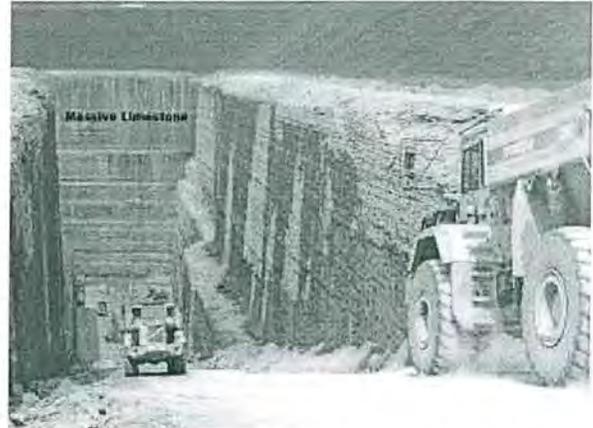
Figure 3. Monitor installation in massive roof rock.

In a massive roof beam devoid of discontinuities, no movement would be expected (figure 3). If a discontinuity such as a wedge exists, and a monitor is not installed within the rock affected by it, the monitor will not show movement prior to failure (figure 4). Conditions most conducive to the use of monitors for collecting roof movement data are in layered strata of roof rock as shown in

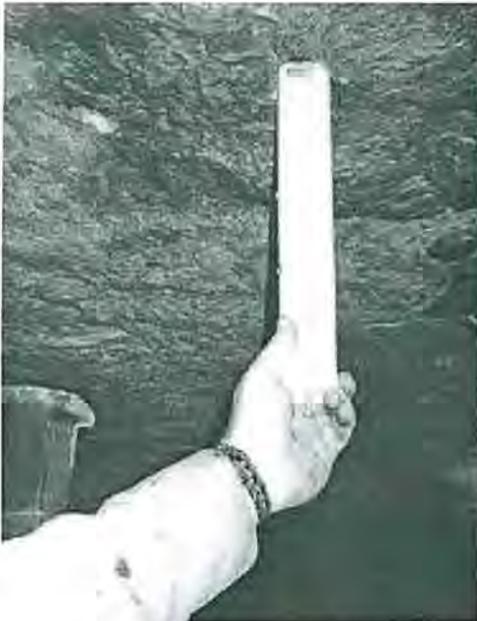
Figure 6. Installation of RMSS.

Typical mine site installations of RMSSs by NIOSH personnel were conducted in the following manner (figure 6):

- Mine operator selects sites for installation.
- Installation holes are drilled in roof to appropriate depth.
- Bucket/Basket truck with an operator is provided to obtain access to the roof.
- RMSS is inserted in hole and cable is attached and extended along roof and down the rib.

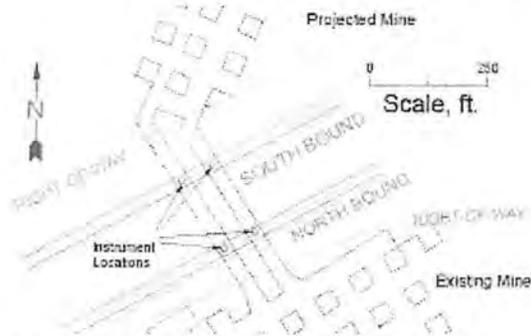
Figure 10. Map showing existing mine workings with projections.

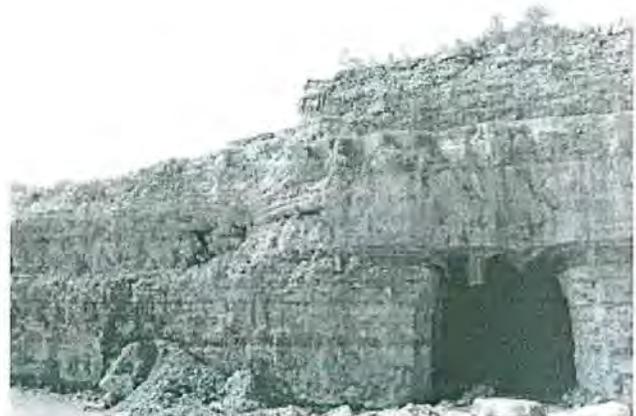
Figure 14. Big Bend Mine portal.

Conditions at Big Bend continued to deteriorate and attempts to mine at other roof horizons failed to substantially improve the situation. On November 3, 2000, because of safety considerations, Liter's decided to surface mine the reserve and abandoned underground mining operations. Figures 14 and 15 illustrate the now exposed roof of the former underground mine after blasting. Figures 16 and 17 provide a close-up view of what had been the mine roof rock. Underground observations relating to the geology combined with the roof movement measured with the RMSSs were apparent once these exposures were reviewed.

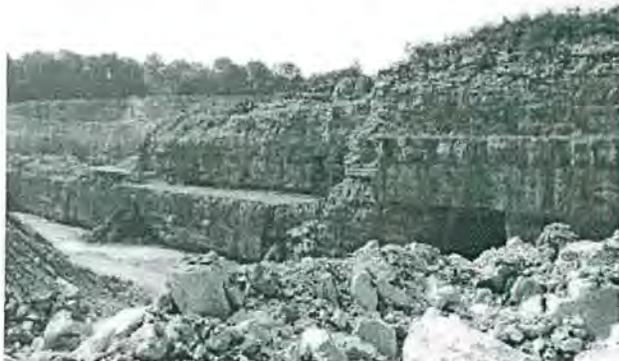
Figure 15. Exposed roof rock at Big Bend Mine.

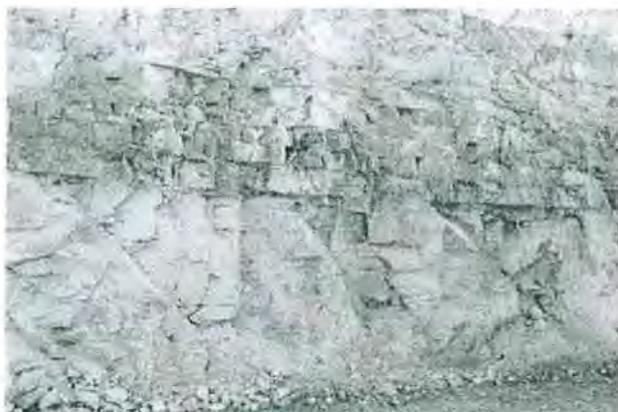
Figure 16. Big Bend roof rock.

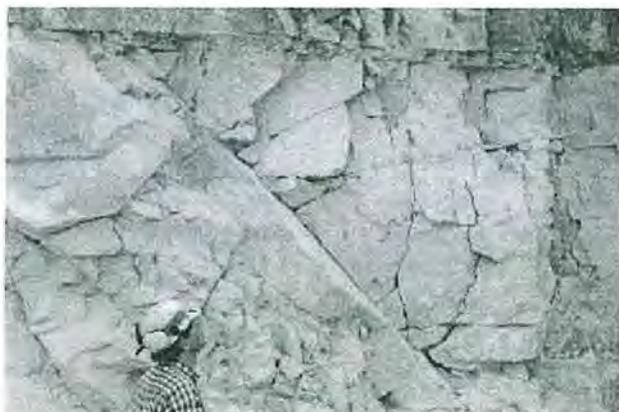
Figure 17. Close-up of roof rock.

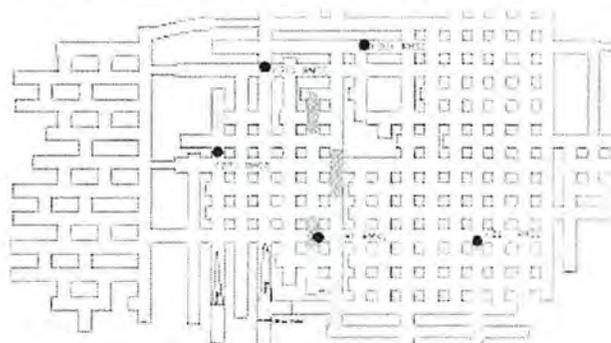
Figure 18. Mine map with RMSS locations.

A breakdown of the 30 RMSS installations, as related to roof movement, is as follows: 3 significant, 2 moderate, and 25 low or no movement. Significant movements are characterized as reaching failure, moderate, as continuing to move or progress, and low, as no or some movement but subsequently stabilizing. Figure 18 shows an area of the mine where all three conditions occurred.
