3<sup>rd</sup> International Seminar on Surface Support Liners:  
Thin Spray-On Liners, Shotcrete and Mesh  
August 25<sup>th</sup>-26<sup>th</sup>, Quebec City, Canada

# The Long-Term Performance of Surface Support Liners for Ground Control in A Underground Limestone Mine

Deno M. Pappas, Timothy M. Barton, Eric S. Weiss

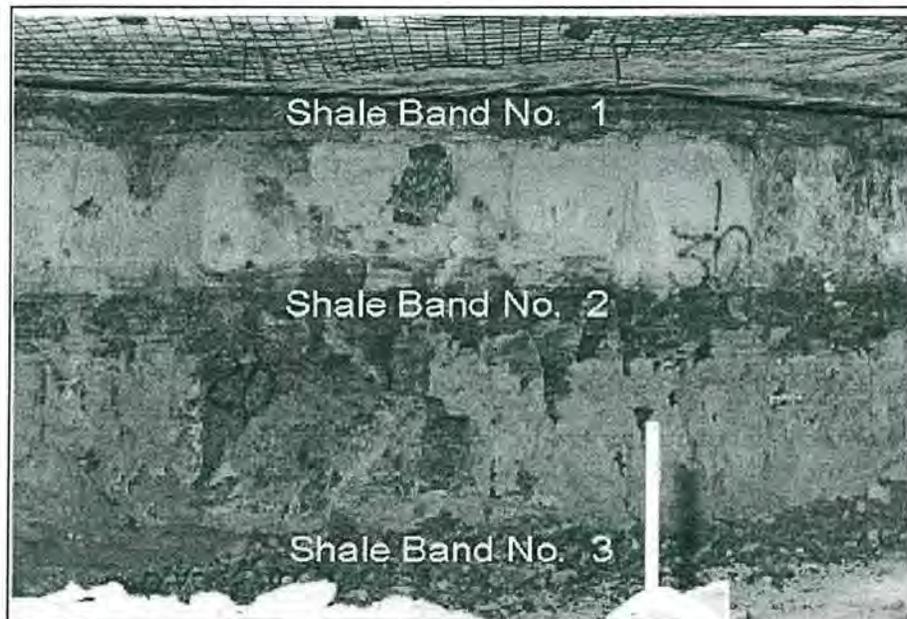
Figure 1 - Shale bands dividing limestone formation at LLEM.

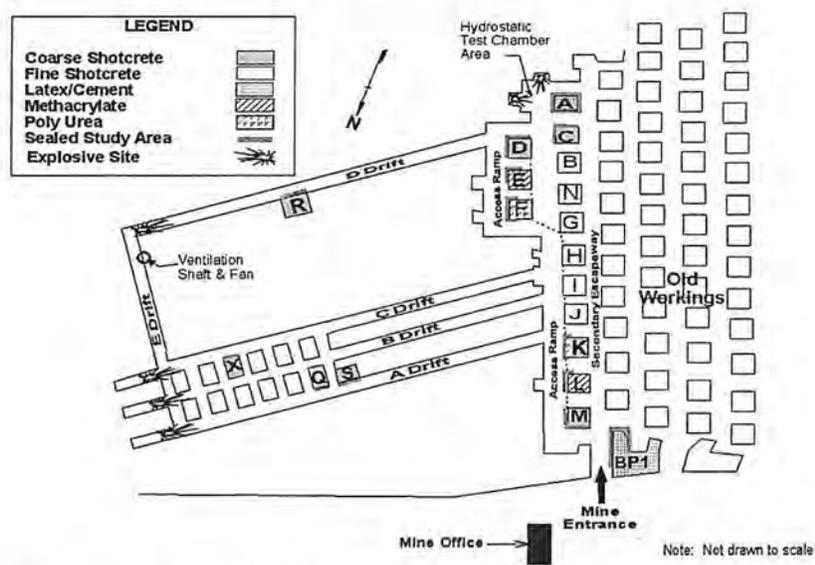
Figure 2 - Diagram of LLEM (not to scale).

- Coarse shotcrete - contains cement, sand, "BB-sized" gravel aggregate, micro silica fume and 1.3 cm acid resistant glass fibers. The shotcrete is applied using dry process equipment primarily composed of a large rotary barrel gun. As with all dry process shotcrete machines, the shotcrete is conveyed dry through the hose and water is added to the dry shotcrete at the nozzle. The nozzleman controls the amount of water to obtain the proper consistency which can vary depending on the particular application. The coarse shotcrete was installed at sites C, D, M, R, S, and X as shown in figure 2.

- Fine shotcrete - contains cement, well graded silica aggregate, micro silica fume and 1.3 cm acid resistant glass fibers. The same dry process shotcrete machine used to apply the coarse shotcrete was used to apply the fine shotcrete. The fine shotcrete was installed at site Q as shown in figure 2.

The latex/cement thin spray-on liner was also applied on a 76 m section of the large barrier pillar (BP1) near the entrance portal (figure 2). This area of the mine is subject to frequent freeze thaw cycles and large changes in temperature and humidity (figure 5). An 8 mm thick double coating of liner material was applied around a corner area and on the unmeshed areas of the adjacent roof. The liner at this site has also performed well, with the exception of four small patches (approximately 3.7 m<sup>2</sup> total area) that have detached from the rib. These patches represent less than 1% of the total area covered. Upon close observation, it appeared the cause of failure was more related to the failure of the rock than failure of the liner material. In three of the cases, the area was located at the bedded shale material near the rib/roof corner. Most likely, the fractured shale was partially degraded when initially sealed. Close examination of the detached liner material indicates that the dominant failure mechanism was the rock failing and not the liner material. However, the weight of the loose rib rock eventually exceeded the strength of the liner (which in two of the cases was a single thickness of 4 mm), allowing a section to tip and fall from the rib. If this site had been properly scaled and the damaged rock removed, in all probability the latex/cement liner would not have detached.

Several different experimental versions of the methacrylate-based thin spray-on liner were installed on small trial areas at sites L and E (figure 2) in 2001 and 2002. The liner trials that did not perform adequately were removed and the methacrylate formulation was adjusted for the next trial. Several adjustments were made to the formulation to decrease the viscosity and improve its tolerance to moisture. Pump and application problems were corrected to provide a more uniform thickness of the spray-on liner to the mine ribs.

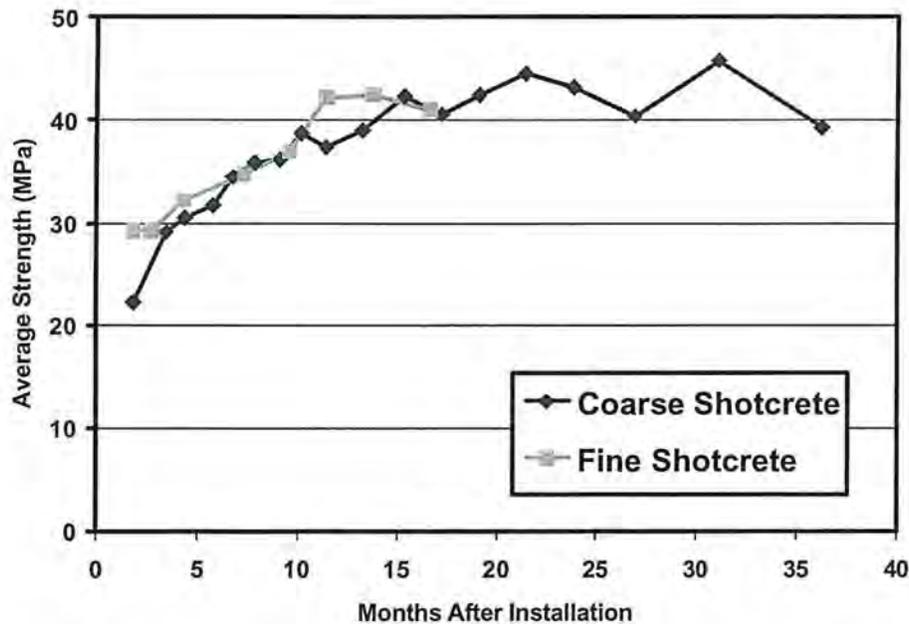
Figure 3 - Schmidt Hammer averaged for coarse and fine shotcrete results - time versus average of compressive strength.

Figure 3 shows a large increase in the coarse shotcrete average compressive strength over the three-year period. Examining the cumulative rate of strength increase from the averaged hammer test results for all the test sites, as shown in figure 4, indicates a 60% increase during the spring and summer of 2000. However by the fall of 2000, the rate of increase had lessened. Shotcrete is normally expected to reach its design strength in 28 days, but may increase in strength another 5-10% after 56 days (Browning, 2002). The coarse shotcrete was installed between November 1999 and early February 2000, so the shotcrete should have reached at least its 56 days strength by the time the hammer tests were started. Consequently, most of the strength increase may be attributed to other factors, perhaps the high humidity levels present during the time in question. Typically, the humidity levels at the LLEM during the summer months are 100% which produces condensation on the rib and roof of the mine (figures 5-6). Possibly, the continual presence of moisture prolonged the curing process of the shotcrete and resulted in the large increase in shotcrete strength. This seems to indicate that spraying the shotcrete with water, in dry mines or dry winter months, may help cure the shotcrete and allow it to reach its full strength.

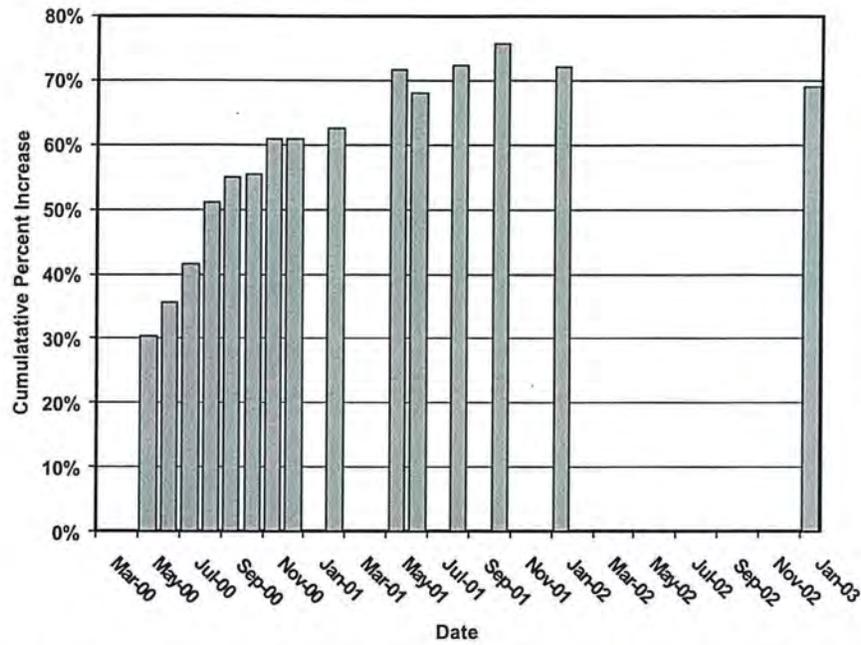
Figure 4 - Schmidt Hammer coarse shotcrete results - time versus cumulative percent increase in strength.

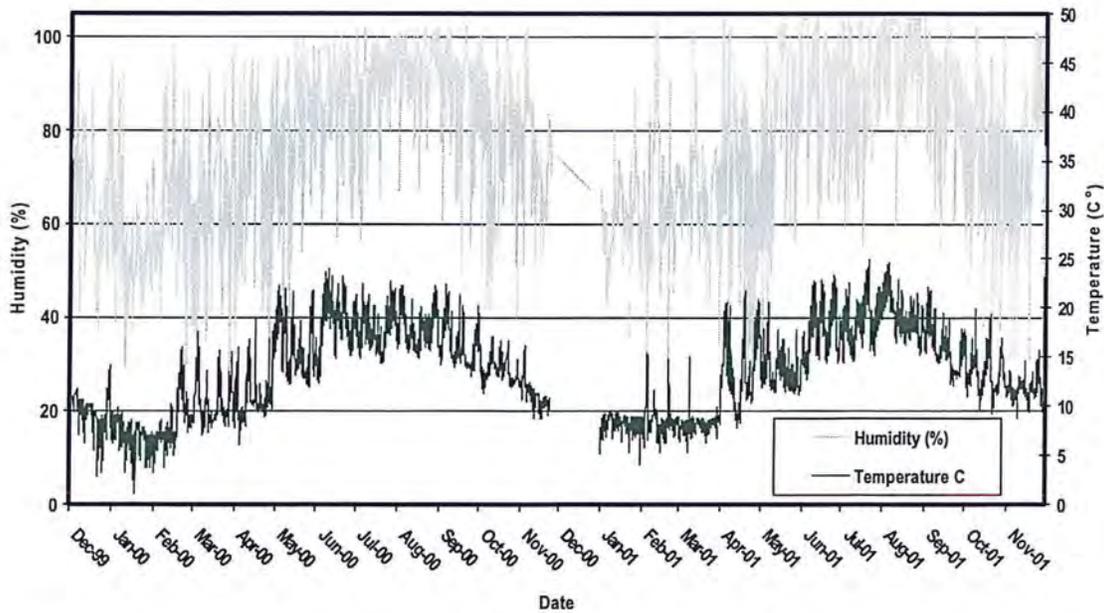
Figure 5 - Weather station data at BP-1 site – time versus temperature and humidity versus time.

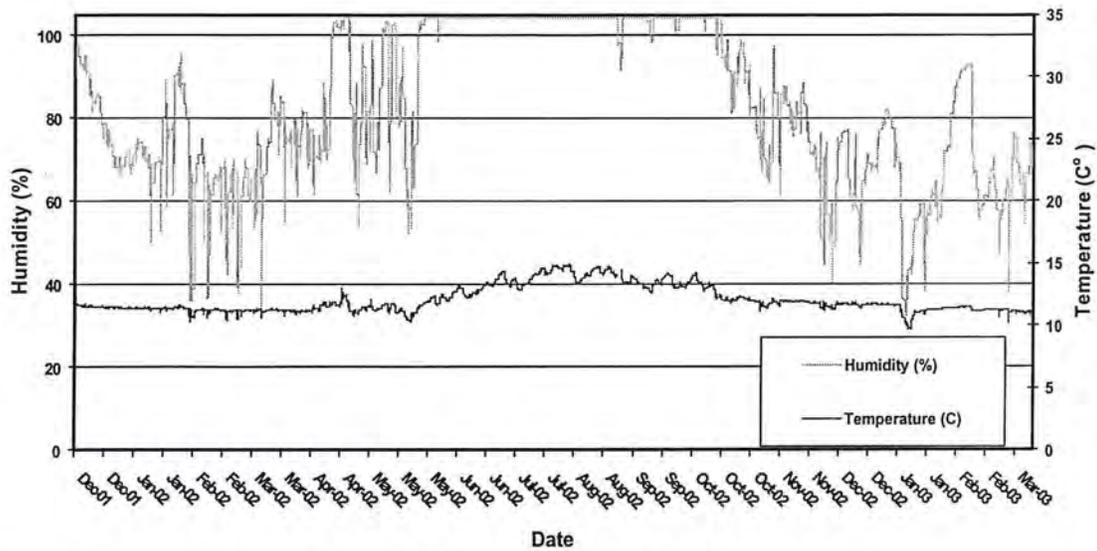
Figure 6 - Weather station data near Pillar Q site – time versus temperature and humidity.

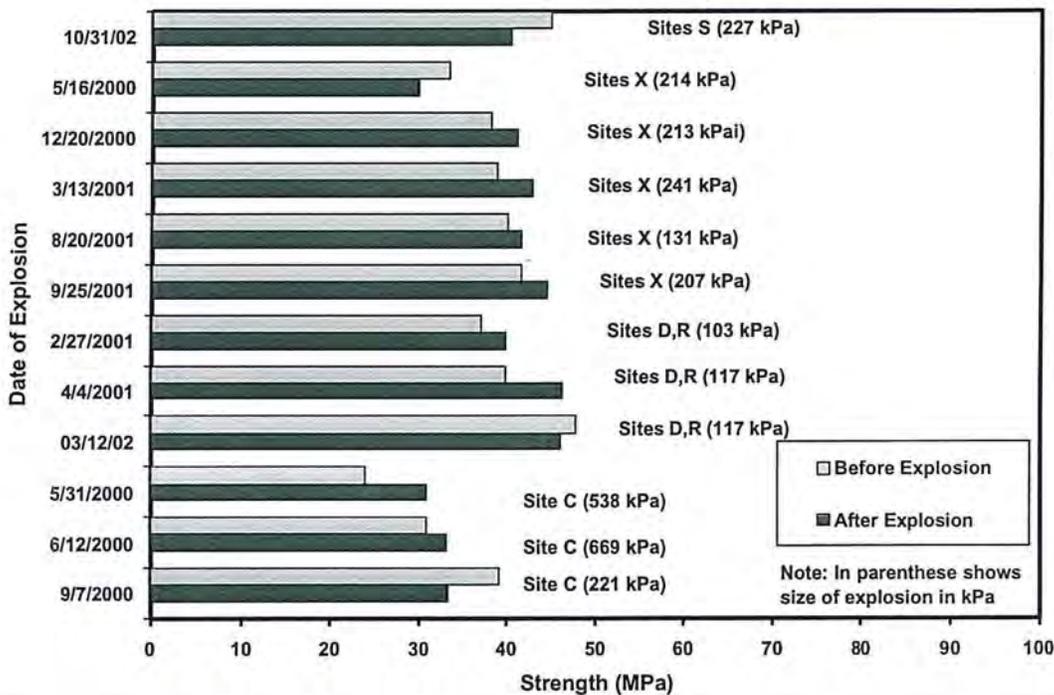
Figure 7 - Comparison of coarse shotcrete strength before and, after explosion tests - estimated compressive strength versus time.

explosion test. As can be seen in figure 7, there is no significant decrease in the shotcrete strength. In addition, examinations of the sites before and after each mine explosion test did not reveal any effects on the physical integrity of the shotcrete. It was apparent after the explosion tests, that the shotcrete had maintained its integrity and stayed completely intact. No fallen roof or rib debris was detected in the areas that were shotcreted. A few areas near site D have scrapings in the shotcrete due to debris hitting the face from explosions tests in the D drift.

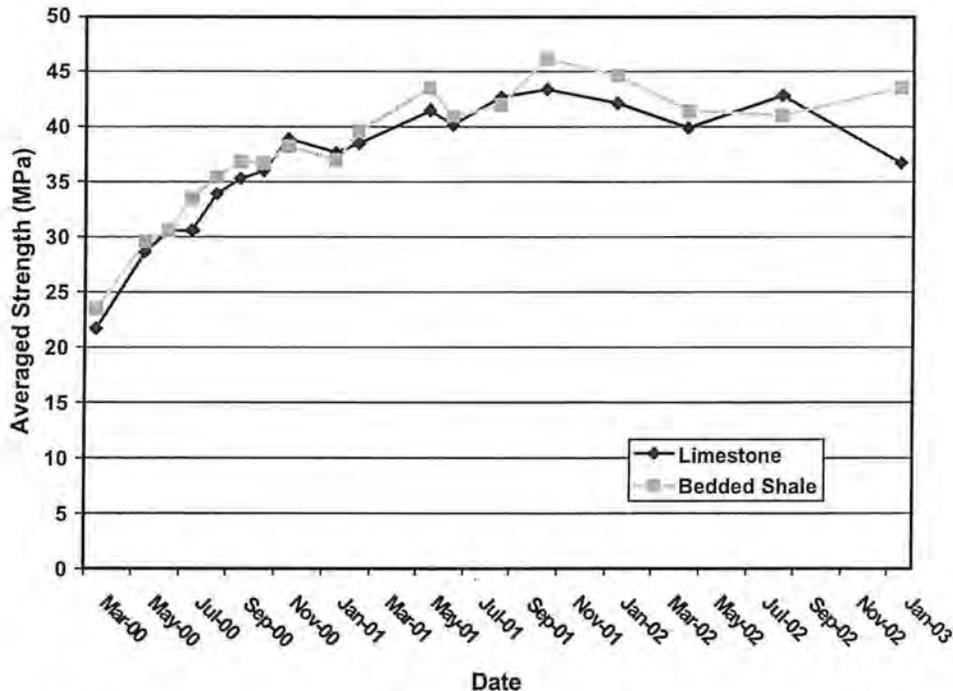
Figure 8 - Comparison of coarse shotcrete strength in the limestone and bedded shale - time versus estimated compressive strength.

Test sites were also established to determine if the shotcrete strength is different on the shale than on limestone surfaces. The preliminary short-term results, as shown in figure 8, do not reveal any significant difference in the shotcrete strength, which appears to indicate that the shotcrete adheres equally well on the bedded shale as it does with the limestone. If the shale binder did not provide a good bond or had detached from the shotcrete, the hammer results would have been significantly lower.

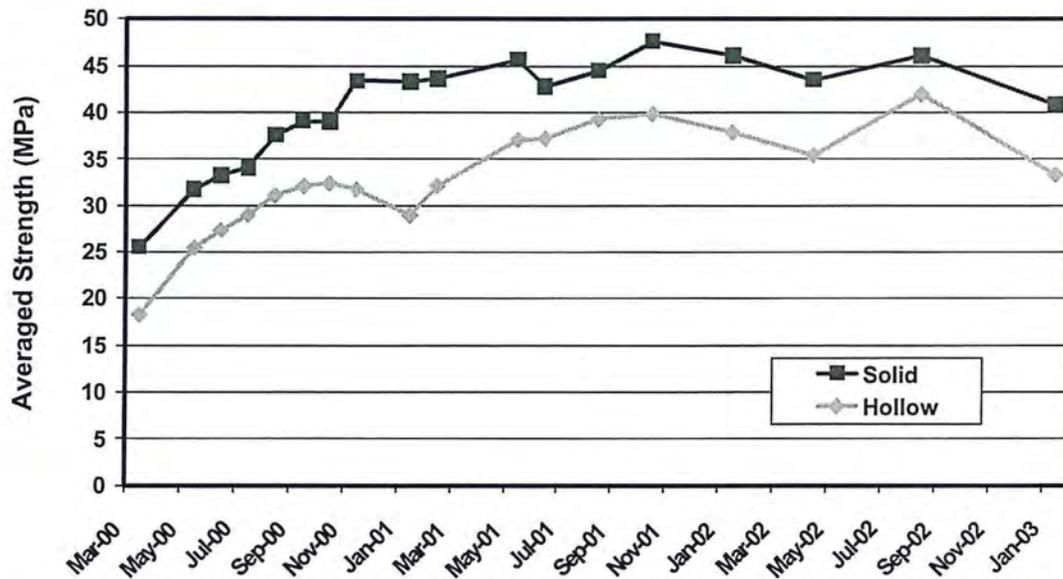
Figure 9 - Comparison of coarse shotcrete strength by bond effects -time versus estimated compressive strength.

“valleys” in figure 9 of the hollow site curve is due to gradual degradation of the hollow shotcrete site after several series of hammer tests. The hammer test data usually rebounded following regrinding of the degraded test site. A few areas were cored to visually examine the hollow sounding areas. Figure 10 shows a cored sample of a void in the coarse shotcrete from site M. Most likely, these hollow soundings are due to the formation of air voids or pockets of shotcrete that were loosely cemented during application. Similar types of voids were found with the fine shotcrete and will be discussed later.

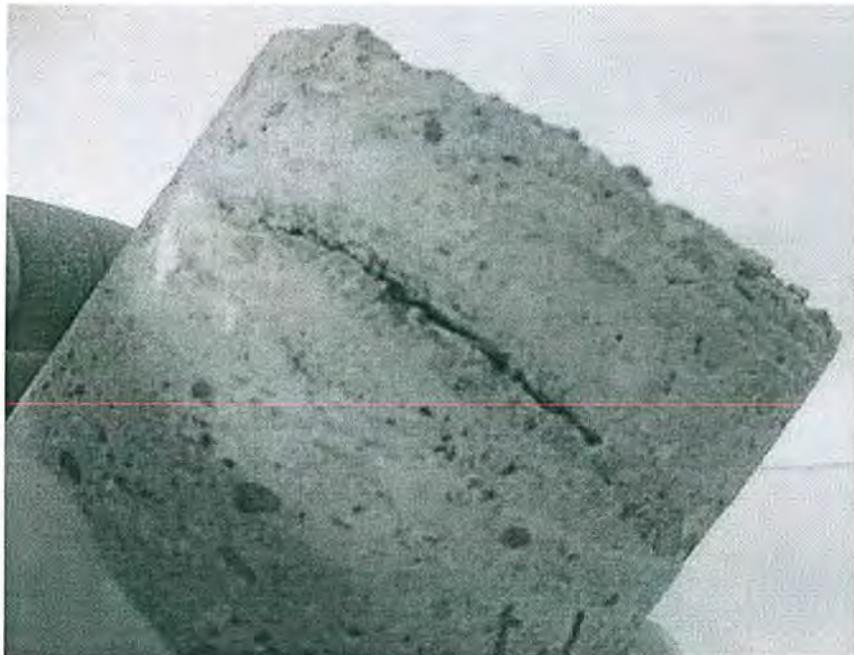
Figure 10.- Coarse shotcrete coring with large void.

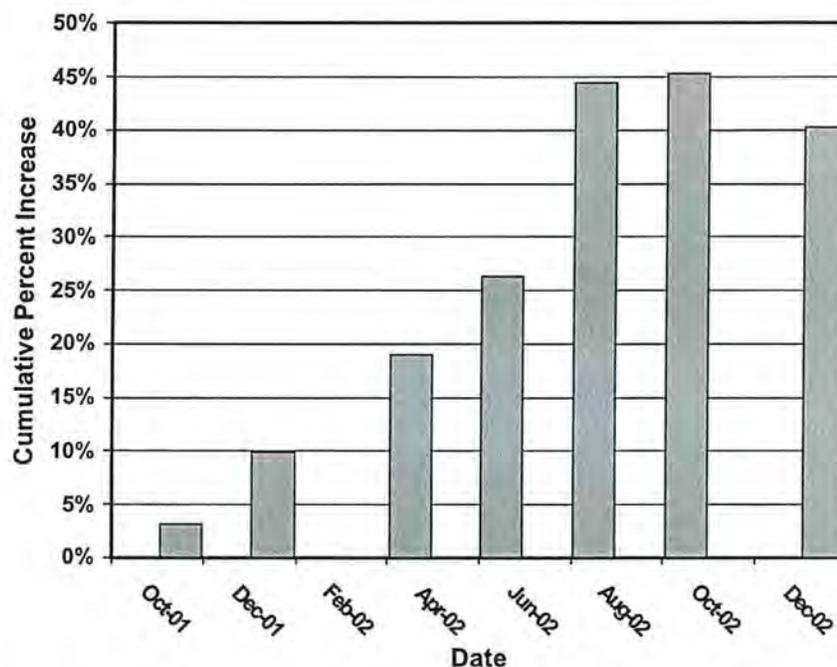
Figure 11- Schmidt Hammer fine shotcrete results - time versus cumulative percent increase in strength.

Fine shotcrete was installed in September 2001 at site Q in A drift. As listed in table 2, a 16% overspray/rebound rate was estimated with the fine shotcrete which was comparable to the coarse shotcrete rate. After 16 months of monitoring its strength using the Schmidt Hammer the estimated compressive strength of the fine shotcrete had increased 45% compared to 72% for the coarse shotcrete for the same time period (figure 4 and 11). Figure 3 shows that the initial 56-day strength of the fine shotcrete was higher than coarse shotcrete (29 MPa versus 22 MPa) however, the maximum strengths appear to be similar (42 MPa vs. 43 MPa). According to the manufacturer's specification sheet, the maximum strength is 55 MPa for the coarse shotcrete and 57 MPa for the fine shotcrete. In addition, the greatest increase in strength for both the coarse and fine shotcrete seems to coincide with the late spring and early summer period, 60% and 35% increase respectively (figure 4 and 11). Perhaps the full curing of the shotcrete (after 56 days) is not so much a function of time, but rather a function of greatest time exposure to moisture. To date, the fine shotcrete has not shown any signs of deterioration.

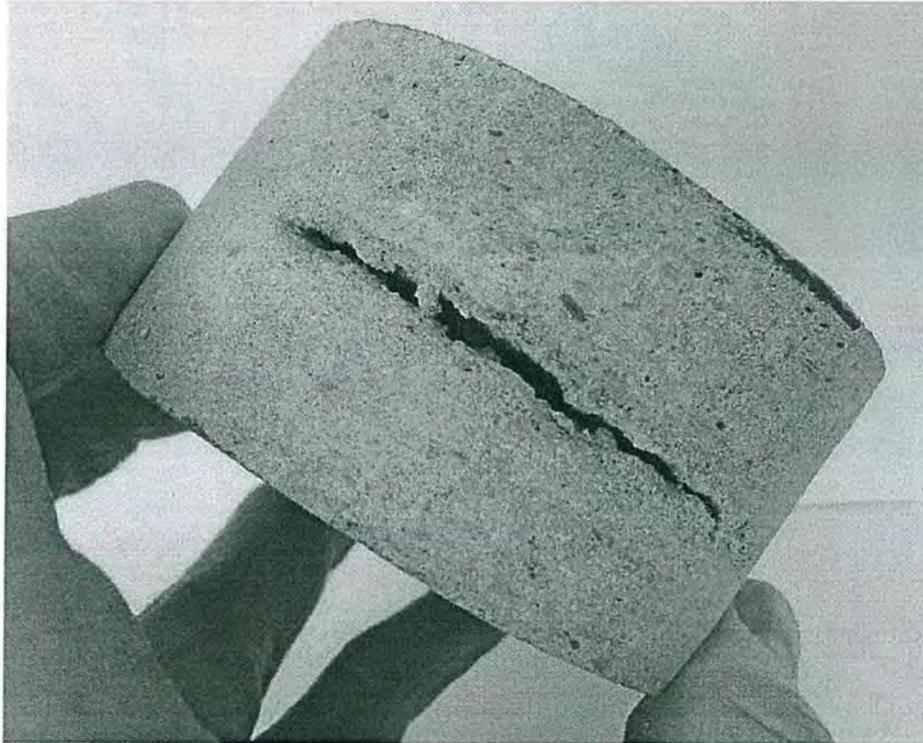
Figure 12 - Fine shotcrete coring with large void.

Cores were taken of the in situ fine shotcrete from an accessible site. Several of these cores were found to have vertical bedded voids, inadequately mixed shotcrete, and shotcrete areas that were poorly bonded to the rib rock. Figures 12-13 show core samples with large vertical voids parallel to the rib face. Figure 13 shows a void that originates from shotcrete that is poorly mixed and cemented together. Perhaps the loosely cemented

aggregate and glass fibers allows the shotcrete to bridge air gaps resulting in narrow vertical voids as each layer is applied.

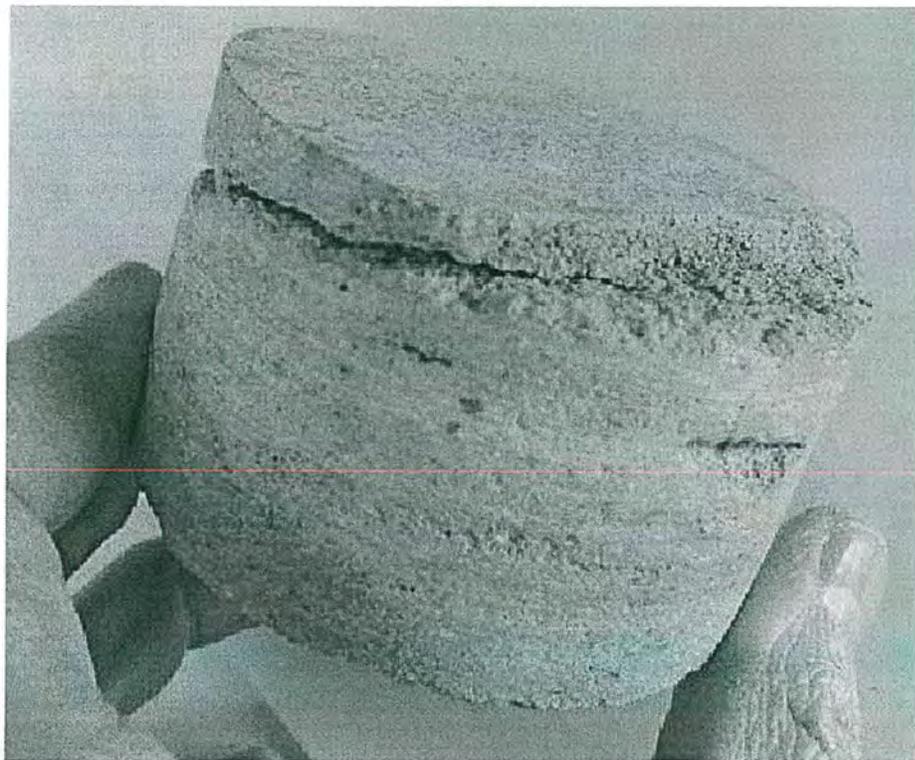
Figure 13 - Fine shotcrete coring with voids originating from poorly mixed material.

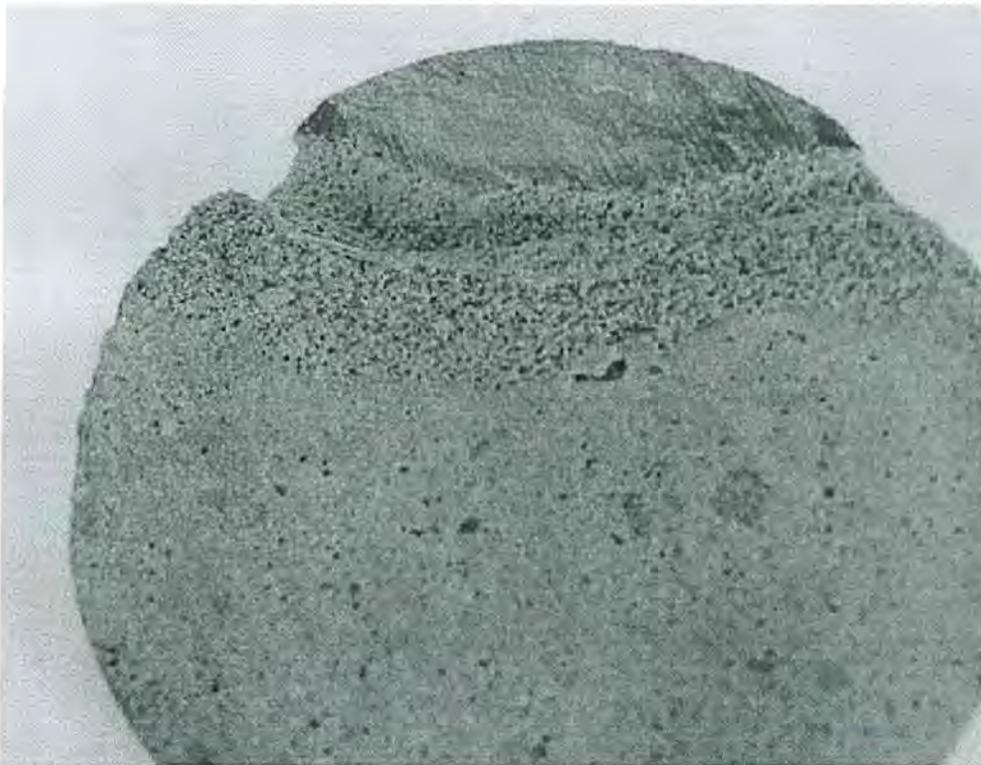
Figure 14 – Fine shotcrete coring with improper water content and loosely cemented material at shotcrete/rock interface.

Also detected in some of the fine shotcrete core samples was a weak bond between the shotcrete and the rib rock. Figure 14 shows a fine shotcrete core cross section that is poorly mixed. Portions of the shotcrete near the rock interface actually crumble loose under the pressure of a finger rubbed across the sample. As a result, the poorly mixed fine shotcrete has a weak bond to the adjacent rib rock. These conditions seem to occur more often with the fine shotcrete than with the coarse shotcrete. Perhaps the larger aggregate size with the coarse shotcrete allowed the shotcrete to mix better than the smaller aggregate size with the fine shotcrete. Another cause for the loosely cemented shotcrete could be a water deficiency in the shotcrete mix.

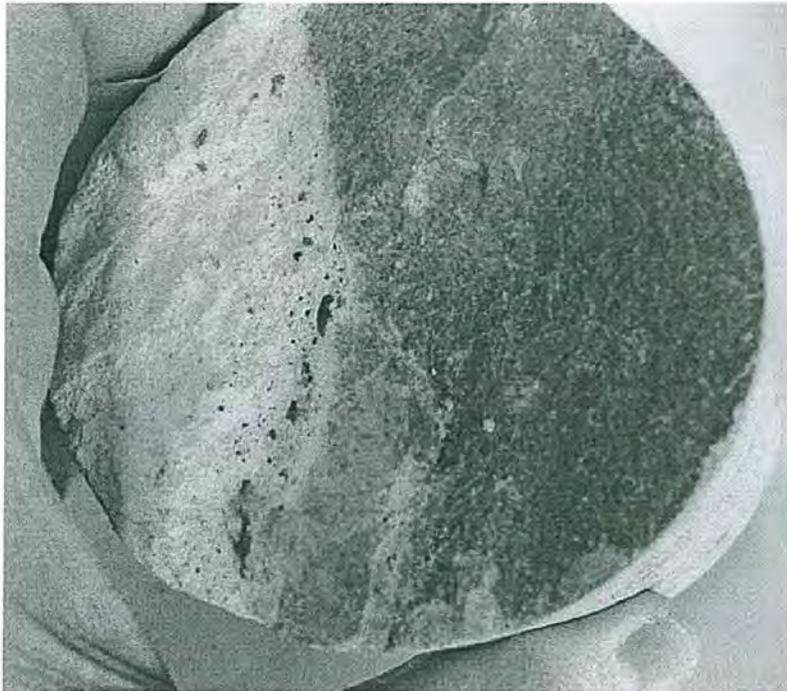
Figure 15 - Fine shotcrete coring with poor bonding at the rock/shotcrete interface due to air pockets and bubbles.

Another bond issue is the presence of dust or air bubbles at or near the shotcrete and rib rock interface. Figures 15-16 show the remnants of air bubbles on this interface which reduces the bond of the shotcrete to the rock. This problem may be related to an improper surface preparation of the test site which will be discussed later in more detail.

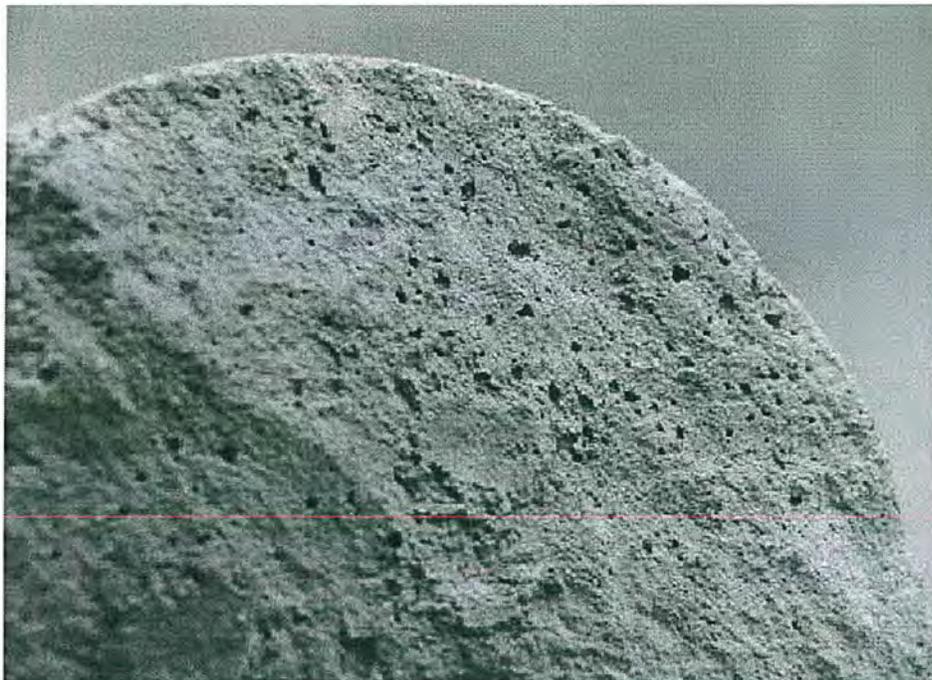
Figure 16 - Fine shotcrete coring with small air bubbles formed at the shotcrete/rock interface.

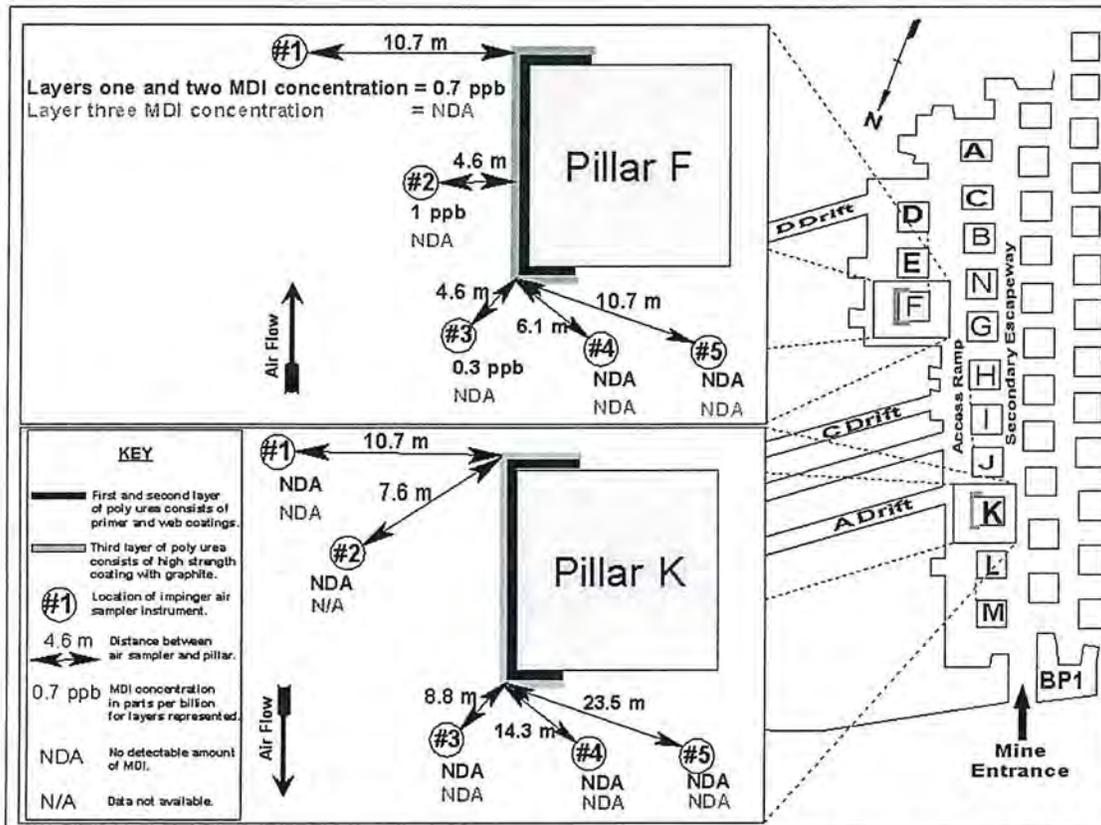
Figure 17 - Diagram of sampling locations and MDI concentration levels at the F and K sites during the polyurea installation (not to scale).

The polyurea "A" component contains diphenylmethane diisocyanate (MDI), which can be a powerful irritant to the respiratory system. According to the Coal Mine Health Inspections Procedures Manual (MSHA, 2003), workers exposed to isocyanate foams can become sensitized, making them subject to severe asthma attacks if they are re-exposed, even at low concentrations. To address these concerns, the Mine Safety Health Administration (MSHA), Physical and Toxic Agents Division were contacted to monitor the MDI concentration levels during the application of the polyurea liner material. MSHA used five midjet impingers with 20 mL of solution (NIOSH Method #5522) with sampling pumps to sample the air (both vapor and droplets) at both application sites. Figure 17, shows the placement of the impingers relative to the pillar.

According to the MSHA report (Arnold, et al., 2002), the sample analysis showed a nearly unquantifiable concentration of airborne MDI present during and following the application of the polyurea (figure 17). All of the measured concentrations were well below the MSHA ceiling value of 0.2 mL/m<sup>3</sup> or 20 ppb. Sixteen of the nineteen samples taken showed no measurable MDI. The first set of readings (readings noted on figure 17 adjacent to the test sites) monitored the application of the polyurea primer and web layers and the second set of readings monitored the application of the final coating. The samples that showed some presence of MDI were mostly located downwind or near the rib during the application of the first two layers at site F. These very low but measurable levels are associated with the polyurea primer and web layers that were applied to site F. Perhaps, the primer layer may be responsible for these readings since this material is atomized longer in the air than the web layer. At site K, no measurable MDI were detected for any of the polyurea layers applied.
