PROCEEDINGS
OF THE
THIRTIETH ANNUAL CONFERENCE ON
EXPLOSIVES AND BLASTING TECHNIQUE

CO Migration from Trench Blasting in Amherst, New York

by Marcia L. Harris and Richard Mainiero

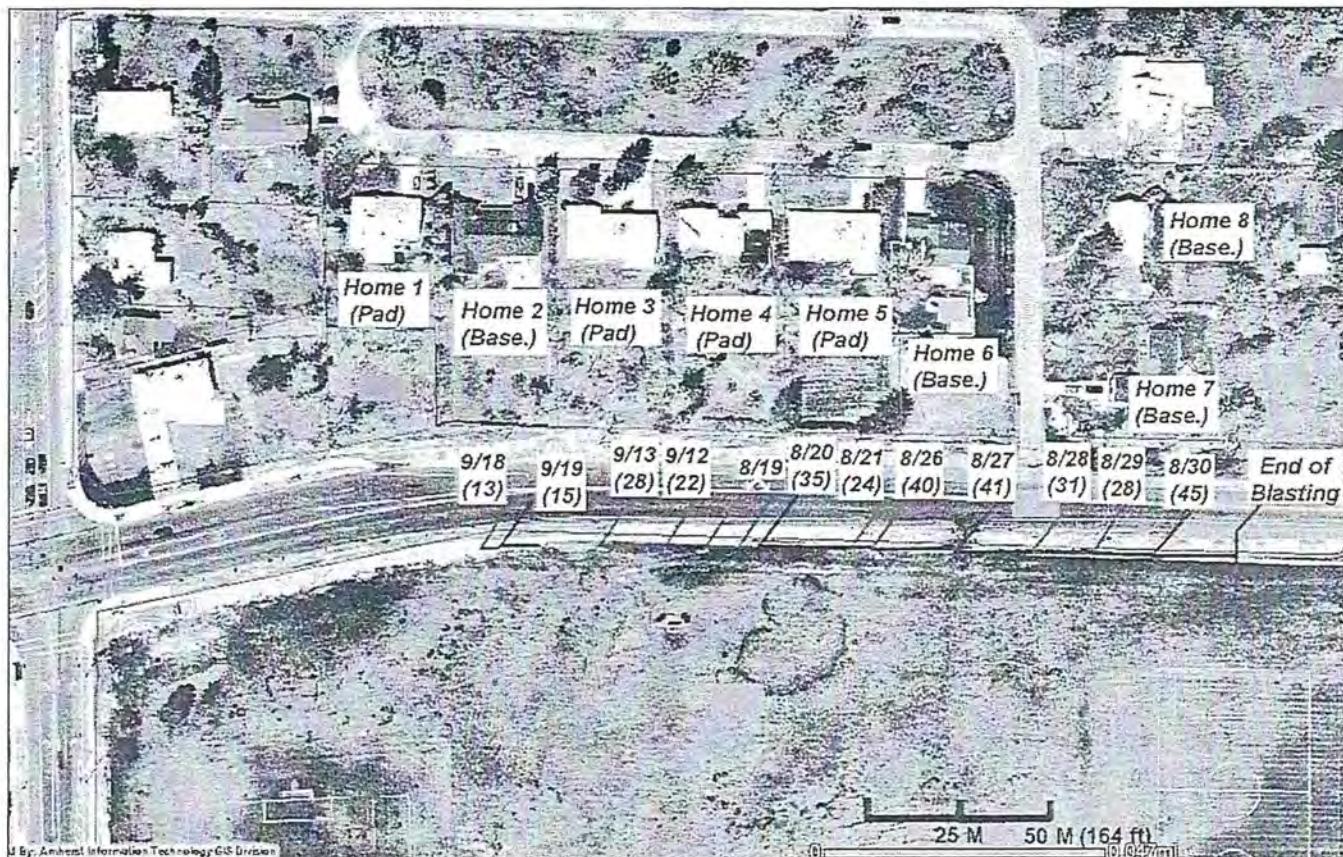
Figure 1 - Area blasted during August and September, 2002. Pad and Base indicate whether the corresponding home is built on a pad (slab) or has a basement. The dates and the number of blast holes are indicated. Each blast hole was loaded with three to four pounds of ANFO.

The first occurrence of CO on this project, took place August 27, 2002, see Figure 1, and was attributed to an automobile running in the garage. The first definite sign that CO was migrating from the blasting occurred on August 28, 2002, when 213 ppm was recorded in a basement. This incidence was followed by two occurrences of elevated CO recorded on September 12. In the first instance, the CO alarm located in the basement adjacent to a crack in the foundation alarmed when the concentration of CO peaked at 67 ppm. In the second instance on September 12, a resident living just beyond 100 meters from the blasting area contacted the EIC to report their own CO monitor had been periodically alarming. They initially disregarded the alarm. An investigation disclosed that CO was present in an unlined sewage ejection pit in the basement at 90 ppm. This appeared to be the avenue by which the CO entered the home. No other source of CO was identified.

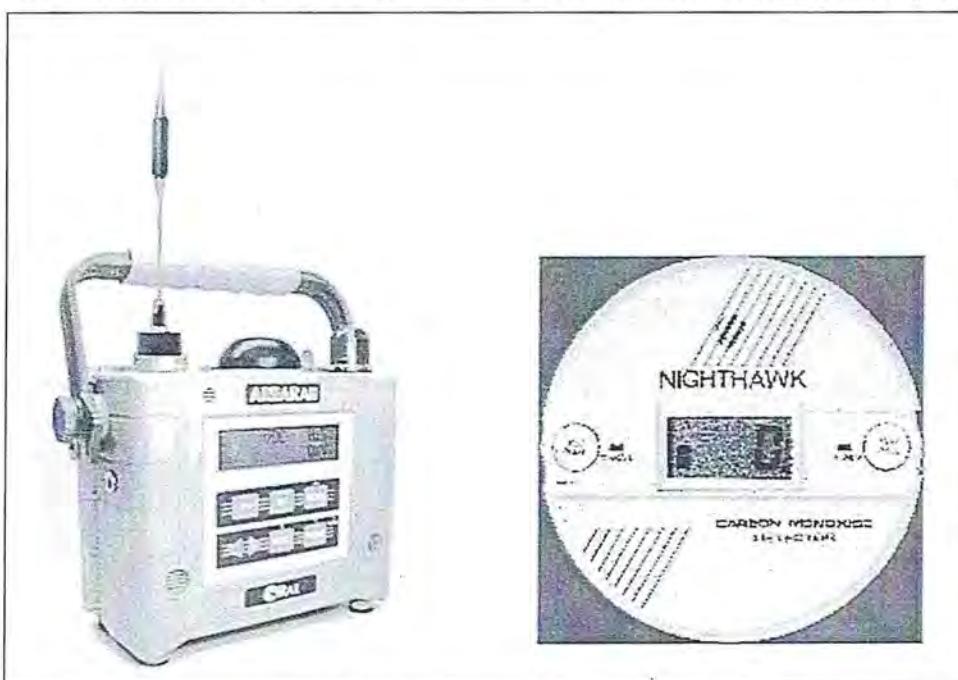
Figure 2 - AreaRAE and Nighthawk gas monitors.

The blasting plan also required that toxic gas monitoring instrumentation be employed. The contractor's environmental consultant set up five AreaRAE monitors (<http://www.raesystems.com/area.html>) in five buildings of special concern for continuous remote monitoring of CO, nitrogen dioxide (NO₂), and oxygen (O₂) concentrations.* The AreaRAE monitors are electrochemical-cell based instruments that sample every 2 minutes and radio transmit the data to a central laptop computer. Nighthawk CO monitors were also placed in each home and business within 100 m (330 ft) of the blast.* The

Nighthawk CO monitors were intended to alert residents in the event that the CO concentration reached levels of concern. These units were designed to alarm within 90 min at 100 ppm CO, 35 min at 200 ppm CO, and 15 minutes at 400 ppm CO.⁶ The Nighthawks also recorded the peak CO level occurring since the last time they were reset. Periodically, the consultant's personnel would check the Nighthawks and reset them. The NYSDOT environmental consultant continued to act in an advisory and backup monitoring capacity. The AreaRAE multiple gas detectors were to be put in place at least 24 hours prior to blasting. Action levels were set at 9 ppm for CO and 0.25 ppm NO₂. If concentrations exceeded the action levels, the person monitoring the instrumentation was to notify a contact person in the affected building, the fire department, the contractor, and NYSDOT. The instrumentation is illustrated in Figure 2. Figure 3 shows the placement of toxic gas monitoring instruments and the location of the first blast.

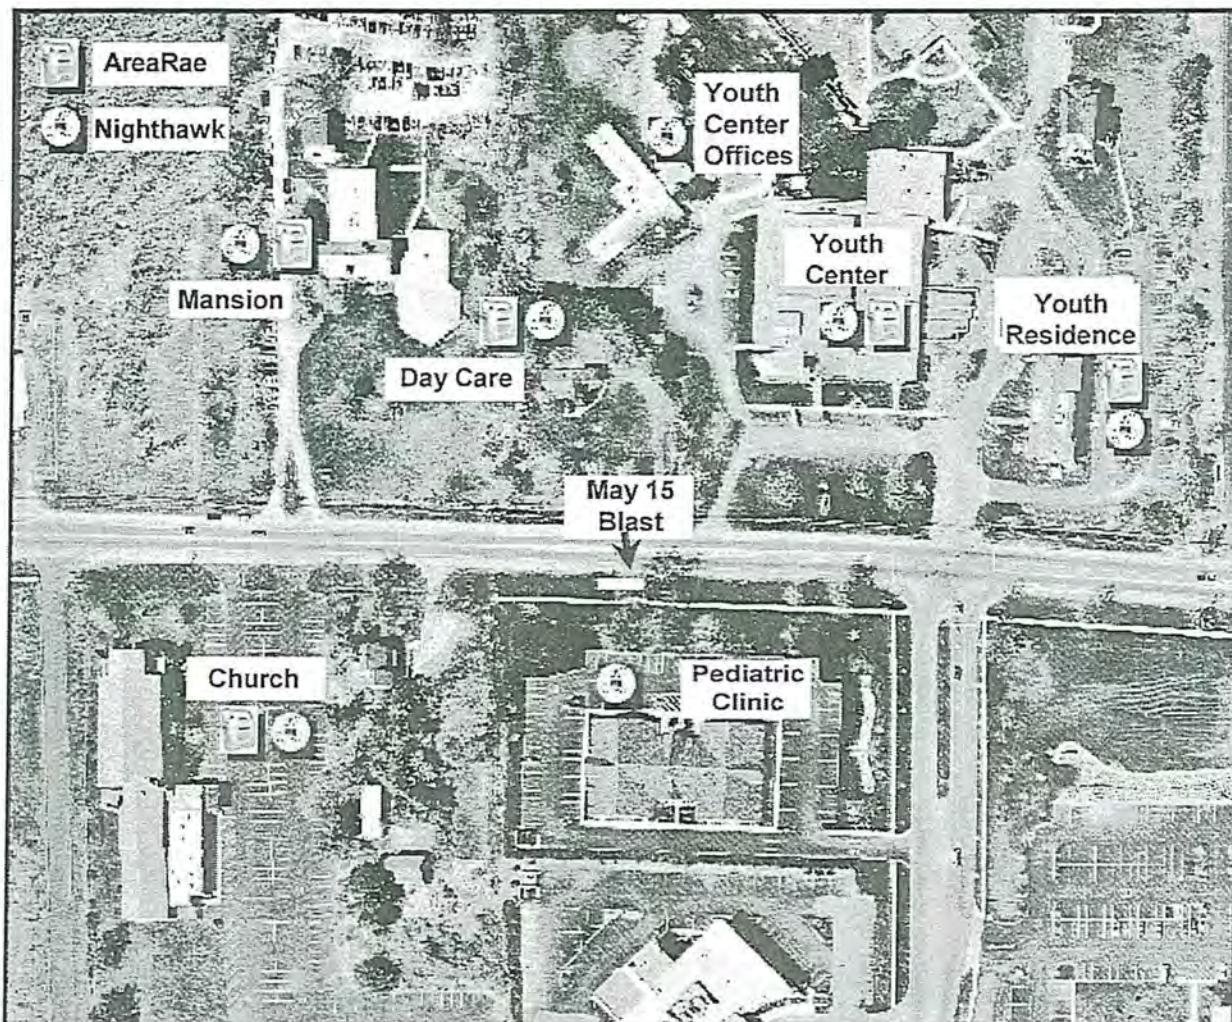
Figure 3 - Locations of instrumentation for May 15, 2003 blast.

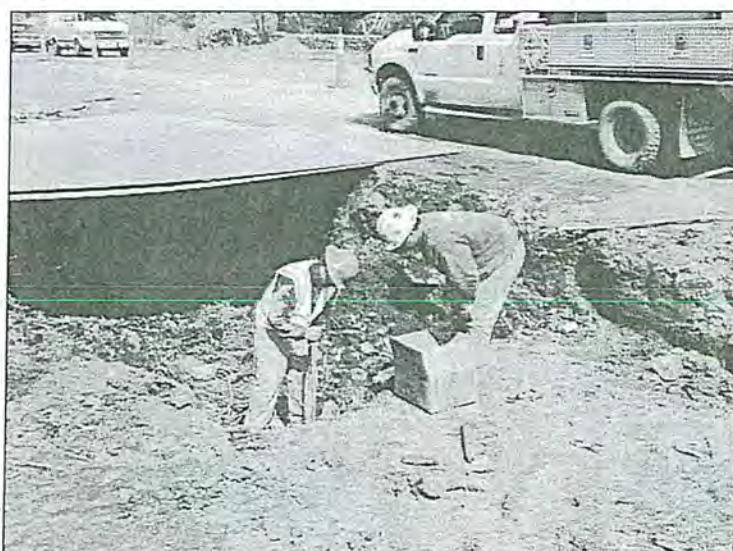
Figure 4 - Steel plates cover the open trench area.

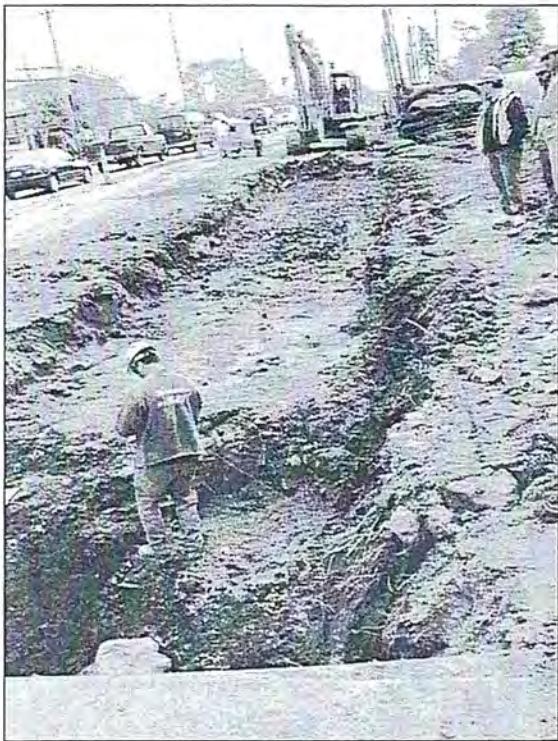
Figure 5 - Overburden is removed from the rock.

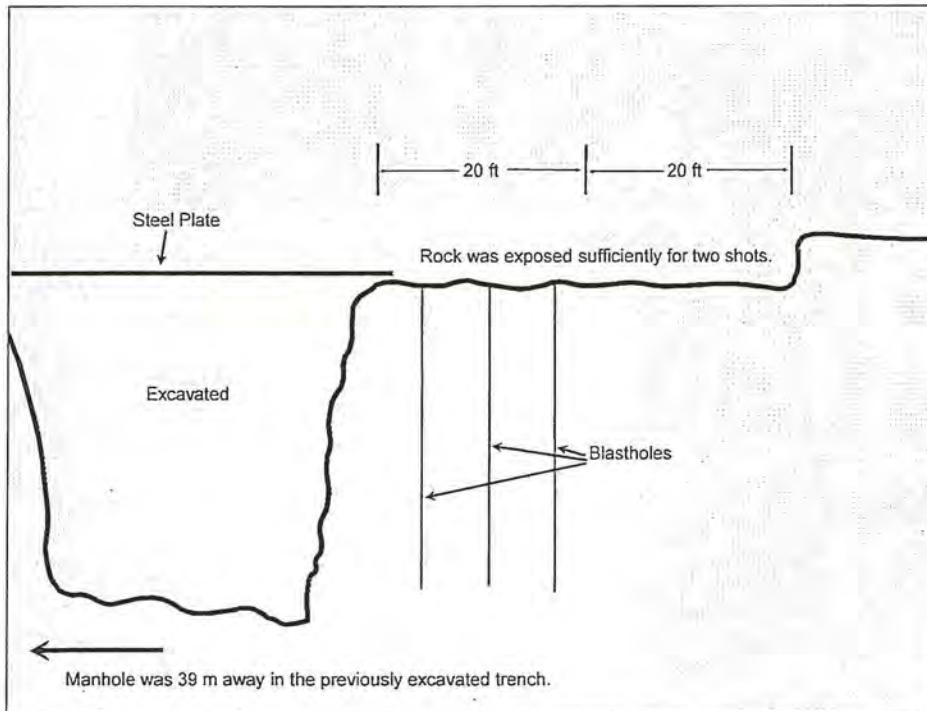
Figure 6 - The blast was designed so the broken rock could move into the excavated space, allowing the gases to vent.

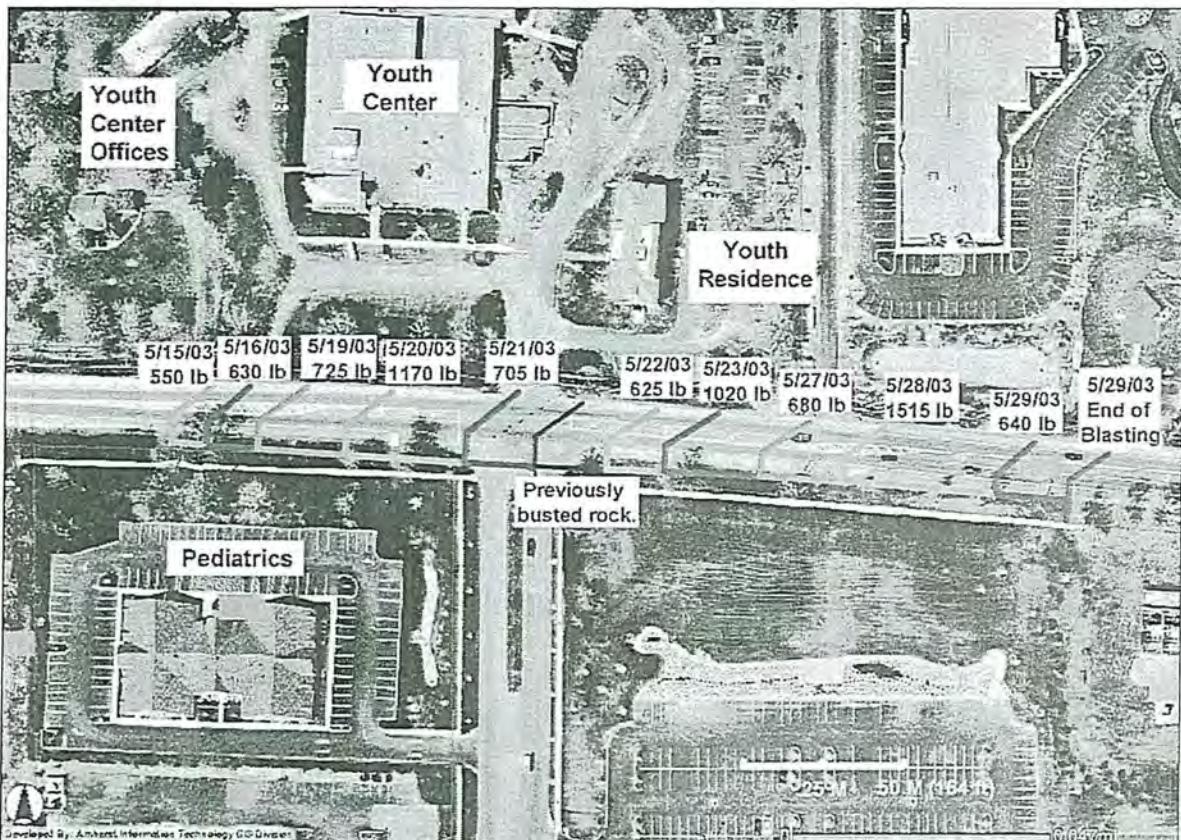
Figure 7 - Locations of blasts during May, 2003.

The first blast was scheduled for the morning of May 15, 2003 (see Figure 7). On the evening of May 14, the environmental consultants for the contractor and NYSDOT set up the AreaRAE and Nighthawk monitors. The consultant for NYSDOT also spoke with the residents and explained the functioning and purpose of the monitors; he reported that all the residents were receptive and cooperative. In the early morning hours of May 15, the AreaRAE at the Youth Center alarmed when it detected 0.4 ppm NO₂. Following an investigation it was determined this was a false alarm and the NO₂ alarm level was reset to 1 ppm.

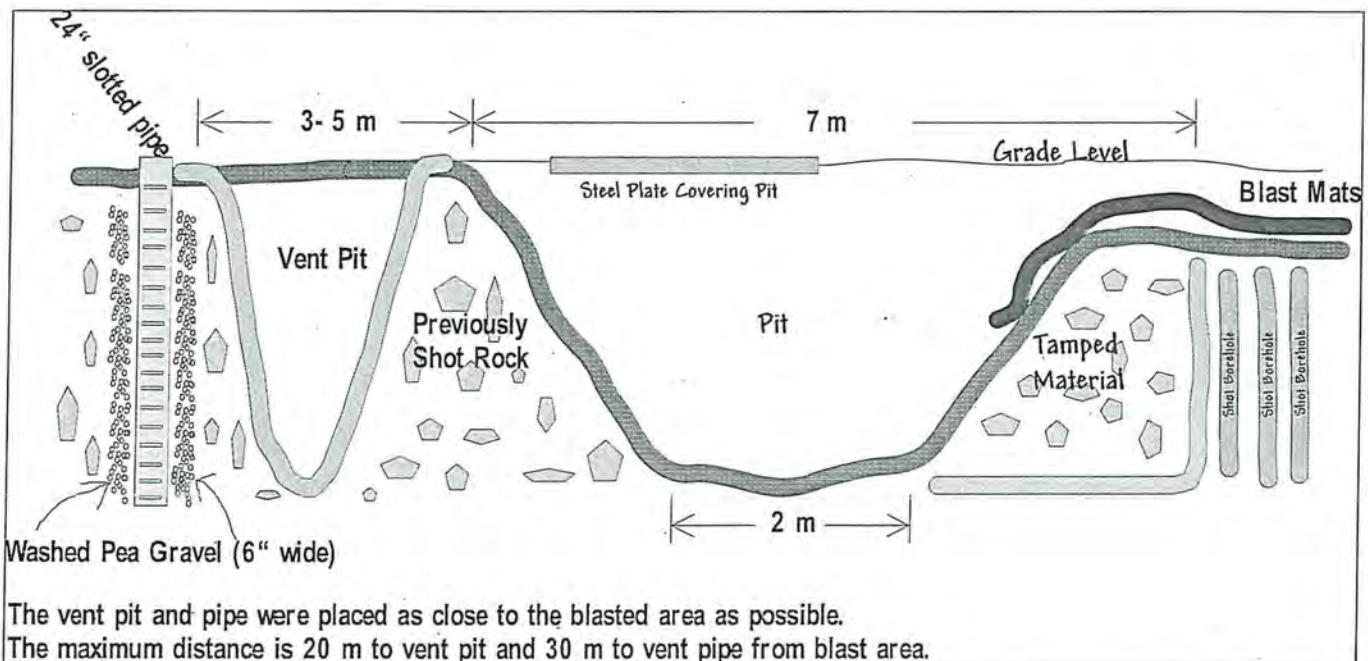
Figure 8 - Final Blast Layout.

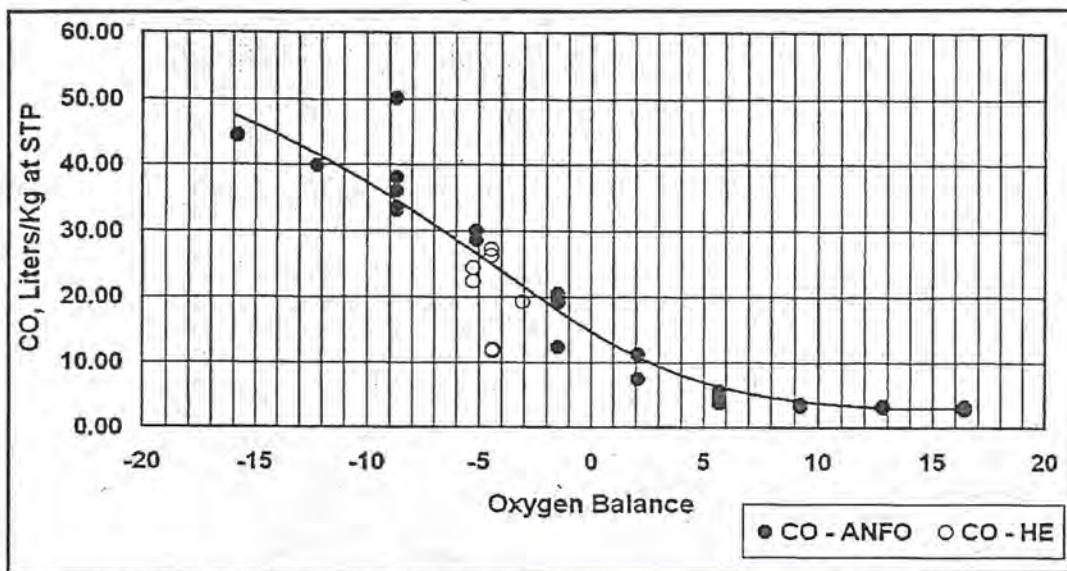
Figure 9 - Effect of Oxygen Balance on carbon monoxide production for 94/6 ANFO and high explosives (cap-sensitive explosives).⁷

A factor that can be controlled and can contribute significantly to the CO produced by the blast is the oxygen balance of the explosive used. Figure 9 shows that the CO production of ANFO increases

significantly as the oxygen balance becomes more negative.¹¹ This is confirmed in Explosives and Rock Blasting which states "An excess of oxygen in the explosives can result in the formation of nitrogen oxides (NO and NO₂) and a deficit of oxygen can cause carbon monoxide (CO) to form."¹² This means that an explosive formulated with too much fuel will produce excessive CO. An explosive formulation with too little fuel will generate excessive nitrogen oxides.
