INSTALLATION AND STABILITY OF INVERTED PYRAMID-SHAPED PLUGS
FOR CLOSING ABANDONED MINE SHAFTS GALENA, KS DEMONSTRATION PROJECT¹

John S. Volosin²

Abstract.-- The Bureau of Mines designed and installed 11 inverted- pyramidal- shaped plugs in a mine closure demonstration project completed in Galena, KS in December 1983. The demonstration project resulted from a study done by the Geological Surveys of Missouri, Kansas, and Oklahoma for the U.S. Bureau of Mines in January 1983. This study identified over 1400 open mine shafts and nearly 500 subsidence collapse features that remained from the original 14,000 shafts sunk in the Tri-State Zinc-Lead Mining District. In Galena, KS, alone over 377 open mine shafts were readily accessible and 150 abandoned mine shafts were within the city limits. Of these, the Bureau of Mines selected 14 abandoned sites for the mine shaft closure demonstration project. During the demonstration project, 11 mine shafts were closed with the inverted pyramid shaped reinforced- concrete plugs, 2 were closed with reinforced concrete caps after backfilling, and one shaft was closed by backfilling only. The stability of the closure devices has been monitored and eva

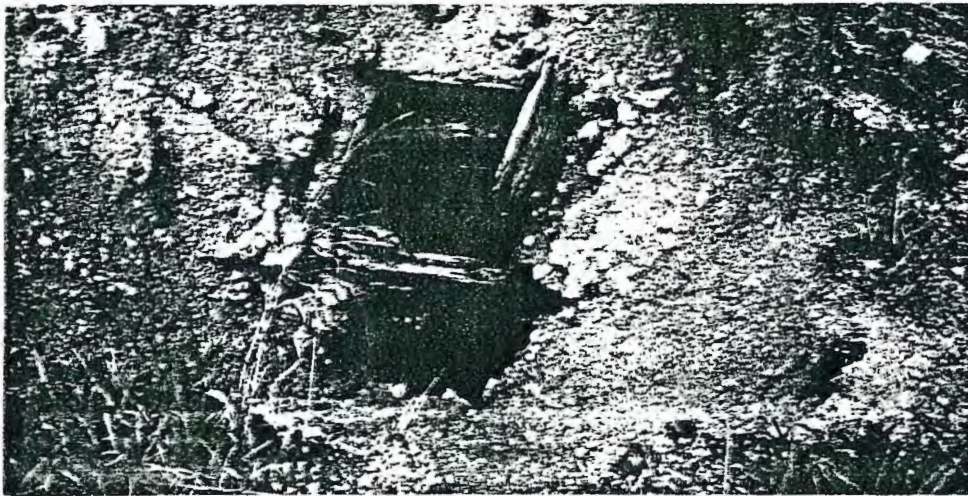
Figure 2.--Typical shaft showing rotted timber and washout along timbers.

Two of the open shafts selected for plugging are shown in figures 2 and 3. A contract was let in 1982 to obtain the shaft dimensions, assess the conditions of shaft side walls, obtain the elevation of an estimated contact between overburden and solid rock, and the location of underground workings in the shaft vicinity. These measurements were used in preparing the competitive bid specifications for the plug installations reported herein. Another contract was awarded in August 1983, to perform the actual closure demonstration work in which 11 shafts were plugged, 2 were capped, and 1 was backfilled.

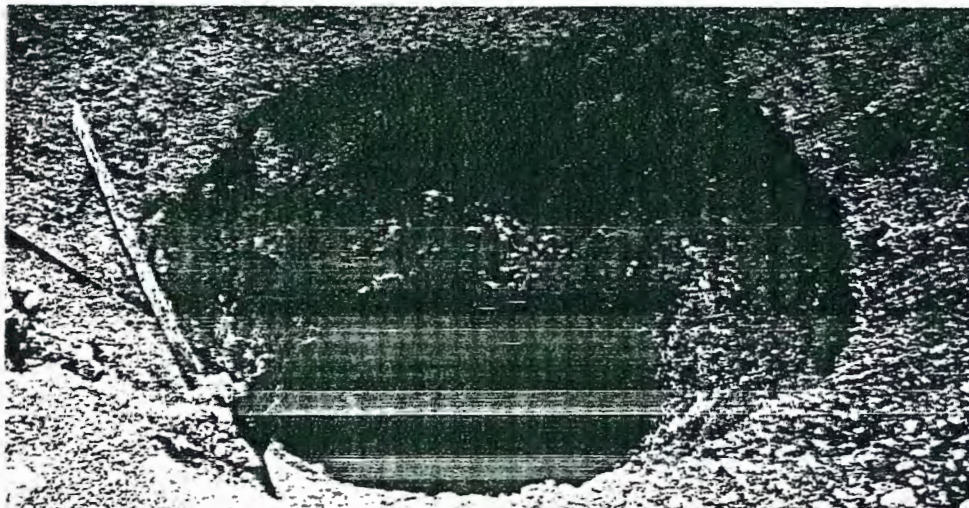
Figure 3.--Typical open shaft showing circular outline in slumping residuum.

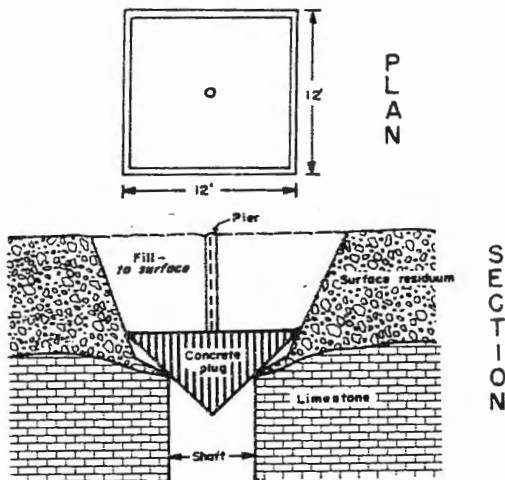
Figure 4.--Installed plug.

The forms were designed to be totally self-supporting. Once they were set in place they were not anchored to any other structure within the mine shaft. They were constructed in three standard sizes of 8, 10, and 12 ft. The size for a given shaft was selected so that the top of the plug was approximately 4 ft larger on a side than the size of the shaft opening. The reference monument, a 4-inch pipe, long enough to extend above the surface level of the ground after backfilling, was attached to the center of the plug. A sketch of an installed plug is shown in figure 4.

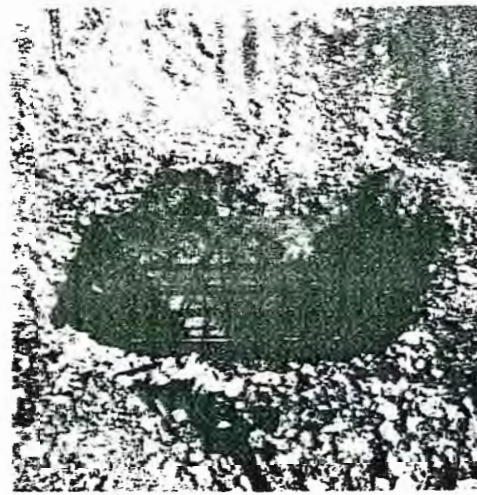
Figure 5.--Eight-ft form showing reinforcing grid.

Eleven forms were required for the demonstration: 3 were 8-ft by 8-ft, 6 were 10-ft by 10-ft, and 2 were 12-ft by 12-ft. The 8-ft by 8-ft and the 10-ft by 10-ft forms were constructed of 3/16-inch hot-rolled low-carbon steelplate welded at the seams. The 12-ft by 12-ft forms were constructed of 1/4-inch hot rolled low-carbon steel. The external edges of the seams were reinforced by the addition of a fabricated angle, approximately 3-inches on an edge, welded to the seam. This reinforced edge proved very beneficial since much of the weight of the plug rested on the corners before seating. A plate was welded in each corner with an eyelet for attaching cables for easy handling and positioning the forms (fig. 5).

A horizontal reinforcing rod grid was placed 1-ft from the top in the 8-ft pyramid forms, 1.25-ft from the top in the 10-ft forms, and 1.5-ft from the top in the 12-ft forms. A 12-inch grid spacing was used as shown in figure 5. Grade 60, No. 7 reinforcing bars were used in each instance.

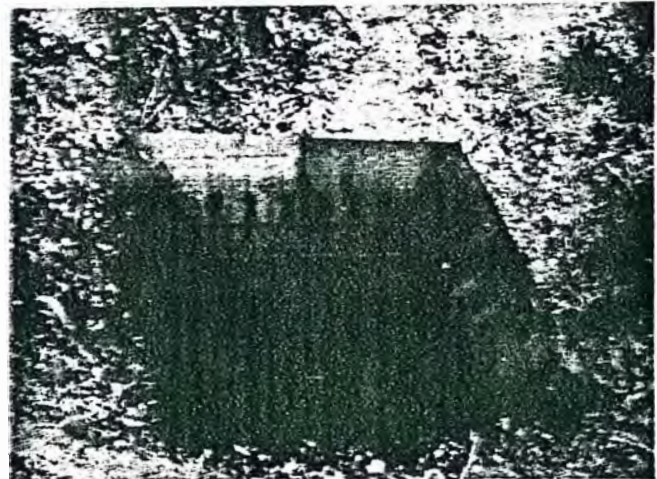
Figure 6.--Ten-ft form showing I-beam position and reinforcing grid.

In the 10-ft form, two S4 I-beams with 0.326-inch web thickness approximately 6 ft long, were welded to a 1/4-inch footplate which was welded to the sides of the form. The beams were arranged parallel to each other and spaced approximately equidistant from the parallel side walls and from each other (fig 6).

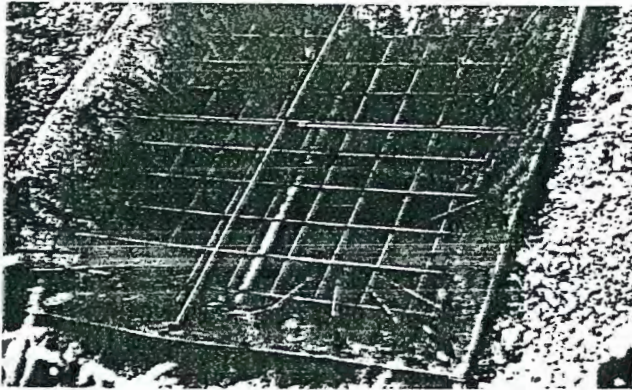
Figure 7.--Twelve-ft form showing I-beams and position of reinforcing bars.

To brace the side walls of the 12-ft form, two S4 I-beams, approximately 8 ft long with a 0.326-inch web thickness, were welded to the form at right angles to each other. The ends of these beams were welded to a 1/2-inch plate at least 1 ft², which in turn was welded to a second 1/2-inch plate at least 1 ft², previously welded to the inside of the form approximately 2-ft from the top (fig. 7).

Vertical reinforcing bars were placed 6 inches from each of the sloping sides of the pyramidal form (fig. 7). They were spaced 1-ft apart at the top of the form and tapered down to a few inches near the bottom. The top end of the rebars extended to within 6 inches of the top of the form. A spacer was welded approximately 1-ft from the top of each form to hold the rods 6 inches from the side walls.

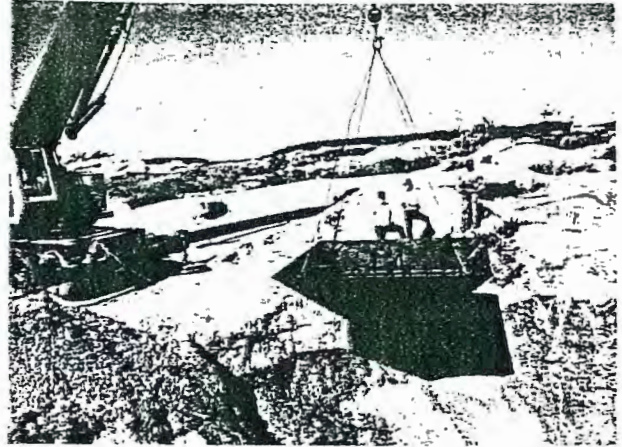
Figure 8.--Lowering 10-ft form into opening.

The pre-fabricated forms were delivered to the site on a flatbed trailer and were unloaded from the truck and placed directly in the hole using a 17-ton crane (fig. 8). In several cases, additional sidewall trimming using the backhoe and/or jackhammer was required to obtain a level position for the forms.

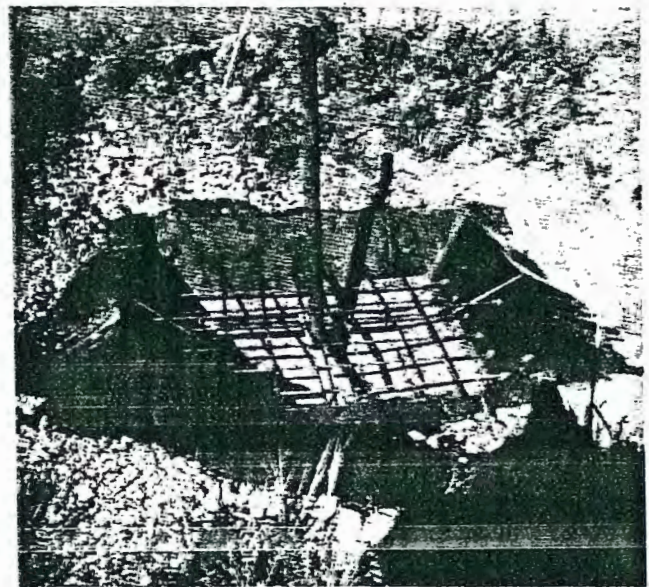
Figure 9.--Ten-ft form showing spider-leg reinforcing over edge of form to support the expanded metal.

Class A concrete was delivered to the site from a local batch plant. Just prior to pouring, a reference monument was attached to the center of each plug (fig. 9). The 8-ft forms each required 3.2 yd³ of concrete, the 10-ft forms 6.2 yd³, and the 12-ft forms 10.7 yd³.

After the first three plugs were placed, it was noted that there were gaps between the form and the sidewalls along the edge of the pyramid shaped form. In these areas, reinforcing bars were positioned over the edge of the form and extended to the side of the prepared opening. This was covered with a 2-ft width of expanded metal, and 4 inches of concrete was poured on this expanded metal.

Before pouring concrete in the last eight forms, steel reinforcing rod was bent and fastened to the installed horizontal reinforcing grid and extended in spider-leg fashion several feet over the edge of the form (fig. 9). The 2-ft wide expanded metal was positioned over these reinforcing rods, and concrete was poured over this when the form was filled (fig. 10). An additional 1 to 1-1/2 yd³ of concrete was required for each shaft because of these modifications.

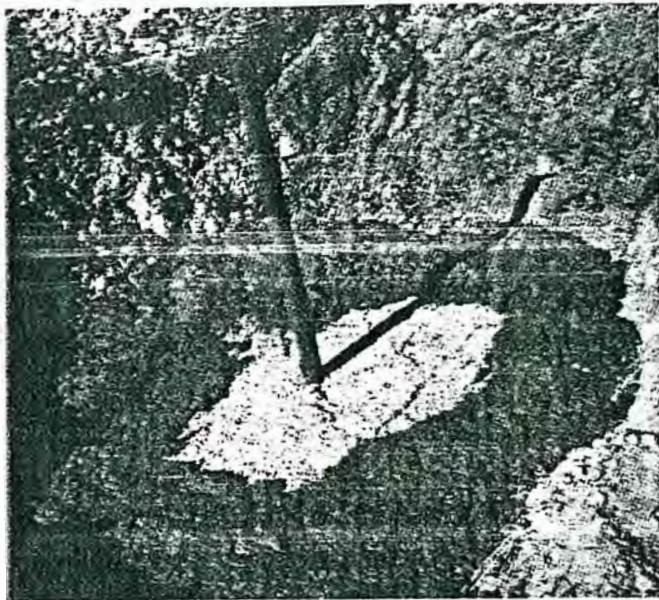
Figure 10.--Ten-ft form filled with concrete.
