## Preventing Falls of Ground in Coal Mines with Exceptionally Low-Strength Roof: Two Case Studies

National Institute for Occupational Safety and Health

## 23rd International Conference on Ground Control in Mining

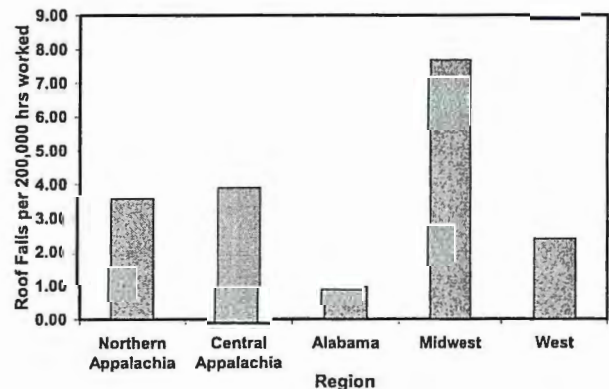
Figure 1. U.S. underground coal mining non-injury roof fall rates, by region.

The probability of a roof fall varies from region to region. Alabama, Utah, and northeast Kentucky all have roof fall rates that are about half the national average. Certain mines in Virginia and Northern Appalachia have high roof fall rates, though on the whole those regions have a moderate risk of roof falls. Roof falls are most troublesome in the Illinois basin, where the rate is approximately twice that in the rest of the country (figure 1).

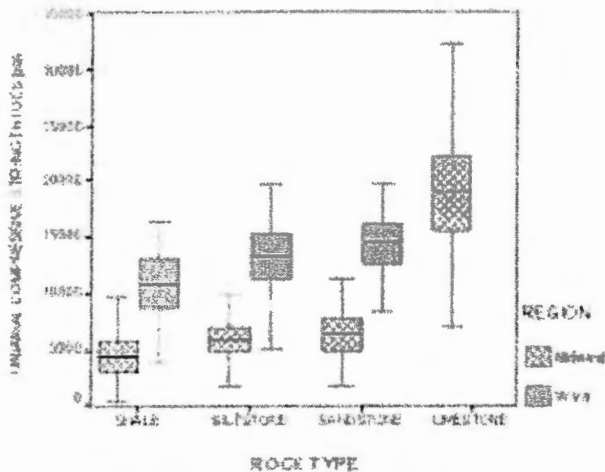
Figure 2. Unconfined compressive strength of roof rock in the Midwestern and Southern Appalachian coal basins (after Rusnak and Mark, 2000).

The variation in roof fall rates is clearly related to geologic conditions. One recent study compared the uniaxial compressive strength of roof rocks in the Illinois basin with those in southern West Virginia (Rusnak and Mark, 2000). The study involved more than 800 rock units and 10,000 laboratory strength tests. It concluded that for each of the three major roof rock types (shale, siltstone, and sandstone), the strength of the Illinois basin variety was less than half that of the same rock in West Virginia (see figure 2).

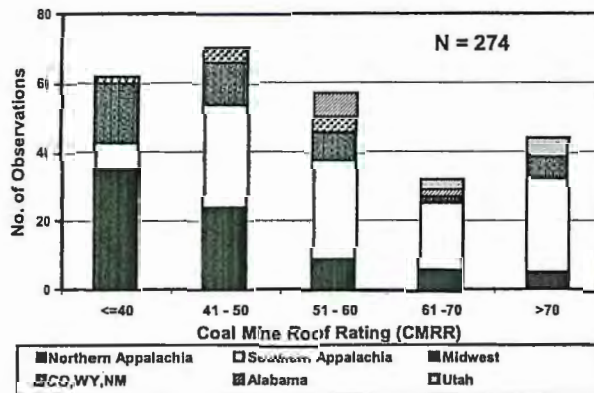
Figure 3. CMRR observations in the NIOSH data base, by region.

The Coal Mine Roof Rating (CMRR) can also be used to compare roof strength in different regions. The National Institute for Occupational Safety and Health (NIOSH) has been measuring the CMRR in its ground control studies for more than a decade, and the NIOSH data base now includes nearly 300 CMRR observations. Figure 3 shows that nearly all the weak roof observations (CMRR<41) have been made in either the Northern Appalachian or Midwestern coal basins.

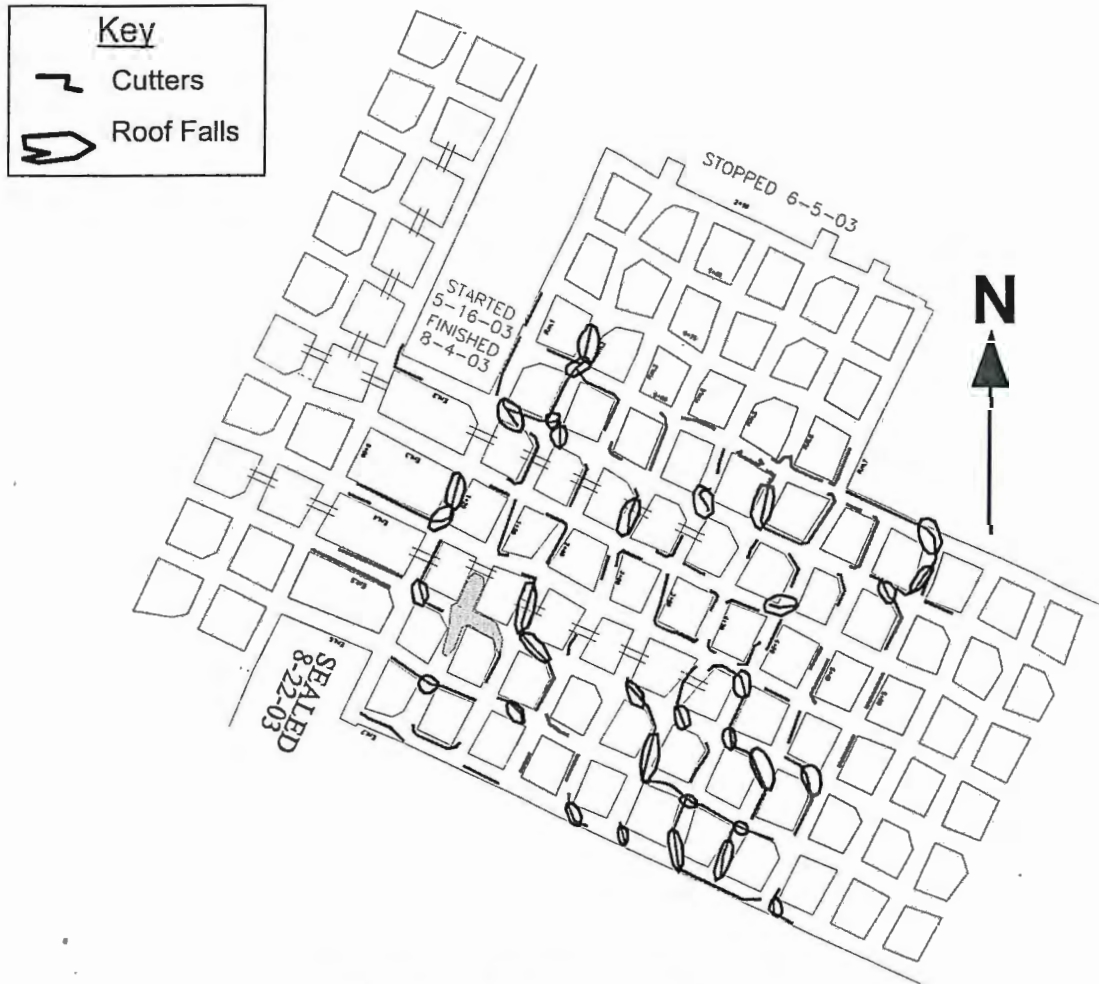
Figure 4. Stress mapping conducted at Mine A.

Underground stress mapping has been used to estimate the stress direction at Mine A. Roof cutters are the only features that were mapped because they are so common. Since cutters that follow a rib are not very helpful, the focus was on ones that traveled across an intersection or entry from rib to rib (see circles on figure 4). These cutters should be perpendicular to the major principal stress.

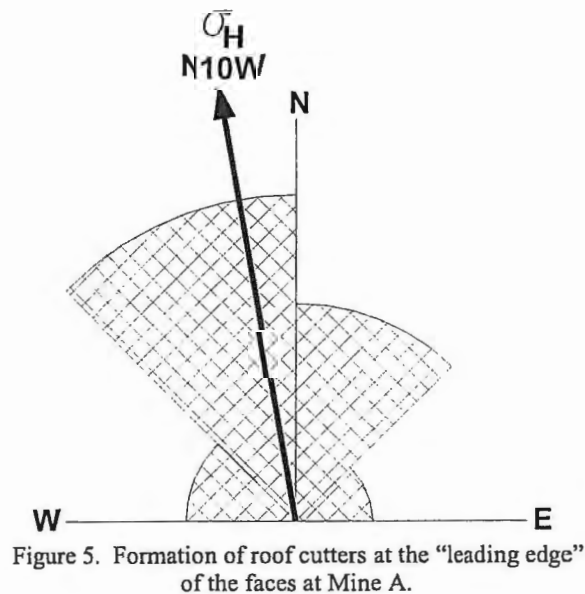
Figure 5. Formation of roof cutters at the “leading edge” of the faces at Mine A.

Figure 5 shows that the stress mapping measurements cluster around a mean orientation of N10°W. Taking all this information together, it appears that N80°E is probably the best estimate for the direction of the maximum principal horizontal stress at Mine A. This orientation explains the directional patterns of cutting that occur in the faces. The cutters have consistently occurred in the “leading edge” (the corner of the entry that is the first to contact the stress) of the entries being mined as illustrated in figure 6.

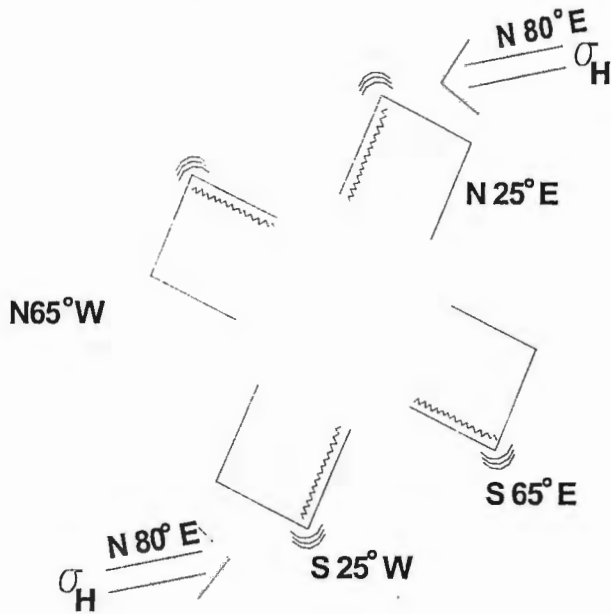
Figure 6. Sketch showing the "leading edges" of entries driven in different directions at Mine "A".

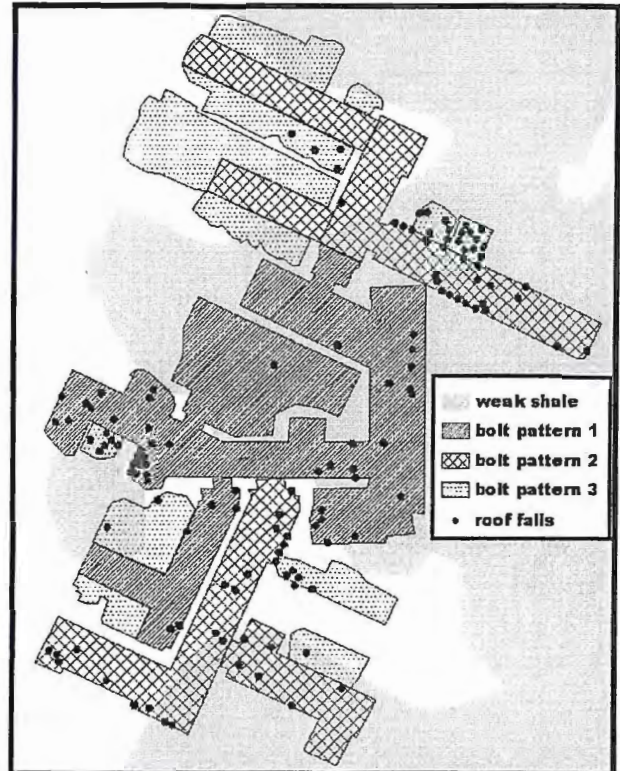
Figure 7. Sketch map of Mine A showing the areas of different roof bolt patterns and thick weak shale. For details on the roof bolt patterns, please refer to the text.

In addition, steel straps, cable trusses, mesh, and wood posts have been employed in some critical entries such as primary escapeways, beltways, travelways, intakes, and returns. Figure 7 shows the approximate areas in the mine where each of these support systems were used.

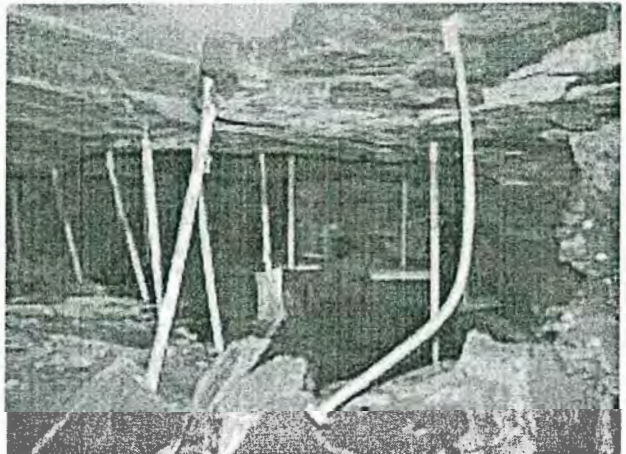
Figure 8. Photograph of roof bolts exposed by weathering of weak shale at Mine B.

The mining height is 52 in, including approximately 16 in of weak drawrock that would otherwise collapse before it could be bolted. The roof rock is 10-12 ft of weak, laminated clay shale, grading into a 10-12 ft thick sandy shale unit. Locally known as "soapstone", the weak shale (CMRR 30-32) contains frequent clay veins and slickensides. The roof rock is very moisture-sensitive and dissolves quickly when immersed in water. Underground, the rock degrades with time and exposure to humidity, resulting in very slabby, ragged roof. Hanging roof bolts are common where the roof has unraveled between them (figure 8).

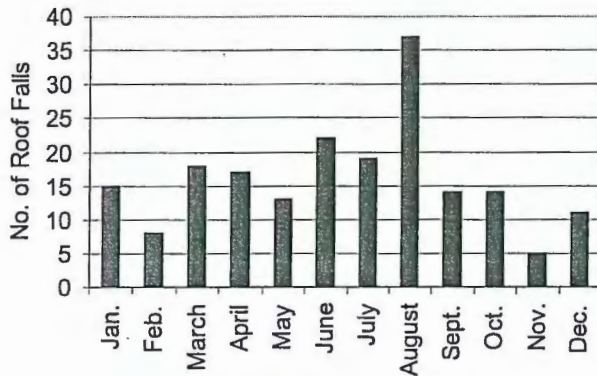
Figure 9. Roof falls at Mine B, by month.

The roof falls at Mine B exhibit two types of time-dependency. First, the roof fall rate during the humid summer months is more than twice what it is during the fall and winter (figure 9). Second, while most of the falls have occurred within 12 months of mining, many continue to occur several years after mining (figure 10).

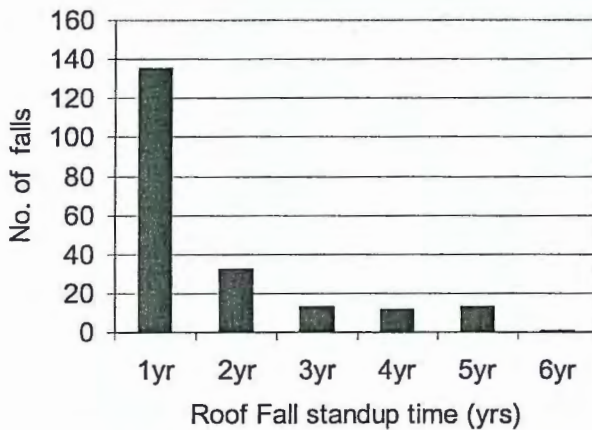
Figure 10. Roof falls at Mine B, entry by stand-up time.

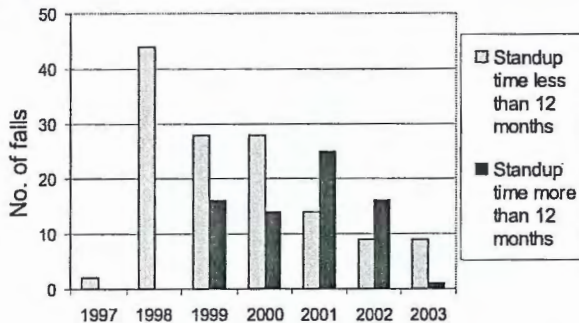
Figure 11. Roof falls at Mine B, by year in which the entries were driven.

Since most of the falls occur in the first 12 months of exposure, the mine moved to shorten the panels which allows the operator to develop and retreat panels quickly. In this weak roof, less panel exposure time means less chance for roof falls. In the mains, which must remain open for a longer time, the installation of supplemental support on cycle has resulted in more stable intersections. The success of these measures can be seen in figure 11, which shows that the number of short term roof falls at mine B have been dropping year to year.
