**VIDEO MOTION DETECTION FOR REAL-TIME  
HAZARD WARNINGS IN SURFACE MINES**

**E. L. McHugh**

National Institute for Occupational Safety and Health  
Spokane, WA

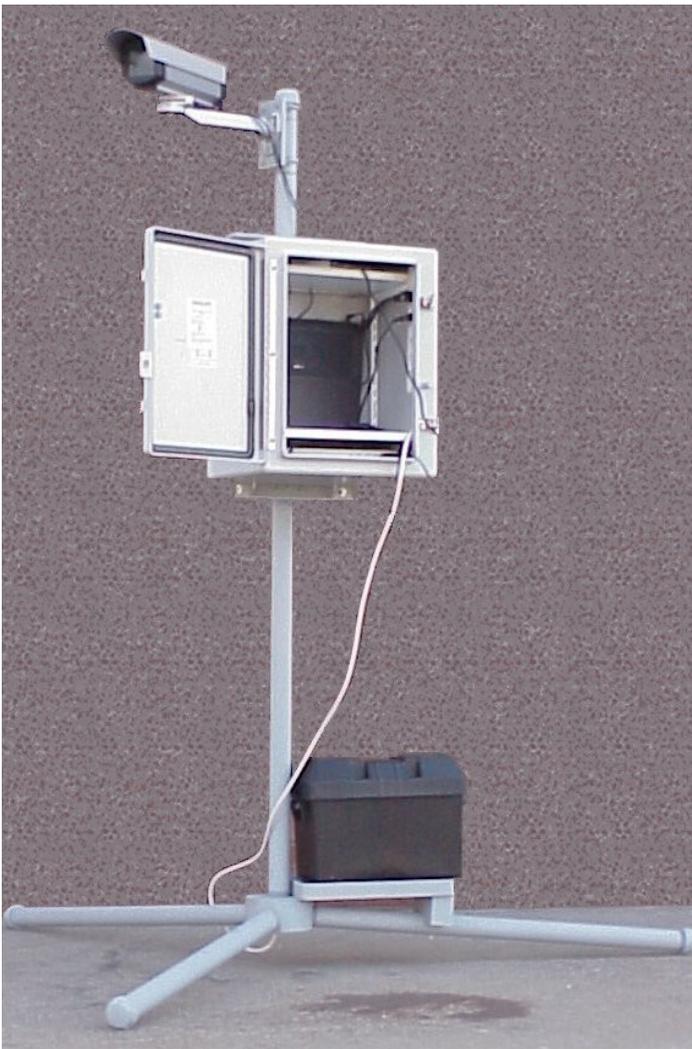
**Figure 1.—Video motion-detection system showing camera, electronics enclosure, and 12-V battery on a tripod.**

A basic surveillance system built around hardware and software from Strategic Vista Corp., Markham, ON, Canada, and GeoVision, Taipei, Taiwan, was tested in the laboratory and in local field trials. The system includes an 8.5-mm (1/3-in) CCD color video camera with 480 lines of resolution, automatic iris, and a 6- to 60-mm (10X) power zoom lens. The camera is connected by means of an external frame grabber to the USB port on a notebook computer. The computer, with a Windows 98 operating system, runs programs (GV100 from GeoVision) that display real-time and recorded video images. All of these off-the-shelf components are powered from a 12-V, 100-amp-hour, deep-cycle battery by way of a 140-W dc-ac inverter. The computer, camera controls, and power connections were installed in a fiberglass environmental enclosure. The enclosure and a mount for the camera were attached to a 2-m-long, 38-mm diameter steel mast screwed into a three-legged base (figure 1). The camera is mounted near the top of the mast in its own weather enclosure.

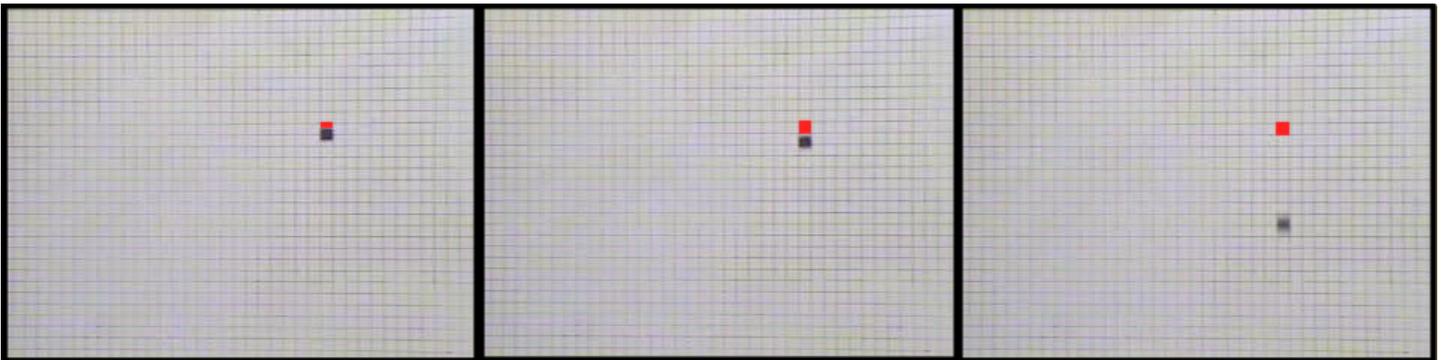
Figure 1.—Laboratory test of video motion detection. The grid in the background is at 25-cm spacing; a 25-cm marker falls after release. The colored box shows the location of the original marker. At the left is the first frame captured after motion detection, the second frame (center) was captured at 0.81 seconds, and the third frame (right) at 0.86 seconds.

Laboratory tests of the system showed that motion is readily detected and recorded. Calibration tests included dropping markers of different sizes and color values against a white board marked with a 25-mm grid as a background. In a typical test shown in figure 2, a black square 25 mm on a side was dropped, triggering the system when it had moved about 10 mm. That change represents about 100 pixels (10 by 10) within the 76,800 pixels in the image (320 by 240 pixels), or about 0.13% of the image. Other tests were used to evaluate stability and file size. For example, the system was left to monitor routine laboratory activity continuously over a 40-hour period. During that test, more than 100 individual events triggered the system, capturing a total of 15.6 minutes of video at about four frames per second. Individual events ranged from less than 1 second to more than 3 minutes. The resulting files totaled 26.7 Mb of hard drive memory. The system manages available hard drive space by writing over the oldest files when storage resources reach a defined level. Other tests showed that very slow motion within the detection area would not trigger the alarm, and recording and alarm functions would stop when motion within the area stopped, even though elements within the view had changed from the original image.

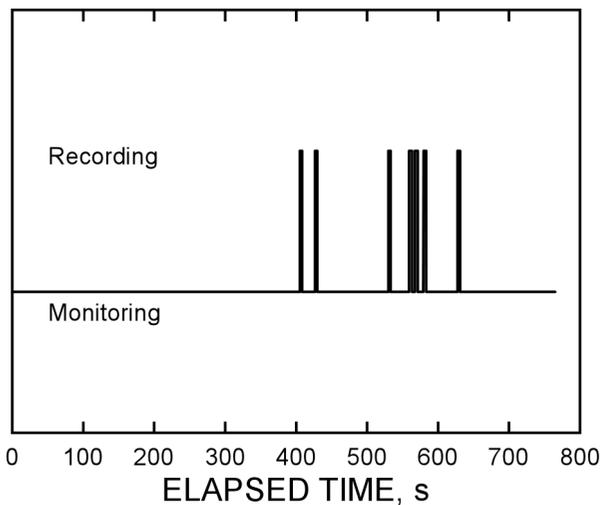
Figure 2.—Video clip recordings triggered by motion detection. During this 13-minute interval, about 25 seconds of video were recorded in seven motion events, including three rockfalls, each lasting less than 4 seconds.

Field tests in a local rock quarry showed that rock falls could be captured. Exterior change detection is based on a wider range of variables than are used in a more-controlled laboratory setting. To evaluate motion detection in the field, the system was set up in a rock quarry to monitor highwalls between 10 and 17 m high at ranges of 30 to 82 m. Rocks at least 15 cm across were dropped from the top of the slopes to generate minor rock falls. The dropped rocks and rock falls were sufficient to trigger the detection system, sounding an audio alarm and recording images of the rock fall. In one 13-minute interval of continuous monitoring, seven motion events were detected, including four manual triggers and each of three induced rock falls. The rock fall events lasted from 3.1 to 4.0 seconds; event times and durations are shown in figure 3. By recording video clips only when a threshold of motion was exceeded, storage resources (e.g., computer media) were reserved only for significant events, and time spent in reviewing recorded activity was minimized.

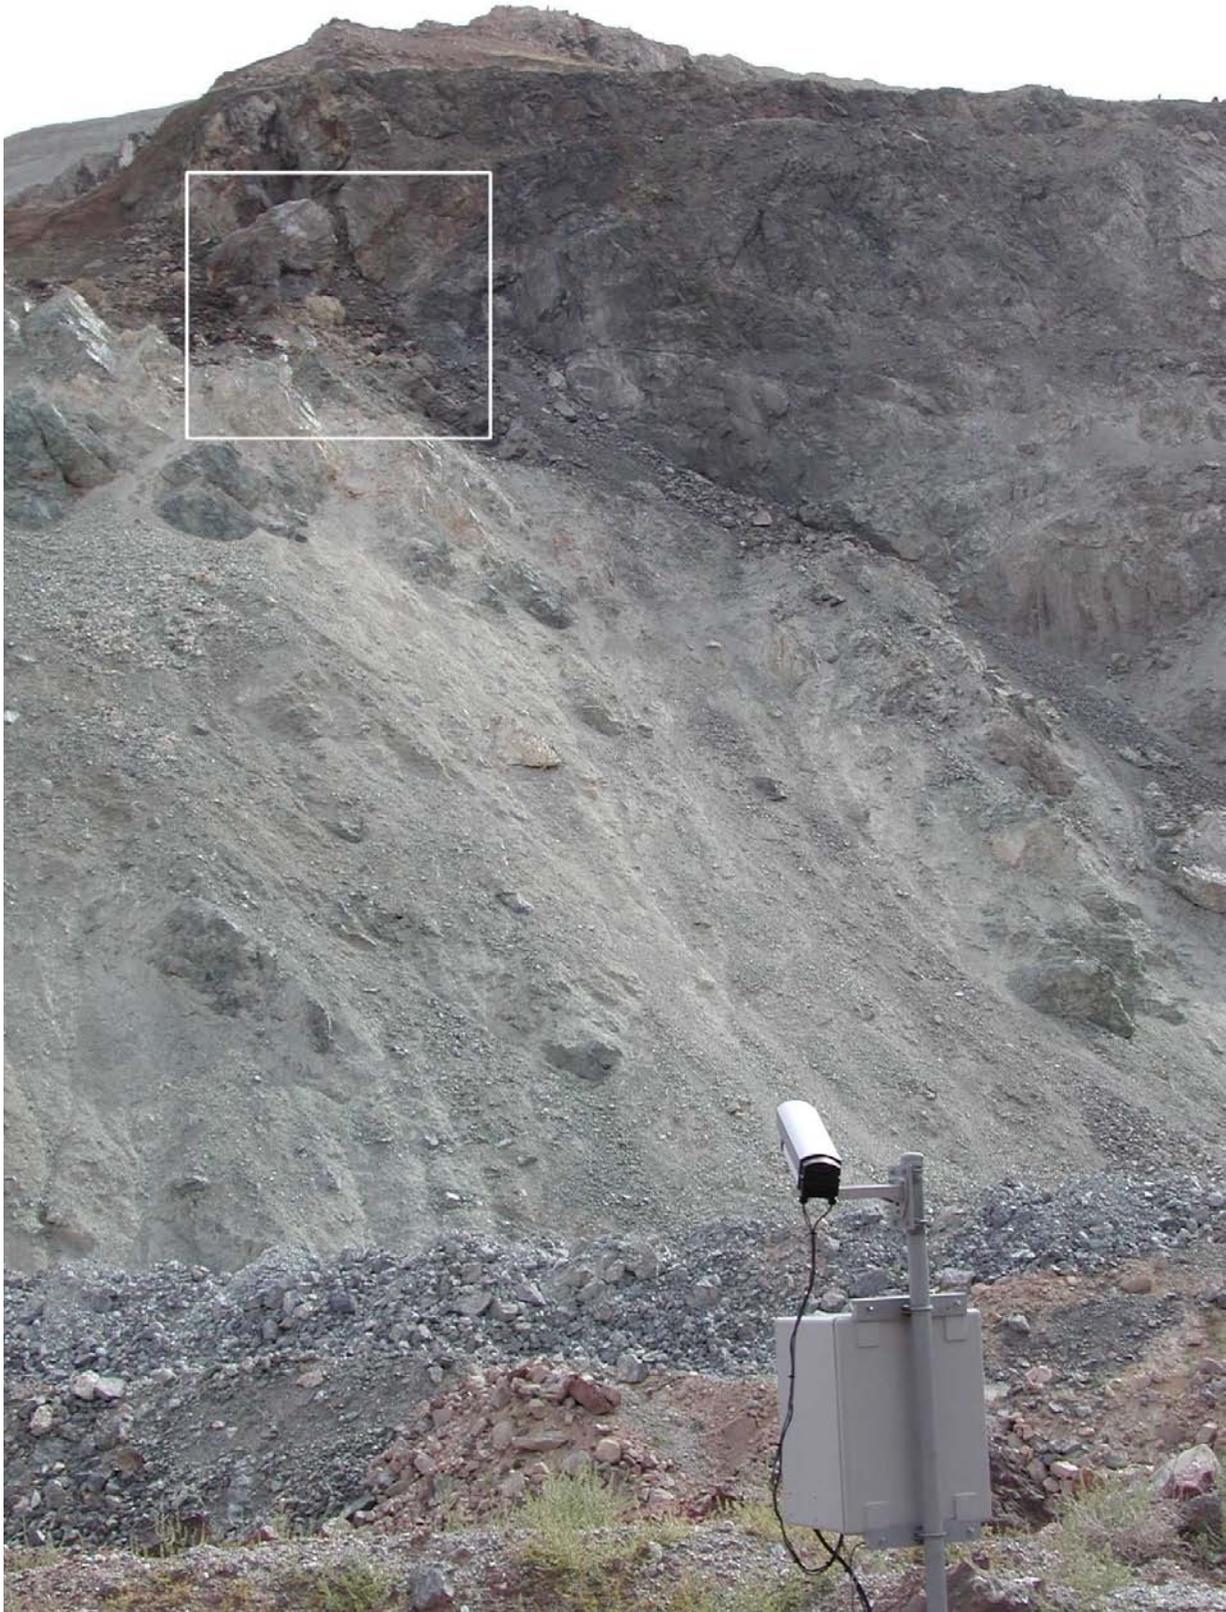
Figure 3.—Highwall at the Yellowstone Mine showing area monitored by video camera (white box).

At the Yellowstone Mine, the motion detection camera was trained on a portion of the highwall, at a range of 134 m, where rockfall had occurred recently (figure 4). No rockfall activity was detected over a 2-day period, but rocks were dropped from above into the image area to generate rockfalls. Each of these was captured in two events totaling 220 frames. Figure 5 shows a video frame that includes the impact of a dropped rock. The rock in motion (blurred) and a small cloud of dust were sufficient to be detected by the system.

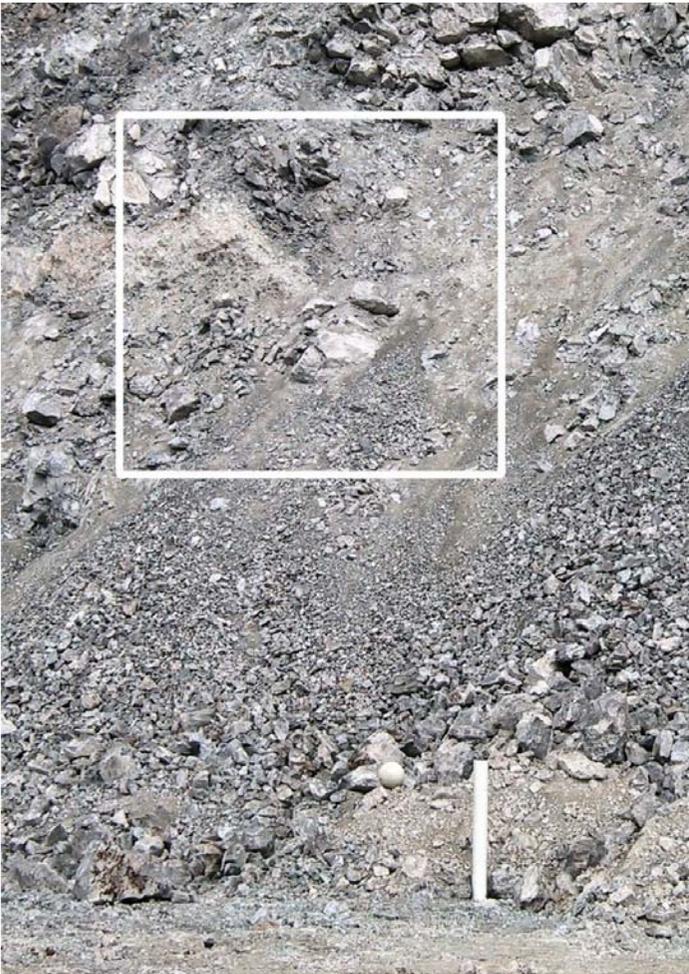
**Figure 5.—Broken rock in Yellowstone Mine main pit. Box shows area monitored by video system. White rod is 1 m long**

On the third day, the system was moved to the floor of the active pit to monitor rock faces at different ranges and settings. In the first configuration, the camera was directed toward a blasted but otherwise undisturbed rock face on the floor of the pit; range was 39 m and resolution was 640 by 480 pixels. For 16 events at this resolution, nine were manual triggers during set-up and testing, five were apparently wind induced, and two captured small-scale sloughs on the slope. In a second configuration, the camera was focused in on a part of the rock face, and resolution was changed to 320 by 240 pixels; rocks were dropped or thrown onto the

slope (figure 6). Three artificially induced rock falls totaling 252 frames were captured. In one event, three sequential rock impacts were followed by sloughing over a total of 72 frames and an elapsed time of 39 seconds (figure 7).

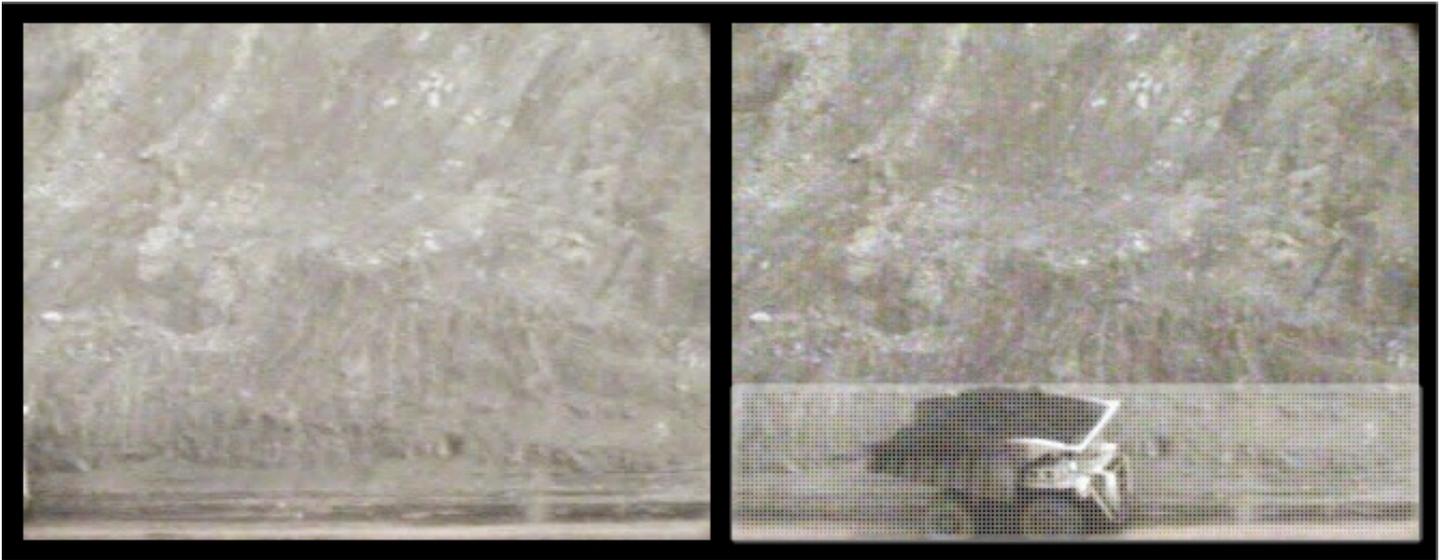
**Figure 9.—Two frames from video clip of spoils pile. Each frame covers about the area shown in figure 8. In left frame, haul truck just entering at left edge was sufficient to trigger recording. Right frame shows masked area that would prevent machinery from triggering system.**

On day 3 at Black Thunder, the video system was positioned on the highwall side of the pit to view the spoil slope above a ramp intersection with the pit floor; range was 154 m. The view includes a spoil face where large-scale sloughing had occurred in recent weeks (figure 9). The video monitor was positioned to include a portion of the haul road along the pit floor so that vehicles using the road could trigger recording if no mask was used. The left video frame in figure 10, where the first parts of the haul truck are barely visible at the left edge, shows that even a very small change in the image can trigger recording. The right frame shows a mask within the image that would avoid vehicle-triggered alarms. Rock movement was detected in none of the 355 events recorded; moving vehicles (haul trucks, graders, loaders, scrapers, pickup trucks) accounted for 132 events, averaging 212 frames per event. Nine events were manual triggers during setup and testing (1,014 frames or 112 frames per event). The weather on this day was very windy and wet; 214 events are attributed to wind-induced camera shake or rain in the air or splattered on the camera enclosure window. In these events, 978 frames were recorded (five frames per event).

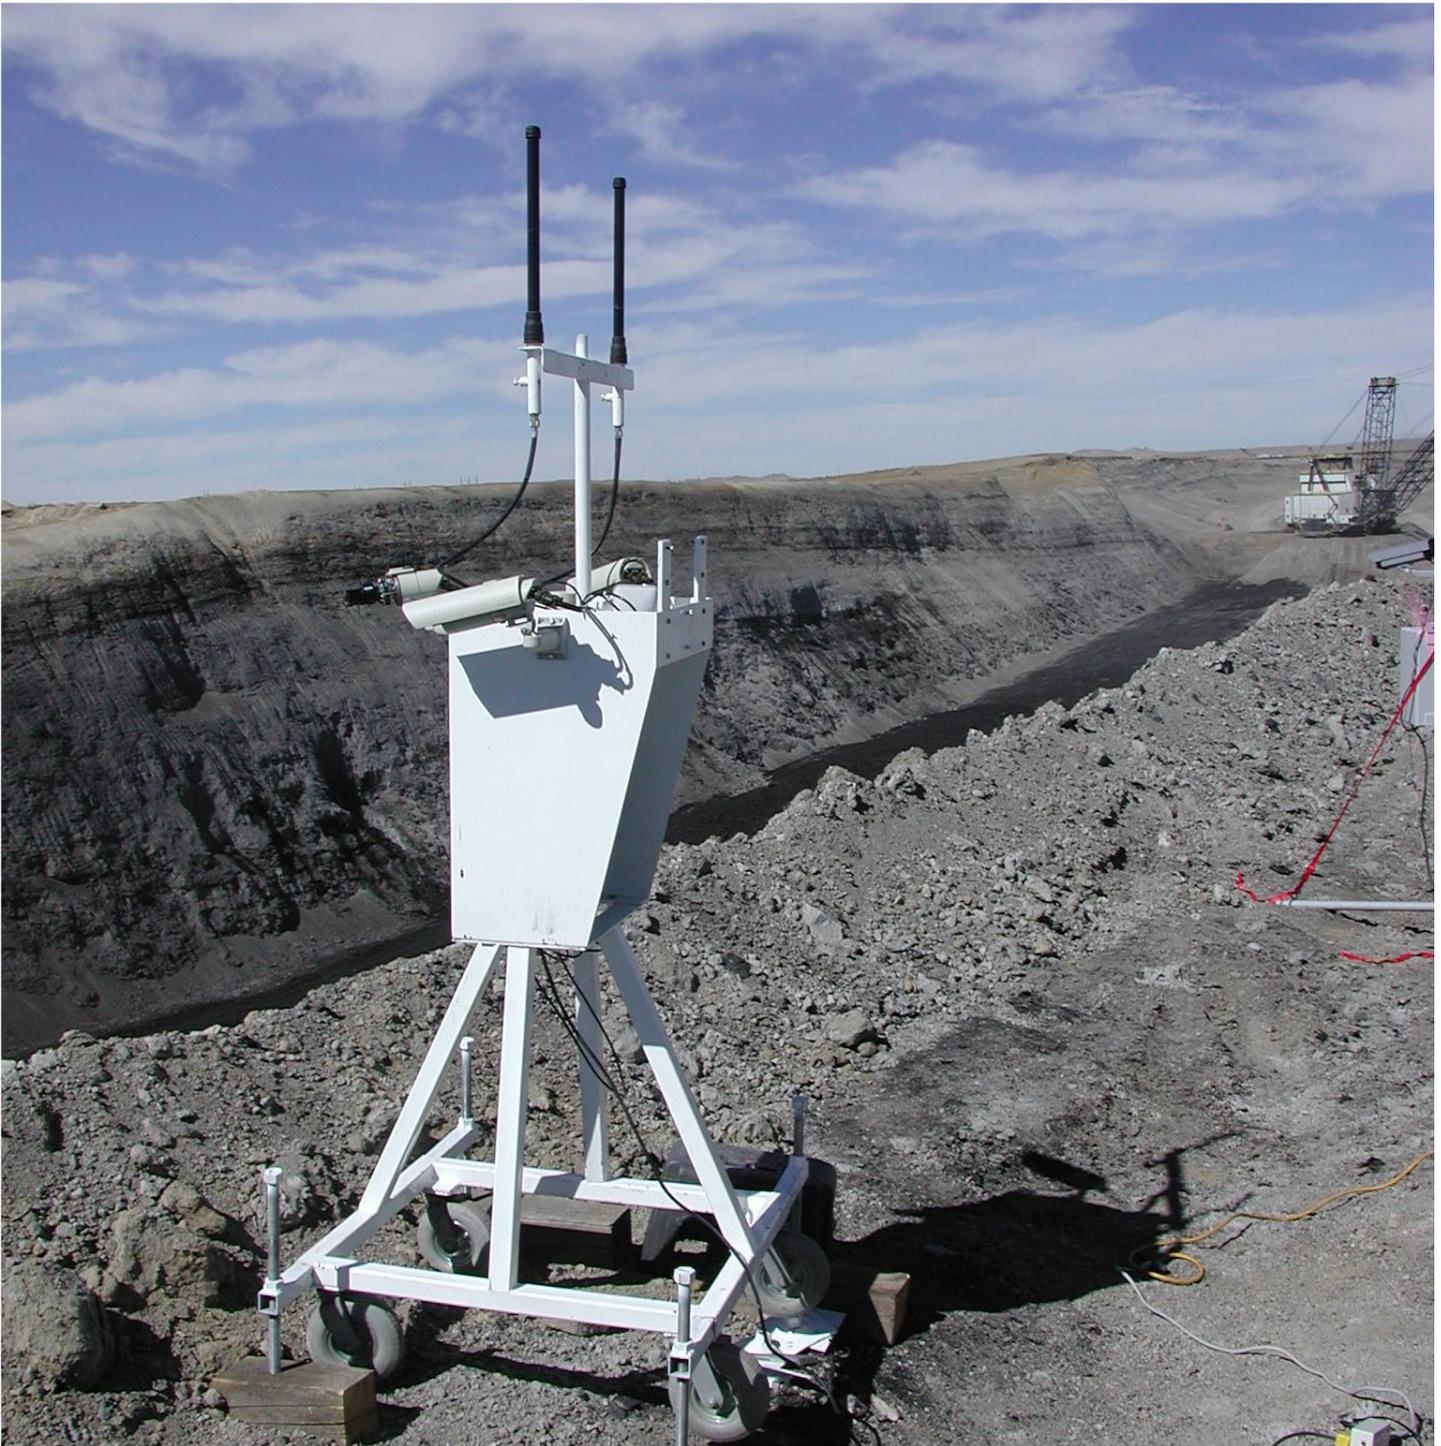
Figure 10.—Multi-camera, wireless-access video monitoring system at Black Thunder Mine.

The minesite experiments also provided an opportunity for first-time testing of a multi-camera video system (figure 11) that represents a next generation from the original prototype. Still in development, the system includes an embedded modular computer to run upgraded surveillance software and radios to provide wireless Internet protocol access. The wireless access will allow remote program control and will provide real-

time video feed from each of four cameras to any notebook, hand-held, pocket, or other wireless-equipped computer within 90 m of the base station. Multiple cameras will allow the system to monitor several areas simultaneously using different resolution, zoom, and mask settings. In addition to slope monitoring, this system could be adapted to a wide range of other monitoring tasks.
