# EVALUATION OF MINE SEALS USING GROUND PENETRATING RADAR

*William D. Monaghan  
Michael A. Trevits  
Michael J. Sapko  
NIOSH, Pittsburgh Research Laboratory  
Pittsburgh, PA*

## **Abstract**

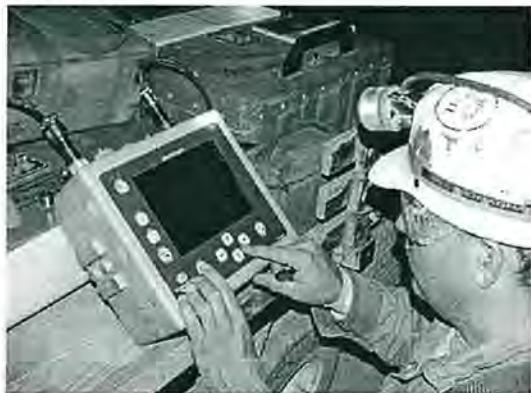
**Figure 1.:** Engineer using the SIR-2 unit.

In this study, GPR was used as a non-invasive means of evaluating mine seal construction uniformity. The equipment used was a GSSI SIR<sup>®</sup> System 2 (SIR-2) Model No. DC-2 control unit built by Geophysical Survey Systems, Inc.<sup>2</sup> The SIR-2 is a lightweight, portable, general-purpose radar system and is available as an intrinsically safe unit for use in the underground coal mine environment (figure 1).

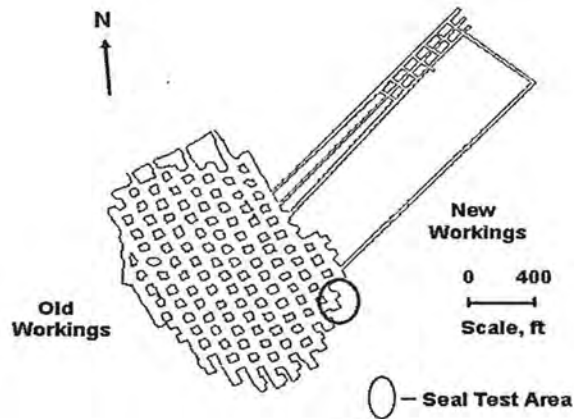
Figure 3.: Layout of the Lake Lynn Laboratory Mine.

The LLEM was built at an abandoned commercial limestone quarry where underground entries 49-ft wide by 33-ft high (old workings) were developed when surface mining ceased in the late 1960's. Later, under the auspices of the U.S. Bureau of Mines, 7,545 ft of new underground development was constructed using 19.7-ft wide by 6.6-ft high entries (new workings). The new workings can be configured to simulate modern-day coal mining scenarios; including room-and-pillar and longwall mining layouts (NIOSH 1999, Triebisch, 1990) (figure 3).

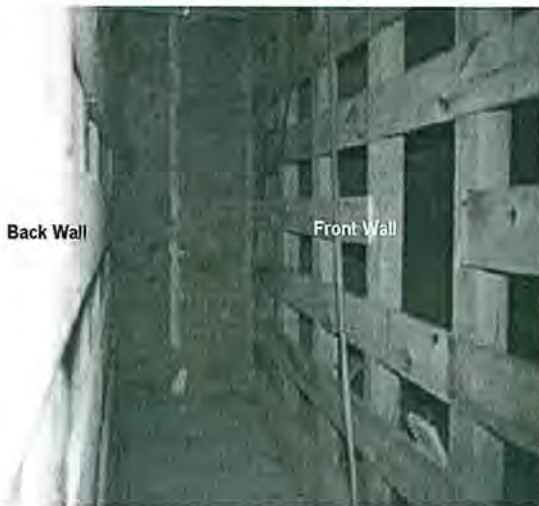
Figure 4.: Photo of inside of Mine Seal No. 1 showing the wooden form.

Mine Seal No. 1, a cast-in-place foamed cement seal, was constructed in the large chamber in the LLEM and building the form was the first step in the construction process. The vertical components of the front and back portions of the form were built from 6.5-in by 5-in posts that extended from the mine floor to roof. A post was placed at both ribs and additional posts were spaced between the rib posts on 35-in centers. The void space behind the posts in the chamber was 8-ft on the left side and 6-ft on the right side.

Next, 8-in wide by 1-in thick boards were placed in a horizontal position and were nailed to each post (figure 4). The boards were placed at the bottom of the form and an 8-in horizontal space was left between each row of boards. This procedure was followed on the front and back walls of the form. Fiberglass insulation was then packed into any void space on the mine roof, ribs, and floor areas to minimize slurry leakage around the form. A 48.5-in space was left by design between the front and back walls of the form for the mine seal. Mine brattice cloth was placed on the inside area of the form, was overlapped on the mine roof and rib areas, and was secured with straps to form a tight seal. Eye bolts were then attached to each post through the brattice cloth and were tied together with 1/8-in galvanized steel cable that was extended between the front and back of the form (figure 5).

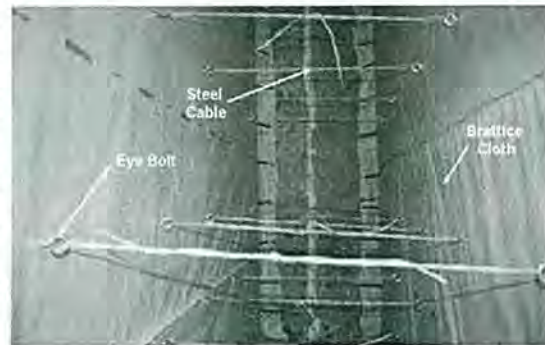
**Figure 5.:** Photo of inside of mine seal No. 1 before foamed cement was added.

The eye bolts were spaced approximately 32-in apart on each post and were used throughout the vertical extent of the form. The eye bolts and cable served to tie the front and back walls of the form together and assisted in keeping the walls parallel and straight.

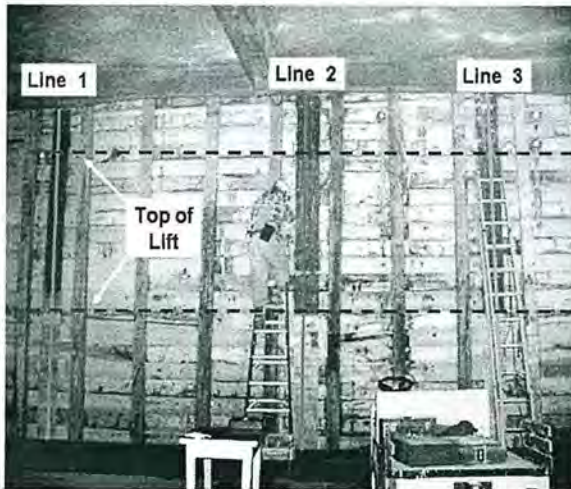
**Figure 6.:** Photo of mine seal No. 1 and location of GPR survey lines.

The seal material was cured for 33 days before the GPR evaluation was performed. In order to gain direct access to the face of the seal, three vertical sections were cut into the wooden form and brattice cloth. The three vertical sections were approximately 8-in wide and exposed the seal material from the mine floor to roof. Three vertical GPR survey lines were positioned along these sections shown in figure 6. The vertical sections were located at 4-ft from the left rib (line 1), about 12-ft from the right rib near the middle of the seal (line 2), and 4-ft from the right rib (line 3). Each vertical section was subdivided into one-foot segments for use as reference points during the GPR evaluation.

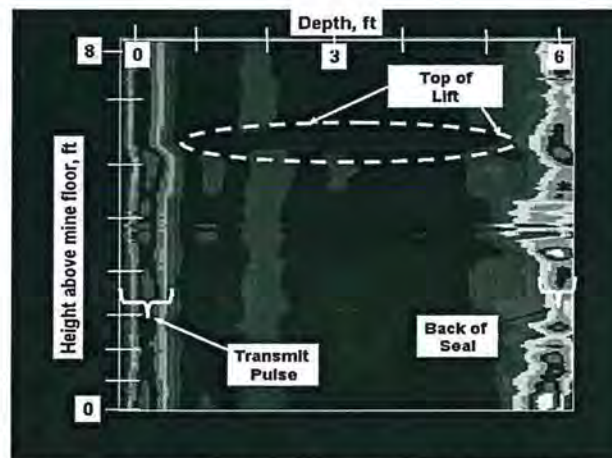
**Figure 7.:** Interpreted radar record (Line 2) for Mine Seal No. 1 using a 400-MHz antenna.

into the record corresponding to the 1-ft marks on the mine seal. In this manner, it was easy to associate any observed anomalies with the specific location on the mine seal. A representative post-processed radar record and the associated interpretations are shown in figure 7. The vertical scale in the figure represents the height above the mine floor and the horizontal scale represents depth into the seal. The reflected pulse energy is shown in terms of a color scale, with hot colors (yellow, white) being the higher level of reflected pulse energy and colder colors (brown, black) the lower levels. Areas in the record shown with similar colors should be interpreted as similar levels of reflected pulse energy. In the radar record, the top of the lift is visible along with the back of the seal. As discussed earlier, the top of a lift represents a boundary in the seal. Figure 8 shows the positions of all observed anomalies from the GPR surveys of the mine seal. As shown in figure 8, a total of 12 anomalies were observed in surveys where the 500-MHz antenna was used and four anomalies were observed in surveys where the 400-MHz antenna was used. Of the anomalies observed, 11 were located near the top of a lift and were either related to the hard surface that had formed at the top of the lift or areas where the seal components could have been mixed at different ratios. The five remaining anomalies could be related to the construction practice of the mine seal (use of eyebolts and galvanized wire).

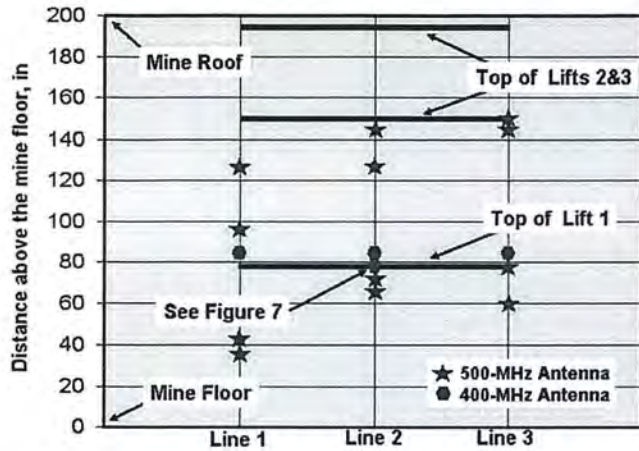
**Figure 8.:** Location of observed anomalies from radar scans of mine seal No. 1.

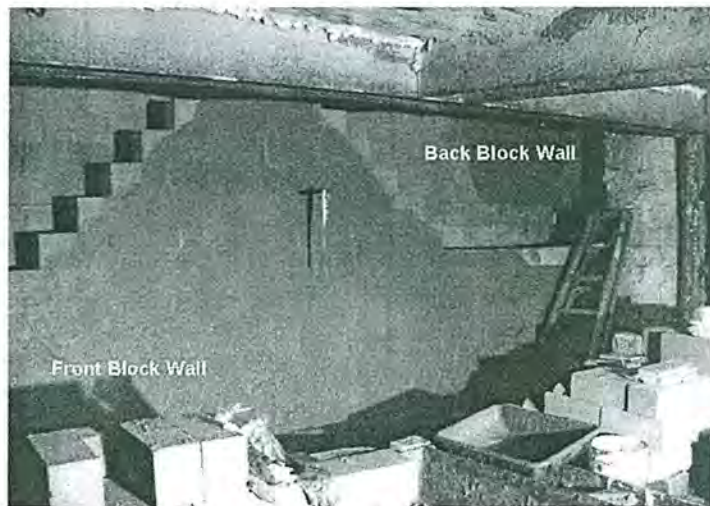
**Figure 9.:** Photo of solid block walls for Mine Seal No. 2.

Mine seal No. 2, a solid block, polyurethane foam, and gravel seal, was erected in the small chamber in the LLEM. The seal was constructed 8-ft high by 20-ft wide and about 2.5-ft thick. The seal was not hitched into the mine roof, rib or floor areas. The seal was built using two parallel walls of solid blocks with a 17.5-in open space between the walls. The walls were constructed with dry-stacked solid blocks (each measuring 6-in by 8-in by 16-in) and was capped by 2-in by 8-in by 16-in blocks and wedges at the mine roof (figure 9).

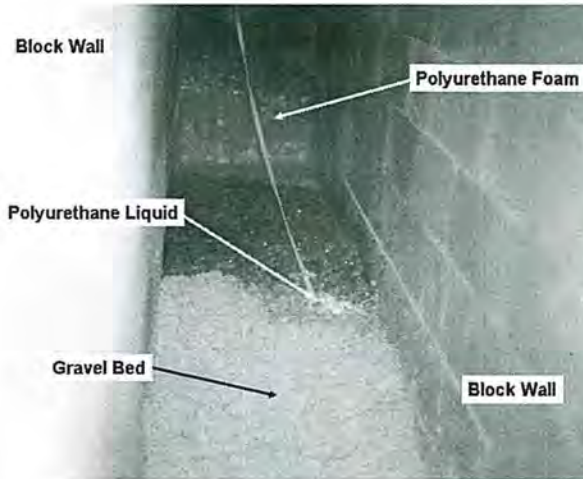
**Figure 10.:** Photo of inner core of Mine Seal No.2 during addition of polyurethane resin.

material was poured into the gravel bed and was supposed to infiltrate the gravel bed before it began to foam. By design, as the resin turned to foam, it was supposed to pick-up and disperse gravel in the resulting matrix. For each lift, gravel was placed to a depth of 10- to 12-in. Polyurethane resin was then poured over the gravel bed at a rate of about 2.5 gpm and the resulting foam rose to a height of about 10-in above the level of the gravel bed (figure 10). The core of the seal was constructed in 7 lifts over a 5.5-day period and any remaining open space above the lifts was then closed to the mine roof using injected polyurethane foam. In all, the seal was built using 292 blocks, 10,350 lbs of limestone and 2,000 lbs of polyurethane resin. Once the inner portions of the seal were built, the exposed face of the seal was coated with B-Bond<sup>2</sup> to a maximum thickness of 0.25-in.

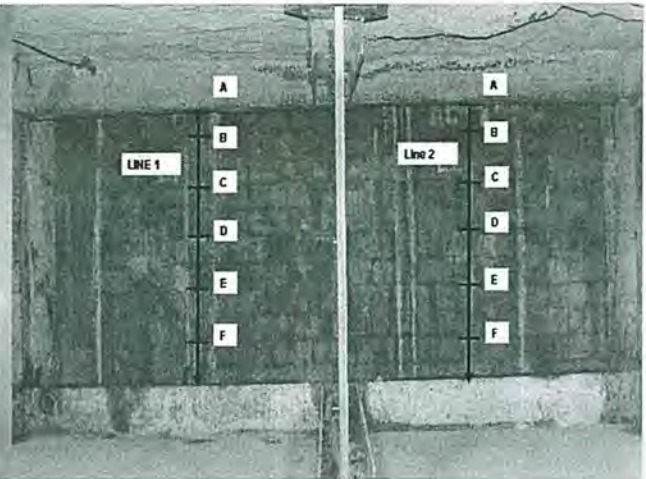
**Figure 11.:** Photo of Mine Seal No. 2 showing GPR survey lines.

GPR was used to determine if the gravel had been evenly dispersed throughout the mine seal. For the radar survey, two parallel vertical GPR survey lines were drawn on the mine seal face and were positioned about 6 ft from each mine rib (figure 11). Reference points (labeled A-F), spaced about 18-in apart, were then placed on the seal and were added to the radar records for comparative purposes. Each survey was made by placing the antenna against the seal face and then slowly moving downward at a constant velocity. The radar survey of the seal was made using 1,000-MHz antenna because this antenna

Figures 12 and 13 show two representative post-processed radar records and their associated interpretations. Reflected pulse energy is shown in terms of a grayscale, with near-white being the highest level of reflected pulse energy and near-black the lowest. Areas in the record shown with similar gray tones should be interpreted as similar levels of reflected pulse energy. The vertical scale shown in the figures corresponds to the reference points (labeled A-F) shown in figure 11.

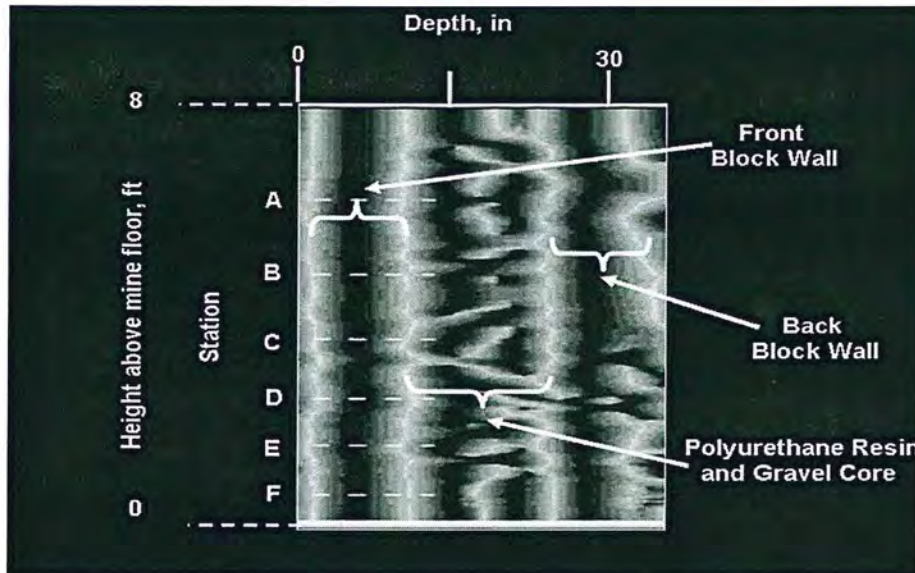
Figure 12.: Interpreted radar record for Mine Seal No. 2, Line 1.

In the radar records (figures 12 and 13), it is possible to see both the front and back block walls. It was hypothesized that the area between the block walls showed varying amounts of reflected pulse energy because of the concentration of gravel in the polyurethane foam was most likely not consistent

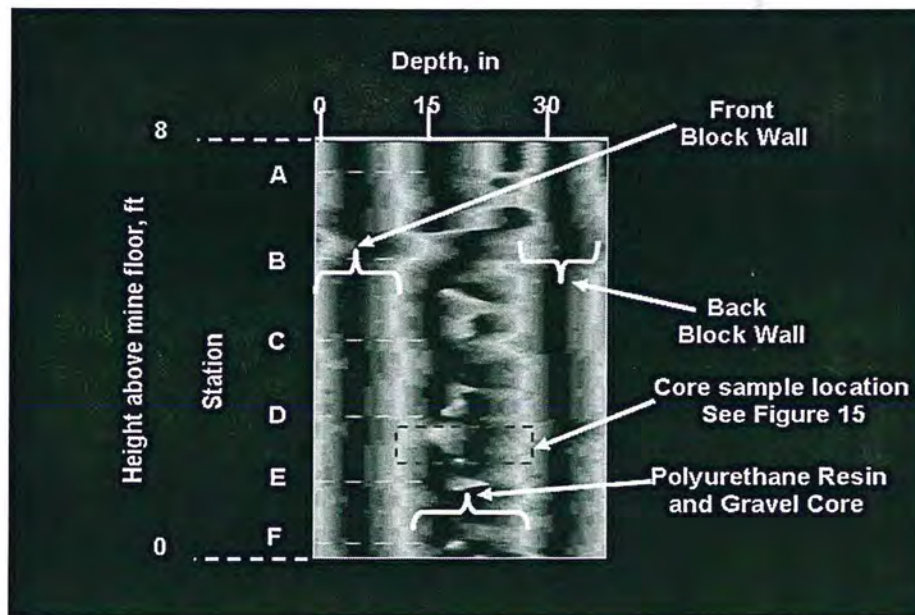
Figure 13.: Interpreted radar record for Mine Seal No. 2, Line 2.

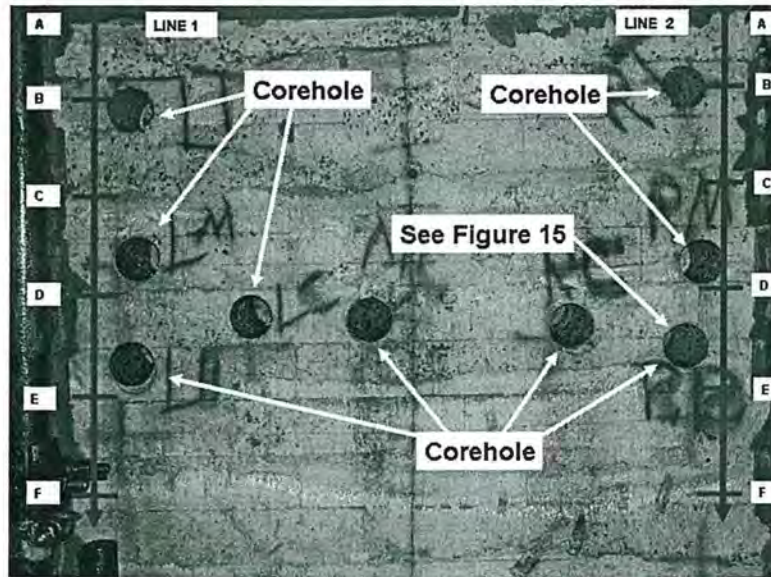
Figure 14.: Photo of Mine Seal No. 2 showing location of coreholes.

throughout the seal. To confirm this hypothesis, several large coreholes (6- by 18-in) were drilled into the seal after the GPR study was completed (figure 14). For this work, the block face of the seal was removed to facilitate core recovery. Figure 15 shows an example of a recovered core sample. This sample clearly shows a lift boundary and a detailed analysis of this core sample showed that the gravel was not evenly dispersed in the polyurethane foam. This confirms the hypothesis made from the radar records.

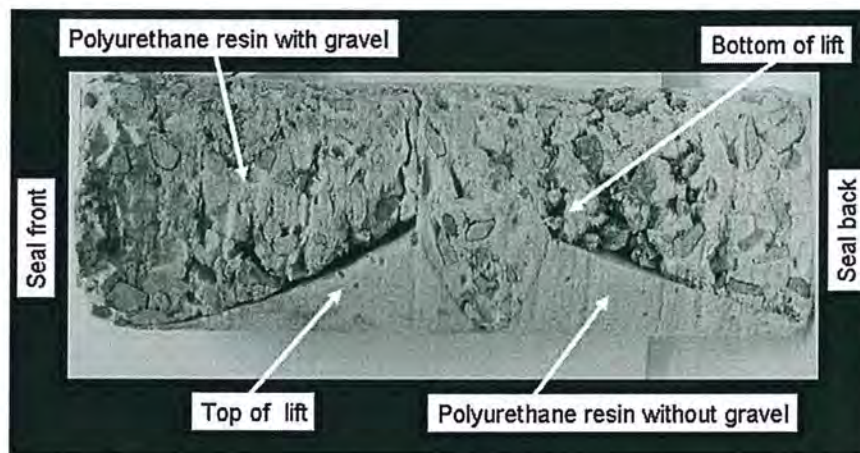
Figure 15.: Photo of recovered core sample from Mine Seal No. 2. Refer to figure Nos. 13 and 14.

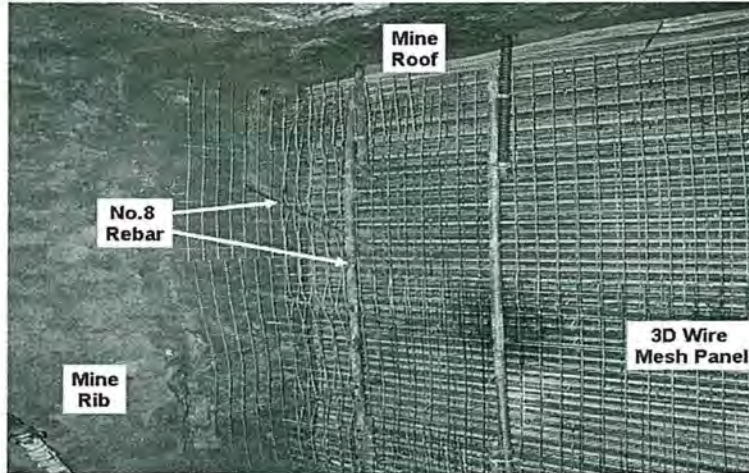
**Figure 16.:** Photo of Mine Seal No. 3 showing the mesh panels and reinforcing bars.

Mine Seal No. 3 was erected in the small chamber in the LLEM. The seal was constructed 8-ft high by 20-ft wide and 11-in thick and was built using Stayfoam<sup>2</sup> panel backing and Insteel 3D<sup>2</sup> wire mesh panels. The panels were anchored to the mine roof rib and floors with No. 8 reinforcing bar (rebar) that was drilled and set into the exposed strata. Across the front of the seal, the segments of rebar that were anchored into the roof and floor strata were affixed with steel strapping to vertical sections of rebar and the wire mesh panels (figure 16). The entire face of the seal was then sprayed with Riregrete<sup>2</sup> gunite to complete the construction.

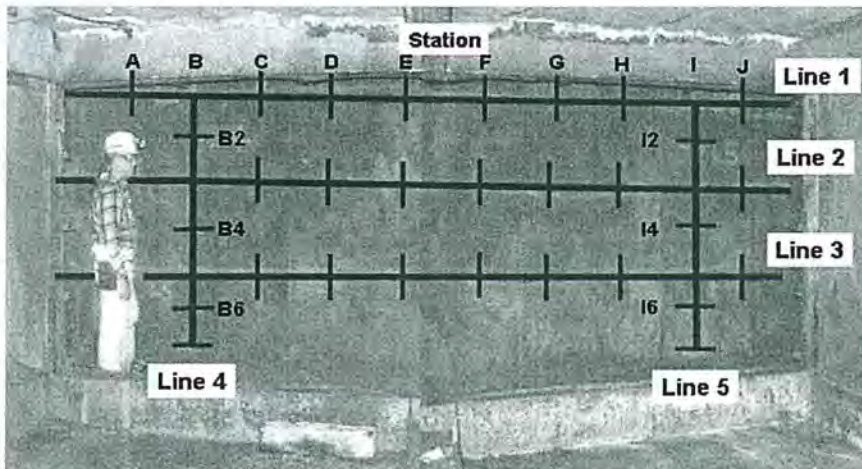
**Figure 17.:** Photo showing Mine Seal No. 3 with GPR survey lines.

GPR was used to determine if the metal construction components could be resolved. For the radar survey, three perpendicular horizontal lines (lines 1-3) were positioned on the seal with the first line located about 6-in below the mine roof interface and the remaining two lines spaced about 24-in apart. In addition, two vertical lines (lines 4-5) were positioned approximately 4-ft from each mine rib. Reference points, spaced 24-in apart, were added to each survey line and these points were also added to the radar records (figure 17). Each survey was made by placing the antenna against the seal face and then moving along the line at a constant velocity. The radar survey of the seal were made using 1,000-MHz antenna because this antenna could provide the necessary depth of penetration and the desired level of resolution. A total of 22 surveys were made of the mine seal and table 3 shows the setup parameters used for each survey.

reference points shown in figure 17. In the radar records, two layers of wire mesh can be seen. The Stayfoam<sup>2</sup> panel however cannot be discerned from the back of the second wire mesh panel most likely because it was attached to the panel. This also explains the higher energy reflections seen in the deeper portions of the radar records (shown as back mesh areas in the records) because the Stayfoam<sup>2</sup> panel had a closely spaced mesh and thus a larger reflective surface.

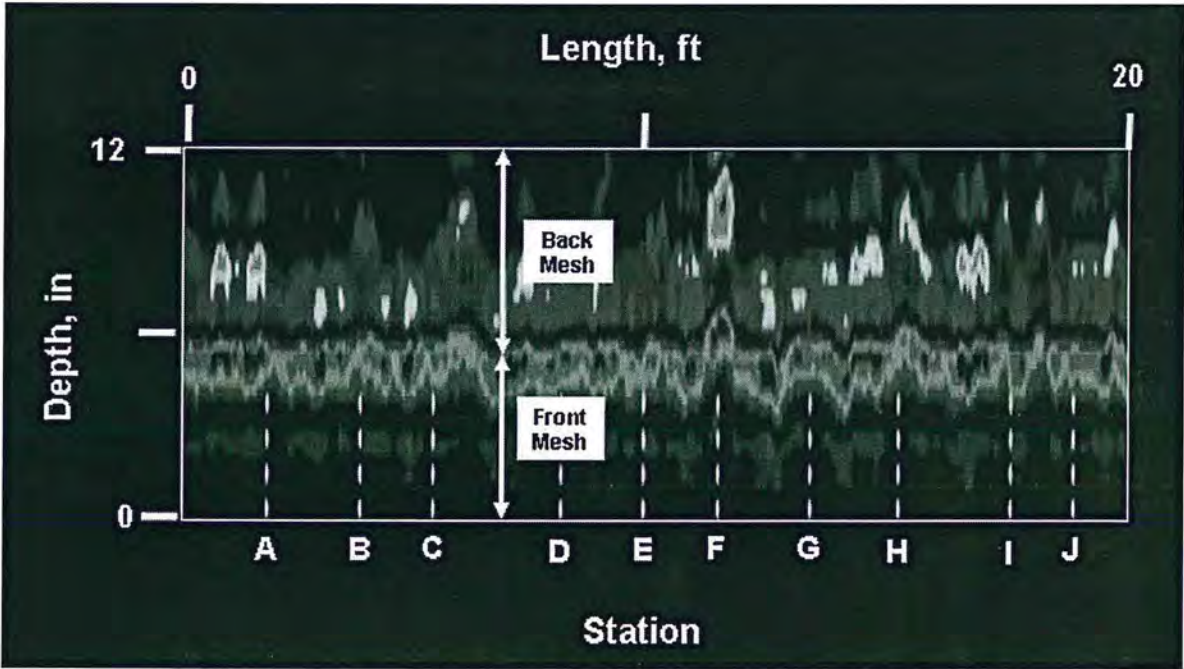
**Figure 18.:** Interpreted radar record for Mine Seal No. 3, Line 1.

Figures 18 and 19 show representative post-processed radar records of Mine Seal No. 3 and their associated interpretations. The reflected pulse energy is shown in terms of a color scale, with hot colors (yellow and bright green) being the higher level of reflected pulse energy and colder colors (brown and black) the lower levels. Areas in the record shown with similar colors should be interpreted as similar levels of reflected pulse energy. The vertical scale shown in the figure corresponds to the
