18TH CONFERENCE ON GROUND CONTROL IN MINING

Modern Shield Technology: Better than Ever but Still Not Perfect

Thomas M. Barczak, Research Physicist
National Institute for Occupational Safety and Health
Pittsburgh Research Laboratory
Pittsburgh, PA

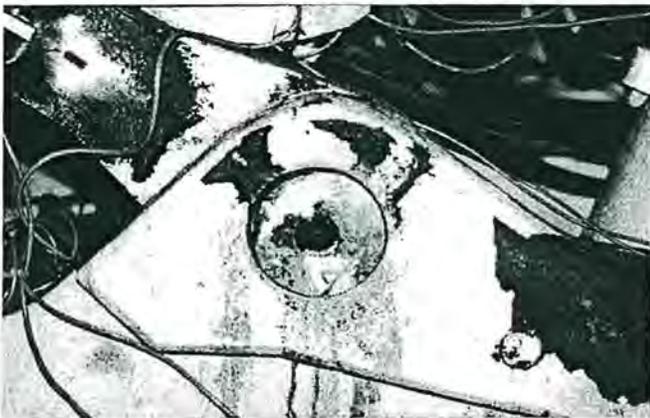
high loading in the caving shield - lemniscate assembly, namely loss of frictional contact at the roof and floor interface and standing the support on the toe of the base. With the possible exception of shields designed for low seam heights, there is adequate space available to increase the bearing area of these clevises and pin diameters to reduce the stress and substantially improve the life expectancy of these components. The joint design problem also needs to recognize the importance of pin tolerance. First, the pin contacts only a portion of the clevis. Typically, arcs of 45 to 60 degrees are used in the design analysis. Obviously, the 45 degree arc assumption will lead to more conservative designs. Conservative assumptions should be made to allow for reduced areas as wear occurs (figure 8). Excessive pin tolerances can lead to point loading by allowing the pin to rack within the joint clevis as illustrated in figure 9. Corrosion effects are also often ignored or not sufficiently accounted for in the design of pins, despite the fact that corrosion is a leading cause of premature pin failures or abnormal wear. Corrosion causes pits to occur in both the pins and the clevises (figure 5) which can reduce the bearing area by 25 to 50 pct and cause a proportional increase in stress.

Figure 8. Reduction in lemniscate pin contact area for worn joint.

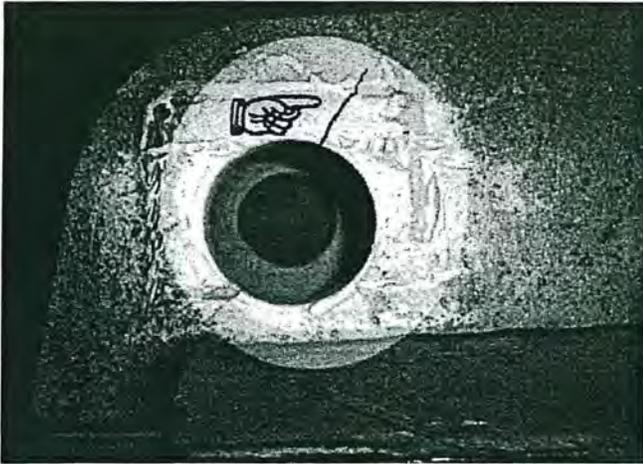
Figure 13. Failure in base lemniscate link clevis.

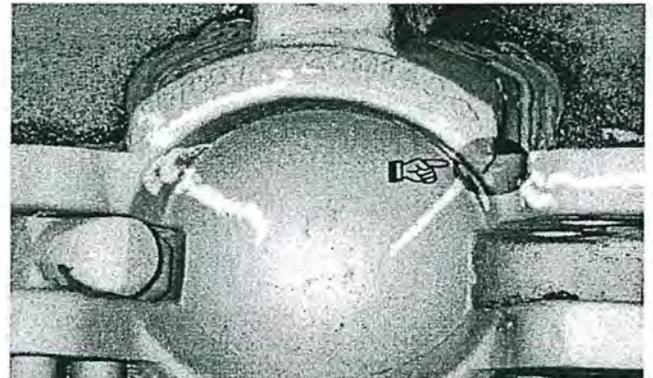
Figure 16 shows failure of a canopy leg socket casting due to a stress riser created by a sharp change in geometry. The failure in this case occurred in the casting itself. This failure occurred on several shield supports in the late 1980's, all of which utilized this same basic socket design. Again, this failure probably could have been prevented by a smoother geometry. Leg sockets are often a source of fatigue failures in aging longwall shields. The leg socket is a critical area since the full load developed within the hydraulic leg cylinder must be transferred into the canopy and base structures to be distributed to the mine roof and floor. An examination of the structural mechanics associated with these base socket failures has led to some other design changes that are intended to reduce the stress concentration in the leg socket casting/base structure connection. The rectangular geometry of the socket casting and its placement between the side rib plates of the base structure position it at right angles to the principal tensile stress caused by the bending of the base structure. This orientation creates a stress intensity factor which helps to promote fatigue-induced fracturing of the weldment. Some shields are now being designed with more of an elliptical or zipper shaped casting (figure 17) so that the front and/or rear edge is not perpendicular to the principal tensile stress, thereby resulting in a reduction of the stress intensity factor.

Figure 16. Failure due to stress riser created by sharp corner in canopy leg socket casting.

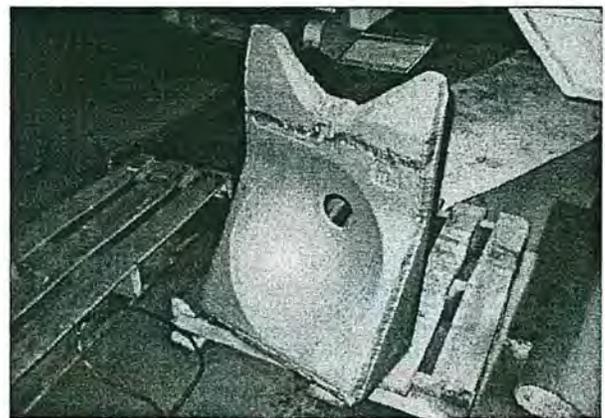
Figure 17. "Zipper-shaped" leg cylinder casting to avoid stress concentration caused by orientation of casting to principal stress field.
