# 18TH CONFERENCE ON GROUND CONTROL IN MINING

## Skin Failure of Roof and Rib in Underground Coal Mines

*Eric R. Bauer*, Mining Engineer  
*Deno M. Pappas*, Civil Engineer  
*Dennis R. Dolinar*, Mining Engineer  
*Frank E. McCall*, Mining Engineer  
*Daniel R. Babich*, Mining Engineer

National Institute for Occupational Safety and Health  
Pittsburgh Research Laboratory  
Pittsburgh, PA

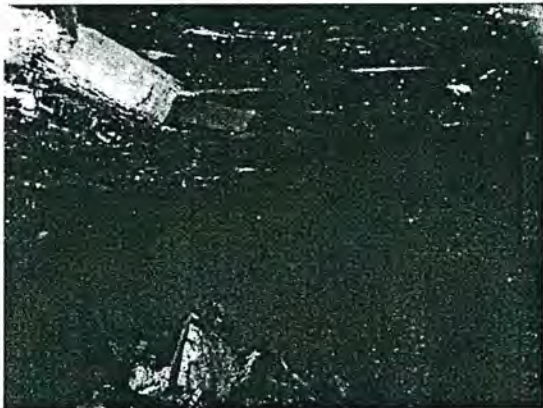
Figure 1. Skin failure of unsupported roof.

For the purposes of this manuscript and analyses, skin failure is defined as "the progressive loosening of slabs, blocks, or layers of rock from the surface of the mine roof or the spalling of pieces or slabs of coal from the coal pillar." Skin failure involves smaller pieces of rock or coal, rather than massive roof failures (above anchorage) or coal pillar failures (bumps and bursts). Skin failures can occur in both supported and unsupported mine strata. Figure 1 illustrates skin failure of unsupported mine roof while figure 2 is an example of skin failure of supported (bolted) mine roof where the failure occurs between the supports. Rib skin failures are illustrated in figure 3 (unsupported rib) and figure 4 (supported rib).

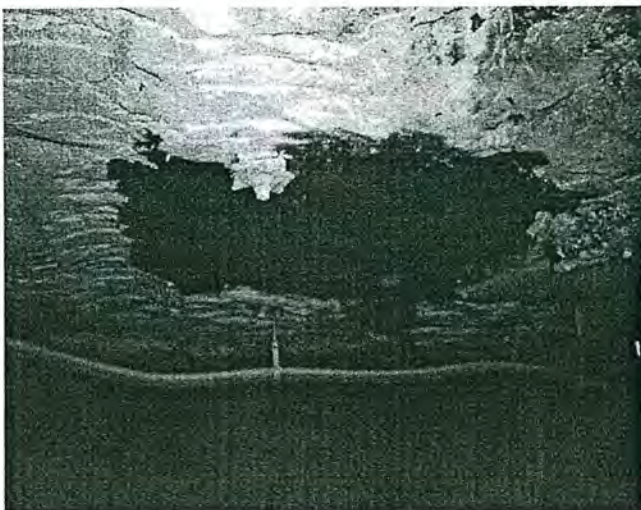
Figure 2. Skin failure in supported roof.

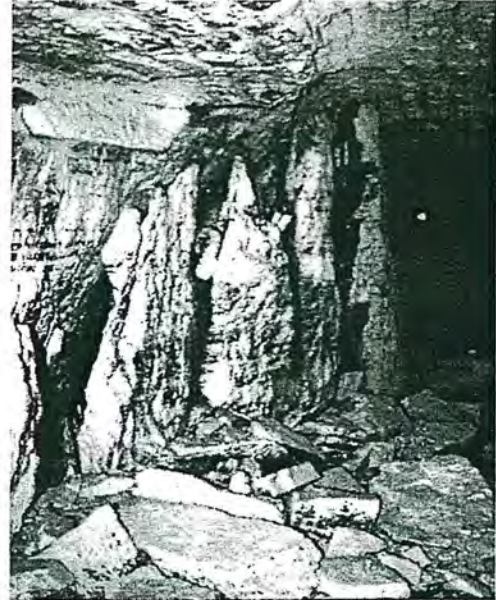
Figure 3. Skin failure of unsupported rib.

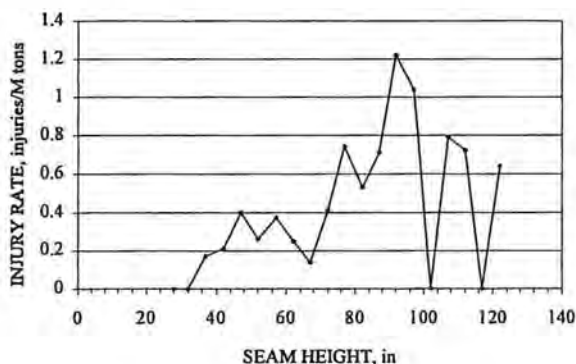
Figure 5. Seam height versus injury rate for rib skin failures, 1997.

Coal ribs can experience skin failure for many of the same reasons. Primarily, rib skin failure is associated with the early stages of the failure of insufficiently sized pillars or the effects of depth. A general observation about rib skin failures is that rib spalling tends to increase as mining height increases. A plot of rib skin failure injuries and seam height for 1997 indicated that the injury rate increased as the seam height increased, up to 8-ft-thick (2.4-m-thick) (fig. 5). For seam heights above 8 ft (2.4 m), no specific trend was evident, possibly because of insufficient data and the probability that more rib support is used in the thicker seams. Rib spalling may also increase as the depth increases, it can be affected by face cleat, and it can be self-perpetuating. As coal breaks from the solid pillar, pillar dimensions decrease and pillar pressures increase. The result is more fracturing and spalling, creating a cycle of spalling and loading that may continue unless control measures are implemented. Rib skin failure is also frequently associated with rock partings within the coal pillar or with draw rock located at the roof/rib interface. Rock partings or bands within the pillar create planes of weakness where differential movement (fig. 6) and failure can occur, leading to spalling (skin failure). When weak draw rock that is subject to failure during coal extraction is present, and is mined with the coal, the draw rock exposed in the coal pillars creates a zone of potential rib skin failure. This inherent weakness makes the draw rock susceptible to spalling from the rib as the coal pillars experience load.

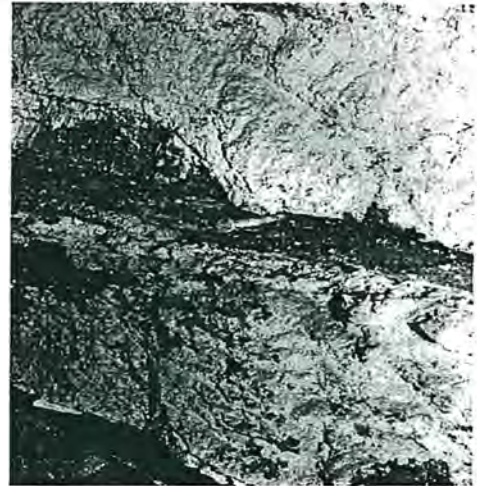
Figure 6. Example of differential movement along parting in coal rib.
