# Characteristics of Mining-Induced Seismicity Associated with Roof Falls and Roof Caving Events

This paper was prepared for presentation at Alaska Rocks 2005, The 40th U.S. Symposium on Rock Mechanics (USRMS): Rock Mechanics for Energy, Mineral and Infrastructure Development in the Northern Regions, held in Anchorage, Alaska, June 25-29, 2005.

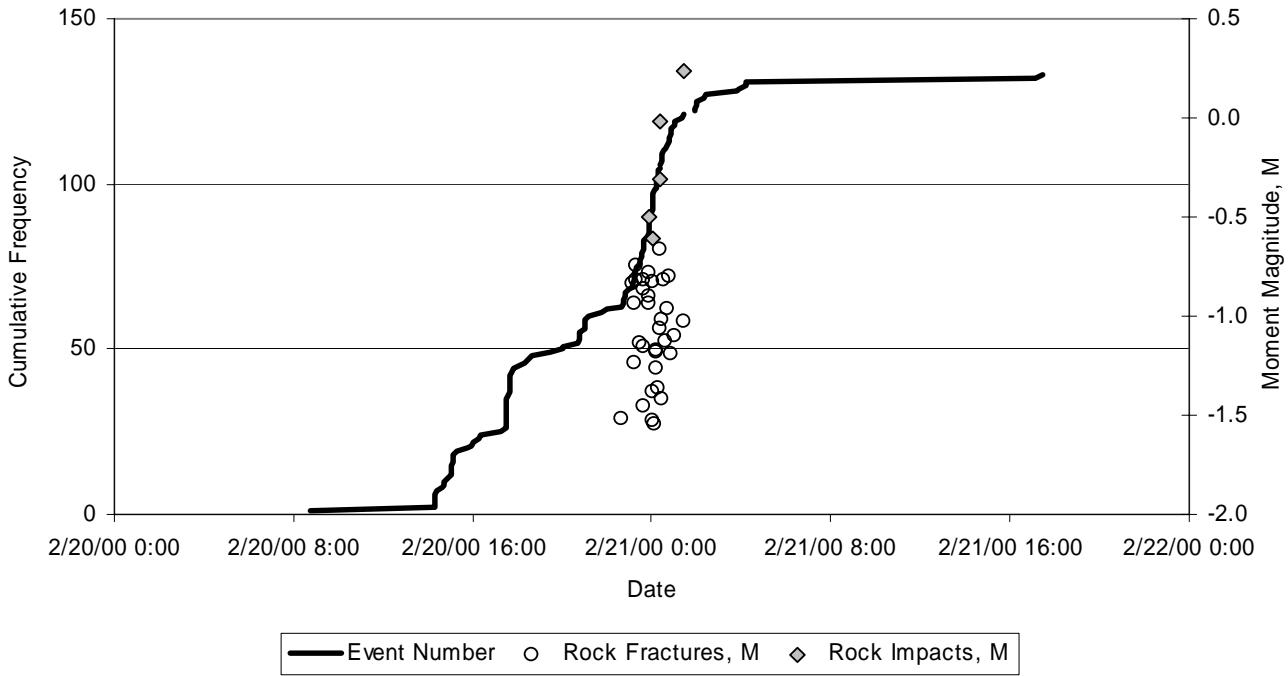
Fig. 1. A plot of the cumulative frequency of the 136 rock fracture events and five rock impact events associated with the February 21, 2000, roof fall at the Springfield Pike Quarry. Moment magnitudes were also calculated and displayed for 32 of the 136 rock fracture and for all five rock impact events.

Five rock impact events and 136 rock fracture events were recorded at this site (Figure 1). Almost all of the rock fracture events occurred over a

The moment magnitude (M) of 32 rock fracture and five rock impact events with the lowest location error measurements are shown in Figure 1. The moment magnitude of the rock fracture events ranged from -1.5 to -0.7, averaging -1.1. The

moment magnitude of the rock impact events ranged from -0.6 to 0.2, averaging -0.2. The last rock impact event at 1:24 a.m. on Feb. 21 was the largest ( $M = 0.2$ ) and most likely represented the biggest mass of falling rock. The magnitude of the event was probably lessened when debris buildup from the previous impacts partially absorbed the energy transfer [3].

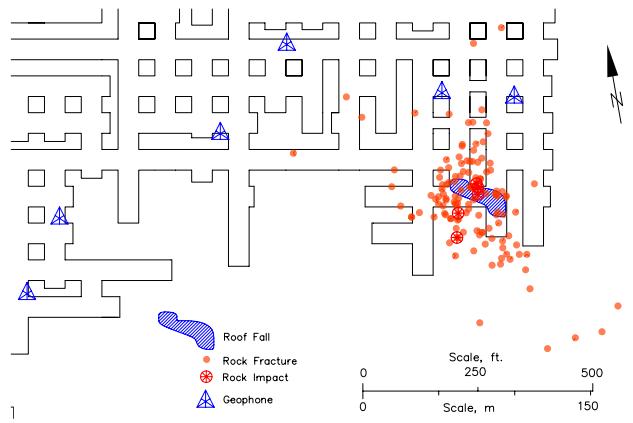
Fig. 2. Location of the 136 rock fracture events, five rock impact events, five geophones, and the February 21, 2000, roof fall at the Springfield Pike Quarry.

14-hour period from 2:17 p.m. February 20 until 4:15 a.m. February 21. The five rock impact events occurred over a 94-minute period and ended with a final major event at 1:24 a.m. on February 21. The locations of the geophones, rock fractures, rock impacts, and roof falls are shown in Figure 2.

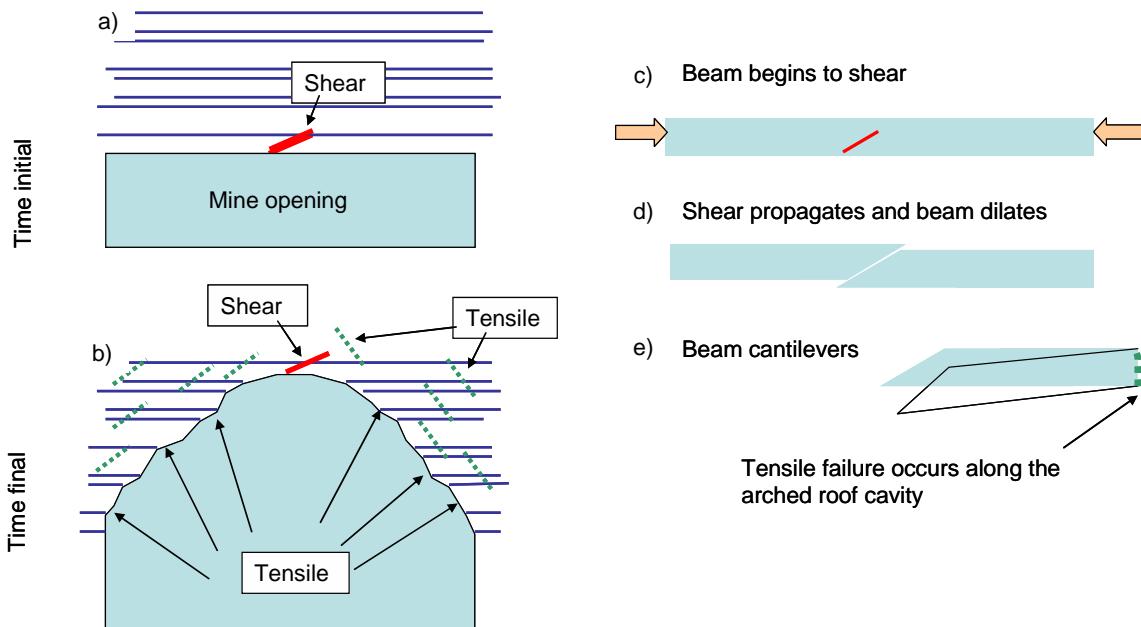
Fig. 3. Generalized sequence in which individual roof beams fail and develop into large roof falls under elevated horizontal stress conditions.

The rock failure process in bedded formations with excessive levels of horizontal stress is initiated when the stiffest and thinnest beds in the roof strata begin to buckle from the horizontal loading [1]. When these layers buckle (Figure 3a), shear and tensile rupture between layers and low-angle shears through the intact rock layers can occur (Figure 3b). Eventually the beam begins to cantilever, initiating a tensile failure along the fixed contact area at the edge of the roof fall (Figure 3c). From this point forward, reductions in super- and sub-adjacent layers lower confinement, resulting in additional low-angle shear failures. One-by-one the individual roof beams are strained to failure, shedding their load to adjacent layers which are also strained to failure. The rock failure process is progressive in nature and reduces when the shape of the roof cavity assumes the more stable arch shape. The roof cavity shape is defined by the sub-vertical tensile failures (Figure 3d). Rock failure can be reinitiated at the axial ends of these roof fall cavities

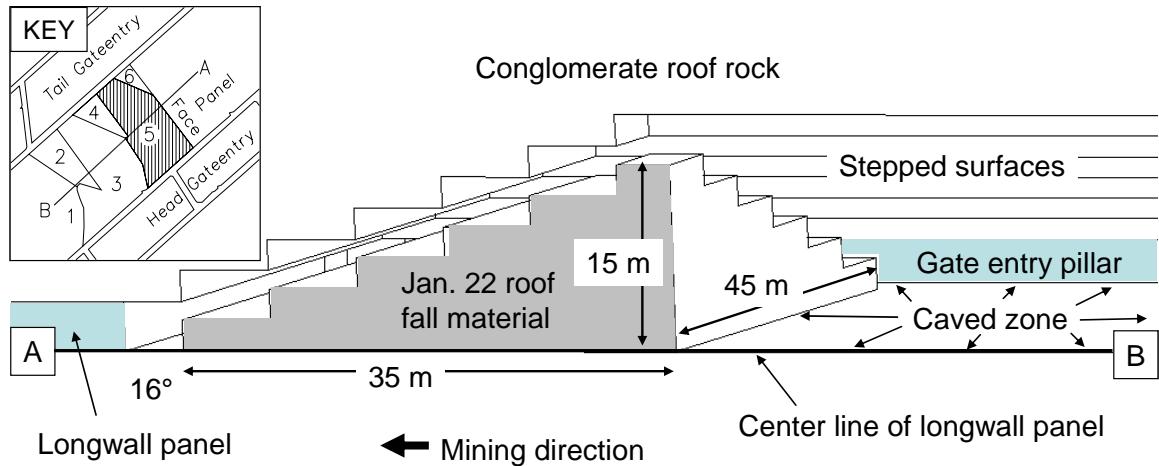
Fig. 4. Generalized sketch of the Jan. 22 roof fall (Fall No. 5), longwall panel No.1, Moonee Mine.

panel roof fall event [9]. This roof fall produced a fallen material geometry similar to half a cone with stepped surfaces (Figure 4). The top of the roof fall failure surface arched approximately  $16^\circ$  over the panel from the longwall face and the two gate entries, reaching a maximum thickness of 15 m in the center of the panel, 35 m from the longwall face (Figure 4). The top of the roof fall cavity was made up of both horizontal and vertical planes that formed a step-like surface. The horizontal planes were most likely associated with local bedding structures within the conglomerate, while the vertical planes were associated with the local jointing, spaced a few meters apart [10]. Above the fallen material, the conglomerate strata continued to bridge across the panel, leaving a 2- to 3-m high air gap. The back side of the fall, facing the previous caved rocks, was approximately parallel to the longwall face but arched toward the longwall face [10]. Edwards [8] and Mills and Jeffrey [10] have indicated that the general pattern described above was typical of longwall panel No.1's roof fall.

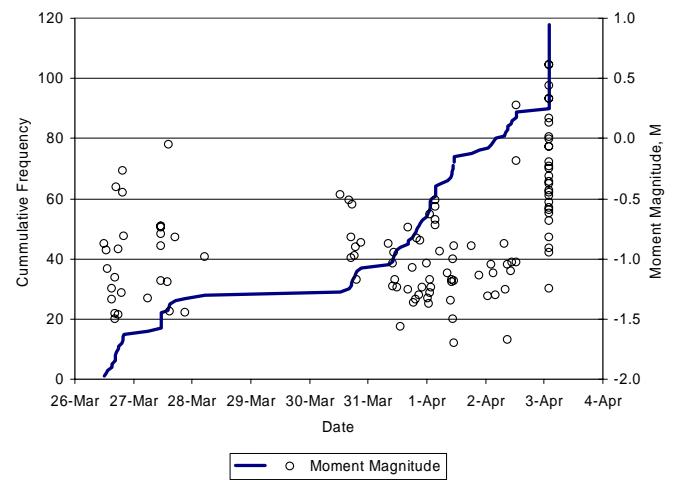
Fig. 5. A plot of the cumulative frequency of the 118 rock fracture events associated with the period between Roof Fall No. 20 and 21 at the Moonee Colliery. Moment magnitudes were also calculated and displayed for all 118 rock fracture events.

example, there were 118 rock fracture events (Figure 5) in the eight-day period that occurred after roof fall No. 20 and prior to roof fall No. 21. Approximately 70% of these seismic events occurred during the last three days of advance. In this case, there was only a weak correlation between advance rate and seismicity. It seems reasonable to ascribe this seismicity to the stepped fracture surface developing in the overlying conglomerate that would soon outline the fallen material for roof fall No. 21 (Figure 6).

cluster of rock fracture events occurred along a northwest-southeast trending dyke 150 m from the longwall face. These events may be associated with fracturing surrounding this stiff intact dyke. The moment magnitude of 118 rock fracture events, shown in Figure 5, ranged from -1.7 to 0.6 and averaged -0.9. Three rock fracture events with moment magnitudes between 0.3 and 0.6 occurred approximately three minutes prior to roof fall No. 21.

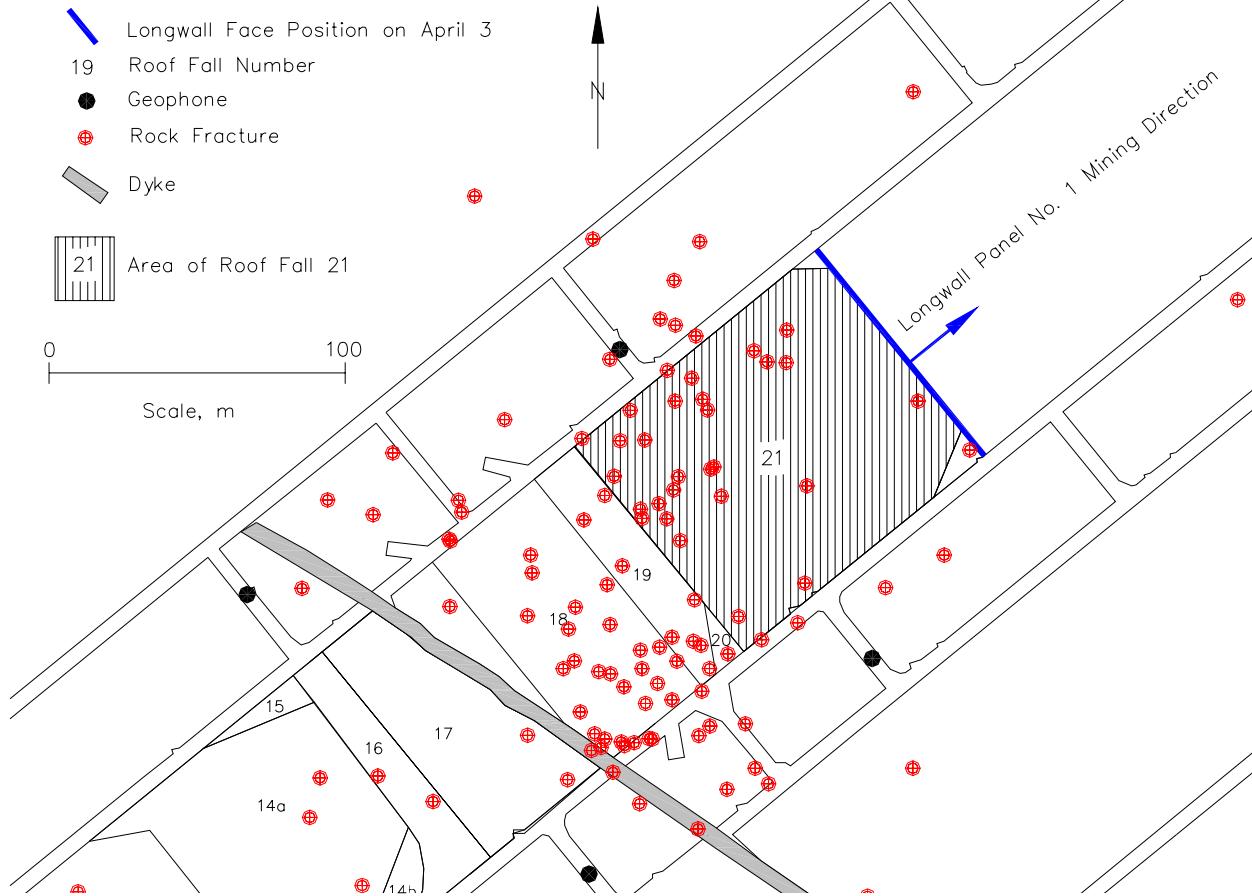
Fig. 6. Location of the 118 rock fracture events, geophones, roof falls, longwall face, and dyke at the Moonee Colliery.

By April 3, the hanging roof extended 97 m encompassing a  $9,830 \text{ m}^2$  area (Figure 6). The average rock fracture event occurred approximately 16 m above the extraction horizon. Also, a small

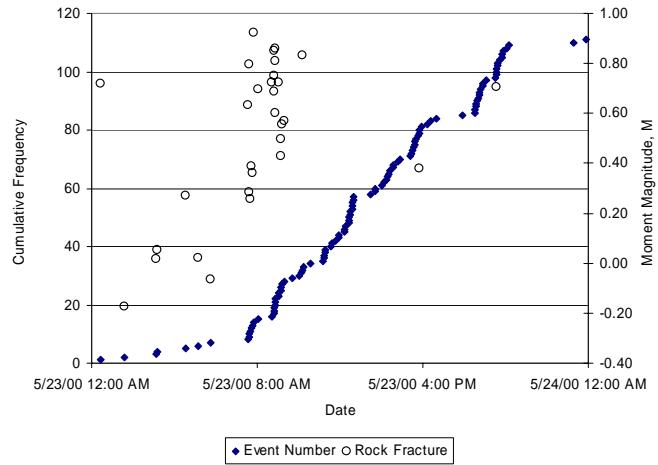
Fig. 7. A plot of the cumulative frequency of the 111 rock fracture events associated with longwall mining on May 23, 2000, at the Willow Creek Mine. Moment magnitudes were also calculated and displayed for 30 of the 111 rock fracture events.

The moment magnitudes of 30 selected rock fracture events are also shown in Figure 7. This subset of the May 23 events was selected because of their low location value residuals. The moment magnitudes of the rock fracture events ranged from -0.2 to 0.9 with an average of 0.5.

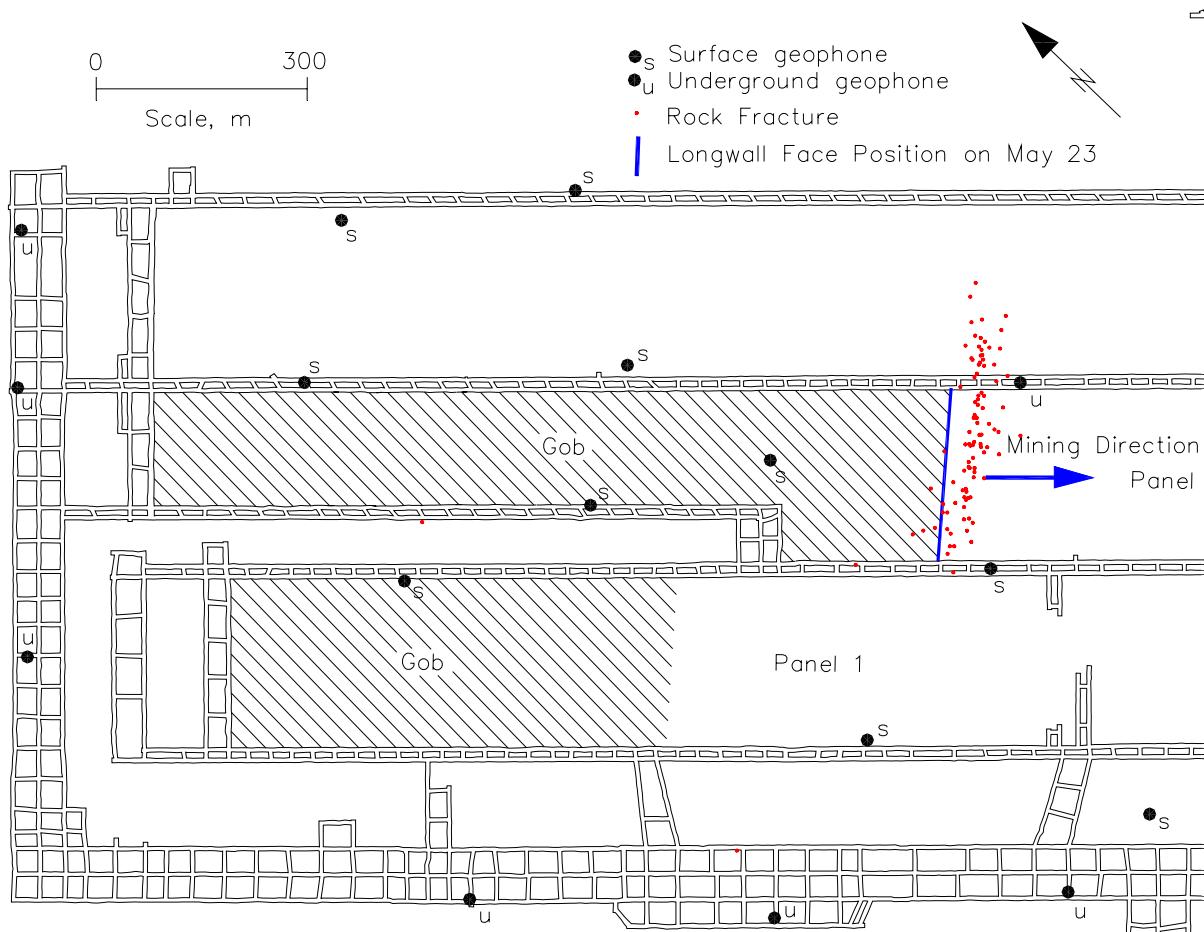
Figure 8. - Location of 111 rock fracture events, geophones, longwall caving zone (gob), and longwall face at the Willow Creek Mine.

The location of 111 rock fracturing events from May 23, 2000, cluster along the longwall face area (Figure 8). There is a noticeable concentration near the headgate entries. Additionally, the events occur both above and below the mining horizon. In examining the data for the entire longwall panel, Heasley et al. [13] found that the events generally occurred in advance of the longwall face, distributed both above and below the mining horizon.

This is most likely an issue of event detection sensitivity. A minimum of eight stations with high-quality arrivals were required to satisfy the criterion for locating events plotted in Figure 8. Average source to receiver distance was 1.1 km. Thus, smaller events which did not satisfy this condition were not detected. Numerical modeling studies by Gale et al. [14] support the notion that events representing incremental fracture in the frontal abutment zone should be larger than events in the gob zone. In the two-dimensional models, fracturing behind the longwall shield was generally not associated with microseismic activity because of low stress drop conditions, a corresponding lack of shear fracturing, and poor transmission of elastic energy through the broken rock mass.
