BLAST VIBRATION DAMAGE TO STRUCTURES

**PROCEEDINGS
OF THE
SIXTEENTH ANNUAL INSTITUTE ON COAL MINING HEALTH,
SAFETY AND RESEARCH**

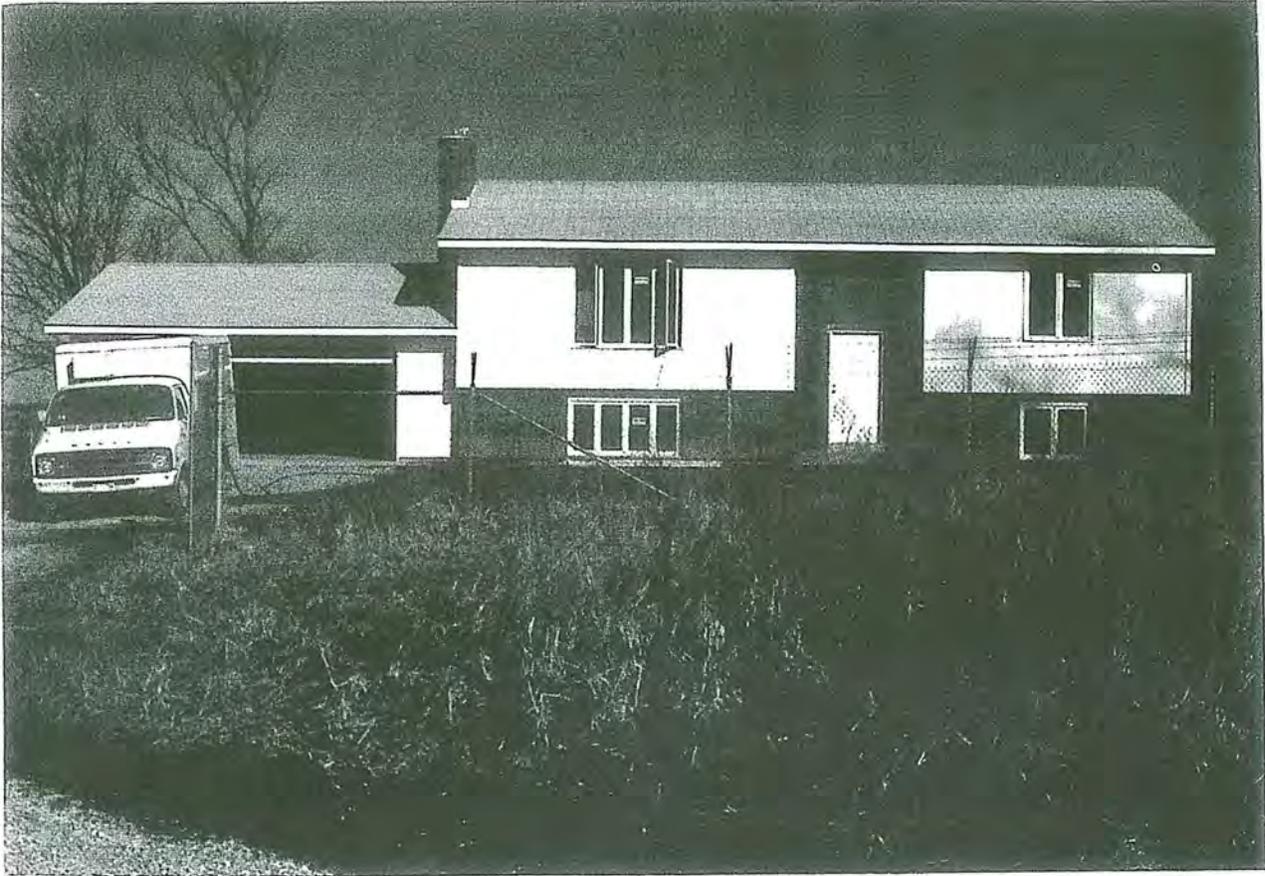
FIGURE 7 - Fatigue test house erected by the Bureau of Mines on the AMAX Ayrshire mine property, Evansville, IN.

The most extensive tests were on an 1100-square-foot wood frame residence built for the Bureau directly on the AMAX Ayrshire coal mine property in Indiana (Stagg, 1984). For a 2-year period, this house (fig. 7) was subjected to, and monitored for response from, low-level blasts, weather cycling, human activity, and static changes such as settlement. As the mine advanced toward the house, the blasting vibrations increased to damaging levels. In a final series of tests following the last blasting cycle, mechanically induced vibrations were used to produce high-cycle fatigue. During this time, researchers employed up to 50 recording channels at 67 locations for dynamic strain and vibrations. Continuous measurements were made of wind velocity and direction, and of temperature and humidity inside and outside the house. Level-loop surveys were made periodically to assess differential settlement.

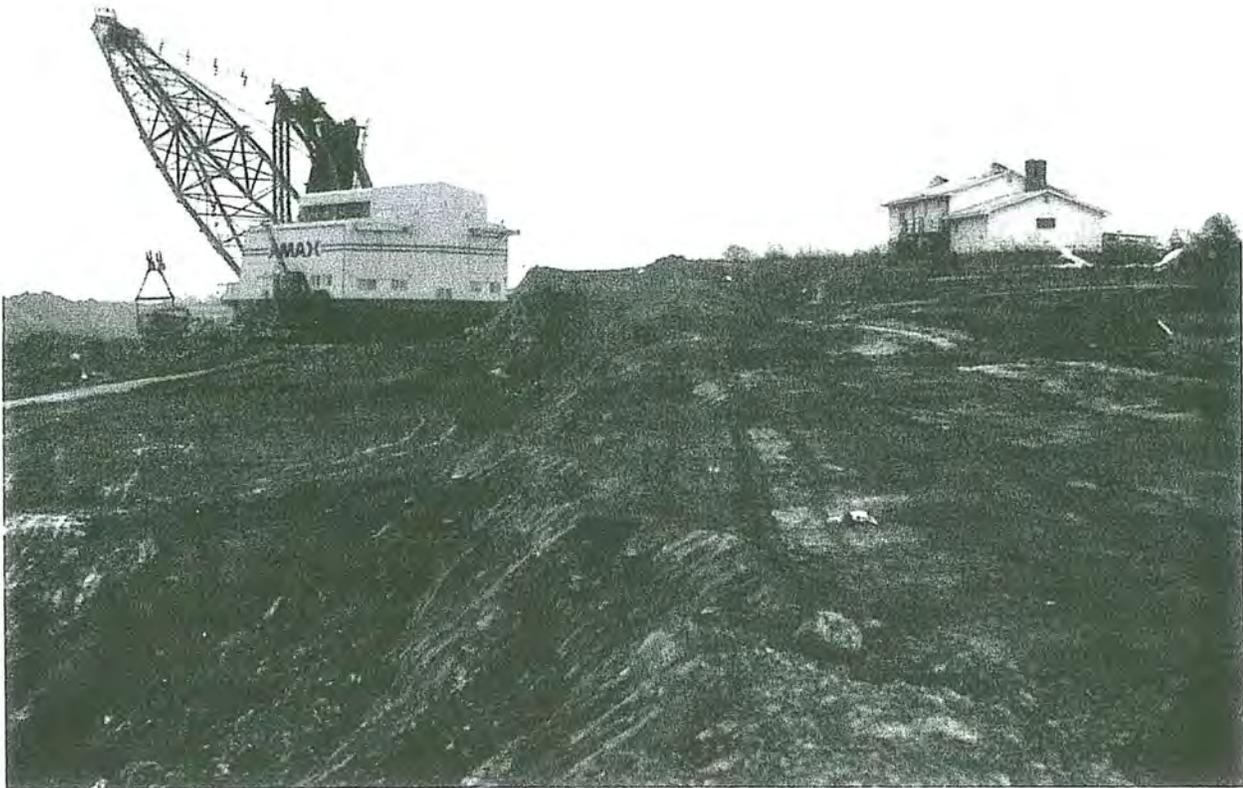
FIGURE 9 - Bureau of Mines fatigue test house on highwall near end of blasting test series.

High-Level Vibration Tests. As the mine approached the house, the level of vibration at the structure became high enough to produce identifiable damage (fig. 9). Peak particle velocity levels in excess of 0.5 in/s resulted from 108 of the production blasts. One
