Longwall Shield Recovery Using Mobile Roof Supports

Frank Chase, Research Engineer
NIOSH, Pittsburgh Research Laboratory, Pittsburgh, PA

26th International Conference on Ground Control in Mining

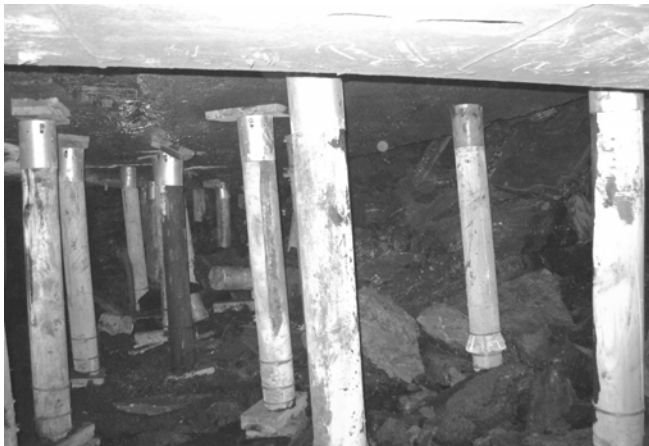
Figure 3. Engineered yieldable timber props equipped with active prestressing mechanical devices used as breaker line supports.

For the most part, there are three general methods that operators employ in order to prevent gob flushing into the working area. The first method relies solely on primary and supplementary intrinsic and standing supports. Traditionally, the standing supports were two or three 4-point cribs installed for each face shield removed. One needs to keep in mind that a shield is being lowered and adequate support needs to be installed to maintain the immediate roof. Many operators have opted to use hydraulic or engineered timber props (figure 3) to reduce the amount of time required to install compared to a wood crib. This reduces miner exposure to the unpredictable gob edge and shortens the move time.

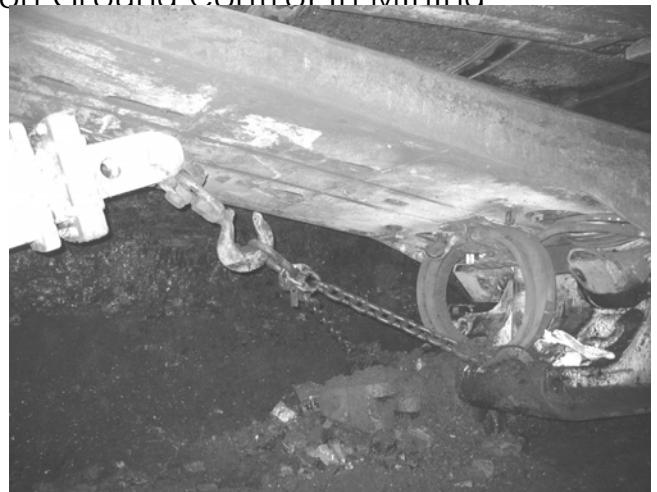
Another method which operators utilize to prevent gob flushing are walking or trailing shields. The majority of the mining community is accustomed to using the terms “walker” or “walking shields.” Therefore, this paper will comply and will use this terminology. If one shield is used, a chain or 1-in-diameter steel wire rope is hooked to the shield's frame (legs or pontoons). The shield is moved out of the face area with a shield retriever. As shown in figure 4, some retrievers have a long boom with a hook on the end. The hook is manually placed in a large clevis that is attached to the chain or wire rope. The boom is raised and the shield is dragged out of the face so that the long axis of its canopy is situated parallel to the face (unmined block of coal) and perpendicular to the other face shields. This shield now functions as a walking shield, and is pressurized a few inches slightly in front of the shield tip and canopy corner to retrieve the next shield. After the next shield is removed, the walking shield is dragged forward

Figure 4. Shield retriever advancing walking shield.

and the process continues. Barring adverse ground conditions, less supplemental roof support (usually cable bolts and free standing support) is required when walking shields are used as compared to the first recovery method. Prior to MRS usage, a single walking shield was employed during shield recovery at Harris.

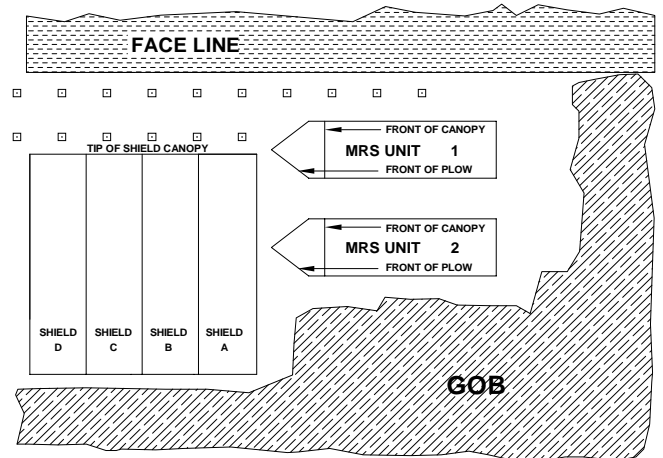
Figure 6 illustrates a MSHA-approved plan employing two MRS’s that was submitted by another mining company. As

compared to figure 5, significantly less support is required when using two MRS’s. Harris has opted to use a single MRS due to the restricted width of the recovery room. The MRS canopy width for the model used at Harris is greater than that of a standard shield. This places the side of a second MRS in close proximity to the roof caving area, and gob flushing causes frequent machine fouling.

Figure 6. Shield recovery plan using two MRS’s.

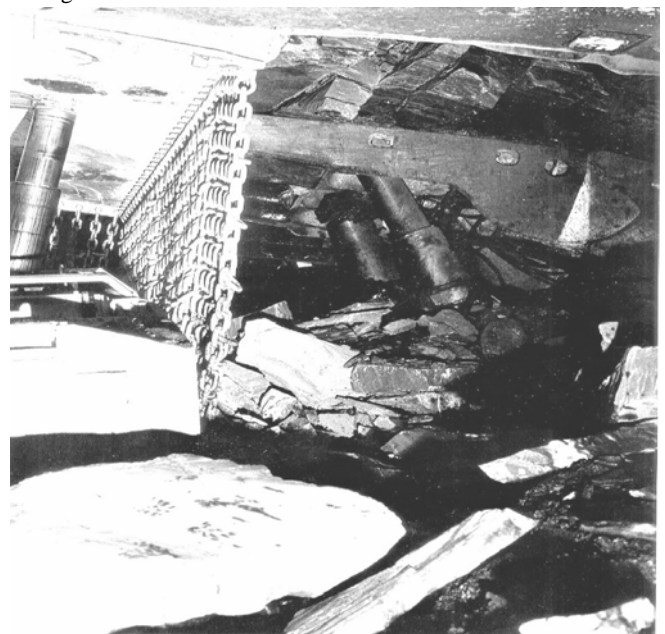
The advantages of MRS's are most evident in adverse conditions. Figure 7 exemplifies some less than desirable conditions in which MRS's have performed well at Harris. This recovery room's roof was highly fractured due to multiple seam stress load transfer and horizontal stress damage. The shield behind the MRS was abandoned because the conditions were extremely difficult at this location and because the shield was nearing the end of its useful life. The decision was made not to

Figure 7. Shield recovery under adverse conditions.

take the risk or spend the time recovering the shield under such adverse conditions. MRS's also have the ability to bulldoze their way through excessive floor debris (figure 8). With walking shields, it is more likely that some of the debris may have to be removed to facilitate their advance.
