IN-MINE EVALUATION OF SMART MINE FIRE SENSOR

R. A. Franks, NIOSH, Pittsburgh, PA
G. F. Friel, NIOSH, Pittsburgh, PA
J. C. Edwards, NIOSH, Pittsburgh, PA
A. C. Smith, NIOSH, Pittsburgh, PA

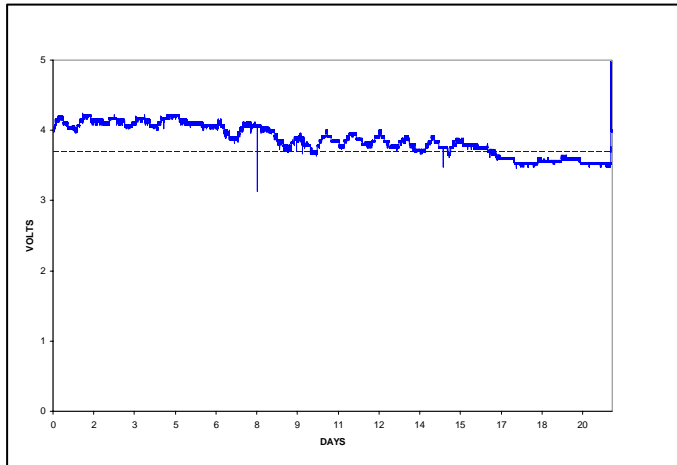
The Smart Fire Sensor System experienced significant drift problems with the Beam Smoke Sensor unit when the system was installed into the main haulage way at Cumberland mine. The drift was attributed to a combination of three or four persistent problems; loosening of screws in the Beam unit's interface assembly due to constant vibration from equipment moving in the haulage way, misalignment of the Beam transmitter unit due to the deterioration of the rib to which it was mounted, periodic build-up of dust on the lens assembly from the high air-flow and temperature fluctuations in the haulage way. No one specific cause was determined to be the reason for the drift. An example of the drift over a 20 day period is shown in figure 2.

Figure 2. Beam sensor response in the main haulage way.

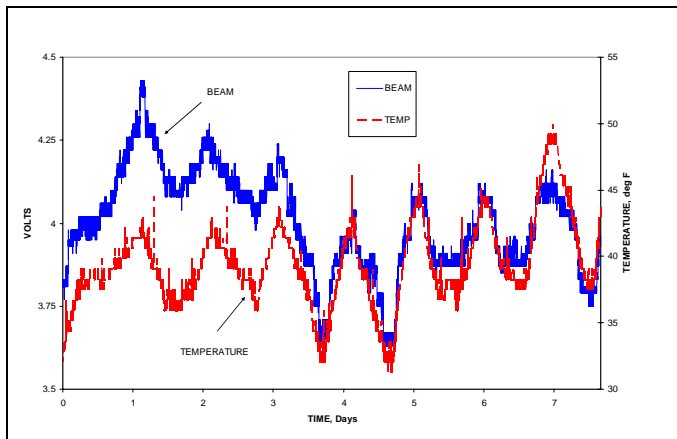
Diurnal temperature effects on the Beam and MOS2105 sensors were observed in the haulage way. This temperature change was due to the proximity of the haulage way sensor station to the intake air. An example of the close correlation of the periodic fluctuations in signal level of the Beam sensor with a similar change in ambient air temperature in the haulage way is shown in figure 3 for a seven-day period. The maximum value occurred about 6:00 PM and the minimum value about 7:00 AM on a recurring daily basis. These times corresponded to maximum and minimum outside air temperatures.

Figure 3. Beam and Temperature responses.

In an attempt to correct this temperature response problem, foam insulation was placed around the open perimeter of the Beam housing to isolate the electronics from the mine air and prevent convective cooling. However, this did not eliminate the problem. The MOS2105 sensor also showed a voltage drop due to severe winter temperatures,

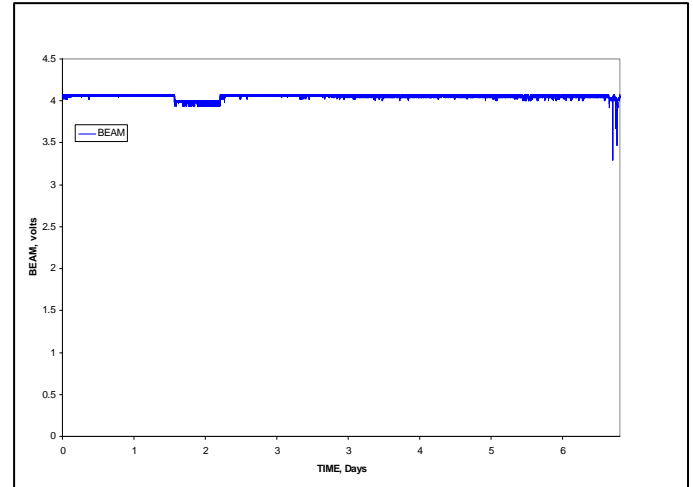
An evaluation of the Beam sensor's output temperature dependence under more stable temperature conditions in the Emerald Mine charger entry is shown in figure 4. The sensors were located in a split from the mine's electric-vehicle charger entry. In this evaluation, the temperature was not recorded by the mine monitoring system as it was at Cumberland Mine. Also, at the sensors' location in the split the air velocity had a relatively low value of about 40 fpm.

Figure 4. Beam response in Emerald Mine.

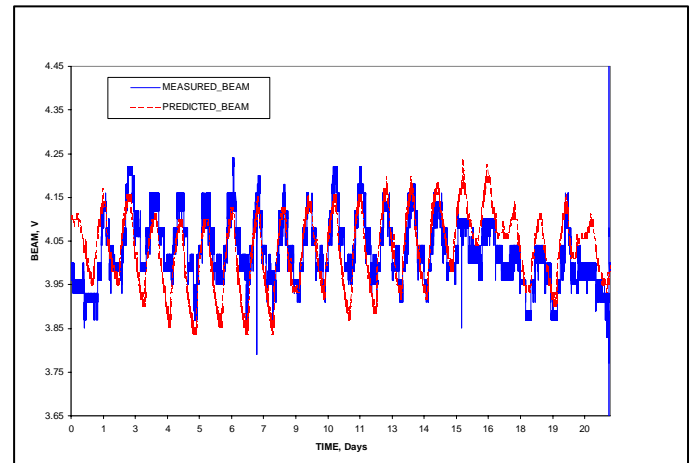
An attempt was made to determine the exact dependence of the Beam's output upon ambient temperature by an evaluation of the correlation between the two parameters for a stable haulage way data set. For a 20 day period, the dependence of the measured Beam output signal upon temperature resulted in a fit of the Beam signal to a power of the air temperature measurement.

$$\text{PREDICTED_BEAM} = T^{0.329} \quad (1)$$

where T is the measured temperature in °F, and PREDICTED_BEAM is the predicted Beam signal in volts. The correlation coefficient is 0.62, which defines a moderate correlation. Figure 5 indicates that the period of the measured Beam oscillations is well represented by the PREDICTED_BEAM value, but the amplitudes are less well represented.

Figure 5. Measured and predicted Beam signals, based on ambient temperature.

It should be noted that this correlation applies to this particular set of data, and for which there was no long term downward drift in the

Beam output signal. Any modifications to the smart sensor unit as imposed temperature compensation would require the addition of a temperature measurement device to the smart fire sensor set and that a temperature compensation algorithm be applied to the data normalization process.

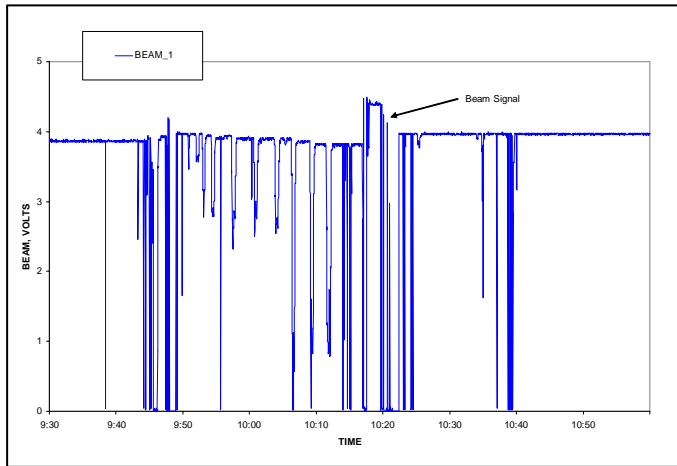
Since the Beam smoke detector is an optical smoke sensor, the Beam had a persistent problem with dust accumulation on its lens surfaces and the unit was indiscriminant in its response to the various types of particulate matter that were dispersed into its optical path. The effect of rock dust on the Beam sensor had been investigated in the SRCM. In the SRCM rock dust was hand-dispersed at entry mid-height upwind from the Beam sensor unit. The Beam sensor responses in the SRCM evaluations are shown in figure 6. The airflow was maintained at 250 fpm during these evaluations.

Figure 6. The Beam affected by Rock Dust in the SRCM.

It can be seen in figure 6 that the Beam recovered to its pre-rock dusting value after the last intense injection of rock dust into the air stream. Two differences were possible from the perspective of rock-dust deposition between the SRCM and the in-mine evaluations. One possible difference was the rate of deposition of rock dust on the Beam lens cover. In the case of the in-mine evaluation, the deposition rate would be gradual. A gradual deposition rate might not be detectable by the logic inherent to the Beam sensor. Another possibility could be the presence of diesel combustion byproducts which could accumulate as a film on the Beam's plastic surface to which the dust could adhere. During the evaluation, it was also observed that rock dust periodically accumulated on the Beam lenses. The Beam lenses were cleaned and the unit reset to restore the Beam to its normal value of 4 volts.

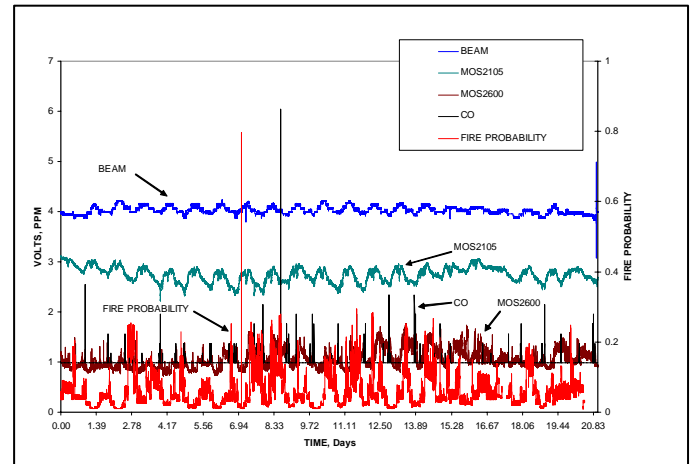
In an attempt to address the downward drift of the Beam's output signal in the environment of the main haulage way, the screw connections at the terminal strips in the Beam's interface box were tightened, and the unit was returned to service. The results of the evaluation for a 20 day period showing the stability of the Beam output signal are depicted in figure 7. This would indicate vibrations induced in the Beam's interface box was a significant factor in the long-term evaluation of the smart fire sensor in the haulage way.

It should be noted that figure 7 shows an isolated fire probability of 0.8 that occurred on day 6. However, during that time only a small decrease in the Beam output voltage occurred, so the NN does not indicate an alarm event.

Figure 7. Sensor responses and predicted fire probability in the haulage way.

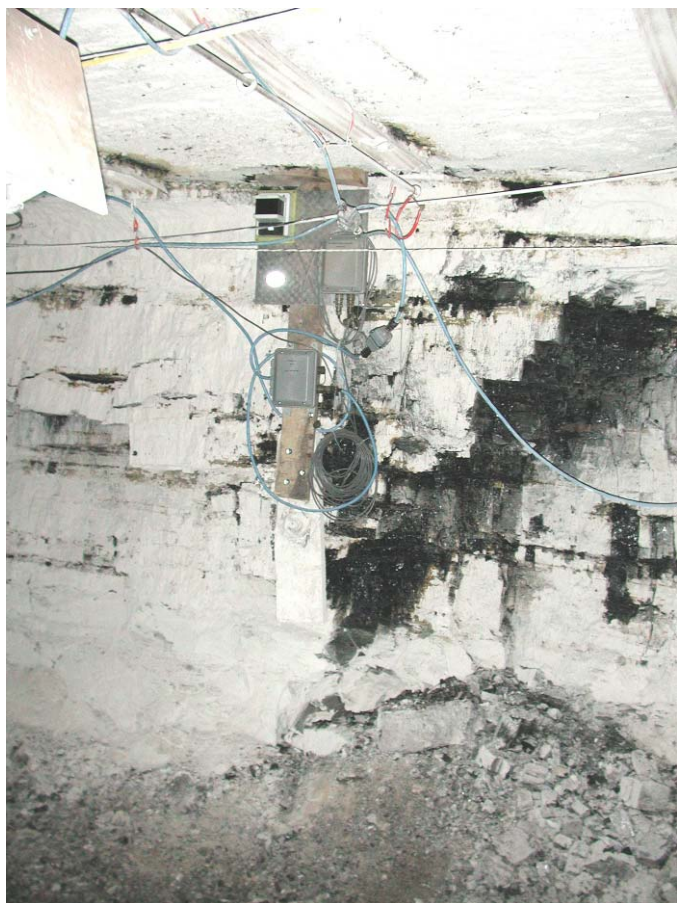
Spalling of the haulage way rib to which the Beam's transmitter unit was attached also caused alignment problems with the Beam detector. Figure 8 shows the Beam transmitter unit mounted on the rib in the haulage way. In a simple lab experiment, with the Beam set up along an approximate 6 foot path, the unit showed a significant voltage loss in the receiver output with slight lateral movement of one corner of the receiver's mounting-plate in a direction perpendicular to the optical path. Although the same displacement on the 30 foot path-length in the mine would require five times the movement, the results indicated that a continual slow movement of the rib mounting caused by the working rib would produce a continual voltage drop in the Beam. The Beam transmitter mounting supports on the main haulage way rib eventually collapsed at some point in time after the Beam unit had been removed from the haulage way.

Figure 8. The Beam transmitter mounted on the rib in the haulage way.

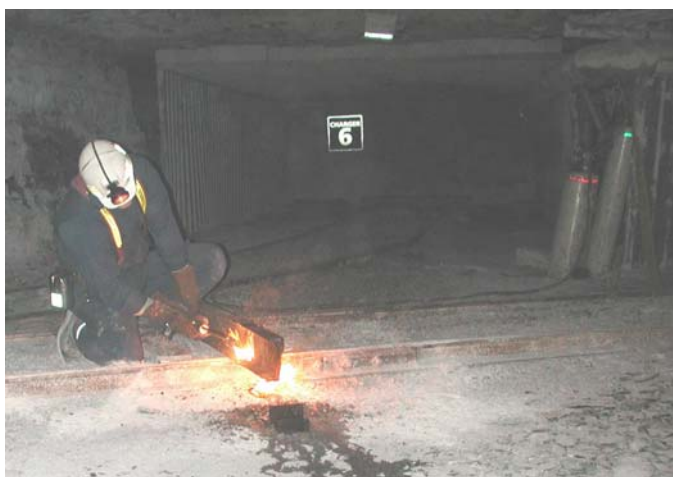
Figure 10. Flame cutting of a piece of rail.

For validation purposes, the new modifications of the NN program were applied to the data from the in-mine rail cutting operation depicted in a photograph of the flame cutting experiment (figure 10). The sensor measurements are shown in figure 9. No HH alarms resulted. Figure 9 shows that there were CO values greater than the 10-ppm alarm level. Although the fire probability exceeded 0.9 during the burn, the normalized Beam values were greater than 0.8. As noted earlier, the criterion for an HH alarm required both the fire probability to exceed 0.9 and the normalized Beam values to be less than 0.8. This

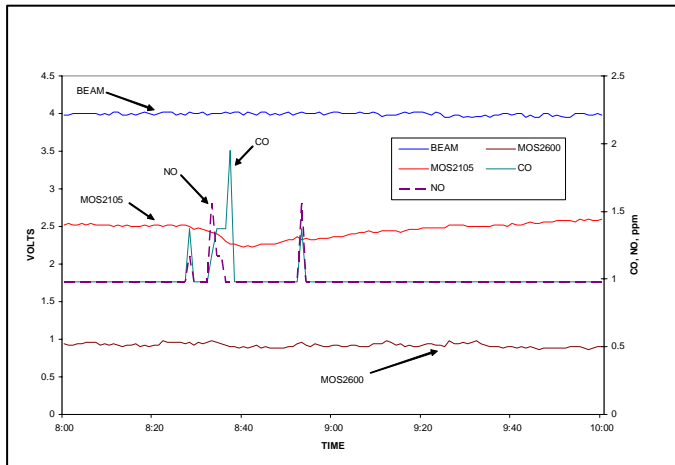
Figure 11 shows the identification of a typical nuisance emission in the haulage way during the evaluation that shows the MOS2105 sensor responded simultaneously with the NO and CO sensors. The responses by the CO and NO sensors were less than 2 ppm.

However, the absence of the Beam sensor's response is indicative of an absence of optical obscuration. The predicted fire probability from the NN algorithm was less than 0.11. Although the emission source was not known, it most likely was a diesel engine which produced insignificant smoke obscuration compared to a fire.

Figure 11. Sensor responses in the haulage way at Cumberland.

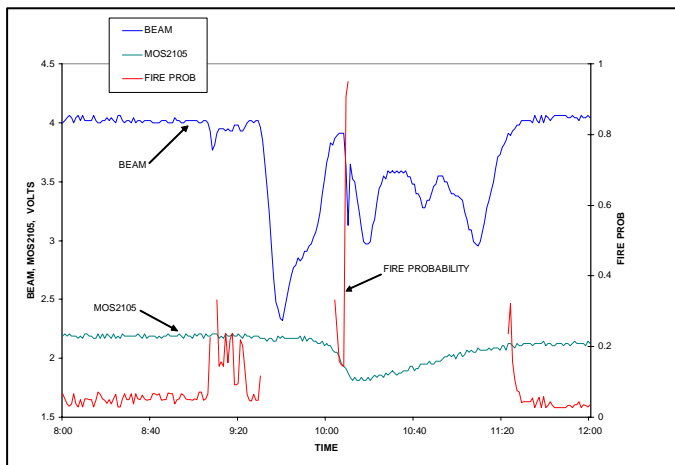
Another example is shown in figure 12. In this case, given the response of the MOS2105 to NO, and a small response of the NO chemical cell sensor to this event, the speculation was that a diesel-powered scoop operation was in progress in the belt entry to remove coal spillage upwind from the sensors which resulted in dust-laden air flow. The broken probability curve in figure 12 is a consequence of the Beam sensor response being more than ten standard deviations below its mean value and the MOS2105 sensor response increase being less than ten standard deviations above its mean value. In this case there is a source other than smoke, such as optical path blockage by equipment or dust, which induces the Beam sensor response. When this occurs, the fire probability is not calculated and no alarm is given.

Figure 12. Sensor responses and predicted fire probability in belt entry.

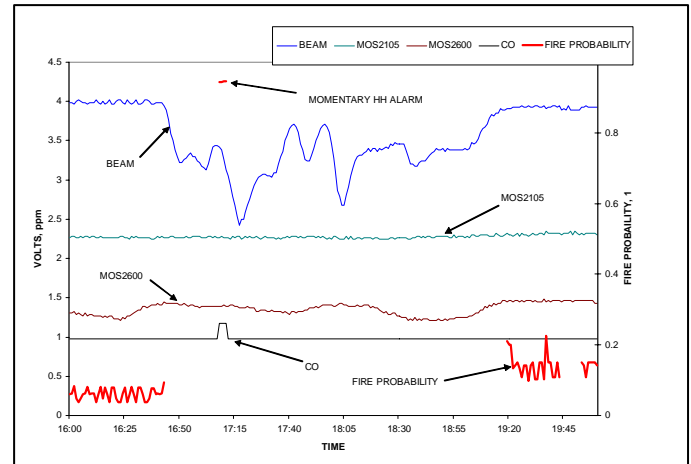
Another event of the type depicted in figure 12 occurred in the belt entry later in the evaluation. Figure 13 shows the sensors' outputs. This resulted in one HH alarm. It should be noted that breaks in the red Fire Probability curve in figure 13 indicates that the fire probability was indeterminate at that point in time as it was just prior to and just after the momentary HH alarm. Figure 13 also shows a small increase in the CO at the time of the HH alarm.

Figure 13. Sensor responses and fire probability in the belt entry.

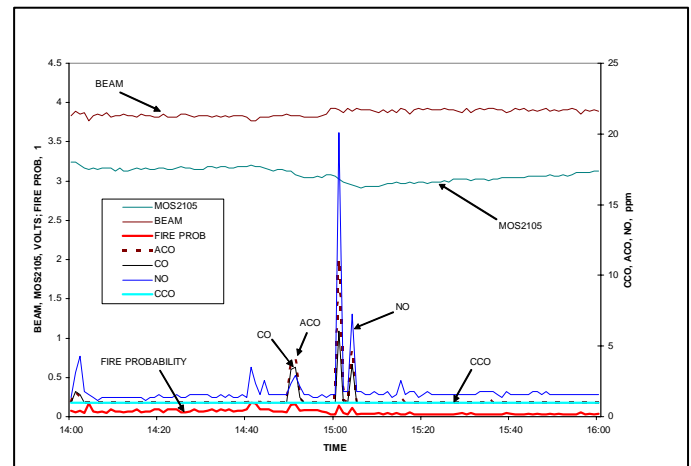
Figure 14. Sensor responses and predicted fire probability.

The Smart Sensor's discriminating capability was compared to that of a diesel discriminating monitor currently in use in mines during the evaluation in the track entry, shown in figure 14. During this event, the CO response from the CO-NO sensor (ACO) was 11 ppm for the measured CO concentration. The NO sensor response was 20 ppm. In this figure, ACO refers to the actual CO response of the CO-NO sensor. CCO refers to the corrected CO response read by the CO-NO sensor based upon the CO and NO historical record. The CO-NO sensor identified this event as a non-alarm with a base line CCO value equal to 0.98 ppm. The fire probability identified with the NN evaluation from the smart fire sensors was 0.14, and the diesel emissions probability identified with the NN evaluation was 0.24. This demonstrates a consistency of the smart fire sensor system with the diesel discriminator unit's evaluation.
