Pillar Strength and Design Methodology for Stone Mines

Gabriel S. Esterhuizen, Sr. Research Engineer
Dennis R. Dolinar, Lead Research Engineer
John L. Ellenberger, Lead Research Scientist
NIOSH-Pittsburgh Research Laboratory
Pittsburgh, PA

27th International Conference on Ground Control in Mining

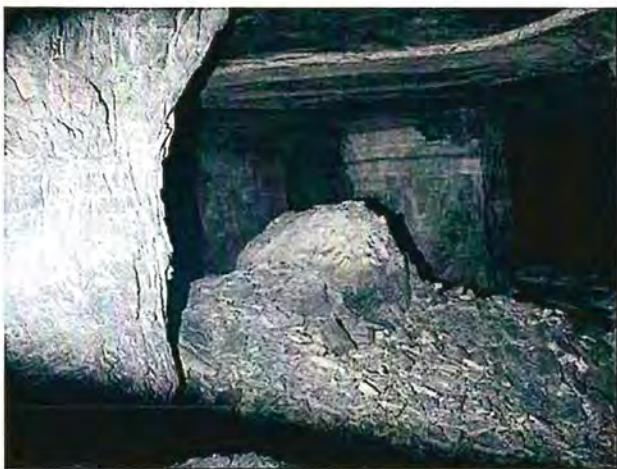
Figure 1. Remaining stump of a collapsed pillar in an abandoned area. Thin weak beds in the pillar and moist conditions are thought to have contributed to the failure. The width-to-height ratio was 0.82 and average pillar stress about 11% of the UCS.^{ws}

- 1) Collapse of entire pillar, as shown in figure 1.
- 2) Rib spalling to a rounded hour-glass shape with open

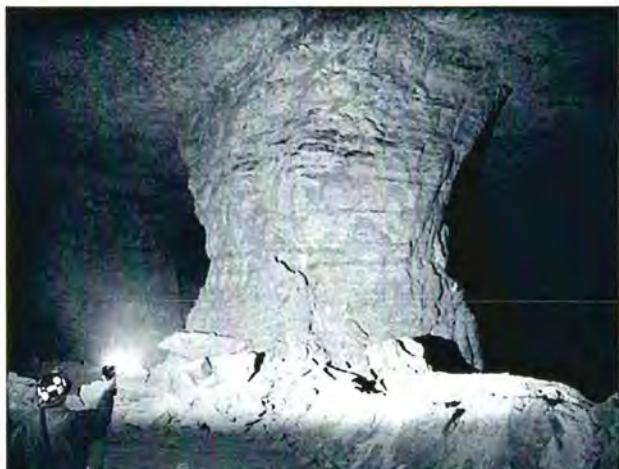
Figure 3. Partially benched pillar failing under elevated stresses at the edge of bench mining. Typical hourglass formation indicating overloaded pillar. Width-to-height ratio is 0.44 based on full benching height. The average pillar stress was about 12% of the UCS.

joints and fractures, shown in figures 2 and 3.

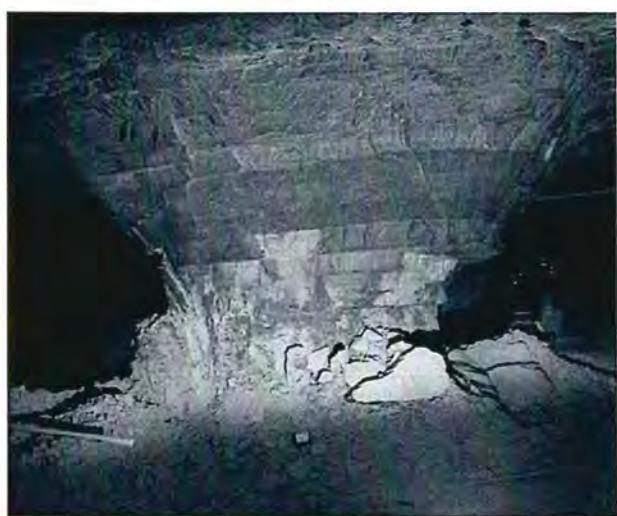
Figure 2. Pillar that has an original width-to-height ratio of 1.7 failed by progressive spalling. Thin weak beds are thought to have contributed to the failure. The average pillar stress was about 11% of the UCS prior to failure.

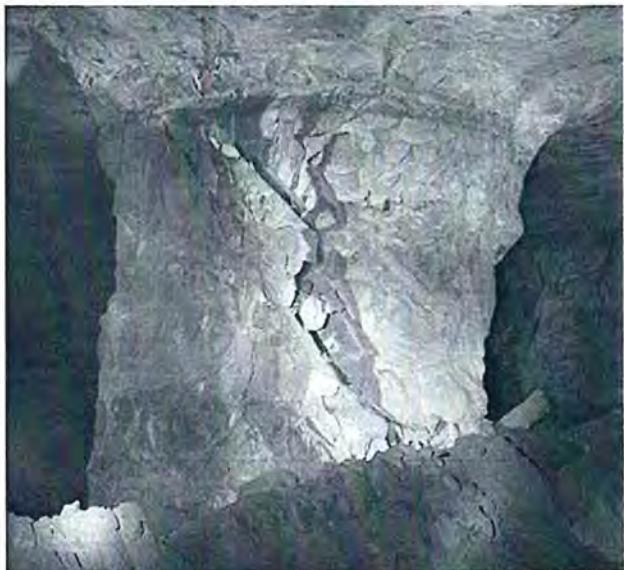
Figure 4. Partially benched pillar that failed along two angular discontinuities. Width-to-height ratio is 0.58 based on full benching height. The average pillar stress was about 4% of the UCS.

- 3) Shearing along large angular discontinuities (dip 30 to 70°) resulting in loss of pillar integrity, shown in figure 4.

Pillars that were associated with angular discontinuities were observed to have failed when the average pillar stress was only about 4-5% of the UCS. The potential weakening effect of a large angular discontinuity is clearly demonstrated in figure 4. These discontinuities are not always readily visible to production staff when developing a pillar, but only become apparent when the pillar becomes fully loaded or when bench mining is carried out around the pillars. Particularly hazardous conditions can result if large angular discontinuities cause unstable blocks to slide or topple from the pillar ribs. Of the eighteen failed pillars

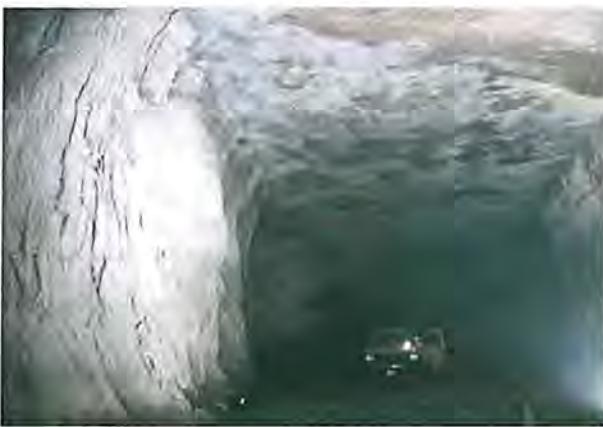
Figure 5. Example of rib slabbing and resulting concave pillar ribs that can initiate when average pillar stress exceeds about 11% of the UCS.

The provision of stable pillar ribs is necessary for safe mining operations. Rib instability can be caused by unfavorable jointing in the rock mass, by rock fracturing under elevated stresses caused by undersized pillars or by poor blasting practice. Figure 5 shows an example of stress-related rib spalling at approximately 900 ft of cover. It was found in some cases that stress-related rib spalling can occur when the average pillar stress exceeds about 11-12% of the UCS. Rib supports, such as screen and bolts, are sometimes used to secure the pillar ribs.

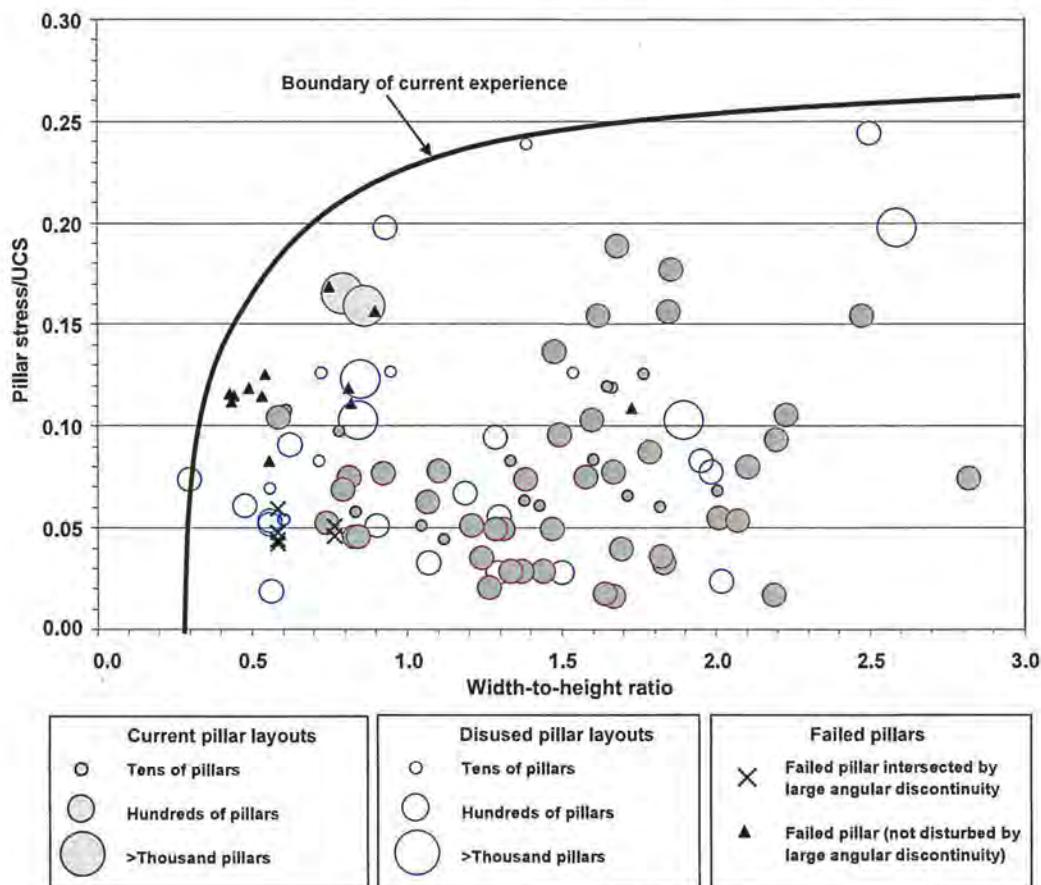
Figure 6. Summary of observed pillar layouts and single failed pillars.

The pillar layouts that were surveyed by NIOSH are presented in figure 6 which shows the pillar stress against the width-to-height ratio. The pillar stress is normalized by the average UCS of each formation, obtained from table 3. The chart also includes

data points representing the 18 failed pillars, while failures associated with the presence of large angular discontinuities are indicated separately. Information on the approximate number of pillars in each pillar layout and layouts that are no longer in use are indicated. Layouts that are disused may have been abandoned because of stability concerns, depletion of reserves or changes in operating procedures. A bounding curve was drawn around the case histories, which represents the limit of current experience with stone pillar performance.

For the purpose of preparing this chart, the width-to-height ratio of the pillars was based on the minimum pillar width. Where pillars were partially benched, the full height of benching was used to represent the pillar height. Actual underground measurements of room and pillar dimensions were used.

All the pillar layouts shown in the chart can be considered to have been "successful" in the objective of providing global support. The results show that these "successful" pillar layouts contain many thousands of stable pillars while the single failed pillars represent only a very small part of the total population of pillars. The relatively low strength of the failed pillars that contained angular discontinuities is also clearly indicated. The chart can be used to compare a current or proposed pillar layout with past experience (32).

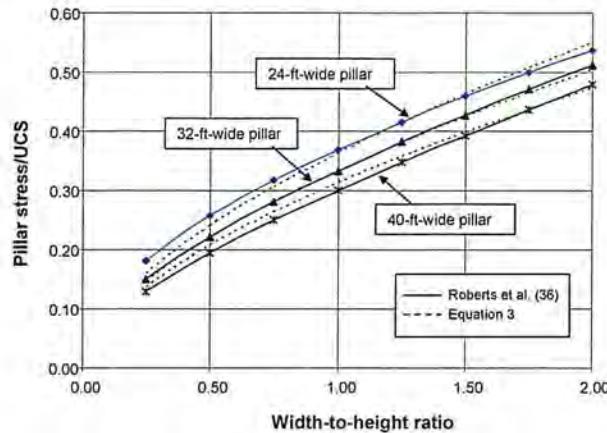
Figure 7. Comparison of predicted pillar strength using the method of Roberts et al. (36) and equation 4.

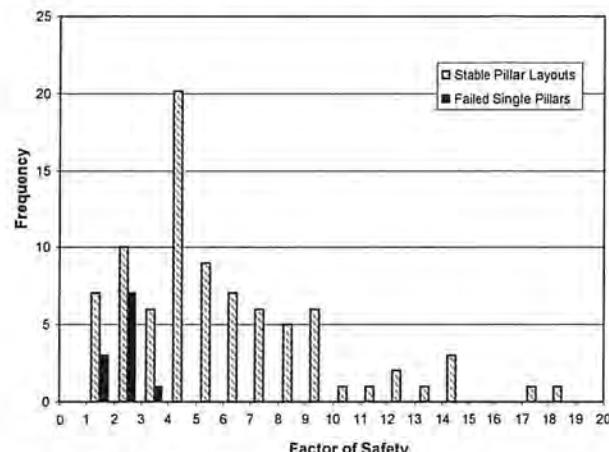
Figure 8. Distribution of factors of safety of successful pillar systems and single failed pillars using equation 4.

Failed pillars that were intersected by large angular discontinuities were excluded from the chart.

The results are presented in figure 8 which shows the distribution of the FOS for the stable pillar layouts and the individual failed pillars. It can be seen that the FOS values of the successful pillar layouts are all greater than 1.0, as expected, with the largest concentration of FOS values falling in the range of 4.0 to 5.0. The minimum FOS of the successful cases was 1.5, which is considered to be reasonable, since no instances were observed in which large numbers of pillars showed signs of distress and overloading, as one might expect in cases where the average FOS approaches 1.0.

The failed pillars can be seen to fall in the FOS range of 1.0 to 4.0 with an average FOS of 2.35. The relatively high value of FOS is not unexpected, since the calculation used best estimates of rock strength and loading, which did not necessarily include local strength variations or geological structures that may have caused the individual pillars to fail at these apparently high FOS values.

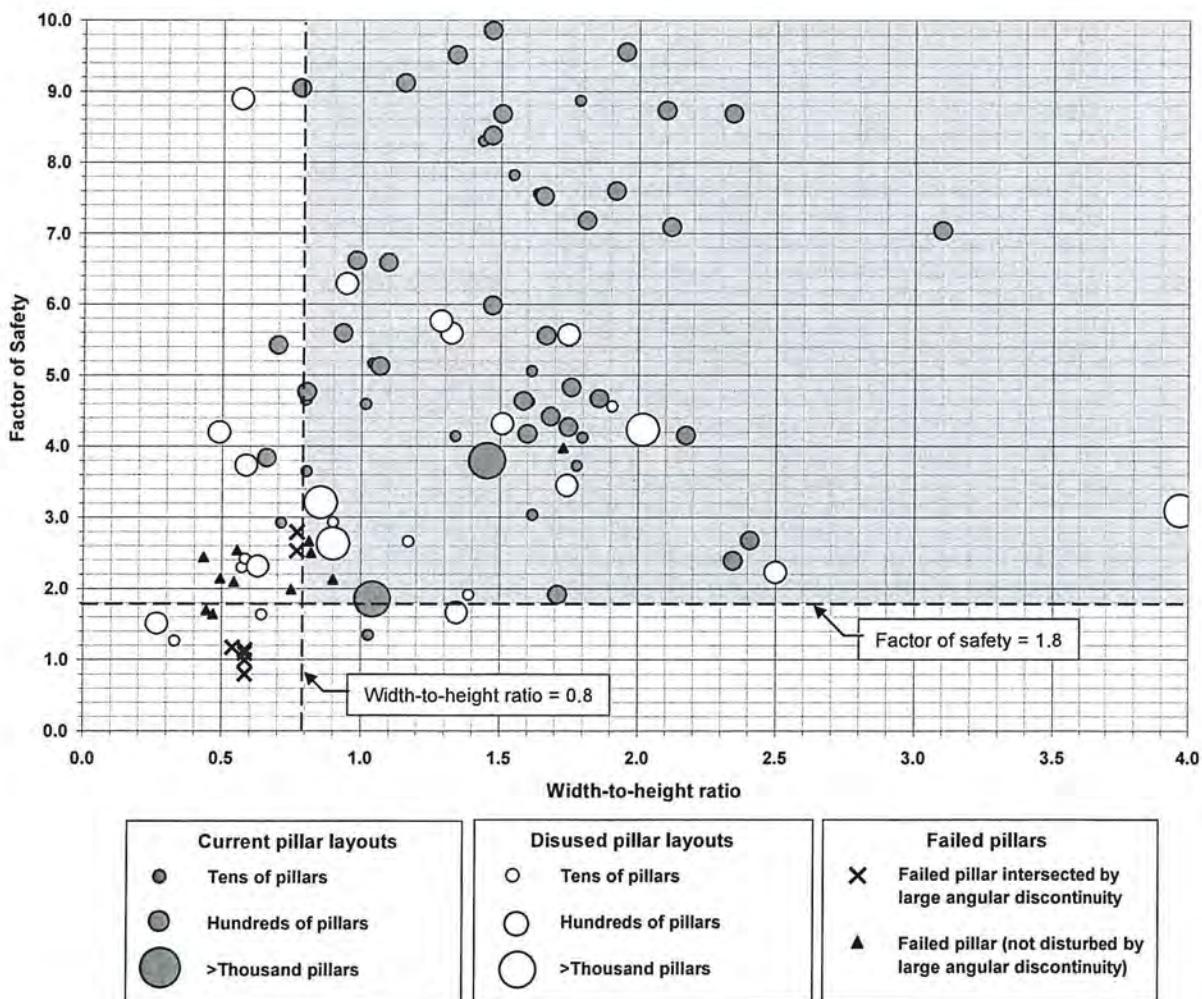
Figure 9. Chart showing the factor of safety against width-to-height ratio using equation 8. Current and disused pillar layouts are shown as well as single failed pillars. The recommended area for pillar design is shaded.

currently operating and disused layouts, failed pillars and the approximate number of pillars in the various layouts. Scaling for the FOS axis was limited to 10.0, causing thirteen cases with FOS values greater than 10.0 not to be displayed. It can be seen that only one of the current pillar layouts has an FOS of between 1.0 and 1.8. This point represents a local area in a mine where rib instability occurred as a result of large discontinuities.

The results shown in figure 9 formed the basis for developing the design guidelines that follow. The guidelines are empirically based, their validity is therefore restricted to rock conditions, mining dimensions and pillar stresses that are similar to those included in this study. Therefore, they should be applicable to the majority of stone mines in the Midwestern and Eastern United States. The guidelines for designing stable pillar layouts are as follows:

- 5) The recommended factor of safety against pillar failure is 1.8 and can be seen in figure 9 to represent the lower bound of current experience. Since the effect of large discontinuities is accounted for in the pillar strength equation, this safety factor is equally valid for pillars that are intersected by large discontinuities.

- 7) Inspection of figure 9 reveals that a number of stable layouts exist that have large safety factors (>3.0) and width-to-height ratios that are less than 0.8. These layouts are mostly at very shallow depths of cover, typically less than 200 ft, and it has been possible to mine with very slender pillars. These pillars were found to be either very narrow, as little as 15 ft, or very tall, up to 125 ft. The strength and loading of narrow pillars are both sensitive to small variations in the overbreak, blast damage and pillar spacing. Large tall pillars, on the other hand, have high ribs which can represent a safety hazard and the roof becomes inaccessible and poorly visible with increased severity of potential rock fall impacts. The strength of these slender pillars is also more adversely impacted by the presence of unfavorable discontinuities than wider pillars. It is therefore not advisable to design layouts with such slender pillars, even with high calculated factors of safety.

The shaded zone in figure 9 indicates the area in which equation 8 is likely to produce stable pillar layouts and coincides with the current experience in stone mines and observations of failed pillars. Since the design recommendations are based entirely on the observed performance of stone pillars, pillars that plot outside the shaded area in figure 9 are beyond the validity of these design guidelines.
