Detecting Strata Fracturing and Roof Failures from a Borehole Based Microseismic System

27th International Conference on Ground Control in Mining

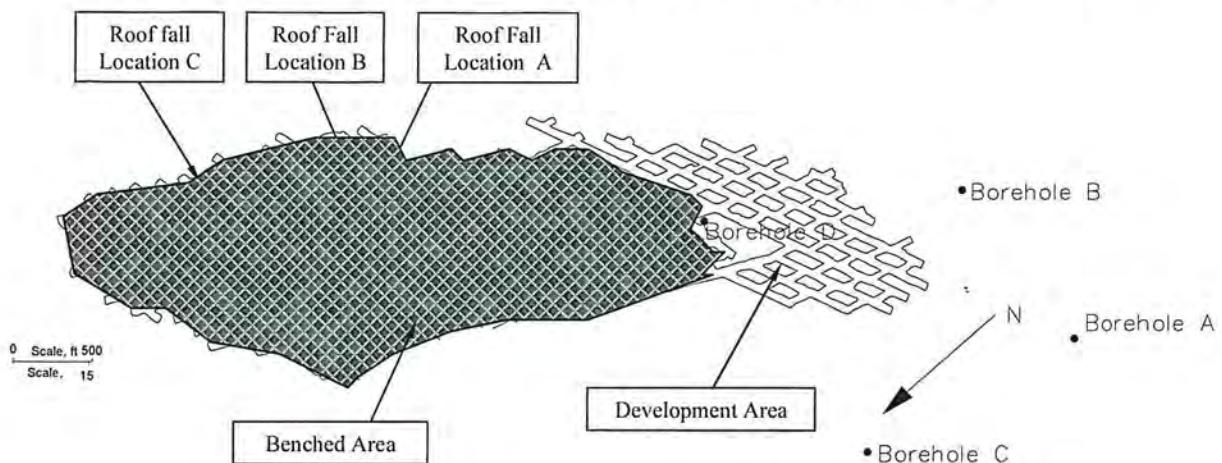
Figure 1. Roof fall areas and borehole locations on a mine map.

The mine management adopted a novel stress control mine design to alleviate the effects of high horizontal stress and improve ground stability. Pillars are rectangular having their long axis oriented parallel to the maximum horizontal stress direction. Pillar size is approximately 46 x 20 m (150 x 65 ft). The percentage of extraction is roughly 60% with 40% left in pillars to support the superincumbent strata. Crosscuts are staggered to develop three-way intersections. During development, rooms are driven to 15.2 m (50 ft) wide by 7 m (23 ft) high using 4.4-m (14-ft) deep wedge pattern blast holes. Subsequently, an additional 11.3 m (37 ft) of rock is extracted by floor-benching. The overburden thickness ranges from outcrop to approximately 274.3 m (900 ft). Figure 1 shows the benched and development areas in relation to boreholes A, B, C, and D where seismic sensors are installed.

Each borehole data acquisition station is powered by six, 12-volt, rechargeable batteries. A twin-unit solar panel recharges the battery pack. The solar panel is mounted on the roof of the instrument housing (figure 2). Each borehole station has 2 GB internal storage capacity and is a web-enabled microseismic recorder/server with a sampling rate from 50 Hz to 10 kHz. The sampling rate during this study was 4 kHz. The essential system components of a borehole site are shown in figure 5. Each borehole data acquisition and processor station communicates with two attached triaxial geophones and the GPS receiver-timing unit. Each timing unit receives a time signal from the GPS and transfers the data to the system so that all four borehole stations are synchronized and record seismic signals on a common time base. Eight triaxial geophones, each capable of measuring seismic wave in three perpendicular directions, are installed in four boreholes (figure 1).

knocked down. These two observations indicated that an air-blast had been produced due to a roof fall. Upon further examination, it was observed that an entire intersection of roof at location A (figure 1) had fallen. The intersection area from the bottom of the benched floor to the top of the roof-line was filled with fallen roof debris. It is estimated that the roof cavity extended about 18 m (60 ft) or more above the normal roof-line. An estimated 31,000 tons of roof rock had fallen in this intersection.

It was further noticed that another intersection, location B (figure 1), had also collapsed and the debris completely filled the entire height from the bottom of the benched floor to the visible roof-line. The condition of this intersection was similar to the intersection at location A. The pillars around these two fall areas were intact and did not show any signs of degradation due to the impact of falling roof debris or stress redistribution pursuant to the roof falls. These 4-way intersections were drifted in November 2001 and benched in June 2006. About 12-ft of immediate roof layer further to the northeast of these falls, location C, had also collapsed (figure 1). This fall was about 29 m (95 ft) long and covered the entire width of the entry. Roof fall areas in locations A, B, and C were abandoned and bermed off in July 2006.

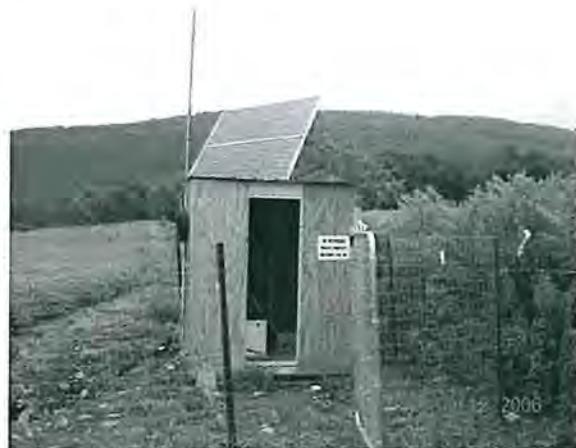
Figure 2. Microseismic data acquisition station at a borehole site.

local data acquisition station (figure 2) is set up with its processor unit, power supply, radio communication, GPS timing, and geophones. Two geophones and associated data transfer cables were carefully handled and placed in the borehole (figure 3). The cable ends were then connected to the local data acquisition station.

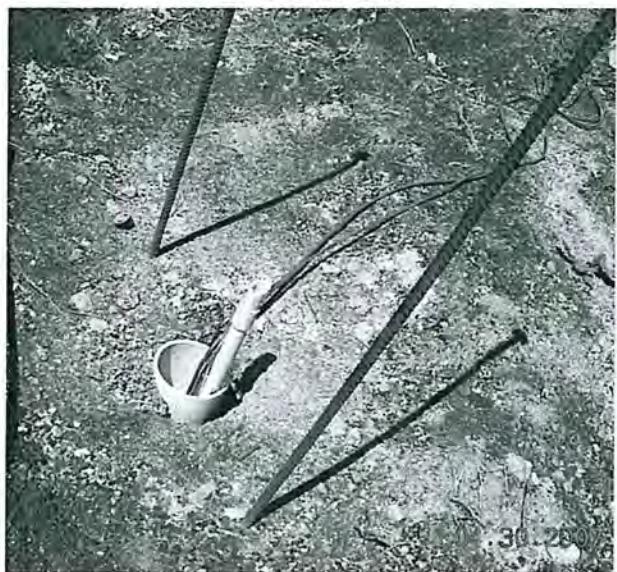
Figure 3. Cables leading from the geophones to the data acquisition processor.

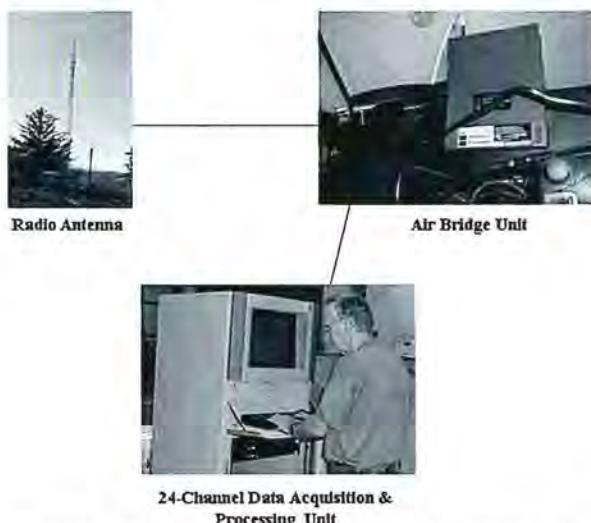
Figure 4. Essential system components at the central site.

The computer at the central site is running a network data acquisition system for real time data acquisition and processing by interfacing with the four borehole stations using TCP/IP communications. The essential system components at the central site are shown in figure 4. The central site controls each borehole site and continuously monitors all 24-channels of the seismic array. Event triggering is controlled by setting limits for individual channels.

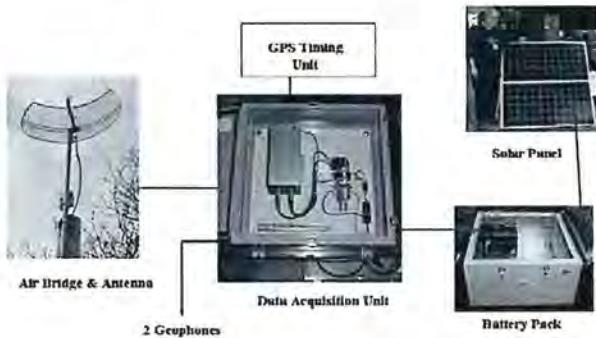
Figure 5. Essential system components at a borehole site.

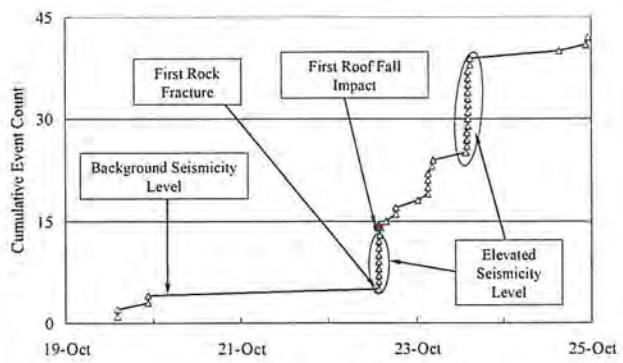
Figure 6. Cumulative plot of rock fracture events.

The background seismicity rate prior to the October 22 roof fall was about two events per day. Figure 6 shows a plot of thirty five rock fracture events recorded during this roof fall episode. The first rock fracture event was recorded at 1:37 PM on October 22 and within a period of 17 minutes another eight rock fracture events were recorded. Thereafter, the event rate slowed down. It resurged at 1:33 PM on October 23 and fifteen events were recorded within a period of about 1 hour and 11 minutes. Later, the microseismicity rate returned to the background level.

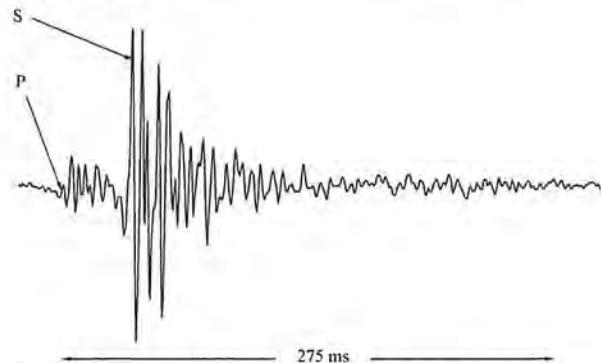
Figure 7. Seismic signature of a rock fracture event showing p-and s-wave arrivals.

Roof fall impact signatures are different from rock fracture signatures. Generally, rock fracture signatures display sharp p- and s-arrivals and the wave amplitude generally decays rapidly within a fraction of a second. The rock fracture event shown in figure 7 lasted for about 275 ms and the maximum particle velocity recorded was 0.05 mm/s. A spectral analysis of the rock fracture waveform using the ESG software yielded a corner frequency of 75 Hz. The amplitude diminished rapidly for all frequencies over 75 Hz. Roof fall impact signatures are long emergent waves of generally more than a second in duration. The roof fall impact event shown in figure 8 essentially represents a s-

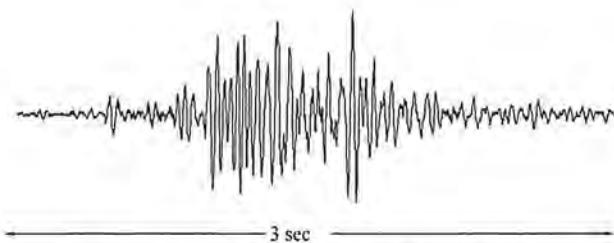
Figure 8. Seismic signature of an impact event.

wave signature. It is characterized by a duration of about 3 sec, maximum particle velocity of 0.2 mm/s, and a corner frequency of 22 Hz. Exact location and source parameters of impact events are difficult to calculate due to the emergent nature of the wave. The first roof fall impact signature was observed at 1:54 PM on October 22. Two more roof fall impacts quickly followed the first impact. Another three roof fall impacts were observed much later on October 22. Currently, plans are being finalized to install additional sensors to extend seismic coverage area and enhance array sensitivity.
