Assessment of stable and failed pillars in underground limestone mines

G.S. ESTERHUIZEN, D.R. DOLINAR AND
J.L. ELLENBERGER

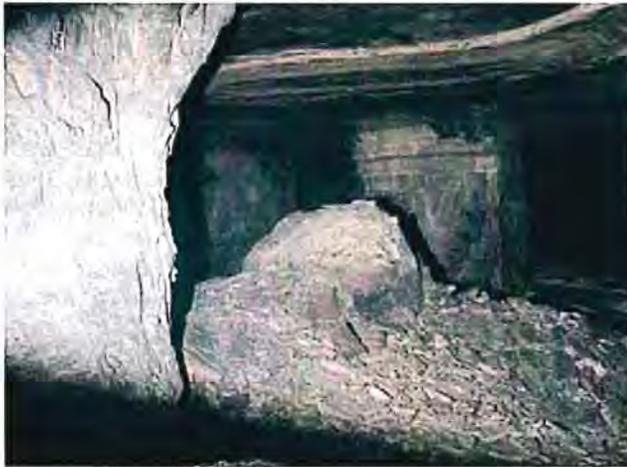
FIGURE 1

Remaining stump of a collapsed pillar in an abandoned area. Thin weak beds in the pillar and moist conditions are thought to have contributed to the failure. The width-to-height ratio was 0.82, and the average pillar stress was about 11 percent of the UCS.

The key parameters describing the unstable pillars are summarized in Table 3, and examples of the failed pillars are shown in Figs. 1 through 4. It can be seen that stress related rib slabbing and spalling is a feature in three of the four failed pillars shown. In addition, the weakening effects of angular discontinuities or thin weak bands within the pillars are clearly demonstrated.

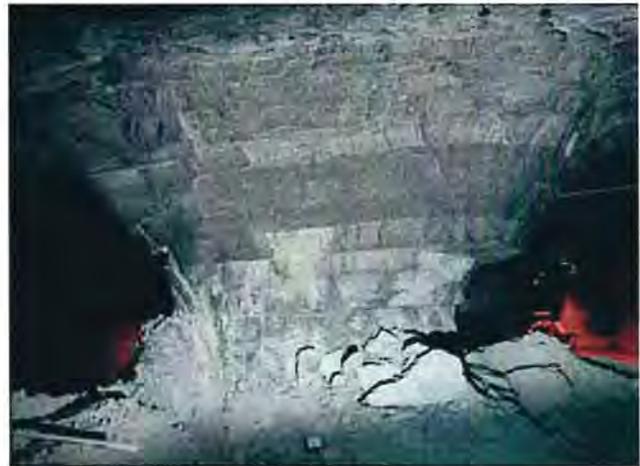
FIGURE 2

Pillar that has an original width-to-height ratio of 1.7 failed by progressive spalling. Thin weak beds are thought to have contributed to the failure. The average pillar stress was about 11 percent of the UCS prior to failure.

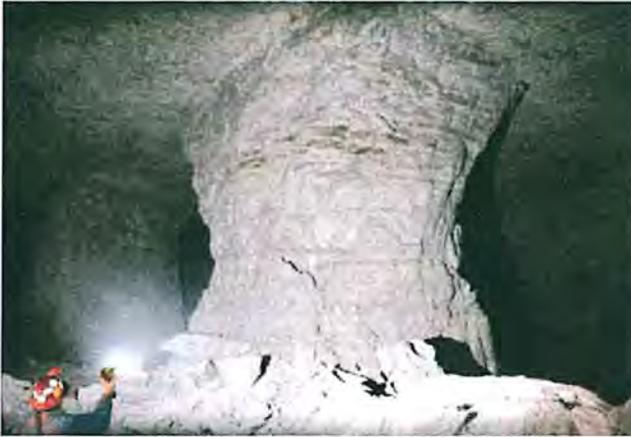
FIGURE 3

Partially benched pillar failing under elevated stresses at the edge of bench mining. Typical hourglass formation indicating overloaded pillar. Width-to-height ratio was 0.44 based on full benching height and average pillar stress was about 12 percent of the UCS.

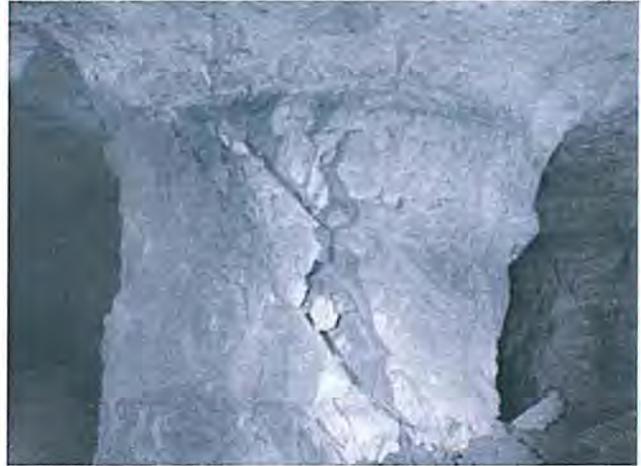
FIGURE 4

Partially benched pillar that failed along two angular discontinuities. Width-to-height ratio is 0.58 based on full benching height and average pillar stress is about 4 percent of the UCS.

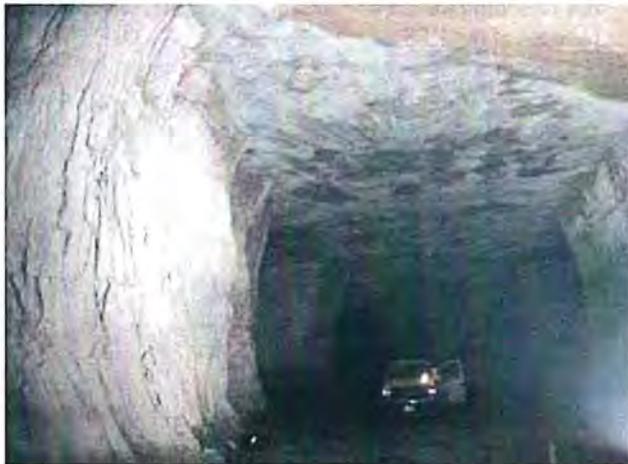
FIGURE 5

The criterion for local stability was assessed by considering all cases where rib spalling or slabbing was observed. Figure 5 shows an example of rib spalling at approximately 900 ft of cover. It was found that rib spalling can initiate when the average pillar stress exceeds about 11 percent to 12 percent of the UCS. In some cases, it becomes necessary to install rib support, such as screen and bolts, to secure the rib walls. However, not all of the pillars that exceeded the 11 percent to 12 percent stress ratio showed signs of rib spalling. Therefore, 11 percent to 12 percent stress level should be interpreted as the lower limit for the onset of rib spalling. An assessment of the results further showed that instability caused by jointing or geological structures was not directly related to the pillar stress but was simply a function of the presence or absence of unfavorable geology.

Example of rib slabbing when the average pillar stress exceeds about 11 percent of the UCS.

- The onset of spalling: As discussed earlier, spalling and slabbing of pillar ribs was observed to start when the average pillar stress was around 11 percent to 12 percent of the UCS. Spalling represents an additional rock-fall hazard that must be addressed when mining. Limited spalling can typically be addressed by repeated scaling of pillar ribs. In cases of severe spalling or slabbing of a pillar ribs, it has been necessary to support the ribs with screen and rock bolts where long-term access is required.

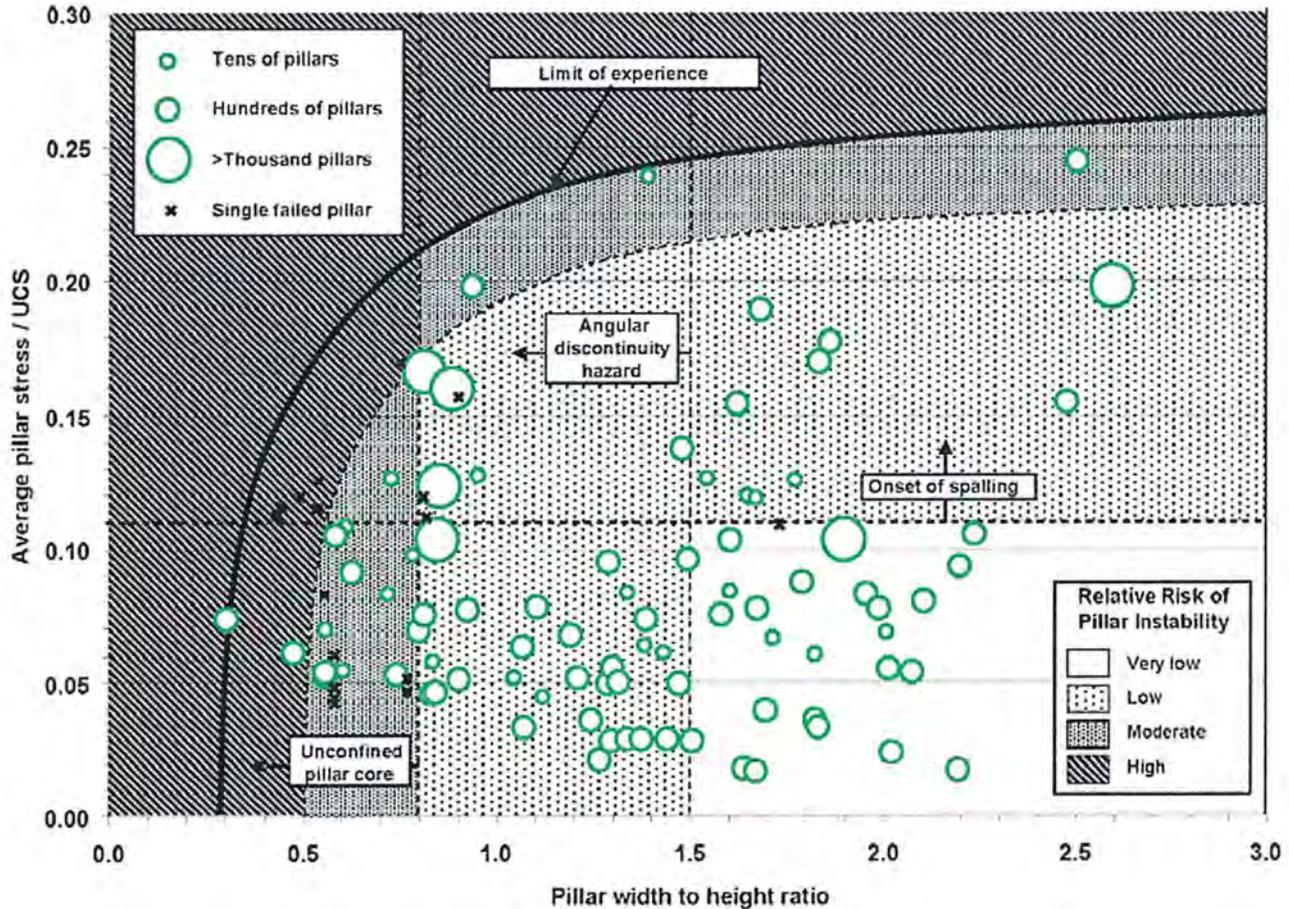
FIGURE 6

All data collected on pillar performance were collated in a spreadsheet, and a pillar stability chart was developed in which the pillar stress, normalized by the UCS, was plotted against the width-to-height ratio of the pillars, as shown in Fig. 6. The pillar dimensions used in this chart are the minimum pillar width and maximum pillar height. This means that the smaller width of a rectangular pillar and the maximum height of partially benched pillars were used in creating the chart. Where possible, dimensions are based on actual underground measure-

ments. However, in the case of the failed pillars, it was not always possible to measure the original pillar dimensions and these were obtained from mine maps showing the original dimensions. The chart shows both stable pillar layouts and the individual failed pillars. The diameter of each stable layout data point is related to the number of pillars in the layout, and varies from tens of pillars to more than 1,000 pillars in some of the cases. The failed pillar data points, on the other hand, each represent only a single pillar.

A number of lines have been added to the chart to highlight potential failure mechanisms, while the background shading indicates the relative risk of pillar instability. Each of these lines and shaded zones are discussed below:

The shaded zones in Fig. 6 indicate the relative risk of instability based on a qualitative assessment of the likelihood and consequences of pillar instability. Darker shading indicates a relatively higher risk. The following four risk zones are indicated:

Limestone pillar stability chart showing stable pillar layouts and single failed pillars. Potential failure mechanisms and relative risk of pillar instability are indicated.

UCS. This point plots within the “Low Risk” zone in Fig. 6. The pillars should be free of stress related rib spalling during initial mining but unfavorable angular discontinuities can compromise their strength. A geotechnical investigation might be warranted to confirm or refute the presence of such structures. The chart further shows that after bench mining to a height of 56 ft, the pillars will plot within the “Moderate Risk” zone because the pillar cores will become unconfined in addition to being vulnerable to large angular discontinuities. It might be prudent to reduce the bench height to 20 ft for example, which will increase the benched pillar width-to-height ratio to 0.83. This will reduce the potential for instability of the benched pillars.

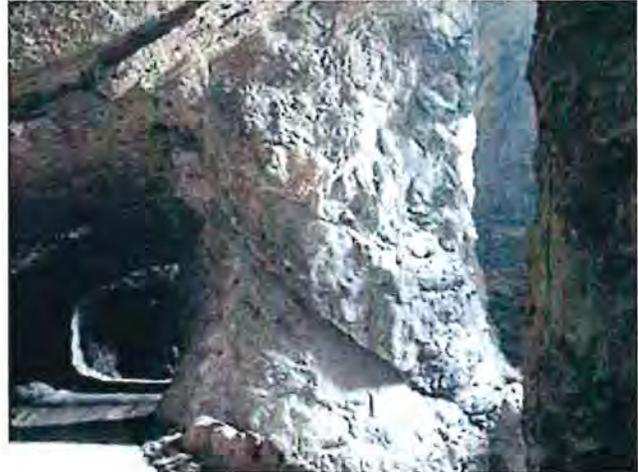
FIGURE 7

- Angular discontinuity hazard: Angular discontinuities that are exposed on both sides of a pillar can cause a significant reduction in the strength of a pillar. Figure 7 shows a pillar that was severely compromised by an angular discontinuity. It was necessary to install long rock bolts right through the pillar to prevent it from failing. During the survey of pillar conditions, large angular discontinuities were observed in several mines, but did not appear to be widespread within the limestone formations currently being mined. When the width-to-height ratio of a pillar is less than 1.5, a discontinuity with a dip of 30° can be exposed on both sides of the pillar.

Example of a pillar that is bisected by a large angular discontinuity.

When designing pillars in this zone, the potential for encountering unfavorable angular discontinuities should be considered.
