Volume 25 Number 6 November/December 2008

A Case Study Examination of Two Blast Rounds at a Nevada Gold Mine

By Ed McHugh, Joel Warneke, and Cristian Caceres.

NIOSH researchers collected basic data from two blast rounds at the SSX-Steer Mine in Nevada as a component of a larger study on controlled blasting, the goal of which is to reduce injuries from falling rocks in underground mines.

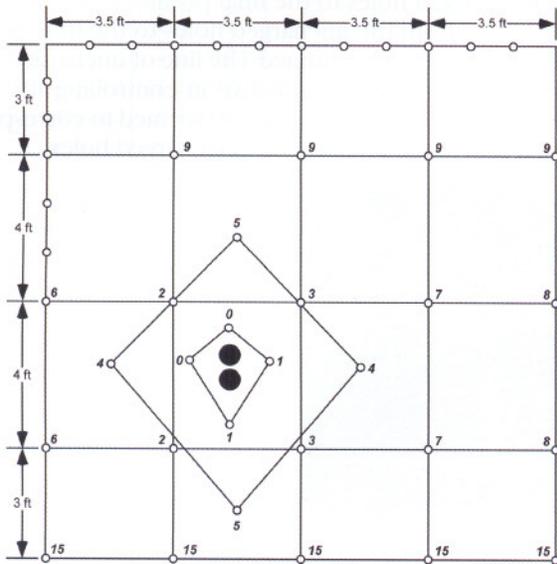
Figure 6. XC11 blast pattern diagram, November 7, 2006.

were 2.2 cm (1-7/8 in) in diameter and the relief holes were 7.6 cm (3 in) in diameter. All holes were drilled to a depth of 3.7 m (12 ft). Perimeter holes were drilled along the back and upper left rib on nominal 0.3 m (1 ft) centers in an attempt to limit the extent of breakage. These were not charged with explosives. Except for the lifters, all blast holes were charged with ANFO. The lifter holes were charged with sticks of Unigel.

The XC11 entry was the end ore panel on the 7170 level. Panel number 10 containing cemented fill was located along the left side while the right side was formed by rock that will not be mined (see **Figure 2**). The design for the November 7 blast is shown in **Figure 6**. The blast holes

Order	Delay no.	Delay, ms	No. of holes
1	0	0	2
2	1	500	2
3	2	800	2
4	3	1,100	2
5	4	1,400	2
6	5	1,700	2
7	6	2,000	2
8	7	2,300	2
9	8	2,700	2
10	9	3,100	4
11	15	5,900	5
			27

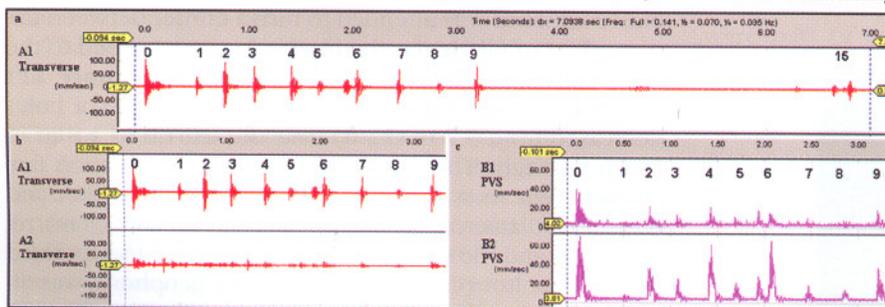
Figure 7. Seismic waveforms from XC 11. a- particle velocity vs time for the duration of the blast (detonator delays 0-15), Monitor A1, Transverse channel; b- particle velocity vs time (detonator delays 0-9) showing higher particle velocities in the A1 Transverse channel compared to A2 Transverse channel; c- particle velocity sum (three channels) vs time (detonator delays 0-9) showing relatively higher velocities in rock (B2) compared to fill (B1).

The Minimate monitors were triggered by the blast at 17:27 and began sampling. The seismic waveforms from monitor A showed peaks for each delay in the blast pattern over a duration of about 7 seconds (Figure 7). As expected, the peak velocities recorded at geophone A1 located 9.8 m (32 ft) from the blast face, were significantly higher than those recorded at geophone A2, which was 16.2 m (53 ft) from the face. The seismic waveforms recorded by monitor B revealed velocities that were clearly attenuated by the presence of the fill. For geophone B1, located 14.0 m (46 ft) from the blast face, the peaks for several blast delay intervals were much-reduced or essentially missing when compared to the signals from geophone B2 (19.5 m or 64 ft from the face) attached to rock.

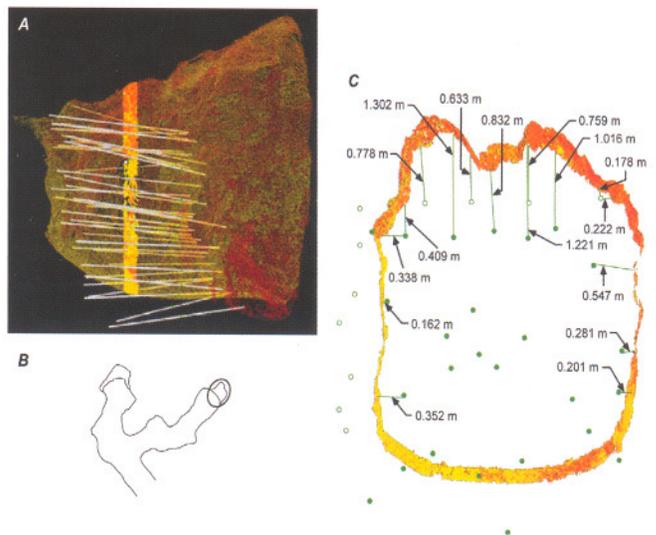
Figure 10. A. Vertical longitudinal section through XC11 from before and after laser scans; showing projected drill pattern and position of the mid-round cross-section. B. Outline of the workings showing location of sections. C. Vertical slice at mid-round showing drill hole intercepts with distances to the ribs and back, solid points were loaded holes and open points were unloaded perimeter holes.

Figure 10a is a vertical, longitudinal section taken

through the post-blast scan. There is considerable breakage above the roof holes near the blasted face. The cross-section areas as determined using slices taken parallel to the face on one foot intervals are indicated in Table 2. At the 1.5-m (5-ft) distance, the area is about what was desired. Figure 10c is vertical section taken at mid-round. The projected positions of the holes are shown with distances from the charged holes to the final profile. Along the back, the distances from the uncharged holes to the final perimeter have also been determined. The line of uncharged roof holes was apparently not effective in controlling the profile. For both walls, the final position seemed to correspond quite closely to the positions of the charged holes.

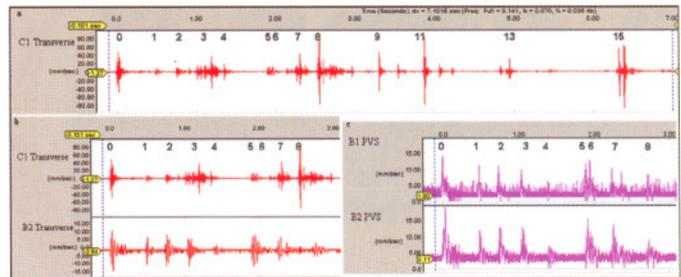
Figure 12. Seismic waveforms from XC 7. a- particle velocity vs time for the duration of the blast (detonator delays 0-15), Monitor C1, Transverse channel; b- particle velocity vs time (detonator delays 0-9) showing higher particle velocities in the C1 Transverse channel compared to B2 Transverse channel; c- particle velocity sum (three channels) vs time (detonator delays 0-9) showing relatively higher velocities in rock (B2) compared to fill (B1).

The blast triggered seismic sampling at 17:21. The seismic waveforms from monitor C showed peaks for each delay in the blast pattern over a period of about 7 seconds (Figure 12). Peak particle velocities at geophone C1, 6.7 m (22 ft) from the blast face, were sharply defined and well dispersed throughout the blast sequence. Waveforms from monitor B demonstrated velocities that were again attenuated in the fill (B1) but somewhat better defined in the rock panel (B2). For the monitor nearest to the blast face (C), both PPV and PVS approached or exceeded 100 mm/s (3.9 in/s) as shown in table 3. Monitor B (located on the opposite side of the rock panel) recorded particle velocities that barely reached the 10 mm/s (0.39 in/s) trigger threshold.

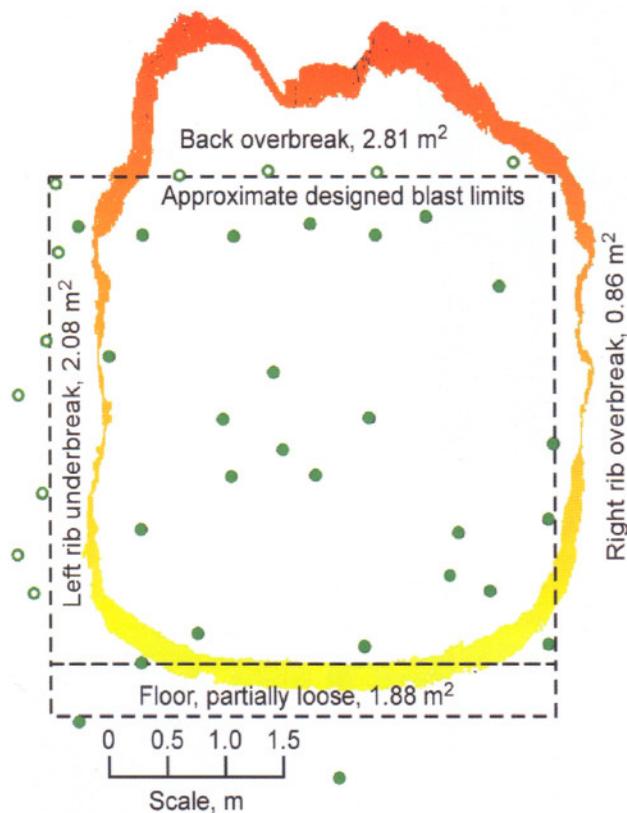
Figure 14. Cross section of the XC11 round at midpoint, showing over-break and under-break in relation to drill holes.

approximately as designed, the laser section at that point shows that over-break in the back accounted for 15.4% of the designed area. Over-break ranged from about 18 to 78 cm (7 to 31 in) in the back and averaged 59 cm (23 in) for a total of 2.8 m² (30.2 ft²). Less significant over-break along the right rib, based on perimeter hole locations, amounted to about 0.9 m² (9.3 ft²), with a range of 20 to 28 cm (8 to 11 in), and an average of 24 cm (9 in) or 4.7% of the designed area. At the same time, under-break occurred along the left rib as shown by the retained, unloaded perimeter holes. The under-break amounted to about 2.1 m² (22.4 ft²), with a range of 32 to 55 cm (13 to 22 in), and an average of 46 cm (18 in) or 11.4% of design. The remaining apparent under-break, about 10%, was in mostly broken material on the floor of the mucked opening.

Figure 14 is a cross-section of the round generated by slicing a 0.30-m (1-ft) section of the laser scan. The drill hole locations projected to mid-round from the hole collars at the drilled face were used to align the designed blast round with the resulting excavation. Deviations from ideal positions for these locations reflect both the actual drilled deviations and errors in projecting the drill holes from the scan aids used to collect hole orientation.
