REDUCING THE FIRE AND EXPLOSION HAZARDS OF FLAME CUTTING AND WELDING IN UNDERGROUND COAL MINES

W. D. Monaghan, NIOSH, Pittsburgh, PA

ABSTRACT

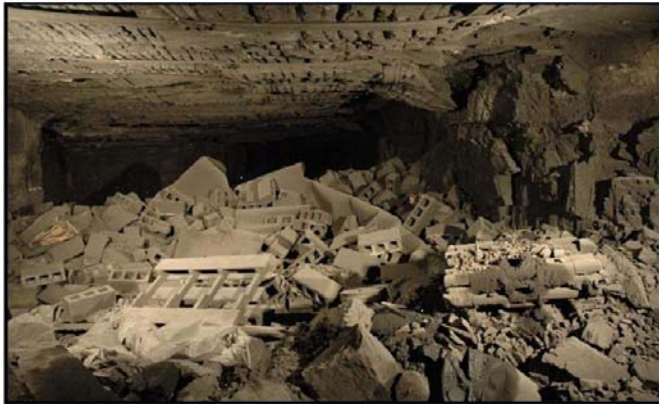
Figure 2. Debris from stopping near explosion (MSHA 2006).

On May 20, 2006 an explosion occurred in a sealed section of the Darby Mine No. 1, resulting in fatal injuries to five miners and injuries to one miner. A methane explosion occurred behind a block seal. MSHA determined that the explosion was caused by sparks that were generated by flame cutting of a metal roof strap that passed above the seal [4]. Figure 1 shows the type of metal roof strap that was flame cut by an oxygen and acetylene torch during the time of the explosion. Figure 2 shows the actual debris from a stopping which was destroyed by the explosion. MSHA further determined that the incident occurred because the operator did not observe basic mine safety practices and because critical safety standards were violated. Mine management failed to ensure that proper seal construction procedures were utilized in building seals, failed to ensure that safe work procedures were used while employees attempted to make corrections to an improperly constructed seal, and failed to adequately train the miners [4].

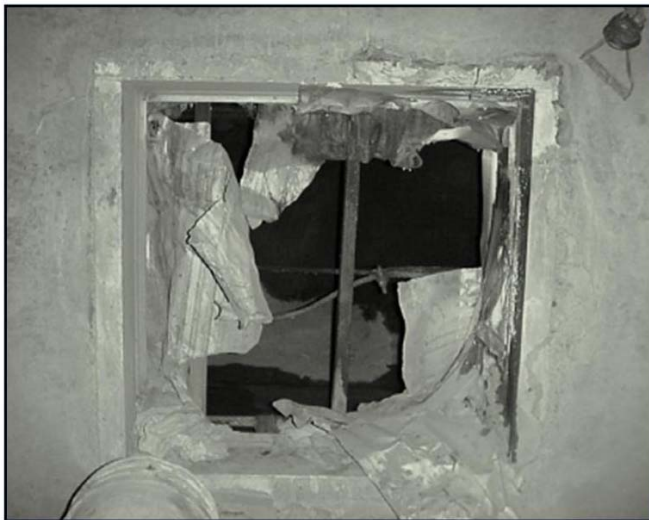
Figure 3. Corrugated, galvanized steel sheeting after explosion (MSHA 2003).

On January 22, 2003, an explosion occurred inside an airshaft under construction for the McElroy Mine in West Virginia. Six miners were inside the shaft at the time of the explosion. The explosion fatally injured three miners and seriously injured the three others. The miners were attempting to remove corrugated galvanized steel sheeting which blocked access to the unventilated water ring being constructed. Figure 3 shows the corrugated, galvanized steel sheeting after the explosion had occurred. After reading 0.2% methane on a hand held detector, the foreman directed the mechanic to cut the panning with an oxygen and acetylene torch. The mechanic ignited the torch and started to flame cut the panning. An explosion occurred when the torch cutting process ignited an explosive methane-air mixture contained inside the water ring. MSHA determined that the incident occurred because the examination for methane was not adequate. An adequate examination would have required testing for methane in all areas that could have been affected by the use of the cutting torch [5].

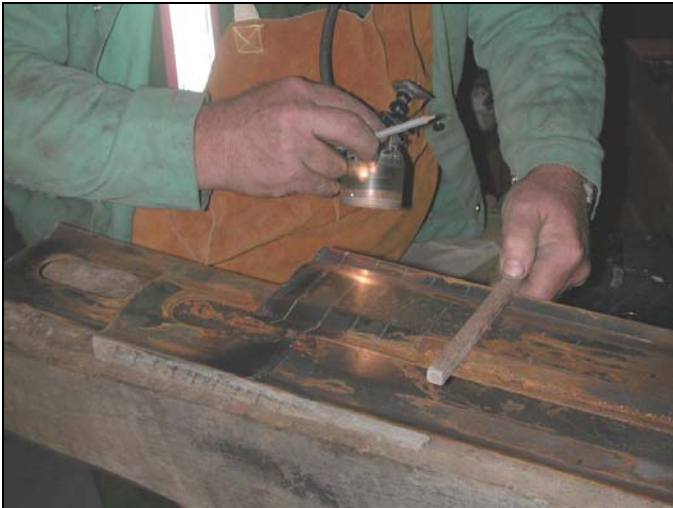
Figure 7. Metal roof strap prior to flame cutting individual strips.

In this experiment, metal strips ranging from 1.27-cm to 3.75-cm were flame cut from the metal roof strap shown in Figure 7. The temperature history of the hot metal strips was obtained by recording the temperature every 250 milliseconds using the IR camera. Figure 8 shows an example of the temperature histories of a 1.27-cm and 3.75-cm metal strip. The 3.75-cm strip's temperature remained above 593 °C for 19 seconds and the 1.27-cm strip's temperature remained about 593 °C for 10.5 seconds. The results from this experiment showed that these hot metal strips were capable of igniting a methane-air mixture.

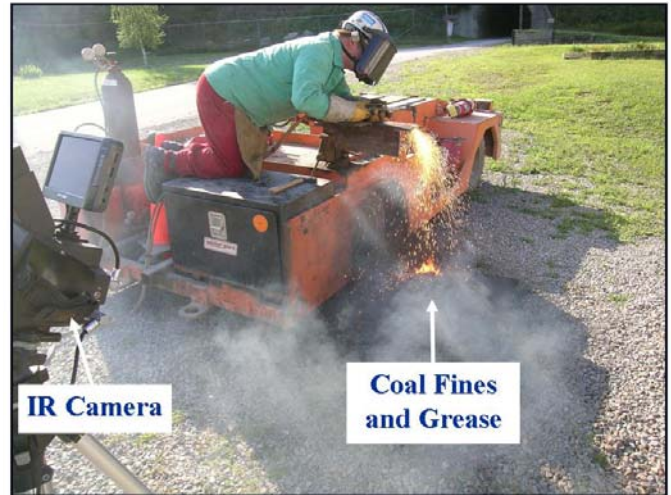
Figure 9. Set-up for hot molten metal experiment.

In this experiment, the effect of hot molten metal on coal dust (minus 200 mesh) and grease was observed. Flame cutting was performed approximately 1 m above the coal fines and grease. The hot molten metal was allowed to fall directly on the coal dust and grease. The temperature of the metal and the coal dust and grease were recorded using the IR camera, shown in Figure 9. The hot molten metal immediately ignited the grease. After several minutes, flames from the grease appeared to be burned out. However, hot spots in the coal dust were observed with a temperature range between 93-145° C.

These hot spots were not visible via the human eye and were only identified by using the IR camera. The IR camera was used to monitor the hot spots for approximately two hours. After two hours, a small fan was placed near these hot spots and airflow of 400 ft/min was passed over the hot spots. This ventilation caused the temperature of the hot spots to increase, resulting in re-ignition of the coal dust and grease. The results from this experiment showed that hot spots can remain for several hours when not properly extinguished and can reignite if

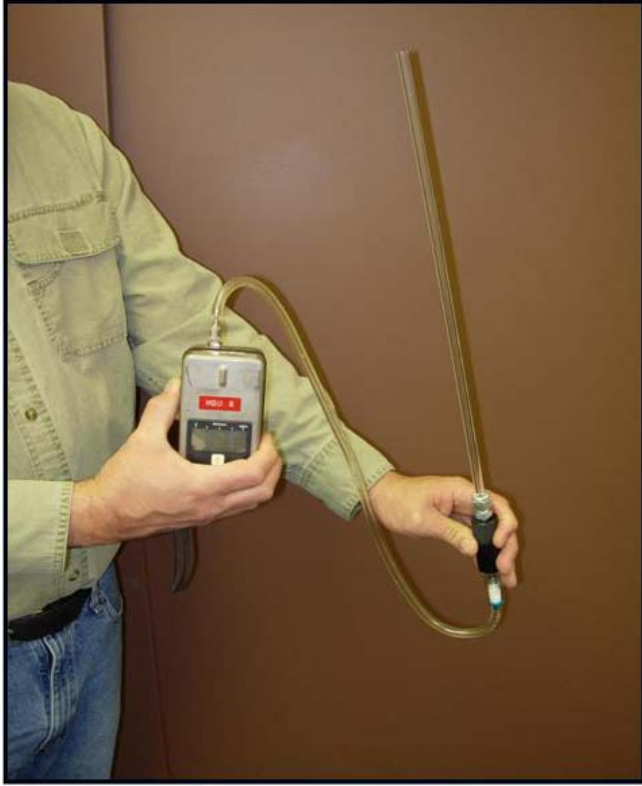
Figure 10. Methane monitor with probe.

1. The proper calibration of methane detection instruments.
 2. The proper use of methane monitors, with and without probes. Figure 10 shows a pump-type methane monitor with a probe.

- Check for methane thoroughly and continuously during the flame cutting and welding operations, and use a methane probe for hard to reach areas. Methane gas is colorless, odorless, tasteless, nontoxic, highly flammable, and is lighter than air so it can accumulate in areas such as roof cavities, get trapped underneath pan lines, and other mining equipment. Ventilation should be adequate to provide dilution of any harmful gases or toxic vapors that may accumulate.

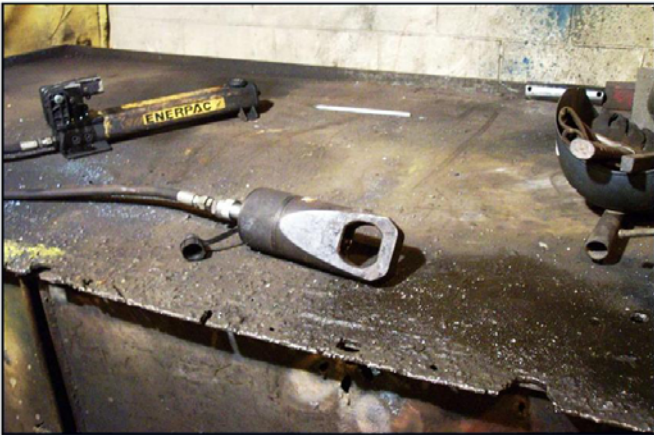
Figure 11. Alternative hydraulic cutter tool for flame cutting.

- Use cold cutting alternatives versus oxygen and acetylene torch for cutting metals, when available. Several mines that were visited are using hydraulic cutters and punches. Figure 11 shows a hydraulic cutter used to cut off rusted bolts and nuts from conveyor structures at an underground coal mine.

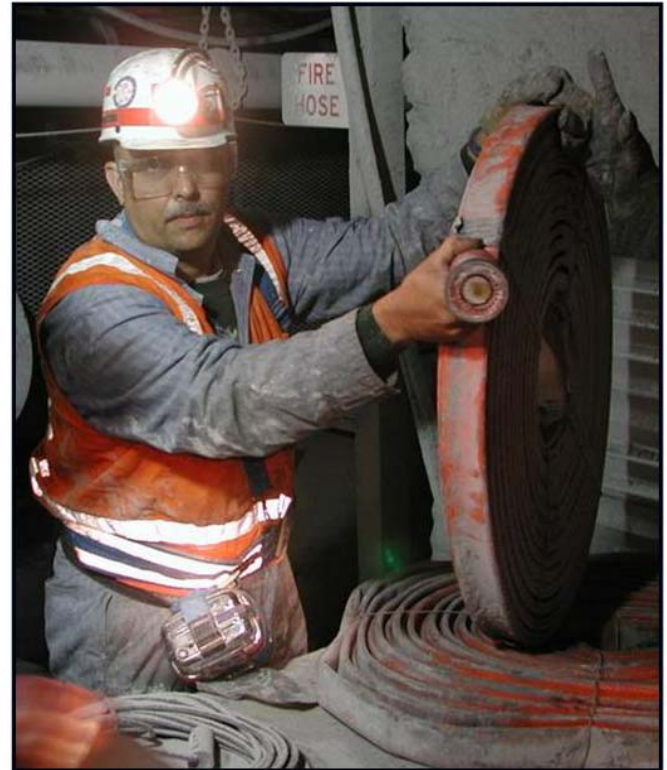
Figure 12. Typical fire hose in an underground coal mine.
