Time Dependent Roof Deterioration at a Central Ohio Coal Mine

Ted Klemetti, Research Engineer
Dave Oyler, Research Engineer
Greg Molinda, Lead Research Scientist
NIOSH Pittsburgh Research Laboratory
Pittsburgh, PA

28th International Conference on Ground Control in Mining

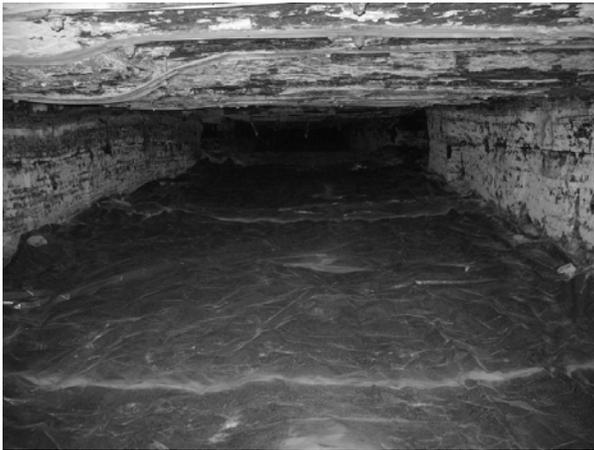
Figure 4. Photo of roof rock collection areas 8-16-07, location 1.

as shown in Figure 4. The tarps covering the floor were used to separate the fallen roof rock from that already on the floor. The roof rock on the tarps was collected in buckets and weighed with a portable scale. The resulting weights were recorded for each area during the visits to the study site.

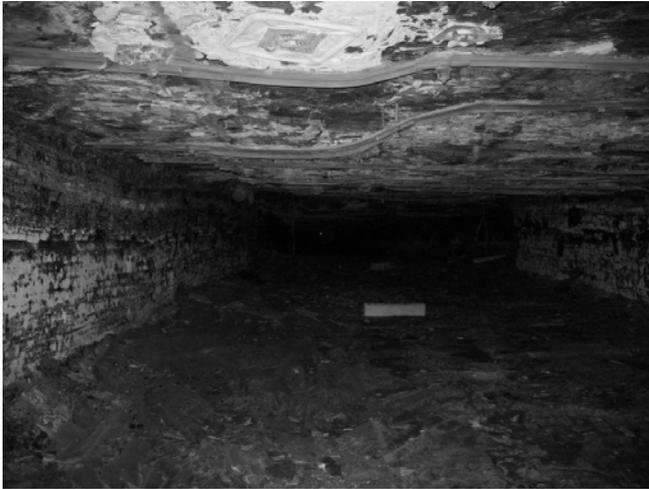
Figure 8. Photo of the rock collection area, looking inby from the intersection, taken on March 3, 2008.

The results demonstrate the improvement expected from sealing roof rocks when compared to the areas that were not coated with the sealant. There does not appear to be any distinct seasonal trends associated with the falling roof rock. The results also indicate that this sealant can be diluted with 50% water and still maintain the same level of protection. Since the spray sealant has no strength, it should be applied as quickly after mining as possible for the greatest effect prior to roof sag. A photo of the roof rock collection area taken on March 3, 2008 prior to rock collection can be seen in Figure 8.

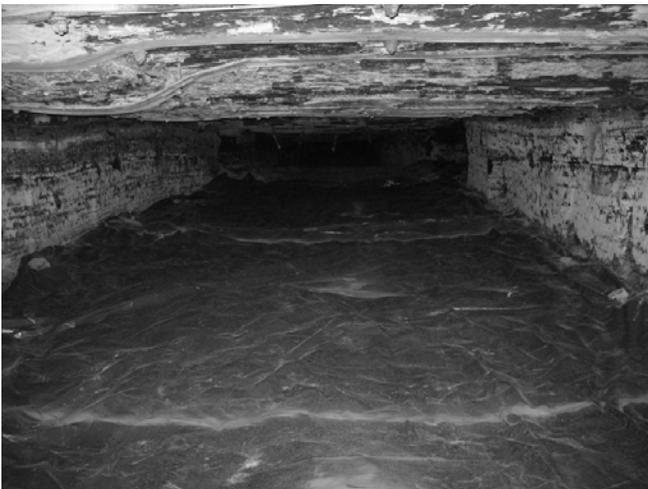
Figure 13. Photo taken 8-16-07 looking inby at study site, location 1.

The final method used in evaluating the deterioration of the roof was visual observation documented with photography. Several photographs were taken during each visit to document the time dependent deterioration of the roof. The locations of these photographs can be seen in Figure 5. The photograph in Figure 13 was taken on August 16, 2007, at onset of study, from the intersection in the study site looking inby, point 5 in figure 5. This photo shows minor roof deterioration and no roof rock on the tarps as would be expected at the beginning of the study. Figure 14 is a photo of the same location taken on June 25, 2008. Figure 14 depicts a much greater level of roof deterioration and roof rock on the tarp than that in Figure 13.

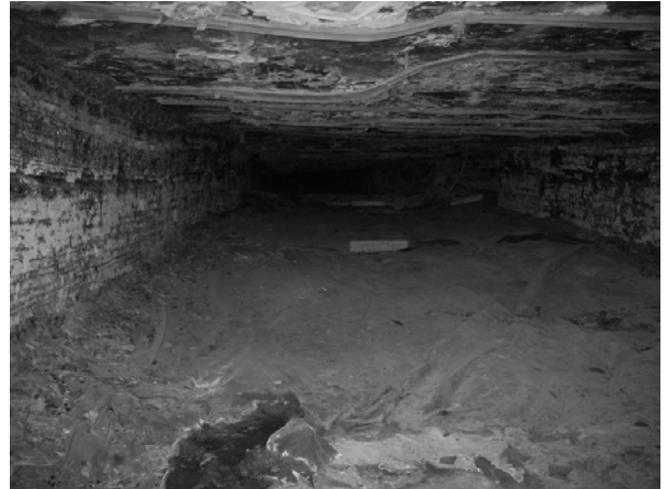
Figure 14. Photo taken 6-25-08 looking inby at study site, location 1.

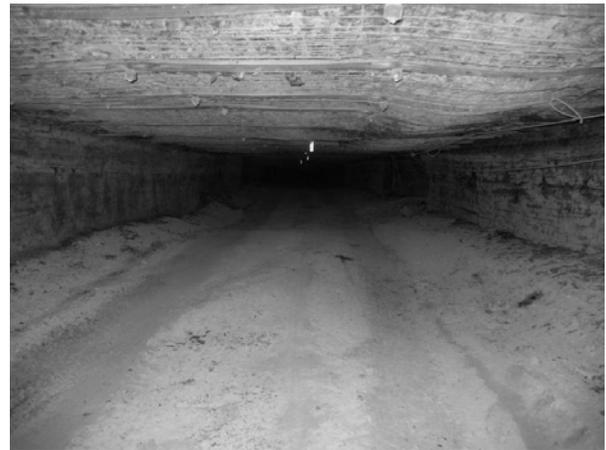
Figure 15. Photo taken 6-25-08 looking inby in adjacent entry with screen, location 15.

roof is screened. As seen in photo in Figure 15 taken during the 10th month of the study, the screen contained the roof rock and subsequently maintained better overall conditions. Several previous studies have shown the benefit to roof screening in moisture sensitive roof control (Molinda et al., 2003; Compton et al., 2007).
