COAL-DUST EXPLOSION AT EXPERIMENTAL MINE.

By GEORGE S. RICE.

Bulletin 44

FIRST NATIONAL MINE-SAFETY DEMONSTRATION

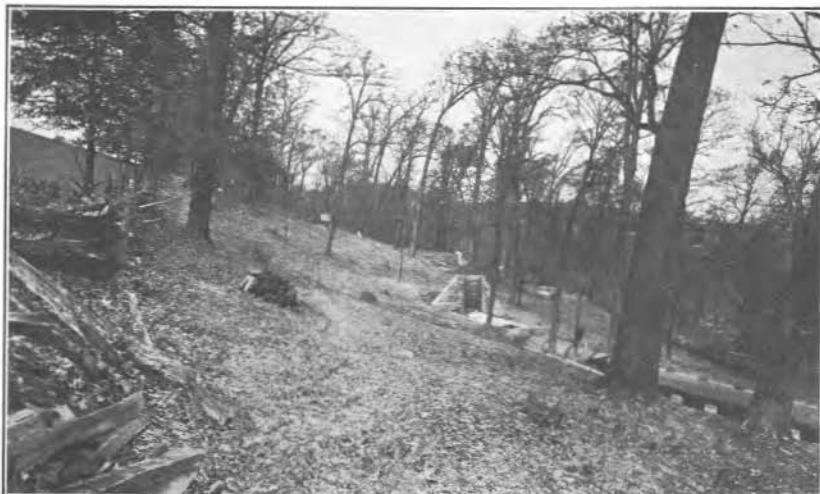
A. VIEW OF SIDE HILL, SHOWING GALLERY ENTRANCE IN CENTER AND MAIN ENTRANCE IN BACKGROUND.

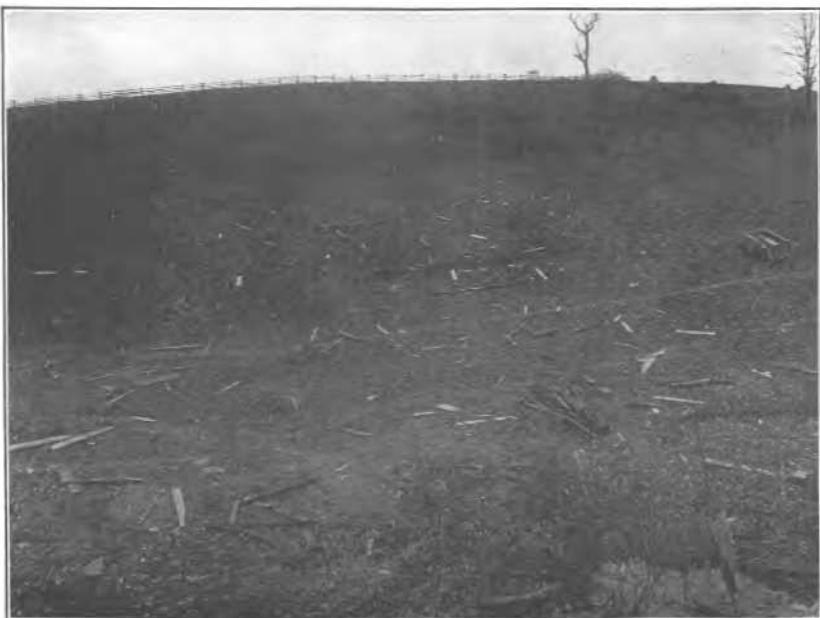
B. SIDE HILL OPPOSITE MINE, SHOWING CAR AND OTHER DÉBRIS THROWN BY THE EXPLOSION.

The mine consists of a pair of entries driven in the Pittsburg bed. These entries are nearly parallel with the "butt" joints of the coal and at right angles to the "faces"; in other words, the entries are what are termed "face" headings. The coal bed rises on a slight grade from the outcrop. A plan of the mine workings is shown in figure 2, and the mouth of the entries at the outcrop is shown in Plate I, *B*.

A mine car containing several hundred pounds of gravel stood on a switch outside of the mine in line with the main entry and 40 feet from the mouth. Twenty-five feet beyond it there was a car loaded with $1\frac{1}{4}$ tons of coal. The gravel car, weighing about 2,000 pounds, was thrown over the top of the coal car, and landed 184 feet away on the opposite slope of the ravine that passes the foot of the dirt dump. It then bounded four times and landed 45 feet from where it first struck, making the total distance moved 229 feet (see Pl. II, *B*, and *A-A'*, fig. 2).

The effect of the explosion at the mouth of the main entry is shown in Plate I, *B*. The pieces of timber in the foreground are the shelves that were blown out of the mine at the time of the explosion. This illustration also shows the concrete construction at the mouth of the entry, which was heavily reinforced. The reinforcing bars of the concrete arch and sides of the entry are five-eighths inch square, which, together with $\frac{1}{4}$ -inch round rods placed longitudinally, form a complete network of steel. This construction extends the entire length of the concreted portion of the entry.

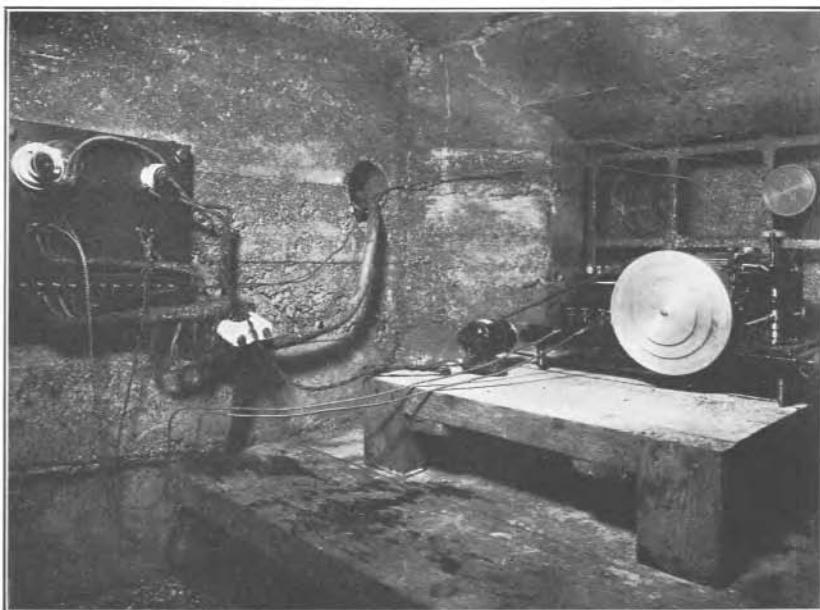
A. INTERIOR OF AN INSTRUMENT STATION, SHOWING MANOMETER AND PRESSURE CIRCUIT BREAKER.

At the time of the test five instrument stations had been constructed—one attached to the external gallery, two in the gallery entry, and two in the main entry. These stations were erected for safely housing the recording manometers used to obtain pressure curves. They were also designed to house circuit breakers (both pressure and flame) for respective velocity records and automatic gas-sampling devices. The four mine stations are built in the rib and are lined with reinforced concrete. In the entry side there is a heavy-ribbed cast-steel plate, through which connections are made to the instruments (Pl. III, A). Entrance behind the instruments is obtained through an adjoining compartment, the doorway of which to the entry is guarded by a ribbed cast-steel door. The cast-steel cover and door are made to resist pressures of 600 pounds per square inch. The plate is permanently bolted in place and the door, after closing, is made tight by iron wedges.

The equipment at present includes circuit breakers and three manometers of the Altofts type. At the time of the experiment, only two manometers and two pressure circuit breakers could be used. The two manometers were placed in the main entry stations at 40 and 140 feet, respectively, from the mouth of the entry. The circuit breakers were also placed in these stations, and a small wire was placed where the first blown-out shot could break it and thus indicate the start of the explosion. The velocity records are automatically registered by instruments in the observatory on the hillside, from which point the shots are ignited by battery.

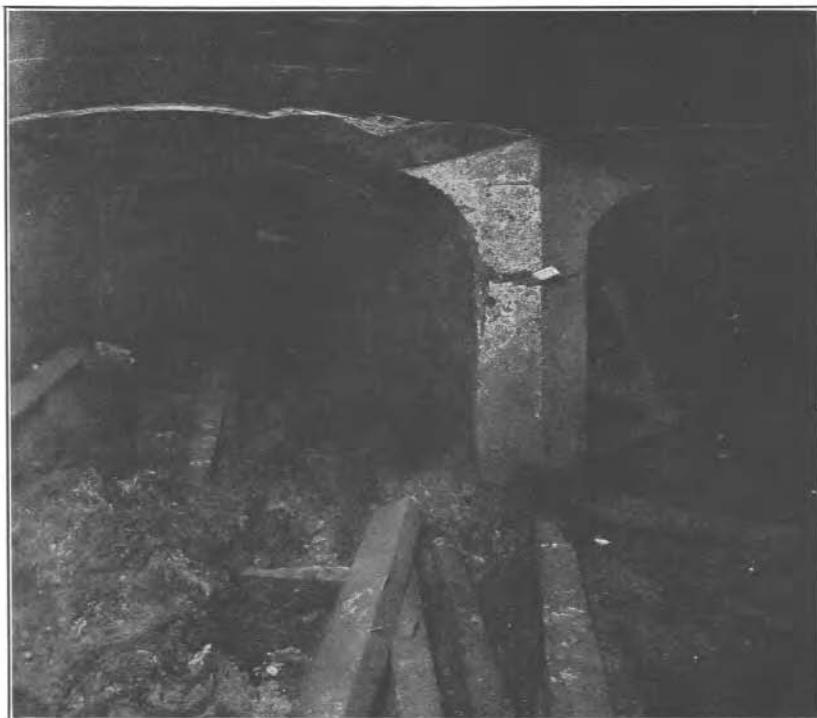
B. JUNCTURE OF GALLERY ENTRY AND AIR COURSE, SHOWING BROKEN REINFORCED CONCRETE CORNER WITH CURTAIN AND WOOD IN THE CREVICES.

As in the explosion on October 24, the concrete arching was lifted. The concrete corner of the Y was broken by a horizontal fracture and the upper half lifted so that a stick and pieces of a curtain brattice

were blown into the opening and held fast when the concrete settled back to its normal position (Pl. III, *B*).
