## Reducing the fire and explosion hazards of flame-cutting and welding in underground coal mines

W. D. Monaghan, member SME, is general engineer with the National Institute for Occupational Safety and Health, Pittsburgh, PA. Paper number TP-09-006. Original manuscript submitted January 2009. Revised manuscript accepted for publication May 2009. Discussion of this peer-reviewed and approved paper is invited and must be submitted to SME Publications prior to Sept. 30, 2010.

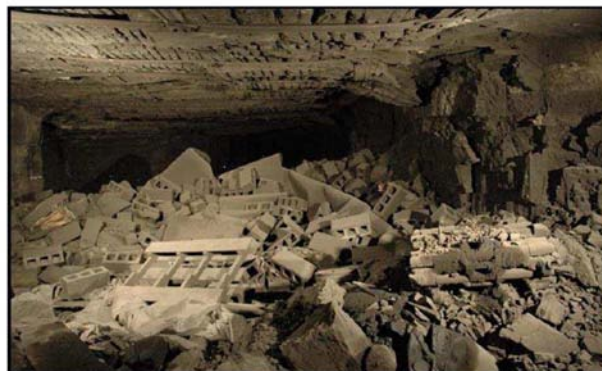
**FIGURE 2**

Figure 2 shows the actual debris from a stopping, which was destroyed by the explosion. MSHA further determined that the incident occurred because the operator did not observe basic mine safety practices and critical safety standards were violated. Mine management failed to ensure that proper seal construction procedures were utilized in building seals, that safe work procedures were used while employees attempted to make corrections to an improperly constructed seal and that miners were adequately trained (MSHA, 2006).

**Debris from a stopping near the explosion in Darby Mine No. 1 (MSHA, 2006).**

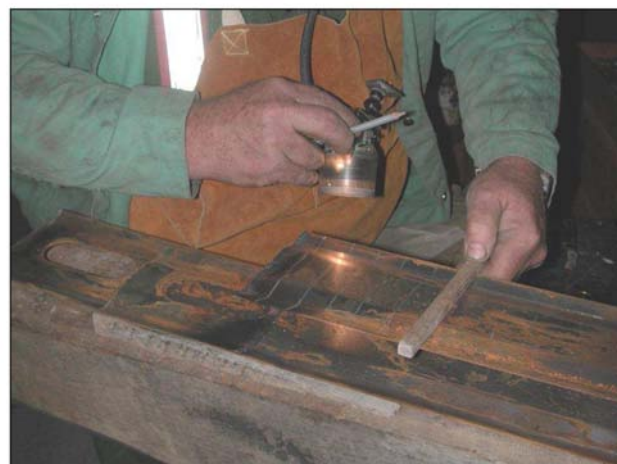
In this experiment, metal strips ranging from 1.27 to 3.75 cm (0.5 to 1.5 in.) were flame-cut from the metal roof strap shown in Fig. 7. The temperature histories of the hot metal strips were obtained by recording the temperature every 250 milliseconds using the IR camera. Figure 8 shows an example of the temperature histories of a 1.27-cm (0.5-in.) and a 3.75-cm (1.5-in.) metal strip following the cut. The 3.75-cm (1.5-in.) strip's temperature remained above 593° C (1,099° F) for 19 seconds, and the 1.27-cm (0.5-in.) strip's temperature remained

**FIGURE 7****Metal roof strap prior to flame cutting individual strips.**

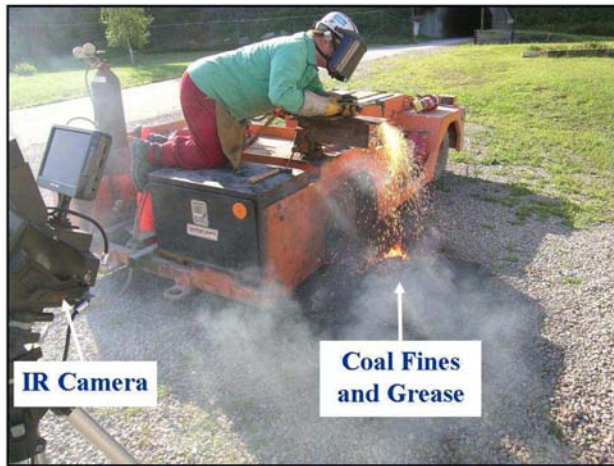
**FIGURE 9****Setup for hot molten metal experiment.**

In this experiment, the effect of hot molten metal on float coal dust and grease was observed. Flame-cutting was performed approximately 1 m (3.3 ft) above the float coal dust and grease. The hot molten metal was allowed to fall directly on the float coal dust and grease. The temperatures of the metal, float coal dust and grease were recorded using the IR camera, shown in Fig. 9. The hot molten metal immediately ignited the grease. After several minutes, flames from the grease appeared to have self-extinguished. However, hot spots in the float coal dust were observed with a temperature range between 93-145° C (199-293° F).
