# Roof Failure in Longwall Headgates – Causes, Risks, and Prevention

Peter Zhang  
Mark Van Dyke  
Daniel Su  
Essie Esterhuizen  
Jack Trackemas  
*Ground Control Branch*  
*NIOSH, Pittsburgh Mining Research Division (PMRD), Pittsburgh, PA*

This paper was prepared for presentation at the 52<sup>nd</sup> US Rock Mechanics / Geomechanics Symposium held in Seattle, Washington, USA, 17–20 June 2018. This paper was selected for presentation at the symposium by an ARMA Technical Program Committee based on a technical and critical review of the paper by a minimum of two technical reviewers. The material, as presented, does not necessarily reflect any position of ARMA, its officers, or members. Electronic reproduction, distribution, or storage of any part of this paper for commercial purposes without the written consent of ARMA is prohibited. Permission to reproduce in print is restricted to an abstract of not more than 200 words; illustrations may not be copied. The abstract must contain conspicuous acknowledgement of where and by whom the paper was presented.

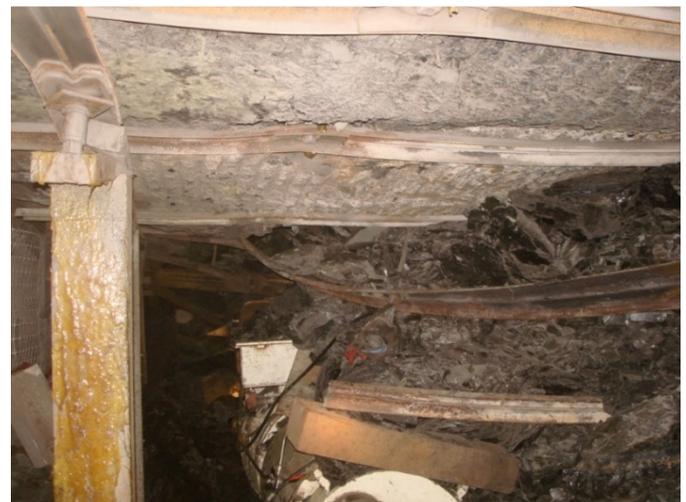
Fig.3. Roof fall by cantilevering over the pillar side in the belt entry.

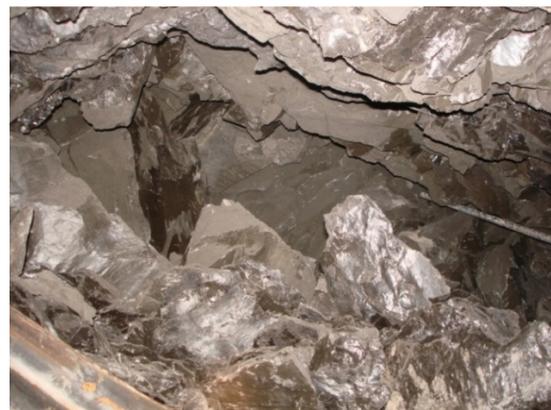
Fig.6. Weak claystone roof fell with slickensides.

- The location of the roof falls was strongly associated with the existence of rider coals and slicken-sides in the immediate roof. However, the exact location of a potential roof fall is difficult to predict by the limited knowledge of variable roof geology and the roof conditions outby the longwall influence zone.
- Though roof falls could occur at both intersections and within mid-blocks, they are more likely to occur within 15.2 m (50 ft) inby the intersections.
- Weak rock at the surface of the immediate roof is likely to break or fracture around the cable bolt plates under heavy loading, resulting in functionality loss of the cable bolts.
