A Case Study of Pillar Collapse at a Limestone Mine in Pennsylvania

ABSTRACT: The sudden collapse of approximately 3 Ha of room-and-pillar workings at a limestone mine in southwestern Pennsylvania in 2015 resulted in an air-blast that injured three mine workers. Subsequent investigations showed that an area encompassing 35 pillars had collapsed. The pillars were 9 to 10 m wide and up to 18 m high. A notable geologic feature is the through-going joints that dip at 50° to 80° and can extend from the roof to the floor of the pillars. These structures are thought to have weakened the pillars well below the strength that is predicted by empirical equations for hard-rock pillar design. This paper presents the relevant geotechnical data related to the collapsed area and numerical model results that were used to estimate the pillar loading underneath the variable topography and compares the pillar loads to some established hard-rock pillar strength equations. The outcome is also compared to a strength equation that was developed specifically for limestone mines in which the negative impact of large angular discontinuities is explicitly accounted for. The results show that the critical sta

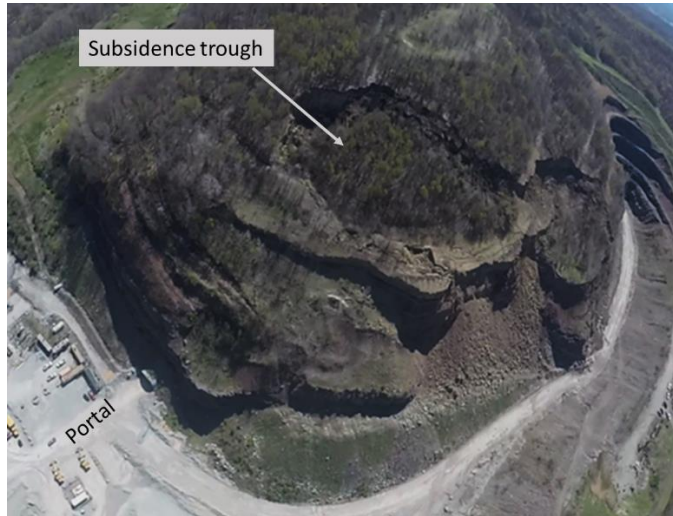
Figure 1. Aerial view of the mine showing extent of surface subsidence associated with the collapse of the pillars.

On April 29, 2015 three miners were waiting near the portal of an underground limestone mine in southwestern Pennsylvania when they heard something like shots being fired in the mine. This was followed by a massive collapse of the room-and-pillar workings in the mine. The air-blast from the collapse knocked the miners to the ground, causing serious injuries to each miner. Subsequent investigations revealed that subsidence of the mountainside overlying the mine workings had occurred. The subsidence area encompassed about 3 Ha. Underground inspections to delineate the collapsed area showed that about 35 pillars had collapsed. A wide-angle, aerial camera view of the mine showing the main portal and the subsidence area is presented in Figure 1.

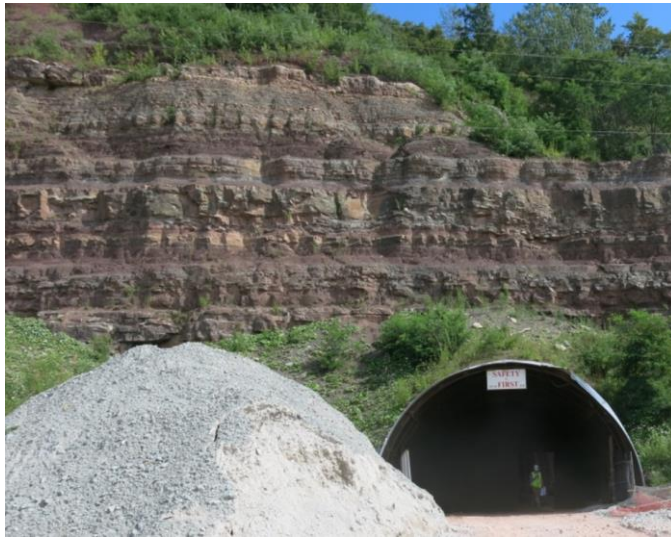
Figure 2. Main portal entering the mine with Mauch Chunk beds exposed in the highwall.

thickness of 30 meters, but is typically 20 meters thick in the Chestnut Ridge mines. It is light to greenish-gray and compositionally ranges from a calcareous sandstone to a sandy limestone. At the mine, the Loyalhanna limestone bed is overlain by distinctive reddish-brown mudstones, shales, and siltstones of the Mauch Chunk beds, shown in Figure 2.

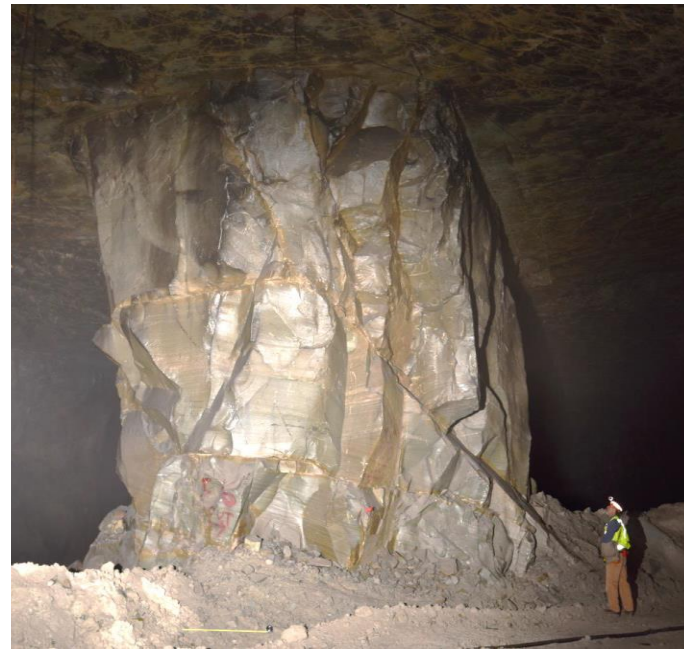
Figure 3. Prominent N60°W striking joint intersecting a pillar south of the collapsed area.

Jointing observed underground showed multiple orientations, although most joints fell generally into a northwest and northeast set with dips ranging from vertical to less than 30°. One particular set of joints stood out in terms of prominence, persistence, and uniformity. This set, with a strike of N60°W, occurred in a well-defined zone 150 meters wide that intersected the main portal area and the eastern half of the pillar collapse zone. Joints in the zone were typically spaced 3-5 m apart and dipped 60° to 80° to the southwest, shown in Figure 3. Some joint traces exposed by the pillars were curvilinear with dips less than 60° in the lower portion of the pillar. Many of the joints near the collapsed area were dilated by groundwater dissolution and some showed apertures up to 6 inches. The joints were perpendicular to the northeast striking thrust fault and are interpreted as transverse joints associated with anticline formation.

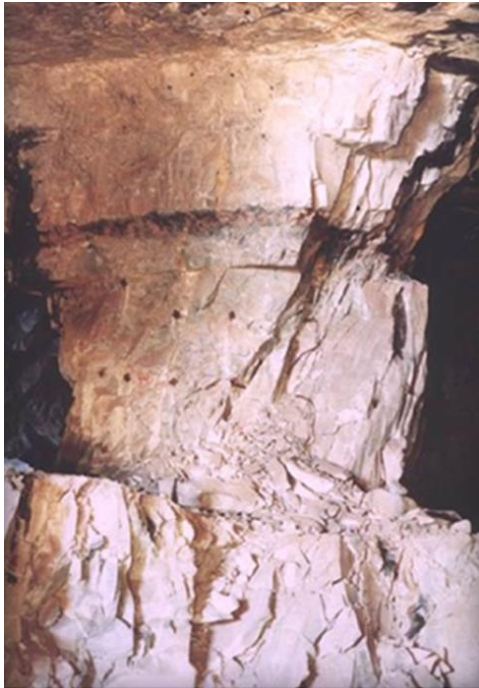
Figure 5. A pillar impacted by large angular joints along the edge of bench mining (photo, by A.T. Iannacchione).

Figure 4 shows the mining layout and the outline of the area that collapsed. A relatively regular pillar layout was followed starting at the portals, but as the mine progressed, poor ground conditions were encountered near the low-angle fault exposed in the highwall and underground. As a result, large blocks of ground were left intact with the objective to resume mining beyond the poor ground. During this time, bench mining was conducted in the area near the portals. Bench mining more than doubled the height of the pillars, exposing continuous angular joints that caused sections of the intended pillars to fall away during the blast. Figure 5 shows such a pillar observed around the year 2001 (Iannacchione, 2016).

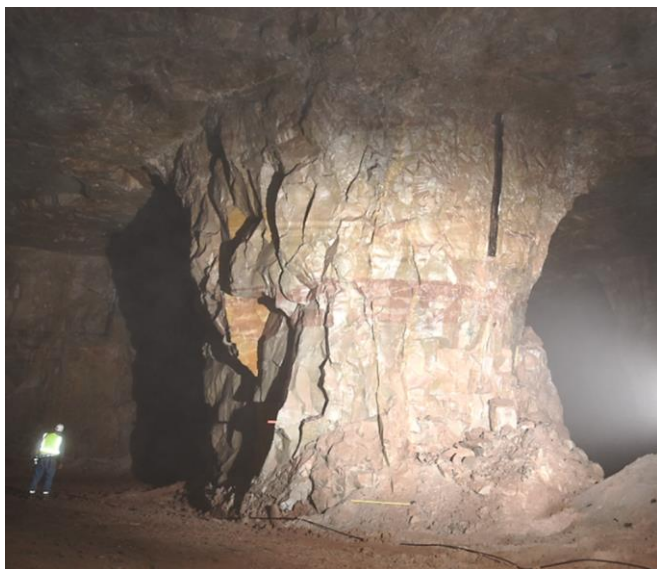
Figure 6. Pillar adjacent to collapsed area affected by angular jointing.

Figure 6 shows a pillar along the escapeway, which demonstrated the type of roof-to-floor jointing observed in this part of the mine. Note that the walkway was not bench mined and was, therefore, about 10 m above the floor of the benched area.

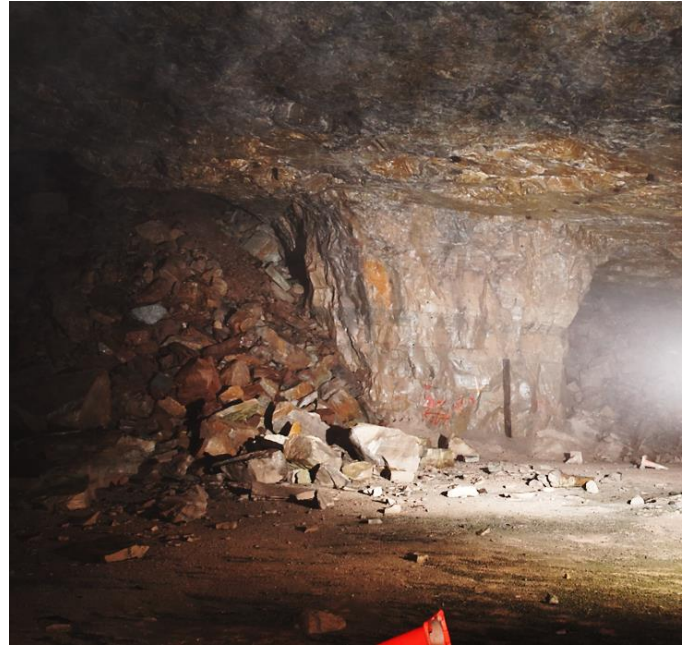
Figure 7. Rubble from the roof collapse and a stable pillar along the edge of the benched area that collapsed.

Figure 7 shows the roof rubble that flowed between the pillars during the collapse. None of the collapsed pillars were visible, owing to the volume of roof rubble that flowed into the mine voids. This raised the question of whether it may have simply been a roof collapse. However, the significant depth of subsidence, without signs of pillar humps on the surface, and the abruptness of the collapse rules out that the pillars may still be standing in the collapsed area. A roof collapse would be expected to be more progressive, taking place over an extended period of time.

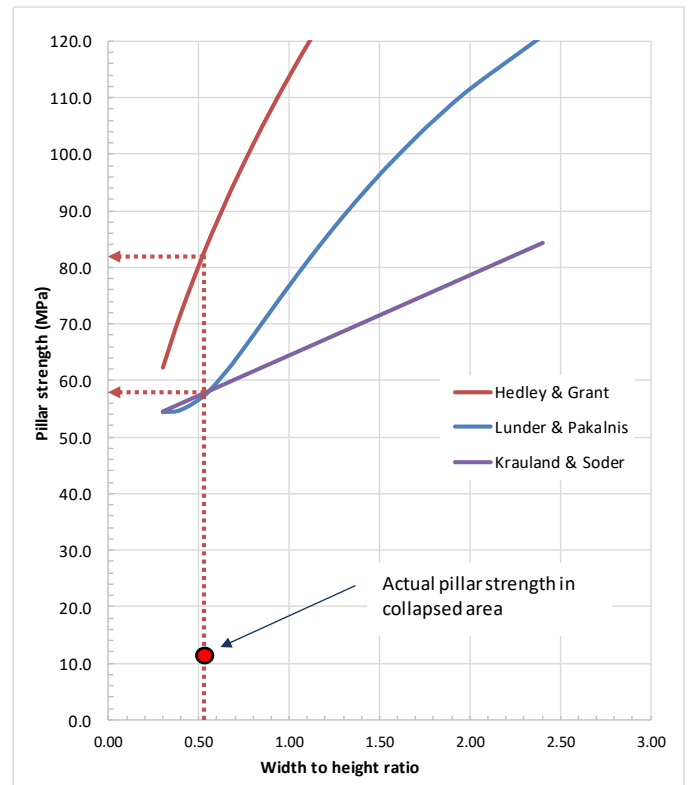
Figure 9. Actual pillar strength at the case study mine compared to predictions using established hard-rock pillar strength equations.

where k is the large-scale rock strength, w is the pillar width, h is the pillar height, σ_c is the intact rock strength, and κ is a confinement parameter. The pillar strengths for 17.7-m-high pillars of various widths were calculated using each equation and shown in Figure 9. For the Hedley and Grant equation, the strength factor relating the large-scale rock strength to the laboratory-scale UCS is 0.58, and for the Krauland and Soder equation the strength factor is 0.354. The actual pillar strength from this case study is also shown in Figure 9. It is clear that the empirically based strength equations would have grossly overestimated the actual pillar strength and would have predicted stable conditions at the mine.

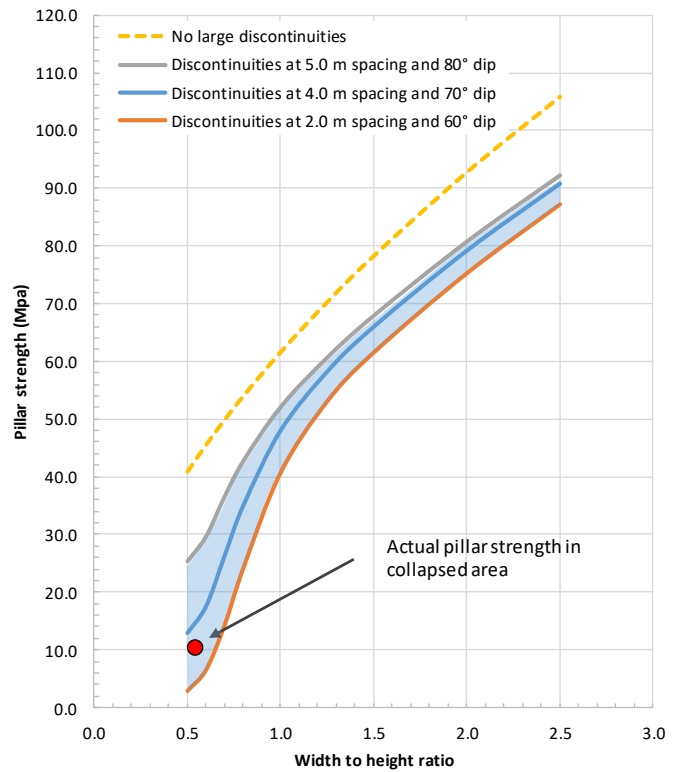
Figure 10. A graphs showing range of pillar strengths determined for the 17.7-m-high collapsed pillars using Equations 4 and 5.

The range of pillar strength results obtained using Equations 4 and 5 are shown in Figure 10. The figure also shows the predicted pillar strength in the absence of any large discontinuities. The range of strengths was determined by varying only the large discontinuity

spacing and dip. The minimum strength is actually achieved when the discontinuity dip is 60°, which was selected to derive the minimum strength curve. The upper solid curve is obtained by selecting the maximum discontinuity spacing of 5.0 m and a dip of 80°.

The results show that the equation predicts a significant drop in pillar strength at the lower width-to-height ratios. Also, the range of likely strengths based on the variability of the large discontinuity geometry includes the actual pillar strength. If the average dip and spacing of the most prominent joint set is used, at 70° and 4.0 m respectively, the equation predicts a pillar strength of 12.9 MPa.
