## Investigation of Acoustic Emission Sensors for Ground Control Hazard Recognition in Underground Mines

Gary Buchan  
NIOSH

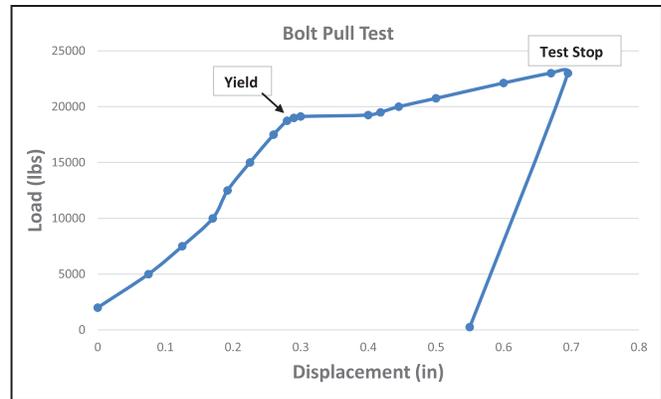
Figure 1. Typical graph of the load versus displacement of the bolt during the pull test.

The bolt specifications were a 1.2 m (4 ft) rebar at 1.59-cm (5/8-inch)-diameter and Grade 60 steel. The bolt plate was a 1/4-inch dome plate. Bolts were typically installed in the machine with approximately 18-inch gage length or an 18-inch space between two crosshead clamps for the bolt pull zone. Load test scenarios included steady displacement at 0.25 cm (0.10 inch) per minute, along with 1-minute holds at various loads, including 5,000- and 10,000-pound levels. All bolts were pulled to yield at approximately 19,000 pounds and then to failure or ultimate strength. Figure 1 shows a typical load versus displacement curve during the bolt pull test. Several tests were conducted with consistent repeatability of load versus displacement for the bolt yielding and load versus hits for the AE activity.

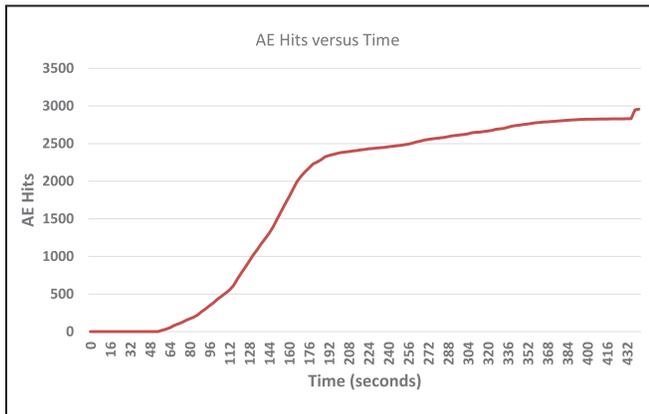
Figure 2. Typical graph of the AE activity (hits vs. time) during the pull test.

When the bolt is loaded and begins to take on stress, AE events will begin and increase in number with the level of stress. These events are then measured by the number of events, which exceed a predetermined threshold and constitute an AE hit. The AE hit is then recorded by the monitoring system software, creating a curve, which increases with the bolt loading or stress as shown in Figure 2.

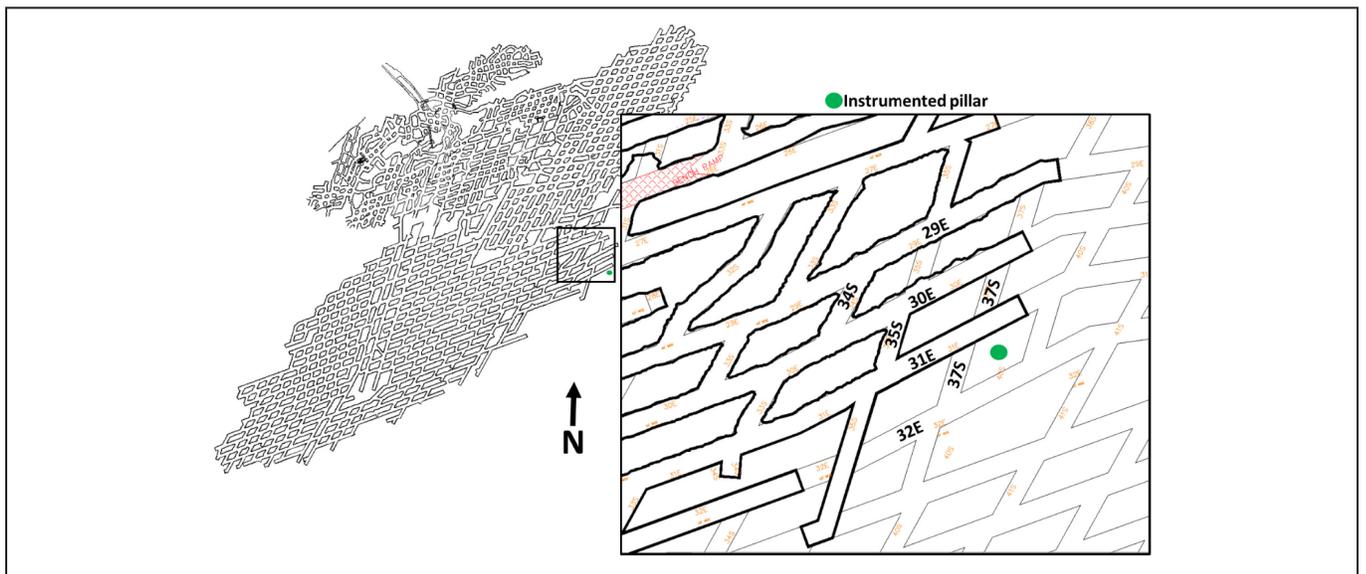
Figure 3. Map of the Pleasant Gap Mine, including a detailed view of the instrumented area for the field test (after Murphy et al., 2018).

The field test is ongoing at the Pleasant Gap Mine, an underground room-and-pillar limestone mine owned by Graymont (Pleasant Gap, PA) and located in central Pennsylvania. A map of the Pleasant Gap Mine is shown in Figure 3. The limestone seam dips approximately 18 degrees in the southeast direction. The mine is located within a structurally complex area of tightly folded anticlines and synclines. The study area for both the microseismic and AE tests, highlighted in Figure 3, is within one of the deepest parts of the mine, approaching 425 m (1,400 ft) in overburden.

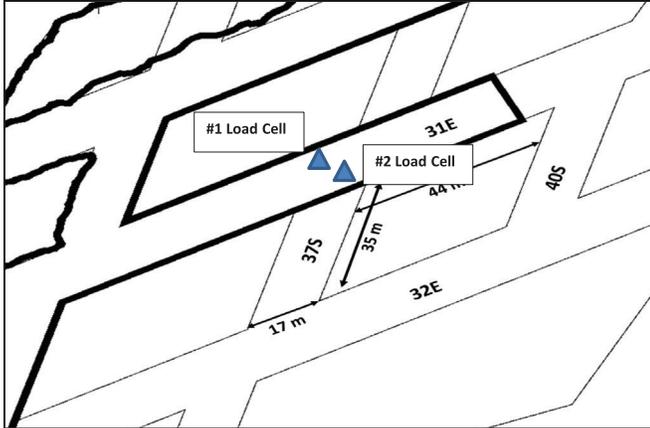
Figure 4. Location of bolts with instrumentation at the Graymont Mine.

Two 3.4-m- (11 ft)-mechanical bolts at 7/8-in diameter and Grade 75 steel were installed along with Geokon Model 3000-100 (100 kip capacity) load cells and 7.6-cm- (3 inch)-square by 5.1-cm- (2 inch)-thick, solid-steel washers to stabilize the load cell during loading (Geokon, 2018). One 150-KHz and one 30-KHz AE sensor were installed to each of the bolt installations. Bolts were installed manually with a battery-operated hand drill to a maximum torque of 50 ft-lb. This was the limit of the drill. Although the bolts were specified to be torqued to 250 ft-lb, it was determined that the anchors would likely not slip and a relative load could be monitored for comparison to the AE activity. The bolts were installed in the crosscut area of 31E x 37S, indicated by the triangles shown in Figure 4.

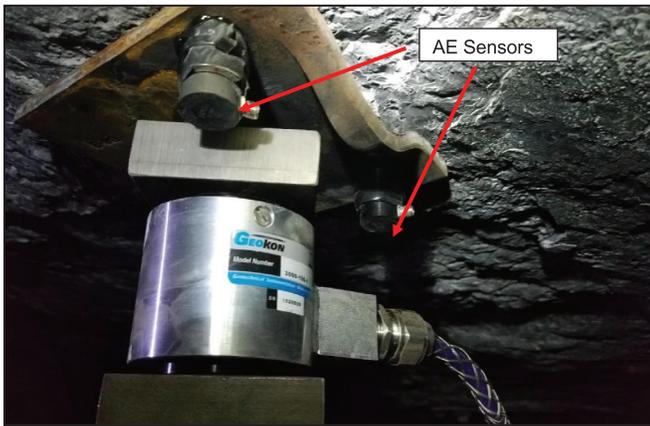
Figure 5. Load cell and AE sensor installation.

AE sensors were then attached to the roof bolt plates with magnets to capture the AE events in the roof strata via the point anchored mechanical bolt. A 150-KHz and 30-KHz sensor was attached to each roof bolt plate for measuring the AE events in the bolt and in the surrounding strata, respectively. Figure 5 shows a photo of the load cell and AE sensor installation. Each sensor has a dedicated coaxial cable attached and routed back to the data acquisition system approximately 250 feet away. Figure 6 shows a photo of the dedicated data acquisition system for the AE sensors (large box)

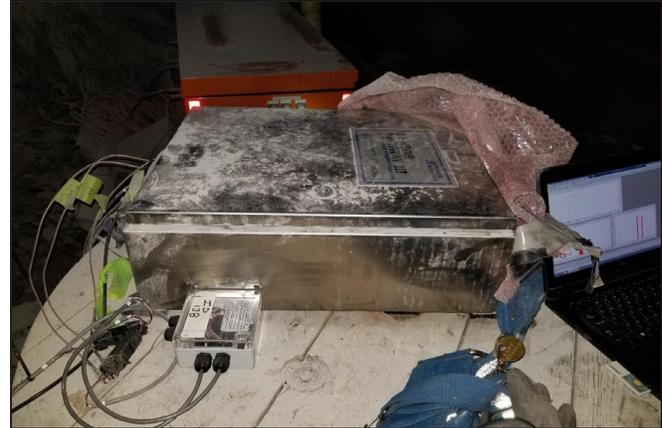
Figure 6. Mistras Sensor Highway III data acquisition system (large box) and the MIDAS unit for bolt load cells (small box).

and the MIDAS unit for the bolt load cells (small box). Figure 7 shows a photo of the area where the bolts were installed.

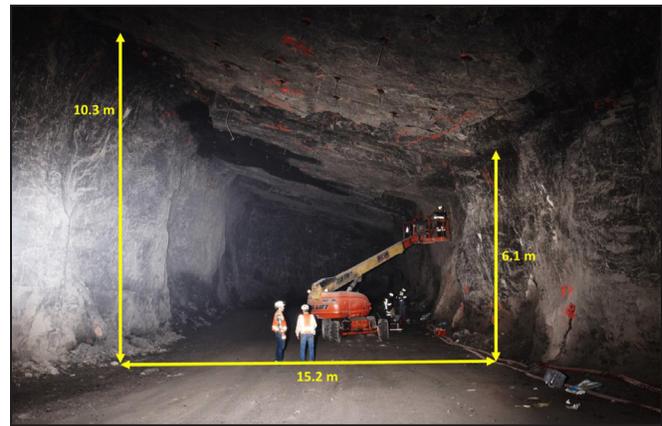
Figure 7. Area of Graymont mine where the instrumented bolts were installed (after Murphy et al., 2018).

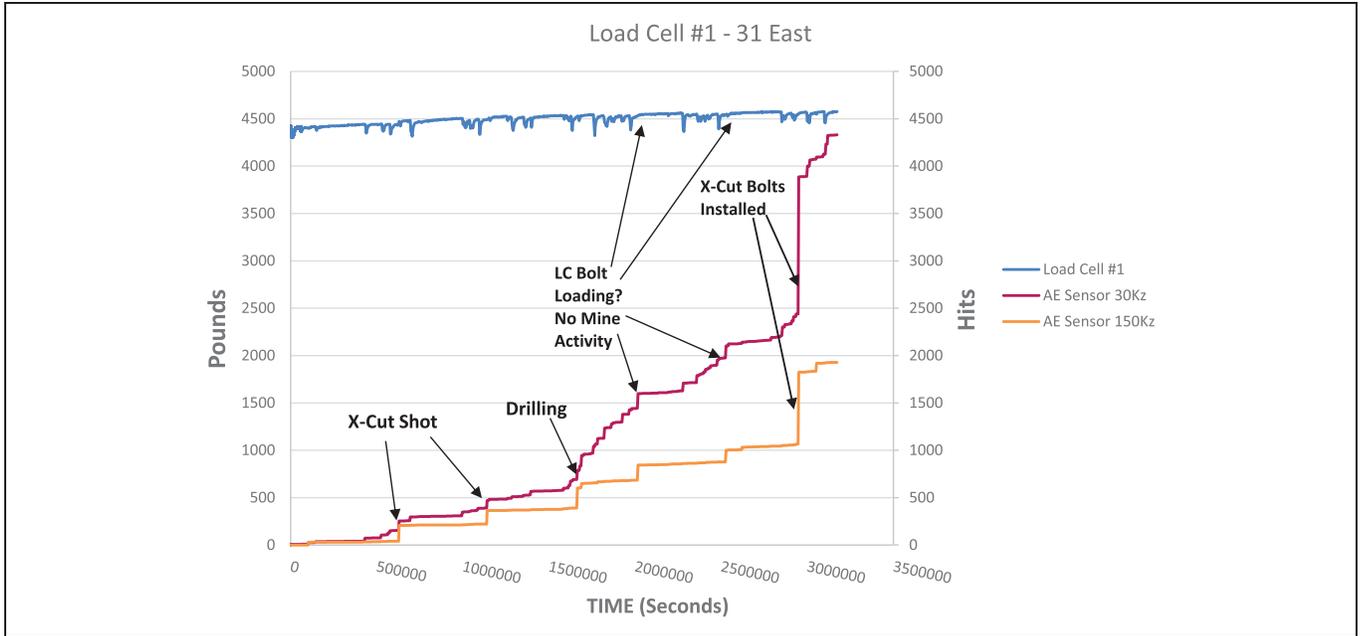
Figure 8. Load cell #1 with bolt load and AE hits.

An area of interest and hypothesis is if an increase in bolt load and simultaneous increase in AE activity for the 150-KHz sensor is either preceded or followed by an increase in the AE activity of the 30-KHz sensors. This would indicate roof cracking or deterioration, causing the increase in bolt load. However, with point anchor bolts, such as those installed for this test, there could be lateral roof movement and no change to the loading on the bolts. The roof cracking would then occur with little or no bolt loading. This would also be expected in a mine experiencing cutter roof development and little roof sag, such as this mine. The data thus far does indicate a greater amount of AE hits for the 30-KHz sensor versus the 150Hz sensor, with the increased activity at the center of the graph in Figure 8 coinciding with only a slight increase in bolt load and no extraneous mine activity occurring. This is preliminary data and will be further monitored with additional field testing data.

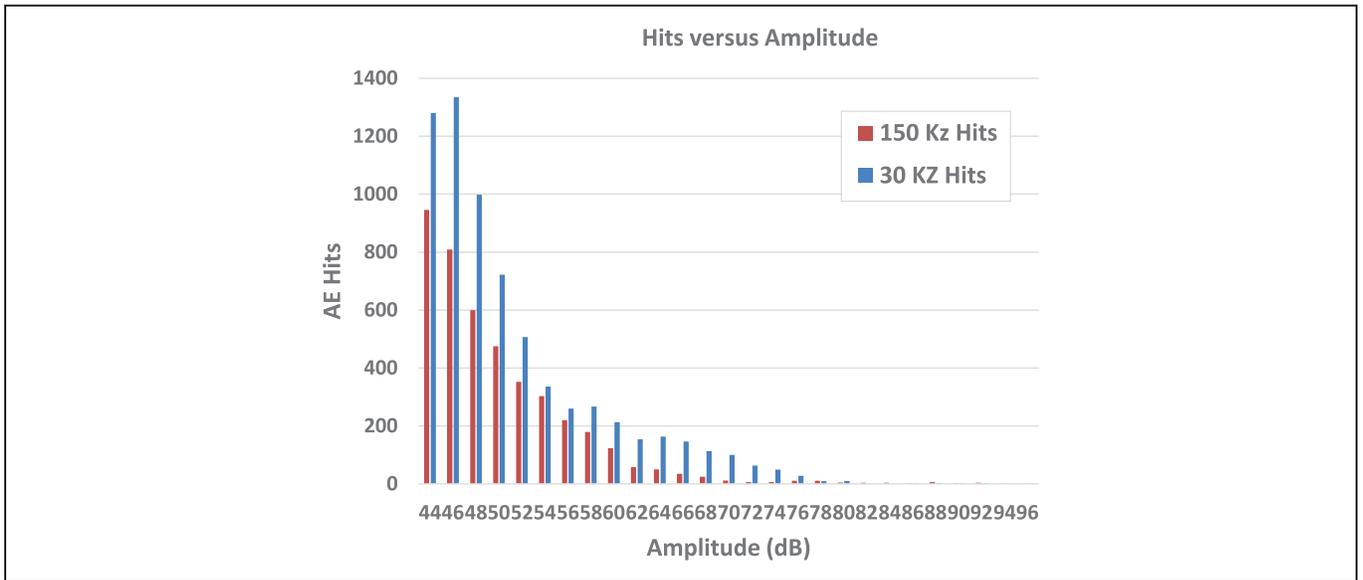
Figure 9. AE hits with amplitude for the 30-KHz sensor and 150-KHz sensors.

AE theory states that emission amplitude is proportional to the crack velocity (Hallier, 2003). A sudden discrete, crack event will produce a greater signal than a slow-moving event over the same distance. Figure 9 shows a diagram of the AE hits with the associated hit amplitude. The blue bars are the 30-KHz sensor, and the red bars are the 150-KHz sensor for both bolts. There

is additional activity at all amplitudes from the 30 KHz sensor, representing the more sensitive lower frequency. The 150 KHz sensor shows amplitude readings more predominantly in the 44 to 60 decibel range, which is typical of metal materials. The hypothesis is that the 30 KHz sensors will pick up the higher amplitude readings from “more significant” cracks in the roof rock; however, at this point in the study, further data analysis is necessary to distinguish between mine activities and roof rock deterioration.
