INJURY SURVEILLANCE AND SAFETY CONSIDERATIONS FOR LARGE-FORMAT, LEAD-ACID BATTERIES USED IN MINING APPLICATIONS

Abstract—Large lead-acid batteries are predominantly used throughout the mining industry to power haulage, utility, and personnel-carrier vehicles. Without proper operation and maintenance, the use of these batteries can introduce mechanical and electrical hazards, particularly in the confined, and potentially dangerous, environment of an underground coal mine. A review of the Mine Safety and Health Administration (MSHA) accident/illness/injury database reveals that a significant number of injuries occur during the maintenance and repair of lead-acid batteries. These injuries include burns from electrical arcing and acid exposure, as well as strained muscles and crushed hands. The National Institute for Occupational Safety and Health (NIOSH) investigated the design and implementation of these batteries to identify safety interventions that can mitigate these inherent hazards. This paper promotes practical design modifications, such as reducing the size and weight of battery-assembly lids in conjunction with lift assists, and using five-pole cable connectors to improve sa

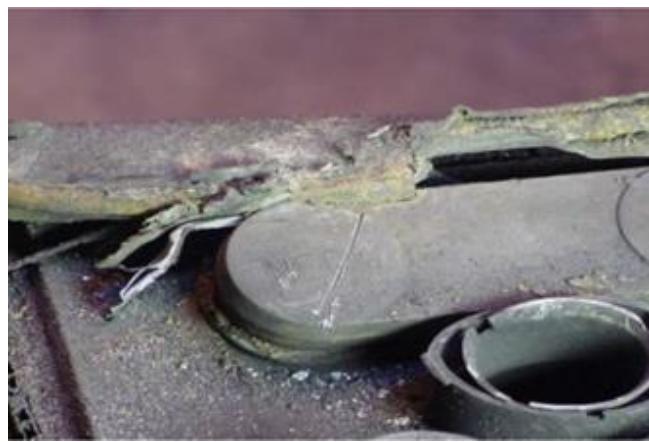
Fig. 1. Scoop-tractor battery showing terminal contact with steel battery tray.

In 2001, two sequential explosions inside the Jim Walter Resources Mine No. 5 in Alabama claimed the lives of 13 mineworkers. The MSHA post-disaster investigation identified the ignition source of the initial explosion as a scoop-tractor battery, damaged from a roof fall. The battery arced and ignited an explosive mixture of methane and air [1]. Fig. 1 shows how the metal battery assembly came in contact with a battery terminal after the enclosure was damaged. The initial explosion severely injured one person and destroyed numerous ventilation controls, which led to a subsequent and larger explosion. Dubaniewicz [2] subsequently recommended a reevaluation of the 30 CFR Part 7 requirements for battery assemblies, with regard to insulation between a battery enclosure and cells to prevent shorting.

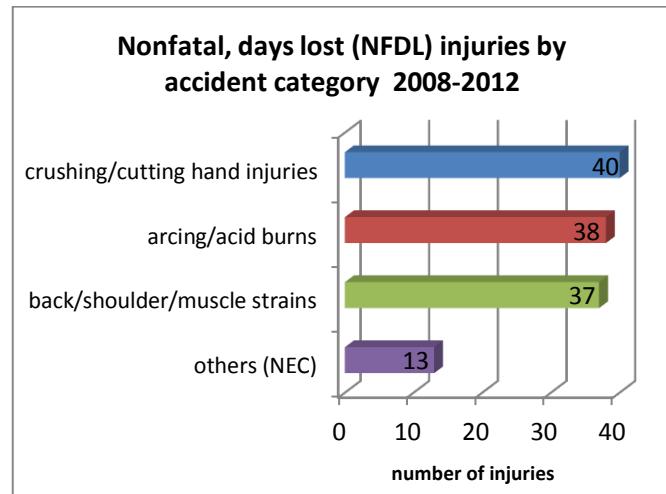
The categories were organized based on the frequency of incidents, as depicted in Fig. 2. Crushing/cutting hand injuries had the highest number of reported cases with 40. The second leading category was arc flash/acid burn injuries, with 38 reported cases. Some of these cases were exacerbated by the lack of PPE, such as face shields or rubber gloves. The third leading cause of injuries was back/shoulder/muscle strains with 37 reported incidents. These injuries included the lifting of individual batteries and cells as well as opening heavy components such as the battery enclosure lids during maintenance tasks. Analysis of the accident data identified the types of questions to be asked and guided the emphasis that would be placed on research priorities when conducting the field investigations.

Fig. 2. Types of injuries, from MSHA Accident, Illness and Injury database.

Accident/Illness/Injury statistics show a small number of cases involving arcing when cables were pulled from the battery assembly (Fig. 2). These reported cases, included in the arcing/acid burns category, often occurred during the maintenance and the charging of batteries because the batteries were not properly de-energized prior to the cables being disconnected. From an engineering standpoint, the addition of a circuit breaker on a battery assembly, as shown in Fig. 8, reduces that potential by providing a local method for de-energizing a battery.

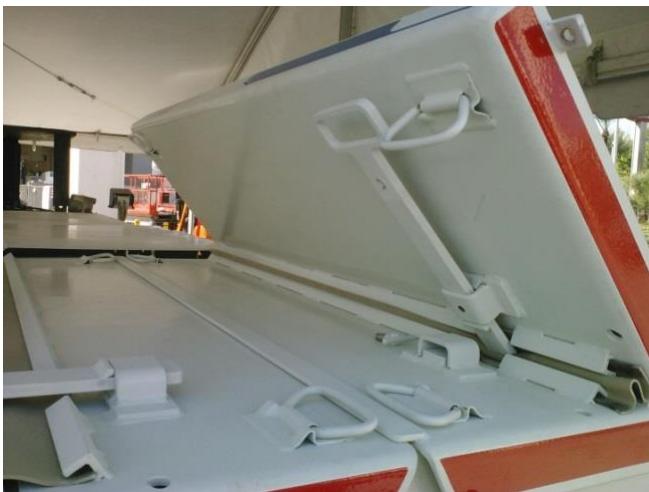
The size and weight of lids may contribute to back and shoulder injuries. Several lid configurations were observed in the field and varied from long, rectangular lids to smaller, square lids, depending on the manufacturer and equipment type. A comparison of the two configurations is depicted in Figs. 3 and 4.

Fig. 3. Rectangular-shaped battery assembly lids.

Weight distribution and handle placement pose challenges to users in terms of body positioning when raising the lids. The challenge is worsened in low coal seams where the limited vertical space creates more difficulty. The smaller size of the square lids can relieve the strain caused by the frequent need to open and close the lids for maintenance and repair work. The ease of opening the lids also affects the performance of maintenance and repair tasks, because a repairman is more likely to put off preventive maintenance if lids are difficult to open.

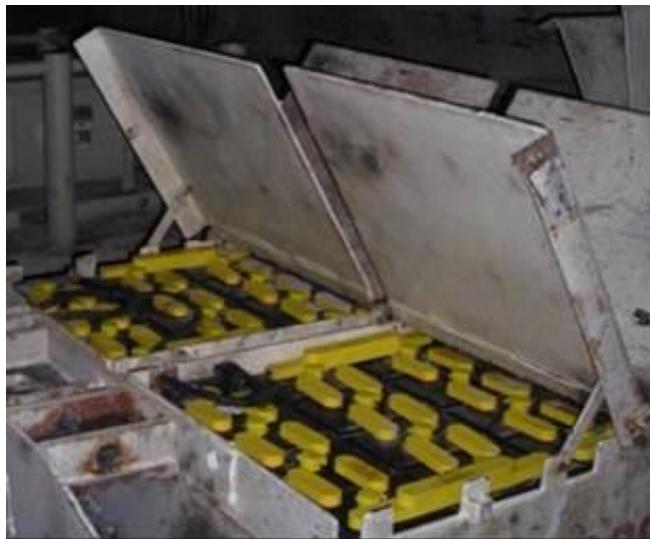
Fig. 4. Square-shaped battery assembly lids.

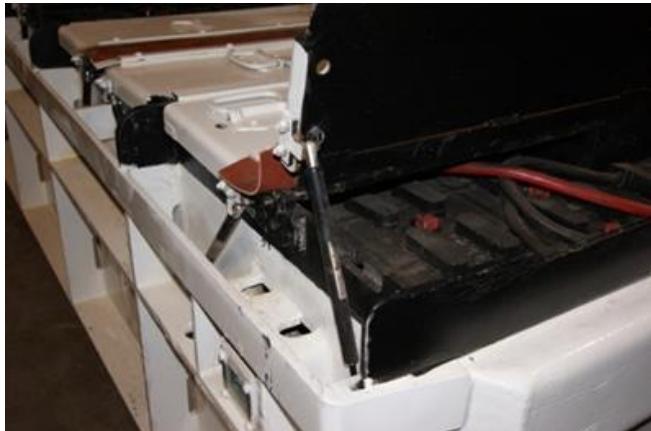
An alternative solution to the weight issue presented by the heavy steel lids is the implementation of lift assists. Some manufacturers offer pneumatic lift assists to help address this risk (Fig. 5). A lift assist helps raise the lids safely by reducing

the musculoskeletal strain to which a mineworker is subjected. Thus, injuries attributed to the frequent raising and lowering of the battery lids for charging, maintenance, and repairs may be significantly reduced. These lift assists are relatively inexpensive and easy to replace if damaged. Furthermore, the costs of these assists may be offset by reducing the costs associated with lost-time injuries.

Fig. 5. Battery assembly with a pneumatic lift assist.

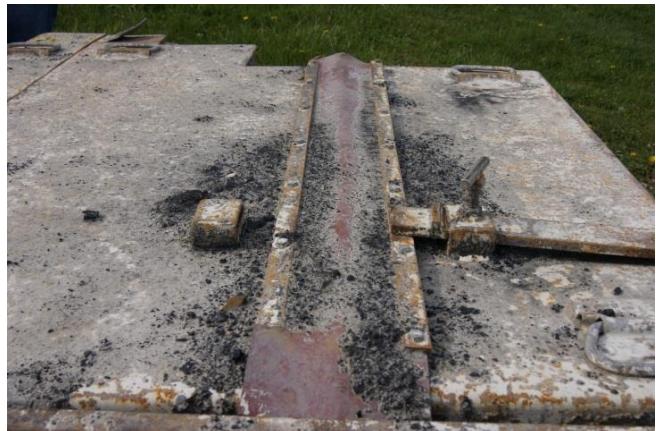
Manufacturers also recommend the use of hinge covers. These covers serve a dual purpose as they effectively keep rock dust and dirt from the hinges, while reducing the accumulation of debris inside the battery assembly (Fig. 6). Debris accumulation can create a potential for a short circuit across battery terminals that may result in a battery fire or explosion. Note in Fig. 6 the amount of debris built up on the battery assembly surface that was effectively kept away from the battery's surface area and terminals by the use of hinge covers.

Fig. 6. Battery assembly with hinge cover.

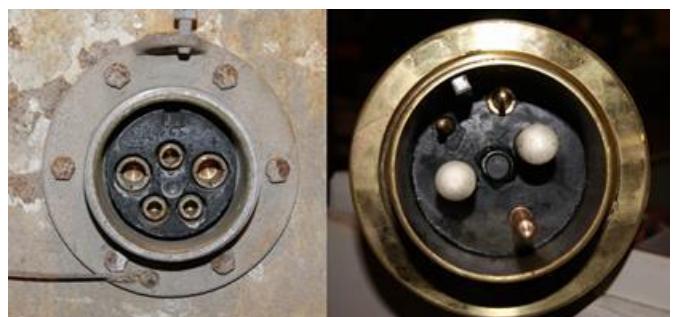
A five-pole, look-ahead charging cable connector is a major improvement to the two-pole connector. This configuration, depicted in Fig. 7, consists of positive and negative pins, a ground pin, and two pins used to "look ahead." The two look-ahead pins serve the purpose of interlocking with the charging coupler and ensuring there is a proper connection prior to starting the charging cycle. This feature also eliminates arcing when the charging cables are disconnected from the battery by tripping a circuit breaker before the power contacts are separated.

Fig. 7. Five-pole battery cable connectors.

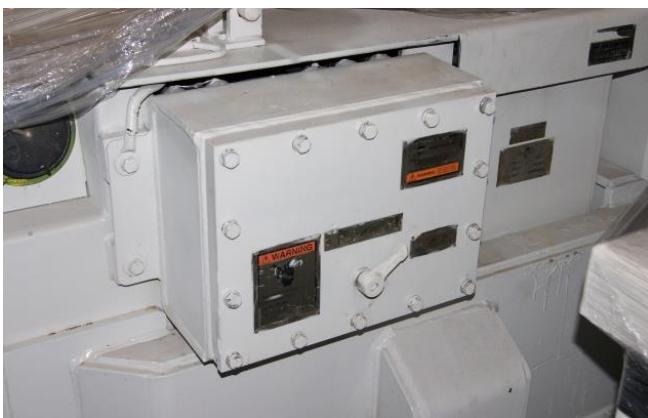
Fig. 8. Side-mounted battery circuit breaker box.

While some OEMs are making this feature standard on 240V models, it is not a practice that is being implemented by all mining companies. These interventions come at an added expense that many operators may be unwilling or unable to incur. At an estimated \$10k per installation, manufacturers realize that some mine operators will forgo this option unless there is a regulation requiring the use of such a safety feature. They consider this to be especially true with intermittent-use vehicles, such as scoop tractors, where the cost associated with adding this feature causes end users not to choose it. However, the use of a battery circuit breaker can prevent arc flash burns sustained by workers while pulling cables from connectors prior to proper de-energization.

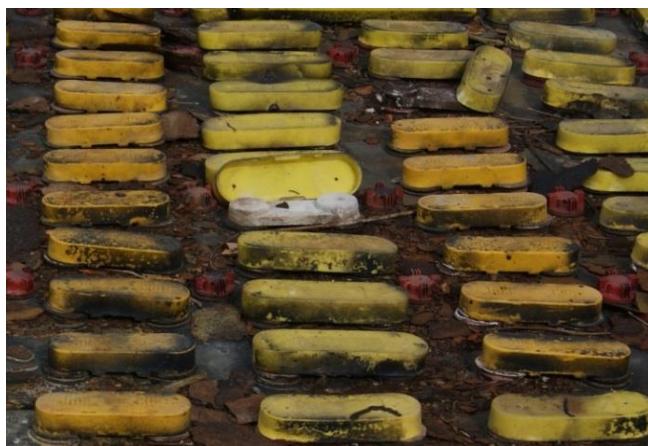
Fig. 9 Debris and leakage buildup on terminals.
