# Strength and Elastic Properties of Paste Backfill at the Lucky Friday Mine, Mullan, Idaho

This paper was prepared for presentation at the 49<sup>th</sup> US Rock Mechanics / Geomechanics Symposium held in San Francisco, CA, USA, 28 June-1 July 2015.

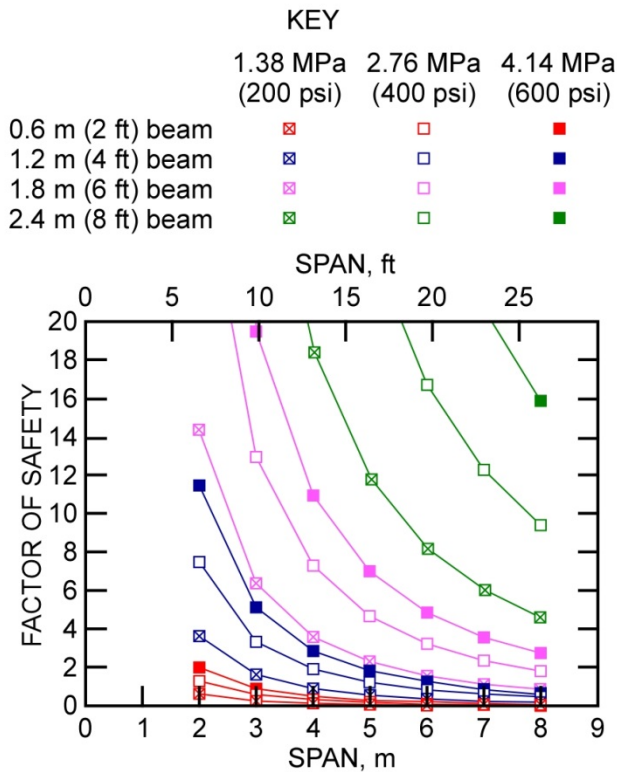
Fig. 1. Factor of safety (flexural failure) versus span length for twelve hypothetical paste backfill beams with varying thicknesses and compressive strengths.

In underhand cut-and-fill stopes, the in-place backfill usually fails in flexure. Therefore, the tensile strength of the paste fill was of interest, particularly reductions in tensile strength caused by the presence of cold joints within the paste backfill. To address this concern, a shotcrete adhesion test system developed by Seymour, et al. [5, 6] was adapted to perform in situ direct tensile tests with paste backfill. In addition, the compressive strength and elastic properties of the paste fill were also needed for a comparative analysis of mine designs using numerical models. This paper presents the results of these mechanical property tests and describes the equipment and procedures that were used to conduct the in situ direct tension tests.

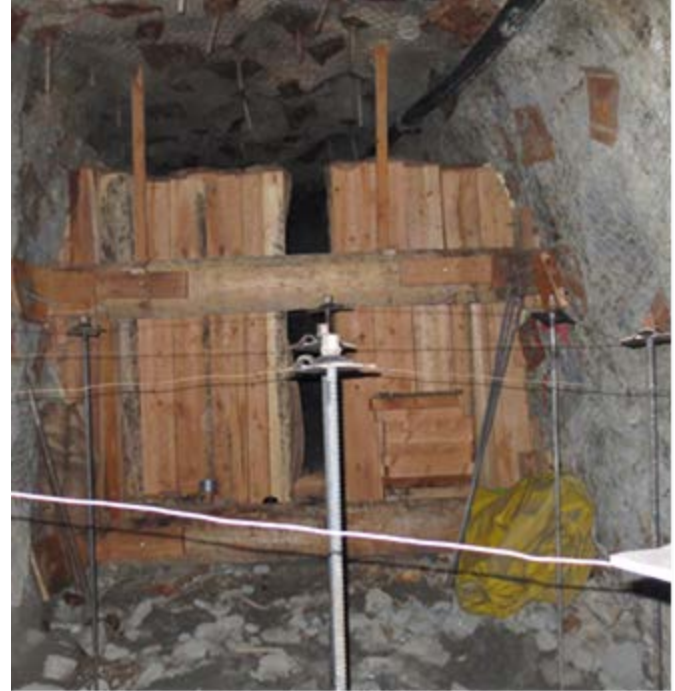
Fig. 2. Preparing a stope for backfill.

Figure 2 shows a typical stope that is being prepared for backfilling. The first step is to spread a layer of broken waste rock or muck on the floor about a 0.15 m (0.5 ft) thick. Steel reinforcement bars or rock bolts are placed into this muck on a 1.2 m by 1.2 m (4 ft by 4 ft) square pattern. The bolts are fitted with steel plates and nuts and then wired together. A sturdy wooden fill fence is constructed at the lower elevation of the stope to contain the backfill and allow for the draining of any excess water. This dam is purposely constructed about 2/3 of the height of the stope to restrict the depth of the pour and thus, limit the thickness of the backfill beam to normally about 2.4 m (8 ft). As a result, a void is intentionally created above the upper surface of the backfill beam.

After the paste fill has cured, a subsequent cut is mined in the vein beneath the backfill. As the loose muck falls away or separates from the bottom of the backfill beam, mesh (usually cyclone fencing) is attached to the exposed bolts to further reinforce the bottom surface of the backfill. Additional bolts are installed as needed to support the mesh and reinforce the backfill. The paste fill, bolts, and mesh thus form a massive structural beam that provides a stable mine roof for the miners working beneath it. As the underhand stope is mined further beneath the backfill, the walls of the stope will begin to converge in response to the high ground stresses at these depths. This horizontal closure exerts pressure on the sides of the backfill beam, eventually causing it to fail in

tension or flexure on its upper surface. The upper portion of the backfill beam is not reinforced with bolts or mesh, nor is it confined. The void above the backfill beam provides space into which the paste fill can fail. Allowing the backfill to fail on the upper surface of the beam creates a safer environment for the miners who are working directly beneath the reinforced bottom portion of the beam.

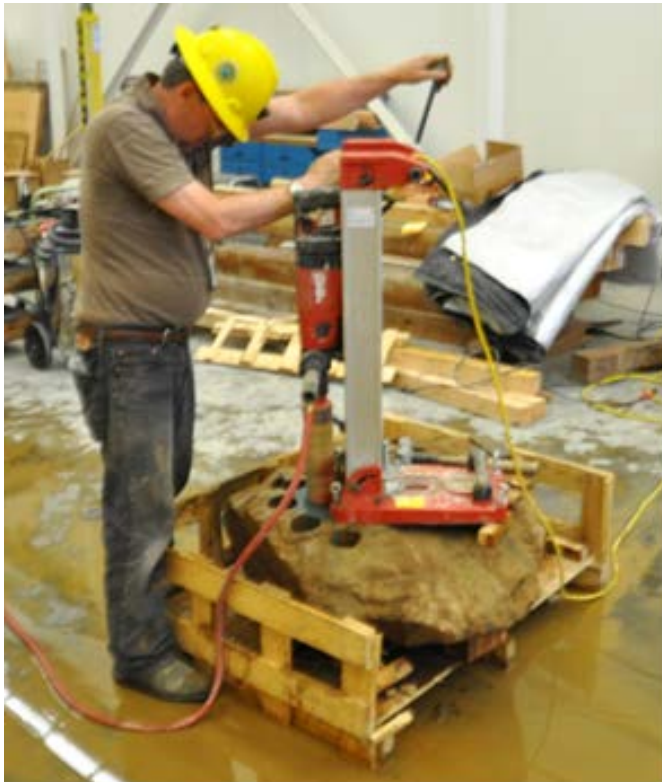
Fig. 3. Core drilling of the smaller paste backfill slab.

The material used for the tests was obtained from two slabs that fell from a roof fall in the 15W stope of the mine. These two slabs were placed on shipping pallets and transported to the SMRD laboratory located in Spokane, Washington. The larger slab was covered with plastic and stored in a secured area behind the facility for in situ direct tension tests. The smaller slab was used to acquire material for standard mechanical property tests. This slab was moved indoors where a set of core samples were obtained using a portable stand-mounted electric drill (Hilti model DD 130) equipped with a 8-cm (3-in) diameter diamond core bit (Figure 3). The cores obtained from the small slab are shown in Figure 4. The color of the core indicates oxidation. The original color of the

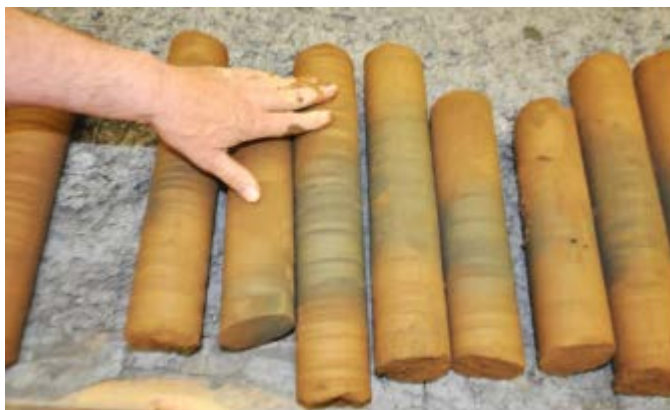
Fig. 4. Cores obtained from the small paste backfill slab.

paste backfill is gray appearing at the centers of the cores. The ends of the core (pointed to by the fingers of the hand) are nearest to the surfaces of the slab and are redder in color due to oxidation of the iron in the mill tailings.

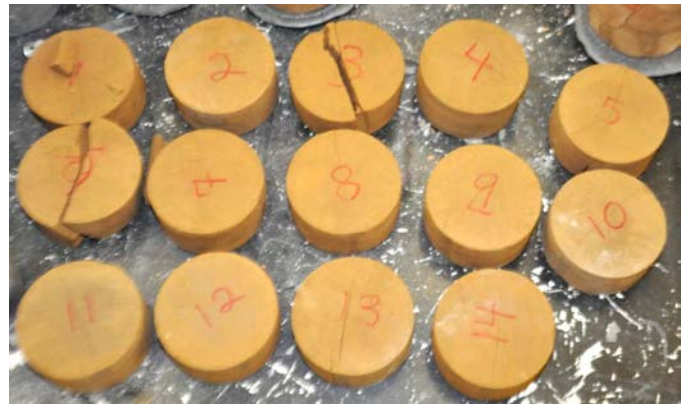
Fig. 5. Brazilian test specimens and typical failure.

Fourteen Brazilian tests were conducted according to ASTM D 3967 procedures using a Tinius Olsen (12,000 lb) servo-controlled press. Figure 5 shows the test specimens and two of the typical failures. Table 1 lists the results from the Brazilian tensile strength tests. The average Brazilian tensile strength (BTS) was 0.47 MPa (68 psi) with a standard deviation of 0.14 MPa (20 psi) and a coefficient of variation of 30%. The average specific gravity was 2.12 with a standard deviation of 0.02 and a coefficient of variation of 1%.

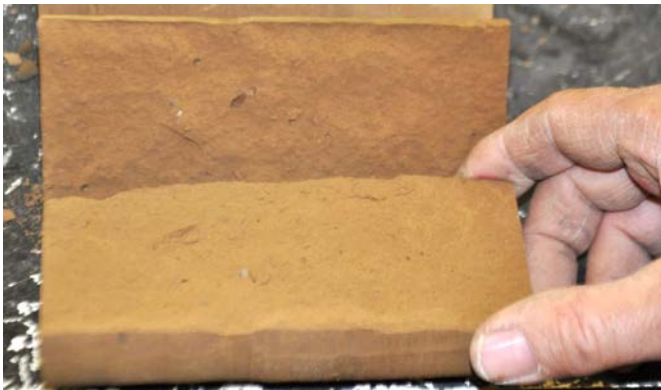
Fig. 7. Typical splitting tensile test failure.

Five splitting tensile strength tests were conducted according to ASTM C 496 procedures using a Reihle (200,000 lb) press. This test is commonly used in concrete construction. The advantage of the splitting tensile strength test is that only one specimen size is needed for both compression and tension testing. A special jig is required to hold the specimen in a horizontal position. Between the specimen and the loading platens are two thin wood strips that deform to the curvature of the specimen and are replaced after each test as shown in Figure 6. A typical failure is shown in Figure 7. The results from the splitting tensile strength tests are listed in Table 2. The average splitting tensile strength (STS) was 0.57 MPa (83 psi) with a standard deviation of 0.10 MPa (15 psi) and a coefficient of variation of 18%. The average specific gravity was 2.10 with a standard deviation of 0.01 and a coefficient of variation of 0.5%.

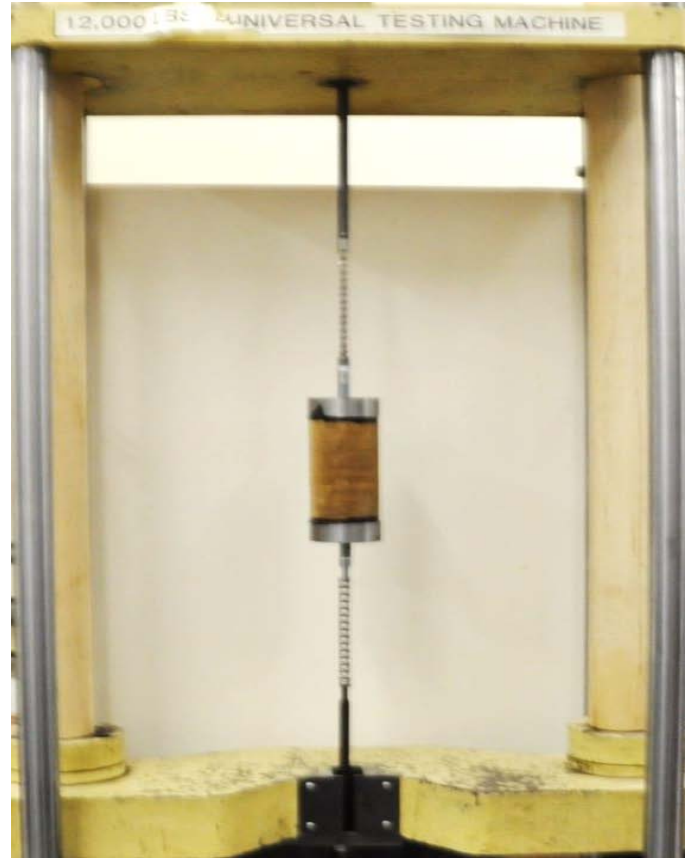
Fig. 8. Direct tensile strength test.

The truest test for tensile strength is obtained by direct tension. Five specimens were tested according to ASTM D 2936, where the specimen was pulled apart. Steel end caps were first epoxied to the ends of each specimen. A chain was attached to the end of each endcap. The chain allows for a straighter pull that minimizes shearing moments applied to the specimen. Attached to the chain was a bolt that was attached to the loading head of the Tinius Olsen press as shown in Figure 8. Usually the specimen did not break horizontally through its center but nearer to one of the endcaps with some shear inclination as shown in Figure 9. Table 3 lists the results from the direct tensile strength tests.

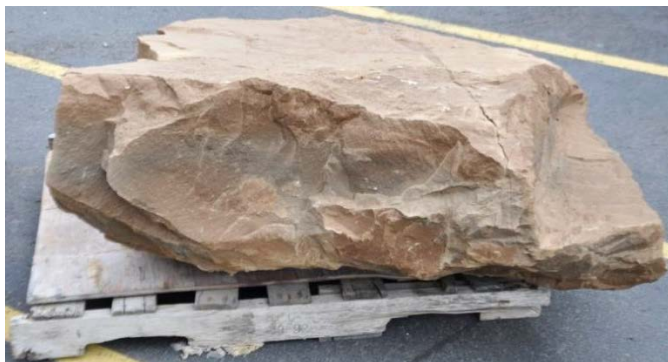
Fig. 10. Larger paste backfill slab on a wood pallet.

A final set of direct tensile tests were performed directly on the larger paste fill slab using an experimental in situ test system that was originally developed for measuring the adhesion strength or bond strength of shotcrete in underground mines [5, 6]. The test involves a number of different drilling steps that produce an attached test core that is then pulled from the host material using a hydraulic ram. The hydraulic pressure at failure is used to compute the tensile failure force and thereby calculate the in situ direct tensile strength of the material. For these tests, the test core is pulled upward against gravity from the larger of the two slabs of paste backfill (Figure 10). This slab is about 1 m (3 ft) long by 1 m (3 ft) wide by 0.6 m (2 ft) high. In this slab, there appears to be a cold joint that lies about 15 cm (0.5 ft) below the top surface of the slab and varies from zero at the surface to a depth of about 30 cm (1 ft).

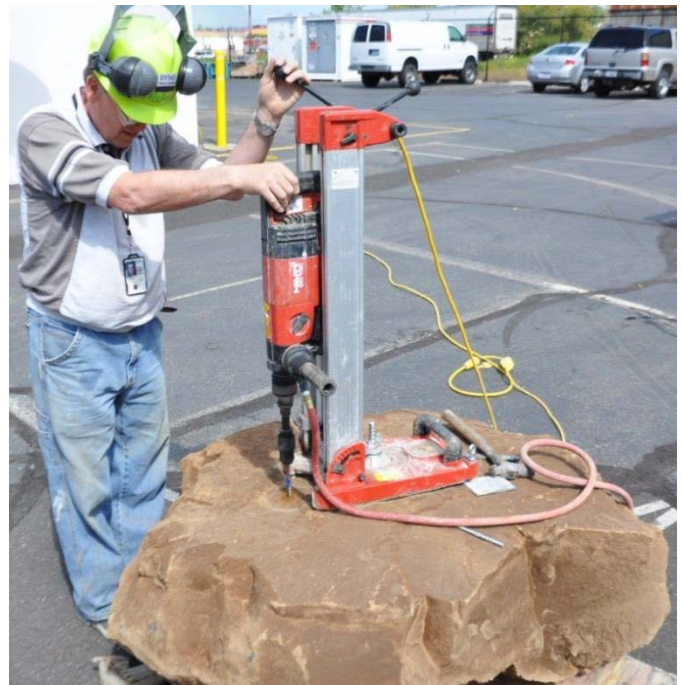
Fig. 11. Drill and stand attached to the backfill slab.

electric hand drill was used to install two mechanical anchored bolts that along with wing-nuts secured the drill stand to the slab. The construction drill was attached to the drill stand and a water hose was connected to the drill. A series of drilling steps are then completed using this stand-mounted drill. The first is to drill a pilot hole for an epoxy anchored bolt as shown in Figure 11. This hole has a diameter of 1 cm (7/16 in) and is drilled to a depth of 6 cm (2.375 in). A two part, high strength epoxy is applied into this hole to anchor the spiral shaped pulling bolt into the slab as shown in Figure 12. The pulling bolt is inserted into this hole, and the epoxy is allowed to cure as shown in Figure 13. The epoxy manufacturer's directions specify one hour of cure time at temperatures above 21 degrees C (70 degrees F).

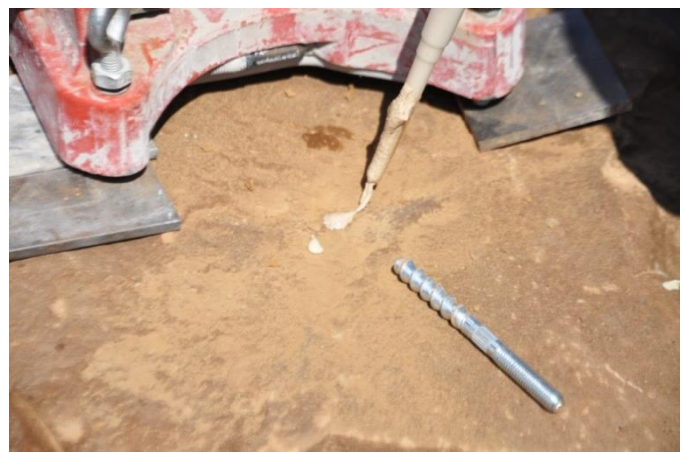
Fig. 12. Pilot hole filled with epoxy prior to insertion of pulling bolt.

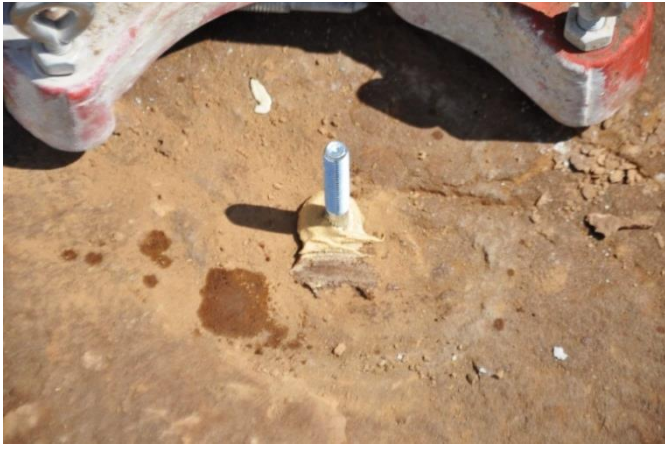
Fig. 13. Pulling bolt placed in the epoxy and cured overnight.

However, this curing time proved to be inadequate because in the first four tests, the bolt was pulled out of the slab. The testing procedure was modified to provide more time for the epoxy to cure. This increased curing time was thought to be needed in order to compensate for the high moisture content in the slab. Tests were performed the following day after the epoxy had cured overnight. The next drilling step used a 10-cm (4-in) diameter core bit that was centered on the epoxied bolt as shown in Figure 14. This hole was drilled to a depth of 20 cm (8 in) into the interior of the slab creating the test core. The depth was marked with tape so that the bit would penetrate the joint but not exit the bottom surface of the slab as shown in Figure 15.

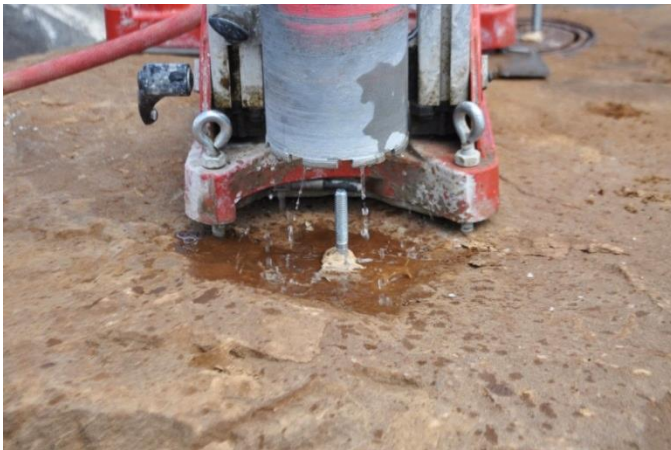
Fig. 14. 10 cm (4 in) core bit centered over the pulling bolt.

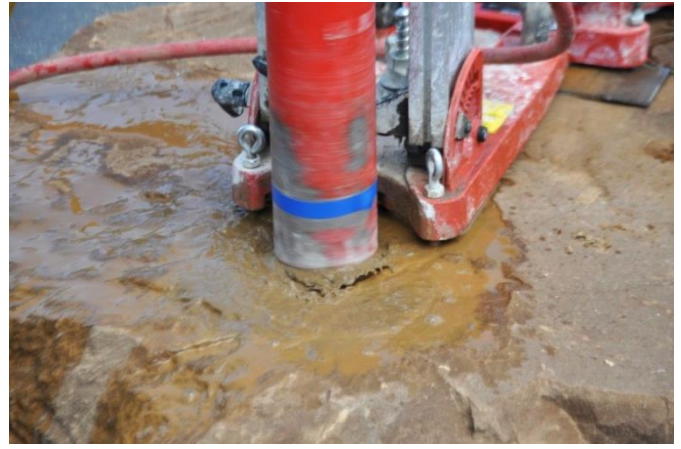
Fig. 15. The core bit is drilled to the depth of the blue tape.

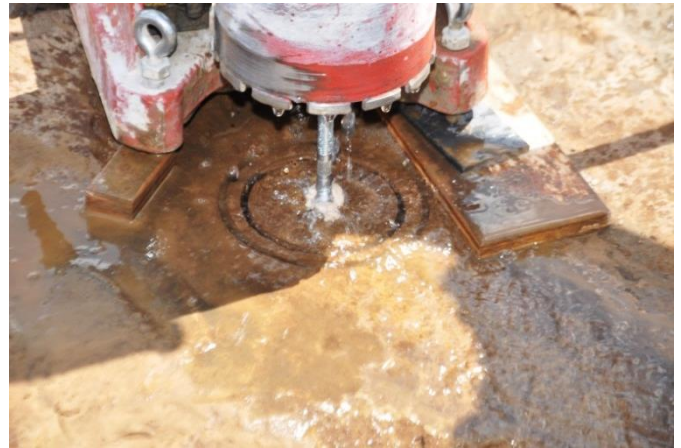
Fig. 16. Shallow kerf drilled around the test core using a 13cm (5 in) core bit.

The final drilling step was completed using a nominal 13-cm (5-in) diameter core bit. This hole was also centered on the pulling bolt, but it was only drilled to the shallow depth of its teeth to produce a kerf around the attached test core as shown in Figure 16. This kerf allowed the pulling fixture to be centered on the pulling bolt and aligned with its axis, thereby minimizing eccentricity during the direction tension test [5].

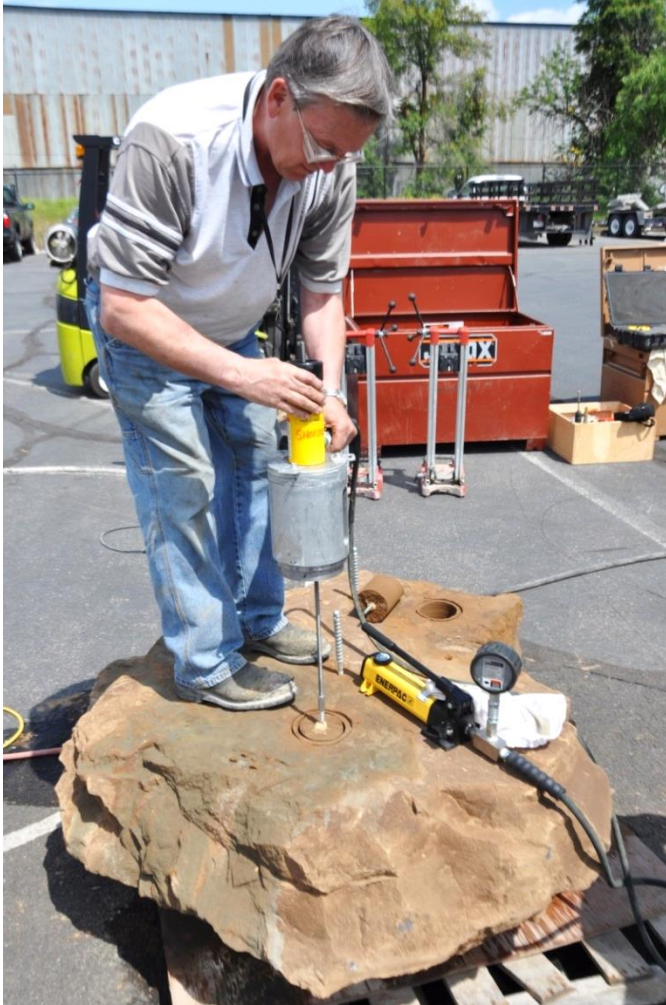
Fig. 17. Hydraulic ram and pulling fixture being inserted over the all-thread.

A coupling nut is then attached to the pulling bolt, and a long piece of 0.9-cm (3/8-in) diameter all-thread is screwed into the coupling nut. The pulling fixture and hydraulic ram are then carefully inserted over the all-thread as shown in Figure 17.

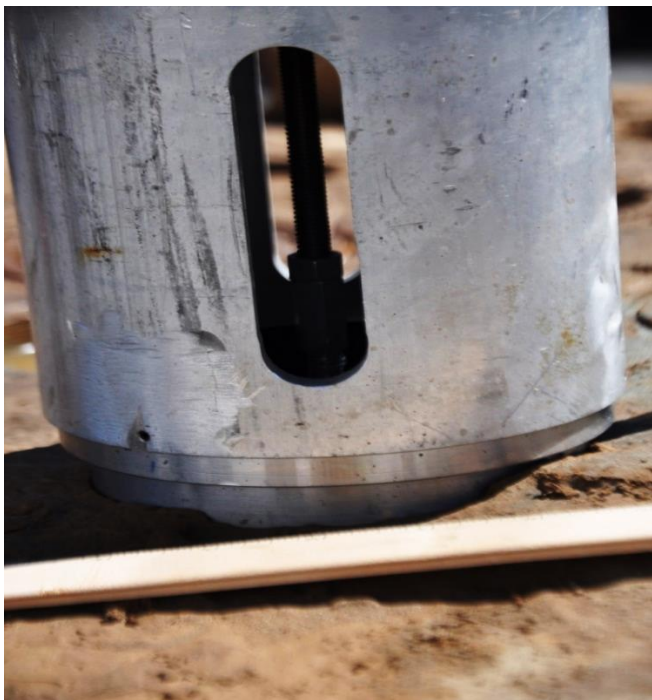
Fig. 18. Seating ring of pulling fixture inserted into kerf.

The seating ring on the pulling fixture is inserted into the kerf as shown in Figure 18. Washers and a speed nut are then attached to the all-thread near the top of the hydraulic ram as shown in Figure 19, and a hydraulic hand-pump, equipped with a pressure gauge, is attached to the hydraulic ram as shown in Figure 20.

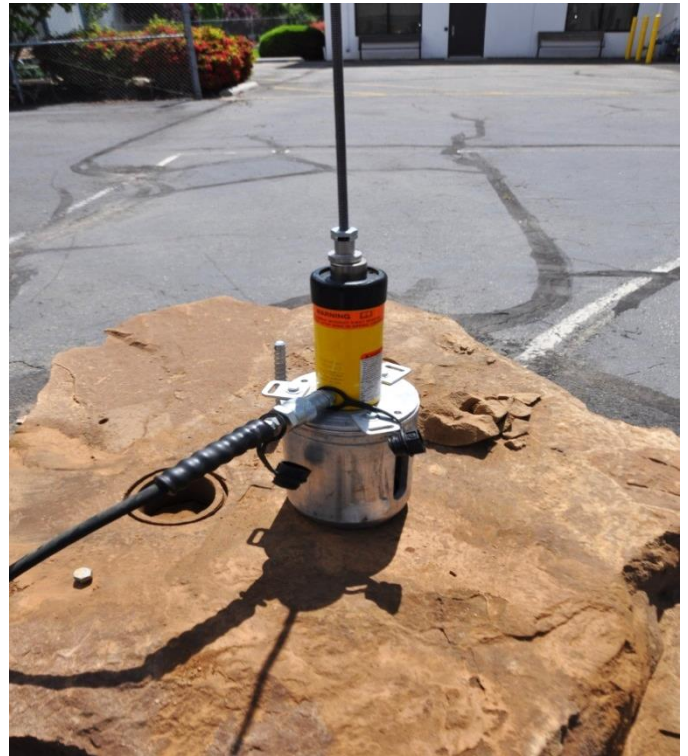
Fig. 19. The hydraulic ram pushes upward against a nut attached to the all-thread that is in turn connected to a pulling bolt anchored in the test core.

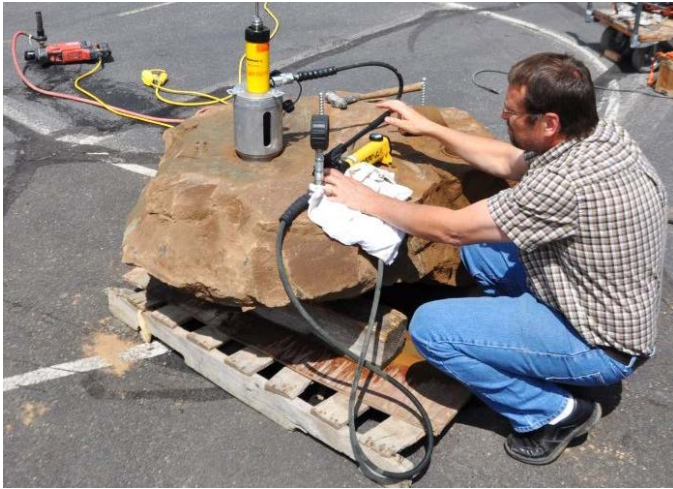
Fig. 20. Performing an in situ direct tensile strength test.

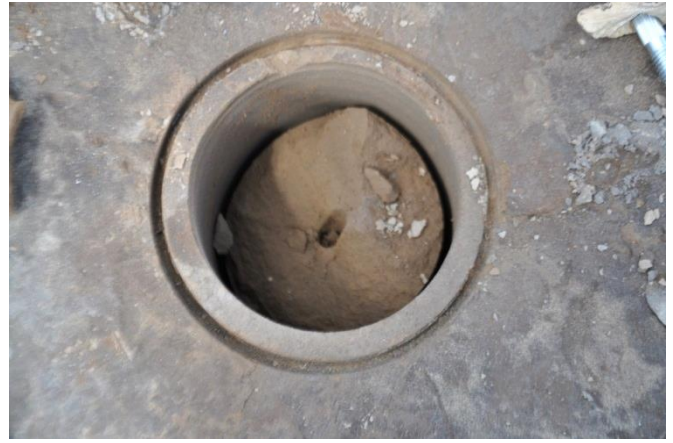
Fig. 23. Shear stress failure shown on the portion of test core remaining in the drill hole.

During these in situ direct tension tests, the test cores generally showed one of the following three types of failure modes: tensile failure, shear failure, or a bolt pull-out failure. Most of the test cores broke in tension at a variety of depths. Figure 21 shows a typical tensile shallow failure. Figure 22 shows a deeper failure in the slab that also includes some shear because the failure surface is included about 45 degrees to the core axis. The failure surface can also be identified by inspecting the test hole as shown in Figure 23. A typical bolt pull-out failure is shown in Figure 24. Although the test cores were drilled to purposely intersect an assumed cold joint, only one of the test cores broke near that horizon. Figure 25 shows the longest of specimens being extracted from the slab, and Figure 26 shows that it might match the depth of the inferred cold joint in the slab. Depending on the type and length of failure, a single test hole was sometimes used for multiple tests. A new pilot hole was simply drilled, filled with epoxy, and a new pulling bolt inserted into the hole. In this manner, several tests could be conducted using a single drill set-up. Figure 27 shows the slab near the completion of these in situ direct tension tests.

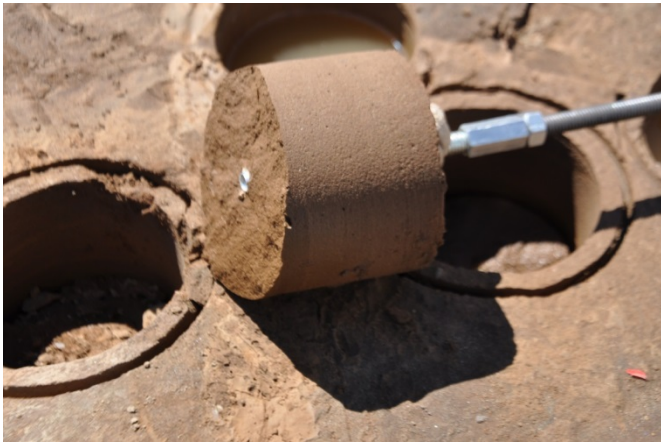
Fig. 21. Typical shallow tensile failure in the paste backfill.

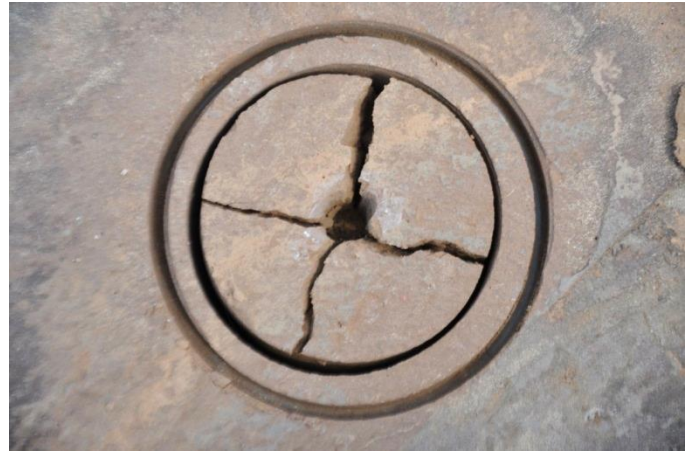
Fig. 24. Typical failure when the epoxy anchored bolt is pulled out of the slab.

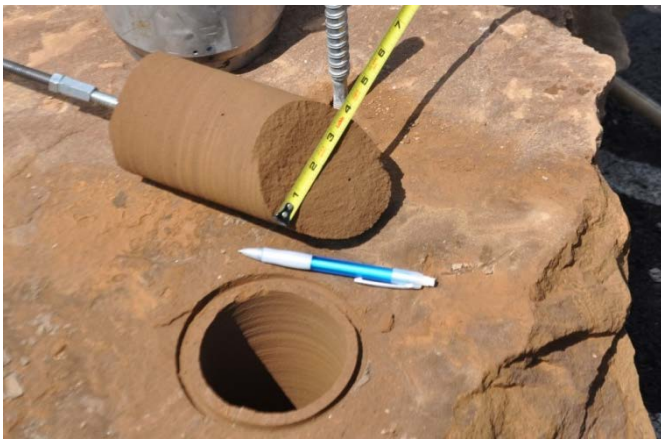
Fig. 22. Typical shear stress failure oriented about 45 degrees to the axis of the test core.

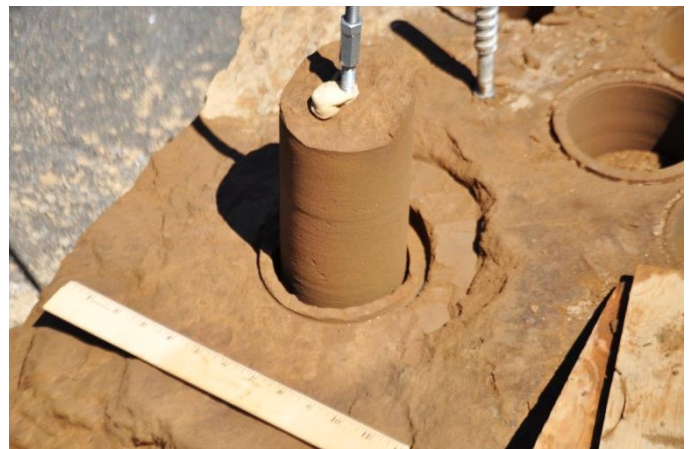
Fig. 25. Removing the longest test core from the backfill slab.

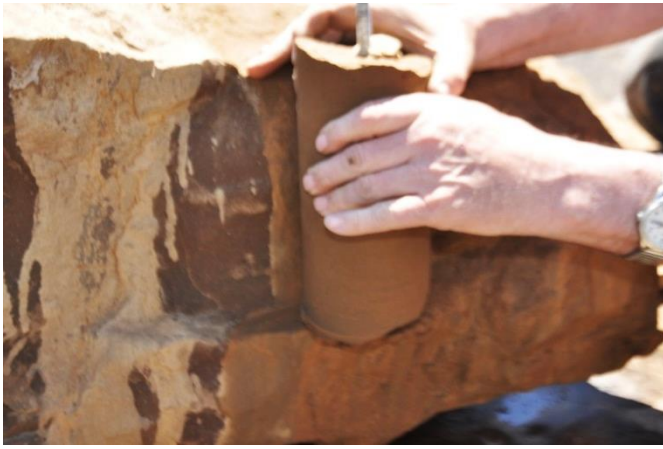
Fig. 26. Failure surface of core appears to match a cold joint.

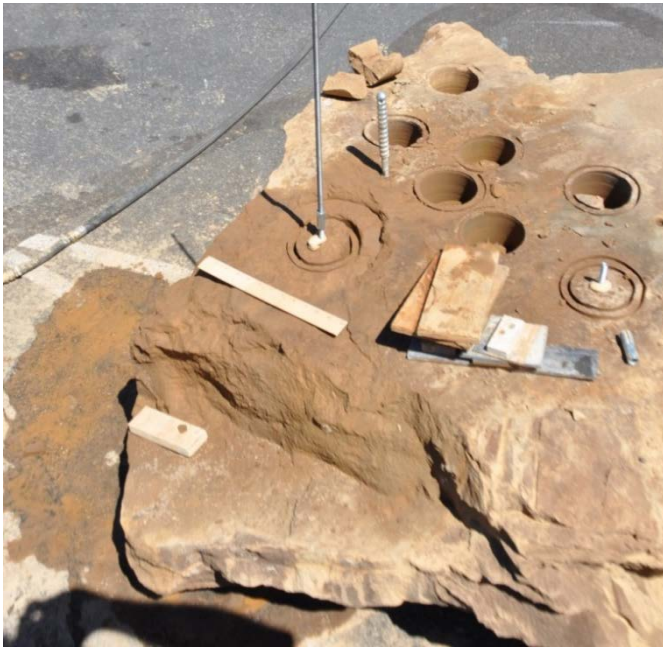
Fig. 27. Paste backfill slab near the completion of in situ direct tensile testing.

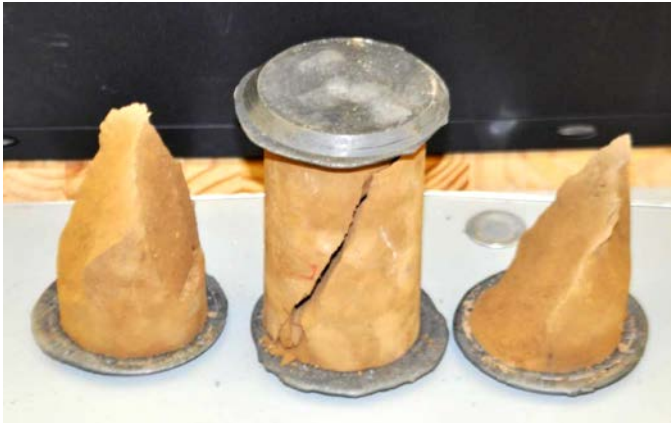
Fig. 28. Typical failure for unconfined compression tests.

Unconfined compression tests were conducted with cores obtained from the smaller paste backfill slab. These core samples were cut to a length of about 14 cm (5.5 in), approximately twice their diameter. Prior to testing, the ends of the specimens were sulfur-capped because the paste fill material was too delicate for surface grinding. Unconfined compression tests were conducted using the Reihle press. The results of these compression tests are listed in Table 6. The average unconfined compressive strength (UCS) of the five test specimens was 4.15 MPa (602 psi) with a standard deviation of 0.33 MPa (48 psi) and a coefficient of variation of 8%. Figure 28 shows some of the typical shear failures exhibited by the compression test specimens.

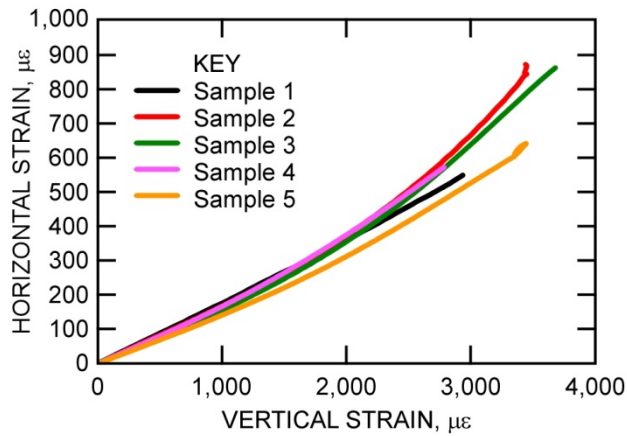
Fig. 32. Paste backfill horizontal versus vertical (axial) strain.

The five stress-strain plots obtained from these tests are shown in Figure 31. All five tests produced similar results. The backfill does not have a linear relationship between stress and strain to failure. As the stress increased, the modulus of elasticity decreases becoming plastic as it approaches the ultimate compressive strength (UCS). However, the relationship between the horizontal and vertical strain is mostly linear as it approaches failure as shown in Figure 32. The absolute value of the ratio of horizontal to vertical strain near the center portion of the curve gives a constant value of 0.17 for Poisson's ratio.

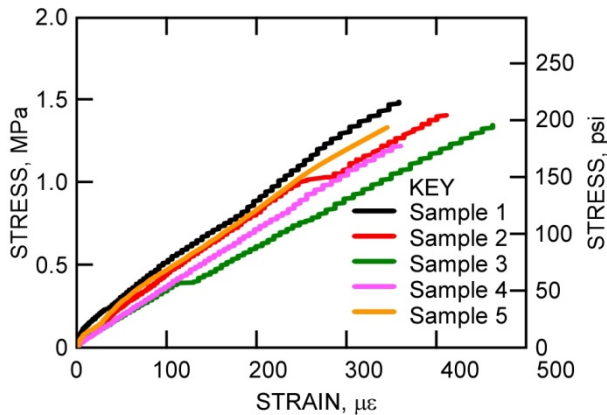
Fig. 33. Paste backfill stress vs. strain from 0 - 30% of UCS.

Because the stress-strain diagram of the paste backfill is non-linear it was divided into three segments at 30, 60, and 90 percent of the average UCS. This results in a three piecewise linear approximation to the non-linear curve. The separate plotted results are shown in Figures 33, 34, and 35. Young's modulus from 0-30% of its UCS is 3.59 GPa (0.52 million psi); from 30-60%, it is 2.28 GPa (0.33 million psi); and from 60-90%, it is 1.10 GPa (0.16 million psi).
