International Journal of Mining Science and Technology

## Analysis of alternatives for using cable bolts as primary support at two low-seam coal mines

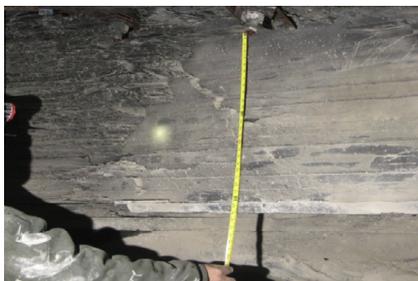
Fig. 1. Laminated silty shale roof rocks observed at Mine B.

The silty shale responsible for difficult ground conditions can be up to 10 m thick and may contain sandstone intrusions. It is overlain by a stronger interbedded sandstone and shale unit. Sandstone is occasionally found close to the coalbed being mined, but typically was found no closer than 2.4 m above the coal bed in the area studied at Mine B. Observations of the rock exposed in roof falls show that it tends to delaminate in thin slabs that are about 25–75 mm thick. Fig. 1 shows the delaminated roof exposed at Mine A and Fig. 2 shows the laminated shale exposed in a roof fall at Mine B.

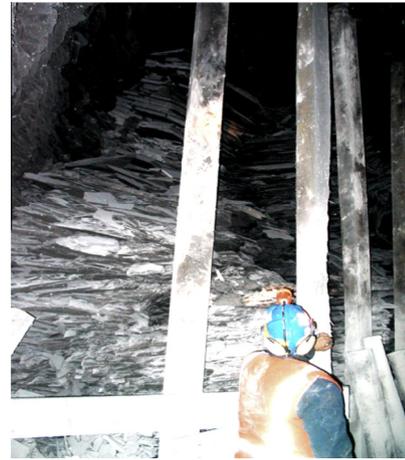
Fig. 2. Large roof fall at Mine A showing laminated nature of the silty shale roof rocks and steep-sided collapse cavity.

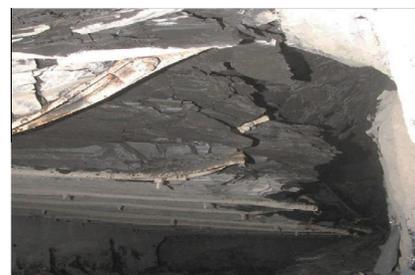
Fig. 3. Severe cutter formation and roof cantilevering at Mine B.

At Mine B, roof control in the areas where the low-strength silty shale is present was generally satisfactory until a 300-m-long roof fall occurred in 2013. The roof also exhibits signs of excessive horizontal stress, with cutters and stress fractures observed. Fig. 3 illustrates the roof damage caused by a cutter that formed well outby the advancing faces at Mine B. The mine layout is adjusted so that the development direction is favorable relative to the major horizontal stress. Prior to the major roof fall, cable bolts were used as part of the primary support system. The large roof fall prompted a change in the mining layout and support system.

tensile stresses in the T3 channel, which may shear the head of the cable bolt [11]. Fig. 3 shows an example of the absence of cable bolts along the right side of the entry, which may have sheared in this manner.

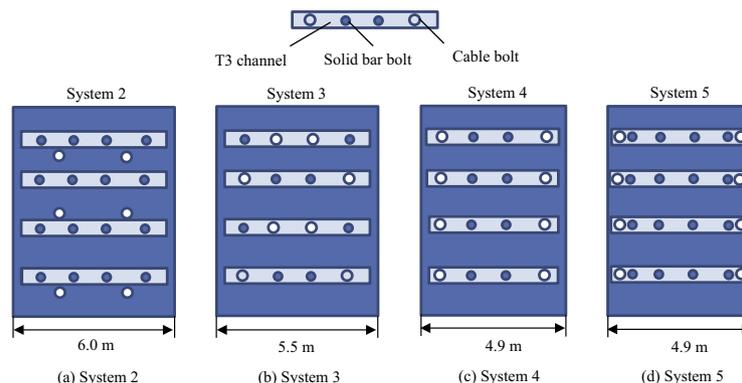
Fig. 4. Schematic illustration of the support systems evaluated, showing locations of solid bar bolts, cable bolts, T3 channel, and entry widths.

Support systems 2 and 3 are the original support systems used at the case study mines, in which alternating rows of cable bolts were used. A schematic illustration of these support systems is presented in Fig. 4.

Support systems 4 and 5 are the final support systems which make use of bolts and cable bolts in the same row as primary supports at Mine A and Mine B respectively.

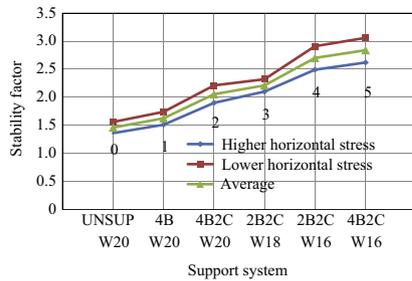
Fig. 5. Assessment of support systems using a recently developed equation for the prediction of entry stability against large roof falls [1].

scenarios are used. Fig. 5 presents the assessed SF values for the five support systems calculated using the prediction equation. It can be seen from the results that the range of horizontal stress conditions considered can produce a variation in SF of about 0.5. The results for the individual cases are summarized below.

- System 0 (UNSUP-W20)*: the roof of the unsupported entry has an SF of 1.46, which falls below the typical range of SF values for supported entries. This confirms that support is required to prevent large-scale roof falls.

- System 1 (4B W20)*: the results for the system with four 1.8-m-long conventional bolts suggest that the addition of large-scale collapse since the SF is increased to only 1.62. This SF value is at the lower end of current roof support practice, indicating that additional support may be required.

- System 2 (4B2C W18)*: the 4-bolt and 2-cable bolt system causes a significant improvement in the SF to 2.06. The improvement is attributed to the cable bolts which are located in rows 1.8 m apart.

- System 3 (2B2C W20)*: this system is assessed to have an SF of 2.21. This higher value is a result of the cable bolts row spacing of 1.2 m in this system, compared to 1.8 m in System 2.

- System 4 (2B2C W16)*: this result shows the impact of reducing the entry width from 6.0 to 4.9 m and simultaneously reducing the cable bolt spacing from 1.8 to 1.2 m. A considerable increase in SF occurs, to a value of 2.70.

- System 5 (4B2C W16)*: this system used at Mine B mine is similar to the system at Mine A (System 4) except that four, fully grouted, conventional bolts are used and the cable bolts are not tensioned. As expected the SF is greater at 2.84. Note that the assessment equation does not consider the application or absence of pre-tension.

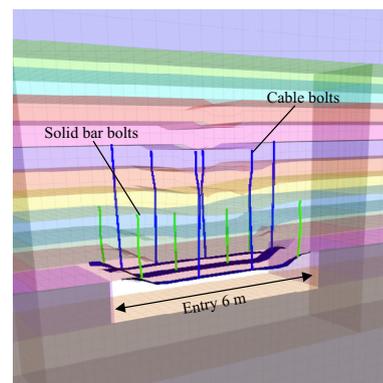
Fig. 6. Example showing the numerical model used to evaluate support system 3.

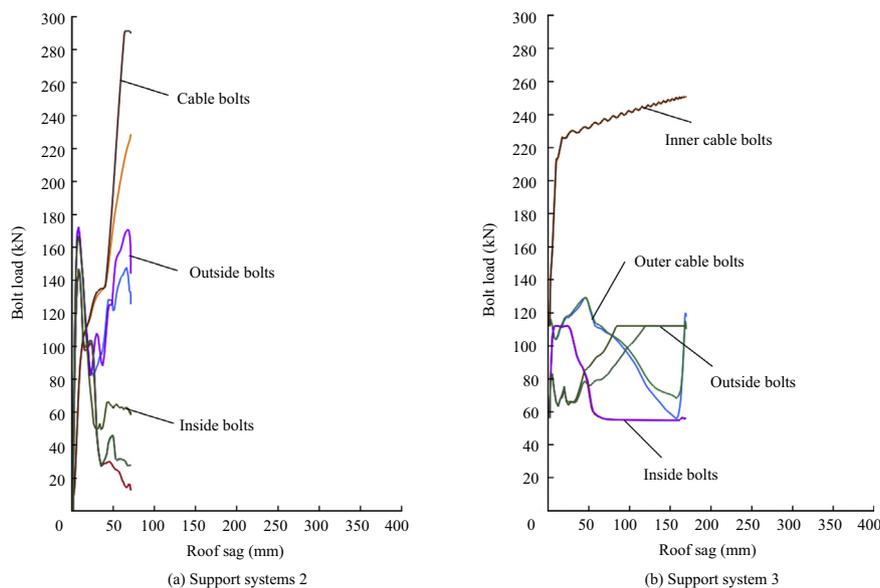
**Fig. 7.** Numerical model results showing bolt loads and roof sag for two support systems at the point of critical stability.

The performance of the fully-grouted, conventional bolt and cable bolt support systems 2 and 3 were evaluated as part of this study. Fig. 7 shows the bolt load versus roof sag for the critical stability condition just before the roof collapses for the two systems. It can be seen that system 2 reaches its critical loading state after about 3 in. of roof sag, while system 3 accommodates up to 7 in. of roof sag. This is not necessarily an advantage, since the roof yield has extended above the two inner cable bolts and they are not achieving their full load capacity.

*System 2:* Fig. 7a shows that one of the cable bolts has reached its maximum tensile load. The other cable bolt is not fully loaded yet. Looking at the development of the bolt loads, one can see that the conventional bolts achieve their maximum load of about 15–17 ton after about 0.5 in. of roof sag. As yielding of the roof rock continues to develop upwards, the conventional bolts start to shed load as they become encapsulated by the yielding roof rocks. The two inner conventional bolts lose most of their load at about 50 mm of roof sag. At about 50 mm of sag, the passive cable bolts have generated about 130 kN of load, similar to the conventional bolts, which are unloading at this stage. When the roof sag exceeds 50 mm, the cable bolt load increases rapidly, with one of the cable bolts achieving its maximum tensile strength and appears to have started to yield. It seems that the passive cable bolts and fully grouted, conventional primary bolts act as two individual systems, with the impact of the cable bolts dominating after the fully-grouted, conventional bolts start to shed load.

*System 3:* the roof sag and bolt load curves shown in Fig. 7b demonstrates that the pre-tension of the cable bolts in system 3 causes the conventional bolts and cable bolts to respond (develop loading) at approximately the same rate. Both support types achieve high loads at less than 25 mm of roof sag. However, the high loads are only achieved by the two inner cable bolts, while

the two outer cable bolts remain at a relatively low stress. The two inner conventional bolts are slowly yielding, because their anchorage zone is located within yielding rock. The height of yield of rock is highest near the center of the entry and envelops the two inner cable bolts sooner than the outer bolts.

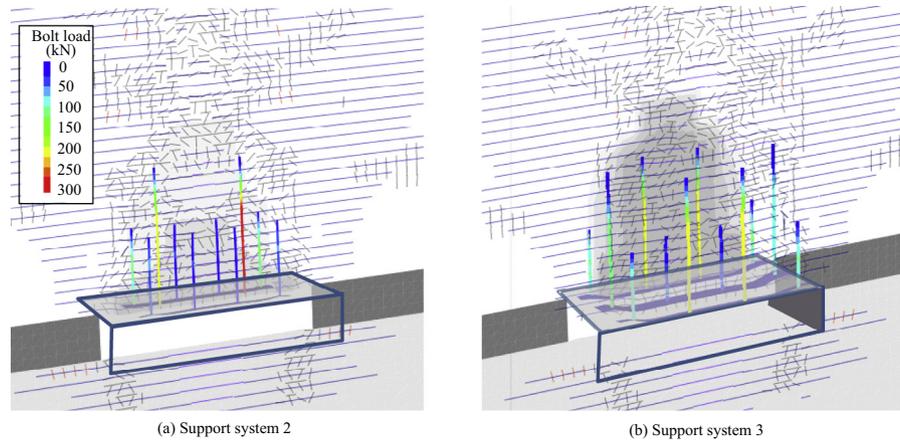
Fig. 8. Diagrams showing support loads and rock damage around entries for support systems at the point of critical stability, just prior to roof collapse.

Fig. 8 shows the extent of rock damage and bolt loads at the critical stability condition for support systems 2 and 3. The distribution of bolt loads can clearly be seen. The gray shading is an indicator of roof sag, showing much greater roof sag being accommodated by system 3. Bedding shear and rock fracture is also indicated in the diagrams. The two inner cable bolts of system 3 can be seen to be encapsulated within the sagging dome of yielded rock. Some floor yield is indicated in both cases.

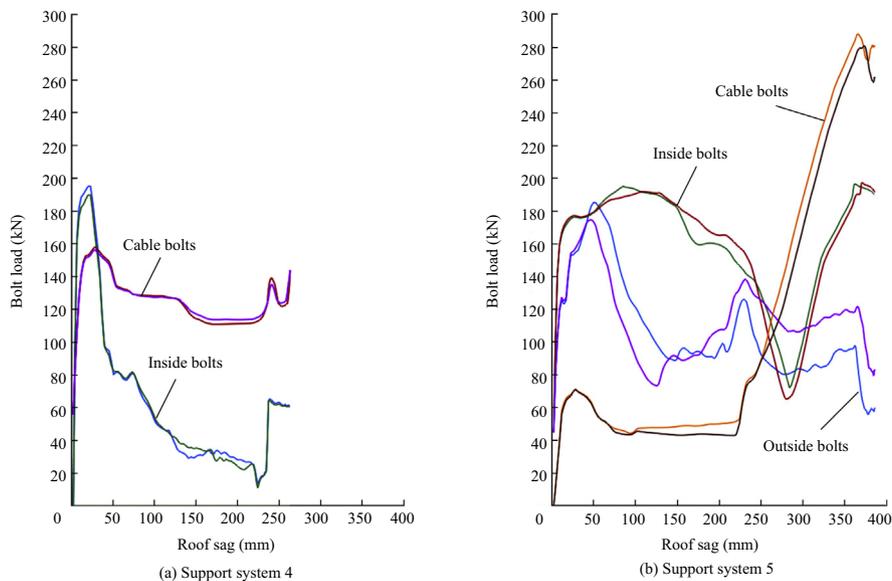
Fig. 9. Numerical model results showing bolt loads and roof sag for two support systems at the point of critical stability.

**System 4:** Fig. 9 again shows that the pre-tensioned cable bolts in system 4 respond much sooner than passive cable bolts. The cable bolts and fully grouted bolts achieve significant loading at about 25 mm of roof sag. The roof sag is arrested after about 250 mm of sag. The fully-grouted bolts start to shed load when the roof sag exceeds about 25 mm. The cable bolts and fully grouted bolts initially act as a combined system. Once the roof yield has progressed above the grouted bolts, the cable bolts maintain a significant load.

**System 5:** the results show that roof sag of about 375 mm can be accommodated before the critical stability condition is reached. This is thought to be related to the added reinforcement provided by the four pre-tensioned and fully-grouted conventional bolts, compared to only two fully-grouted conventional bolts in system 4. Here the passive cable bolts are seen to act like a separate support system, only becoming active after the fully-grouted conventional bolts have shed most of their load.

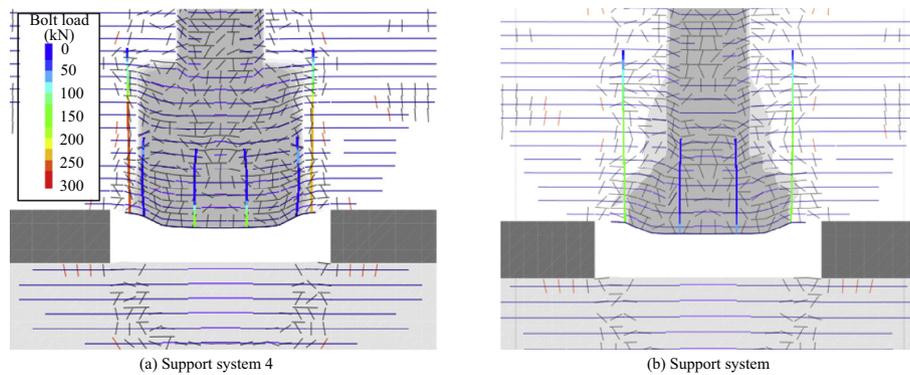
Fig. 10. Diagrams showing support loads and rock damage around entries for both systems at the point of critical stability, just prior to roof collapse.

Fig. 10 shows the rock yield and bolt loading at the point of critical stability for support systems 4 and 5. Fig. 10 clearly shows how the T3 channel acts as a sling between the two cable bolts. In both cases the fully grouted bolts provide only limited support or reinforcement to the yielding roof. The sling action can produce large

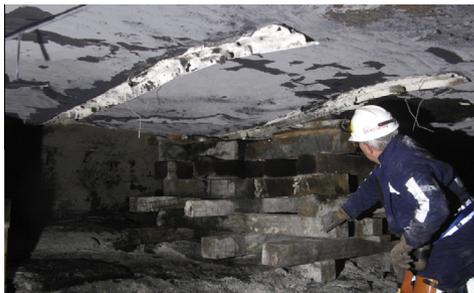
Fig. 11. Example of support system 5 at Mine B.

Fig. 11 shows a case where significant roof sag occurred and the damaged roof is held in position by the sling-effect of the cable bolts and the T3 channel. In Mine B, roof sag was caused by roof yield that has apparently developed above the fully grouted bolts. The roof is supported from the two outer cable bolts, and the T3 channel acts as a sling. Given the low mined height, the mine operational staff could readily identify areas which sagged. When this condition was observed, cribs or other types of standing supports were typically installed to arrest further movement. So, although the support system did not prevent roof sag it did provide a warning of damaged roof allowing remedial actions to be taken to prevent collapse.
