Strength and Elastic Properties of Paste Backfill at the Lucky Friday Mine, Mullan, Idaho

Johnson, J.C., Seymour, J.B., Martin, L.A., Stepan, M. and Arkoosh, A.

This paper was prepared for presentation at the 49th US Rock Mechanics / Geomechanics Symposium held in San Francisco, CA, USA, 28 June-1 July 2015.

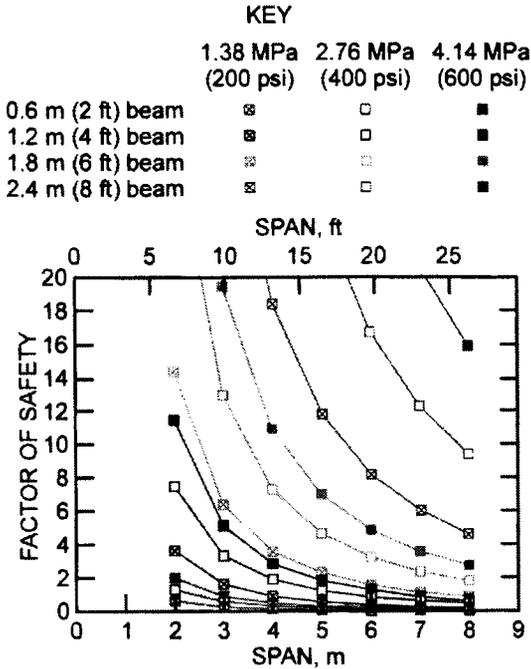
Fig. 1. Factor of safety (flexural failure) versus span length for twelve hypothetical paste backfill beams with varying thicknesses and compressive strengths.

Ground falls are typically the leading cause of fatalities in underground metal mines and a significant source of lost-time injuries [1]. As a result, a well-developed ground support plan needs to be consistently implemented to safely mine under these conditions. In deep underground metal mines, underhand cut-and-fill mining methods are used to mine narrow, steeply dipping veins of ore [2, 3]. In some of these mines, a paste backfill composed of cemented mill tailings is used to support the mined-out stopes or cuts. This cemented backfill forms a massive beam that provides a safe, stable back or roof for the miners who work beneath it on subsequently deeper cuts. The stability of this engineered beam is largely determined by two variables—its thickness and strength. Figure 1 shows computed factors of safety for twelve hypothetical backfill beams using four values of thickness and three values of strength [4]. As indicated by these curves, the thickness of the backfill beam is the primary immediate concern, but the backfill's strength becomes more important as the thickness of the beam increases.

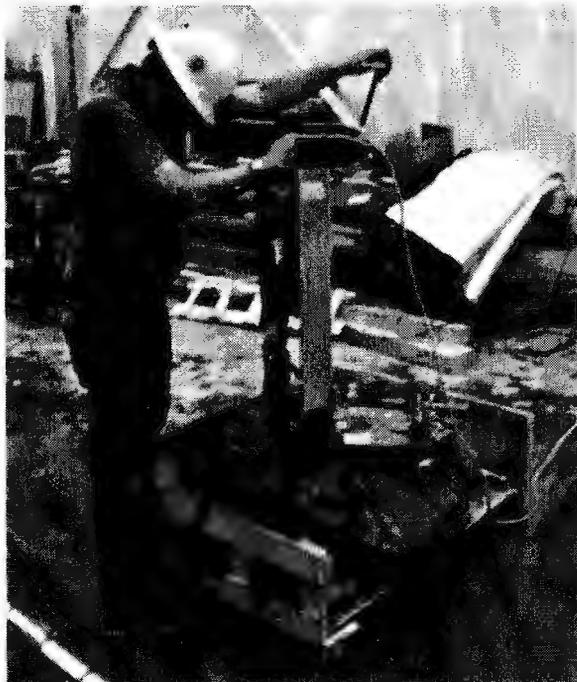
Fig. 3. Core drilling of the smaller paste backfill slab.

electric drill (Hilti model DD 130) equipped with a 8-cm (3-in) diameter diamond core bit (Figure 3). The cores obtained from the small slab are shown in Figure 4. The color of the core indicates oxidation. The original color of the paste backfill is gray appearing at the centers of the cores. The ends of the core (pointed to by the fingers of the hand) are nearest to the surfaces of the slab and are redder in color due to oxidation of the iron in the mill tailings.

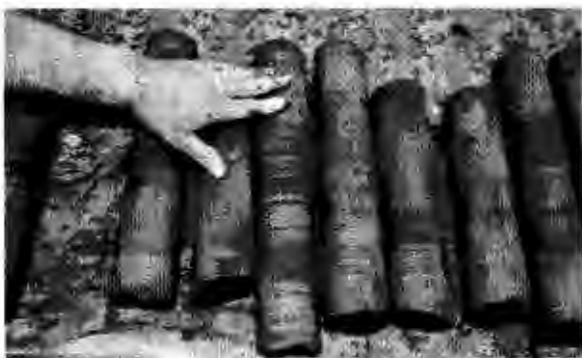
Fig. 4. Cores obtained from the small paste backfill slab.

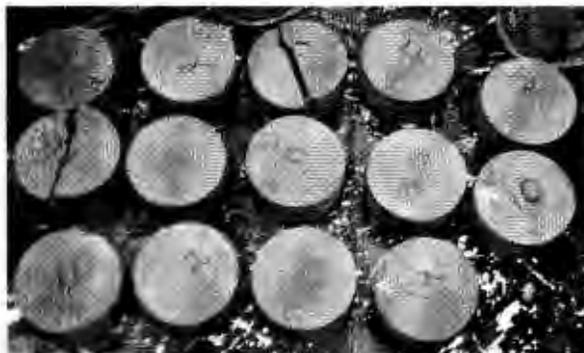
Fig. 5. Brazilian test specimens and typical failure.

Fourteen Brazilian tests were conducted according to ASTM D 3967 procedures using a Tinius Olsen (12,000 lb) servo-controlled press. Figure 5 shows the test specimens and two of the typical failures. Table 1 lists the results from the Brazilian tensile strength tests. The average Brazilian tensile strength (BTS) was 0.47 MPa

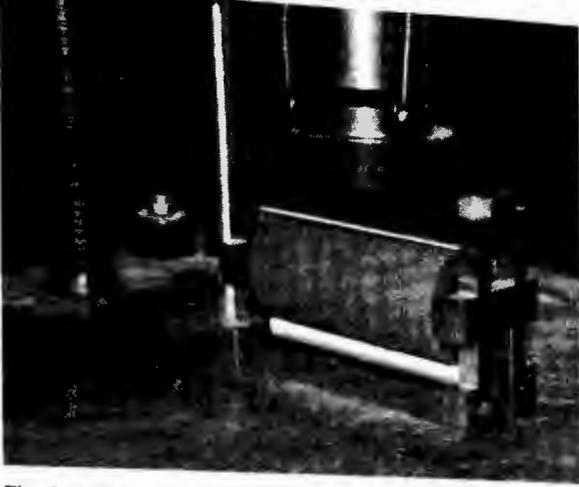
Fig. 6. Splitting tensile strength test.

Five splitting tensile strength tests were conducted according to ASTM C 496 procedures using a Reihle (200,000 lb) press. This test is commonly used in concrete construction. The advantage of the splitting tensile strength test is that only one specimen size is needed for both compression and tension testing. A special jig is required to hold the specimen in a horizontal position. Between the specimen and the loading platens are two thin wood strips that deform to the curvature of the specimen and are replaced after each test as shown in Figure 6. A typical failure is shown in Figure 7. The results from the splitting tensile strength tests are listed in Table 2. The average splitting tensile strength (STS) was 0.57 MPa (83 psi) with a standard deviation of 0.10 MPa (15 psi) and a coefficient of variation of 18%. The average specific gravity was 2.10 with a standard deviation of 0.01 and a coefficient of variation of 0.5%.

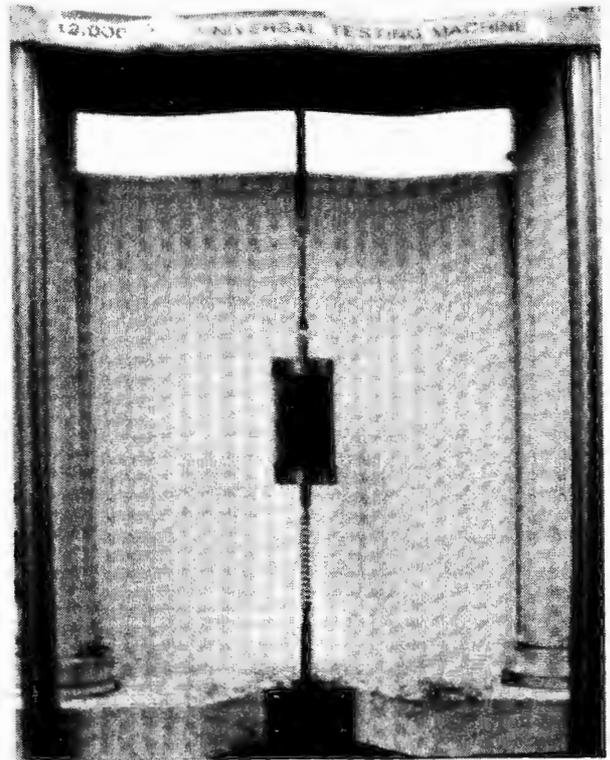
Fig. 8. Direct tensile strength test.

The truest test for tensile strength is obtained by direct tension. Five specimens were tested according to ASTM D 2936, where the specimen was pulled apart. Steel end caps were first epoxied to the ends of each specimen. A chain was attached to the end of each endcap. The chain allows for a straighter pull that minimizes shearing moments applied to the specimen. Attached to the chain was a bolt that was attached to the loading head of the Tinius Olsen press as shown in Figure 8. Usually the specimen did not break horizontally through its center but nearer to one of the endcaps with some shear inclination as shown in Figure 9. Table 3 lists the results from the direct tensile strength tests.

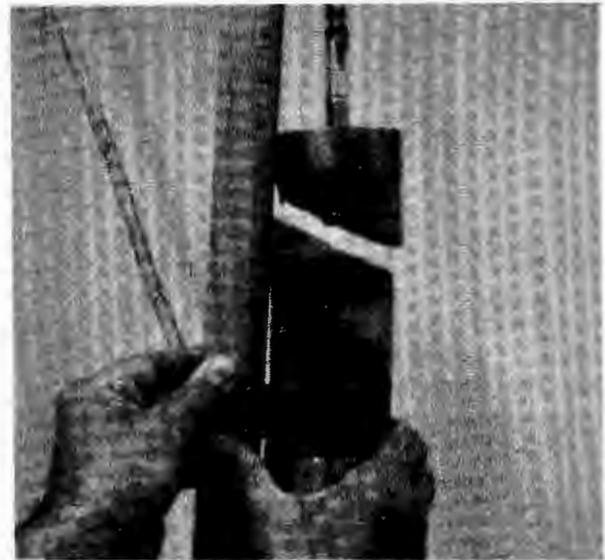
Fig. 9. Typical direct tensile failure.

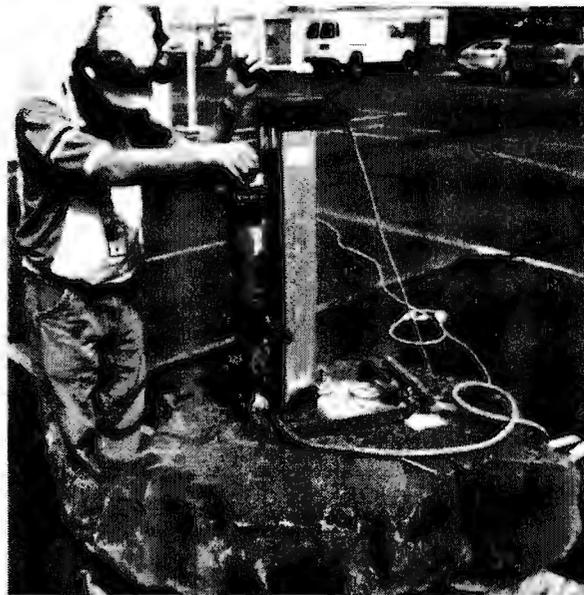
Fig. 11. Drill and stand attached to the backfill slab.

electric hand drill was used to install two mechanical anchored bolts that along with wing-nuts secured the drill stand to the slab. The construction drill was attached to the drill stand and a water hose was connected to the drill. A series of drilling steps are then completed using this stand-mounted drill. The first is to drill a pilot hole for an epoxy anchored bolt as shown in Figure 11. This hole has a diameter of 1 cm (7/16 in) and is drilled to a depth of 6 cm (2.375 in). A two part, high strength epoxy is applied into this hole to anchor the spiral shaped pulling bolt into the slab as shown in Figure 12. The pulling bolt is inserted into this hole, and the epoxy is allowed to cure as shown in Figure 13. The epoxy manufacturer's directions specify one hour of cure time at temperatures above 21 degrees C (70 degrees F).

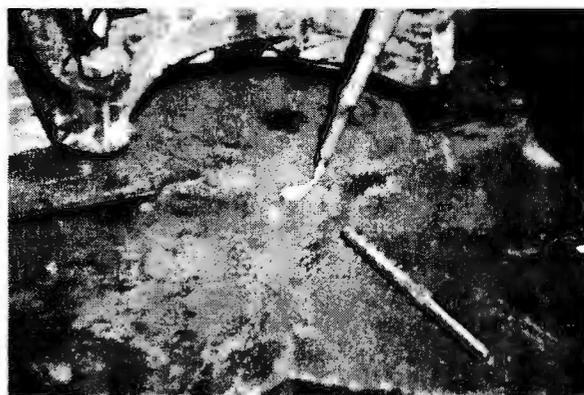
Fig. 12. Pilot hole filled with epoxy prior to insertion of pulling bolt.

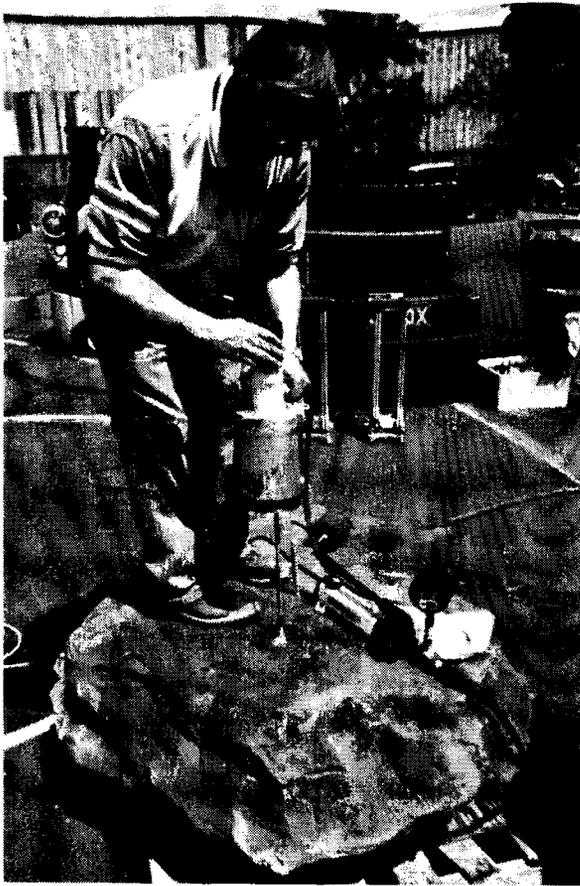
Fig. 17. Hydraulic ram and pulling fixture being inserted over the all-thread.

A coupling nut is then attached to the pulling bolt, and a long piece of 0.9-cm (3/8-in) diameter all-thread is screwed into the coupling nut. The pulling fixture and hydraulic ram are then carefully inserted over the all-thread as shown in Figure 17.

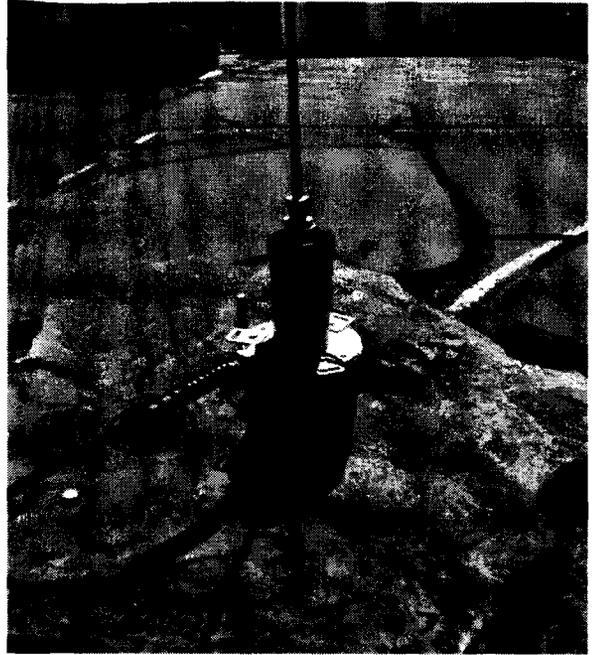
Fig. 19. The hydraulic ram pushes upward against a nut attached to the all-thread that is in turn connected to a pulling bolt anchored in the test core.

The seating ring on the pulling fixture is inserted into the kerf as shown in Figure 18. Washers and a speed nut are then attached to the all-thread near the top of the hydraulic ram as shown in Figure 19, and a hydraulic hand-pump, equipped with a pressure gauge, is attached to the hydraulic ram as shown in Figure 20.

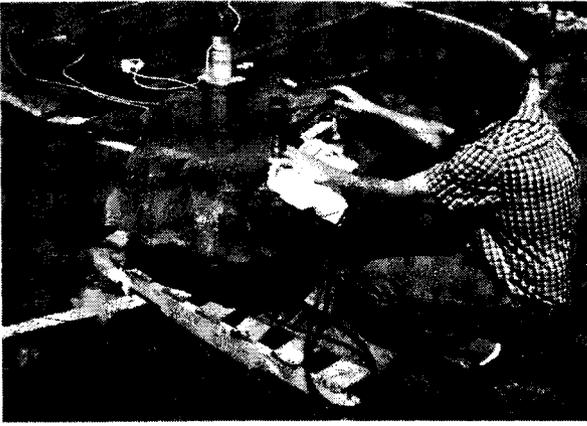
Fig. 20. Performing an in situ direct tensile strength test.

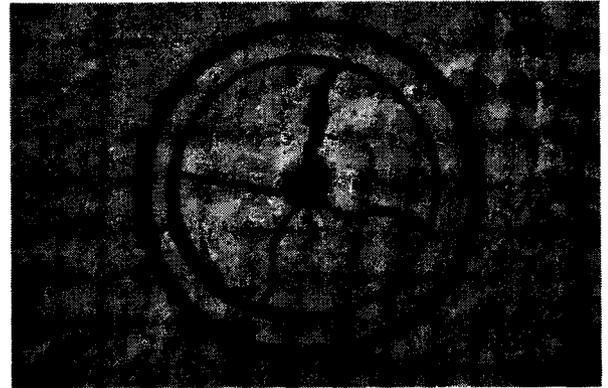
Fig. 24. Typical failure when the epoxy anchored bolt is pulled out of the slab.

During these in situ direct tension tests, the test cores generally showed one of the following three types of failure modes: tensile failure, shear failure, or a bolt pull-out failure. Most of the test cores broke in tension at a variety of depths. Figure 21 shows a typical tensile shallow failure. Figure 22 shows a deeper failure in the slab that also includes some shear because the failure surface is inclined about 45 degrees to the core axis. The failure surface can also be identified by inspecting the test hole as shown in Figure 23. A typical bolt pull-out failure is shown in Figure 24. Although the test cores were drilled to purposely intersect an assumed cold joint, only one of the test cores broke near that horizon. Figure 25 shows the longest of specimens being extracted from the slab, and Figure 26 shows that it might match the depth of the inferred cold joint in the slab. Depending on the type and length of failure, a single test hole was sometimes used for multiple tests. A new pilot hole was simply drilled, filled with epoxy, and a new pulling bolt inserted into the hole. In this manner, several tests could be conducted using a single drill set-up. Figure 27 shows the slab near the completion of these in situ direct tension tests.

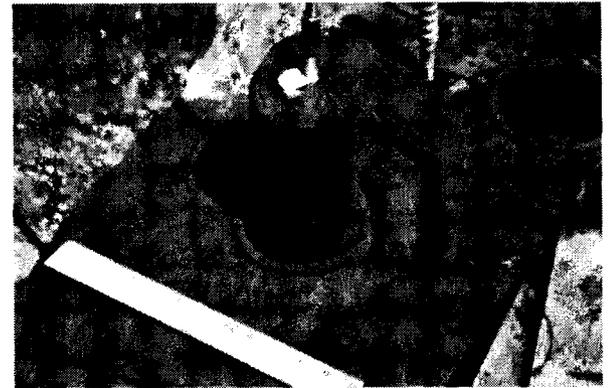
Fig. 25. Removing the longest test core from the backfill slab.

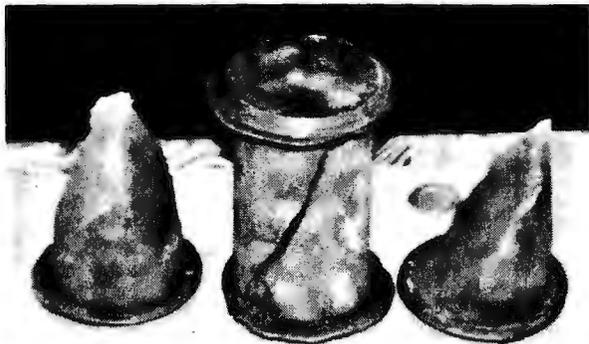
Fig. 28. Typical failure for unconfined compression tests.

Unconfined compression tests were conducted with cores obtained from the smaller paste backfill slab. These core samples were cut to a length of about 14 cm (5.5 in), approximately twice their diameter. Prior to testing, the ends of the specimens were sulfur-capped because the paste fill material was too delicate for surface grinding. Unconfined compression tests were conducted using the Reihle press. The results of these compression tests are listed in Table 6. The average unconfined compressive strength (UCS) of the five test specimens was 4.15 MPa (602 psi) with a standard deviation of 0.33 MPa (48 psi) and a coefficient of variation of 8%. Figure 28 shows some of the typical shear failures exhibited by the compression test specimens.

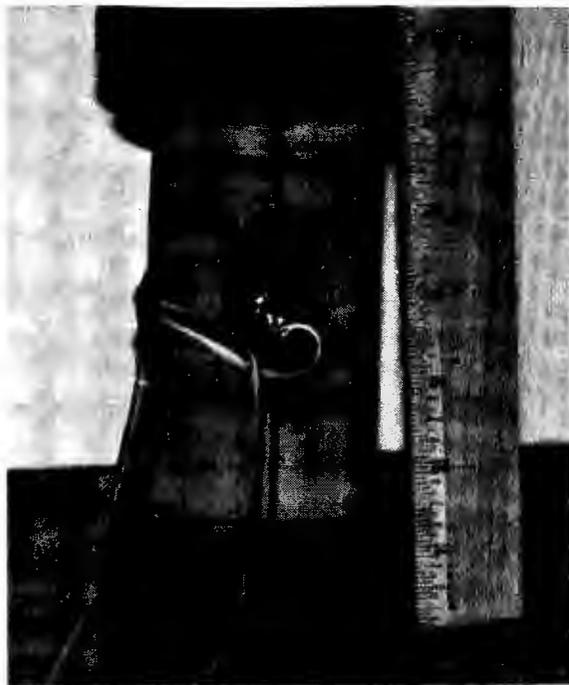
Fig. 29. Strain gauges applied on top of cured epoxy.

Before a strain gauge could be attached to a compression specimen, a small amount of epoxy was applied to selected locations on the surface of the specimen and allowed to cure. After the epoxy had cured, these areas were lightly sanded with 320 grit sandpaper, and then the strain gauges were bonded to these areas. This step was necessary for the strain gauges to adhere to the backfill. Figure 29 shows a strain gauged backfill specimen ready for testing. The typical compressive failure mode was in shear as shown in Figure 30.

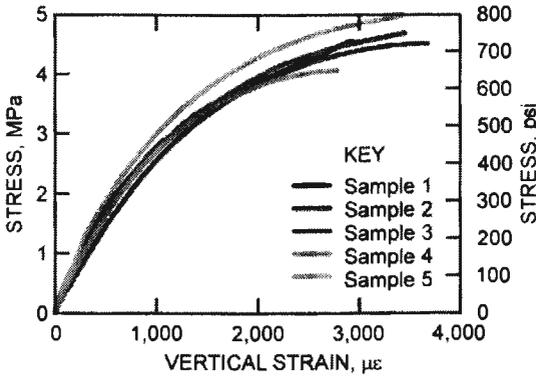
Fig. 31. Vertical stress versus vertical strain of paste backfill.

The five stress-strain plots obtained from these tests are shown in Figure 31. All five tests produced similar results. The backfill does not have a linear relationship between stress and strain to failure. As the stress increased, the modulus of elasticity decreases becoming plastic as it approaches the ultimate compressive strength (UCS). However, the relationship between the horizontal and vertical strain is mostly linear as it approaches failure as shown in Figure 32. The absolute value of the ratio of horizontal to vertical strain near the center portion of the curve gives a constant value of 0.17 for Poisson's ratio.

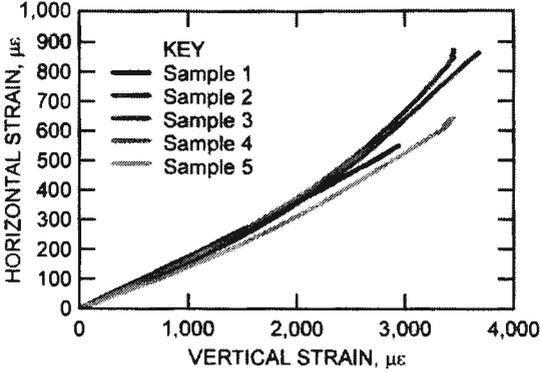
Fig. 32. Paste backfill horizontal versus vertical (axial) strain.

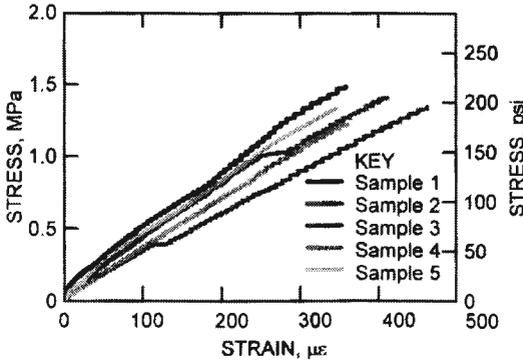
Fig. 33. Paste backfill stress vs. strain from 0 - 30% of UCS.

Because the stress-strain diagram of the paste backfill is non-linear it was divided into three segments at 30, 60, and 90 percent of the average UCS. This results in a three piecewise linear approximation to the non-linear curve. The separate plotted results are shown in Figures 33, 34, and 35. Young's modulus from 0-30% of its UCS is 3.59 GPa (0.52 million psi); from 30-60%, it is 2.28 GPa (0.33 million psi); and from 60-90%, it is 1.10 GPa (0.16 million psi).

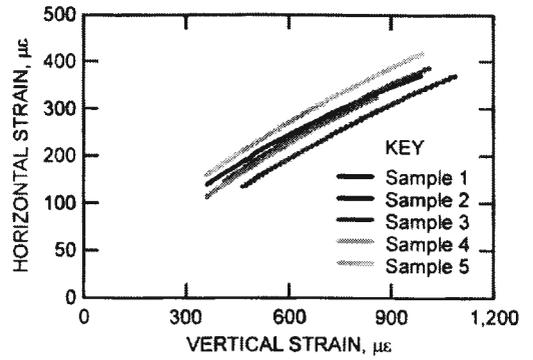
Fig. 34. Paste backfill stress vs. strain from 30 - 60% of UCS.

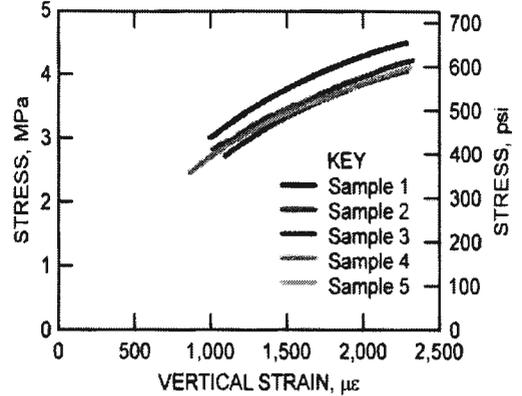
Fig. 35. Paste backfill stress vs. strain from 60 - 90% of UCS.
