Effects of Corrosion on Ground Support and Corrosion Monitoring Methods

¹National Institute for Occupational Safety and Health / Spokane Mining Research Division

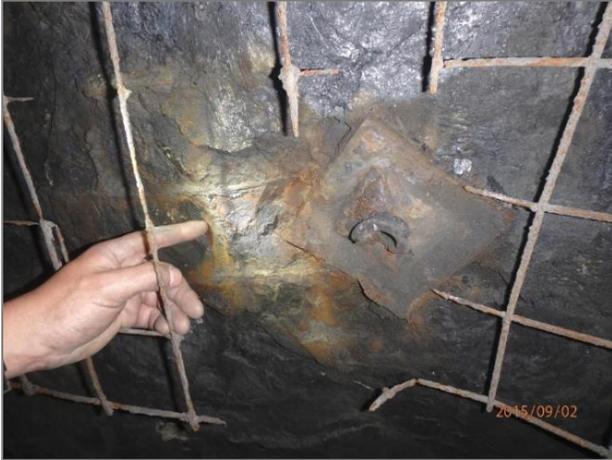
Figure 1. Galvanic corrosion of welded-wire mesh in contact with argillite rock mass.

and tetrahedrite/tennantite. Mineralization occurs discontinuously along the contact between a structural hanging wall (quartz mica carbonate phyllites) and footwall (graphitic and calcareous argillite). The high rate of corrosion is most apparent in ground support in contact with the dark-colored graphitic argillite footwall (Figure 1).

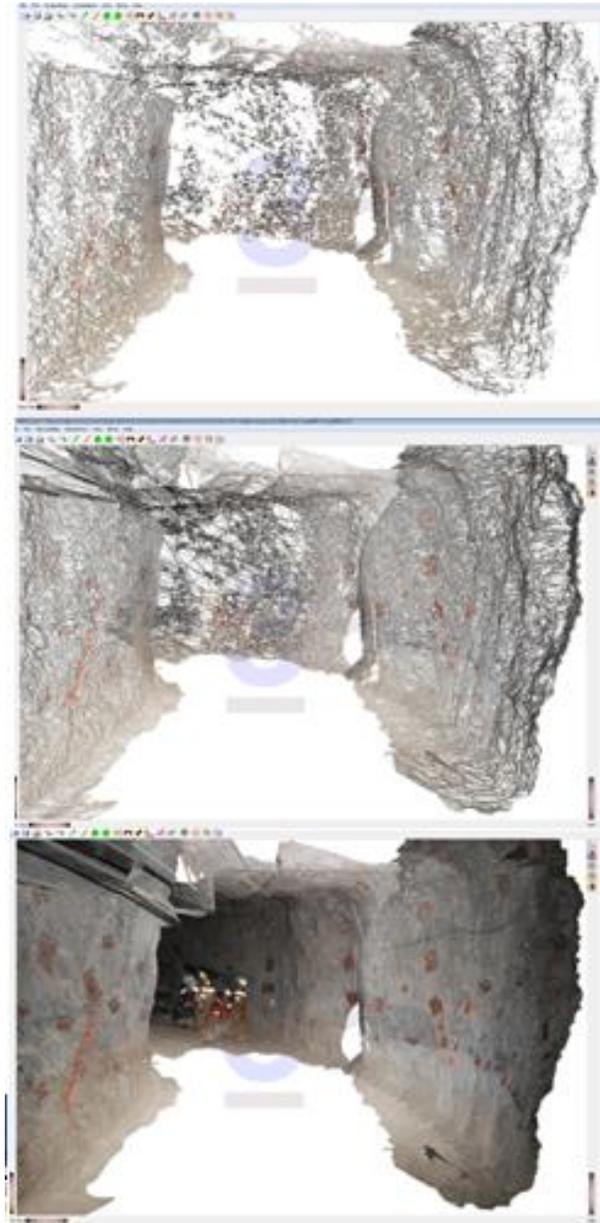
Figure 2. A 3D point cloud generated from a digital photograph pair (top), connected by a triangulated mesh (center), overlain by photographic texture data (bottom).

Photogrammetry is the process of capturing three-dimensional geometry through photography (Figure 2). This technology has been successfully implemented for geometric and spatial analyses in numerous industries, including surveillance, law enforcement, transportation, manufacturing, materials testing, and medicine. Data collection may take as little as a few minutes, can be performed at safe distances from hazardous conditions, and can capture complete geometry for future laboratory analysis. Applied to underground mining, photogrammetry provides the opportunity to develop a visual history of ground support that can help in assessing the progress of corrosion, cracking, bagging, etc., and projecting when rehabilitation might be required to maintain ground safety. Using photogrammetry, SMRD researchers have achieved measurement accuracies within 1.0 mm in both field and laboratory settings [3-5]. SMRD photogrammetry work at

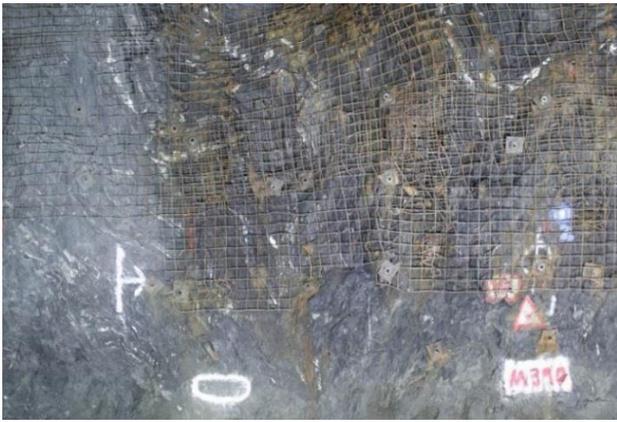
Figure 3. M 390, representing an area with high visual corrosion in dark argillite rock mass.

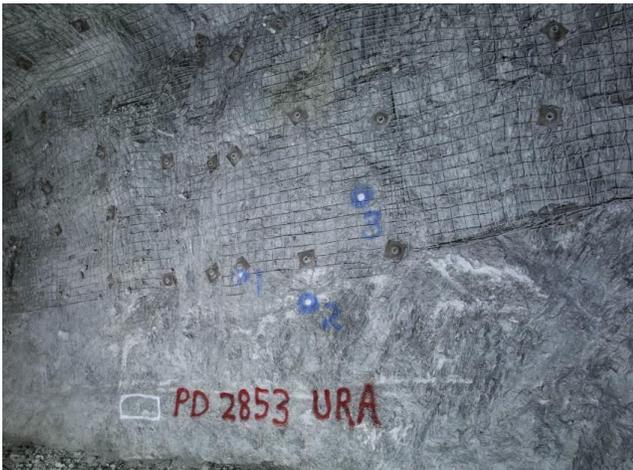
Figure 4. PD 2853, representing the control area with little to no visual corrosion in phyllite rock mass.

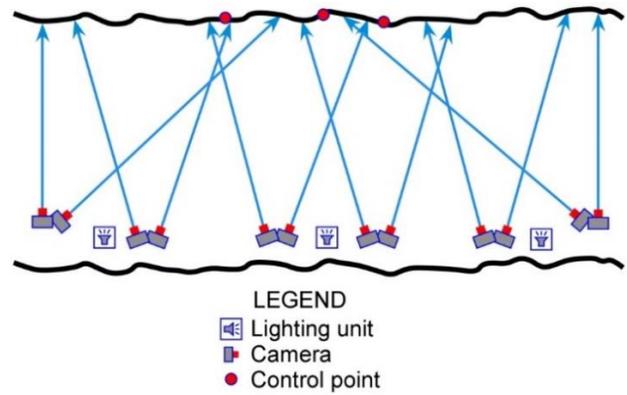
Figure 5. Plan view of Greens Creek Mine photogrammetry survey, showing camera positions, lights, and control points. Tunnel width for both survey sites was typically about 15 feet.

A survey of twenty-four photographs were taken at each site using the light and camera plan view shown in Figure 5. In the figure, the thin blue arrows represent the camera direction for each of the six camera stations. Four photographs were taken at each station—two in the direction of each arrow. The camera was rotated on a tripod to take the sequence of pictures required while the three lighting units remained stationary throughout each survey. To calibrate and map the mine excavation, three control points were placed on the rib at each site, represented by red dots in Figure 5. Each survey took approximately twenty minutes to conduct. Image resolution for the control site was 5.8 mm/pix, with a survey error of 3.3 mm. The high-corrosion site's image resolution was poor at 11.4 mm/pix, with a survey error of 4.7 mm. This could be improved in by positioning the camera closer to the rib or by using a higher resolution camera. Short range laboratory photogrammetric surveys achieved a survey error of 1.1 mm with a resolution of 0.6 mm/pix. In an attempt to catalog geometric change only due to corrosion, undistorted sections of mesh were chosen at each survey site for measurement.

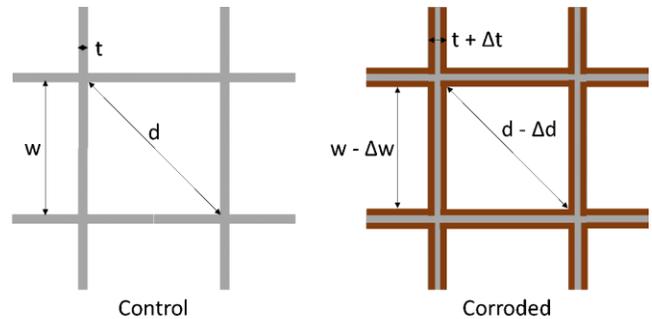
Figure 6. Conceptual diagram of geometric change in early-stage corroded welded-wire mesh section versus control. Gray represents original mesh while brown represents oxidized coating that develops due to corrosion.

Three types of measurements were made at each survey site: single-wire width (t), wire-to-wire distance (w), and diagonal distance between welds (d) (Figure 6). Wire strands at the high-corrosion survey site had undergone bulking, resulting in larger wire width measurements ($t + \Delta t$) than strands at the survey control site. Geometrically, wire, wire-to-wire and diagonal measurements were less ($w - \Delta w$ and $d - \Delta d$, respectively) for the high-corrosion site than for the control due to thicker strands being closer to each other in the mesh. Such a selection for the control site is shown in Figure 7.

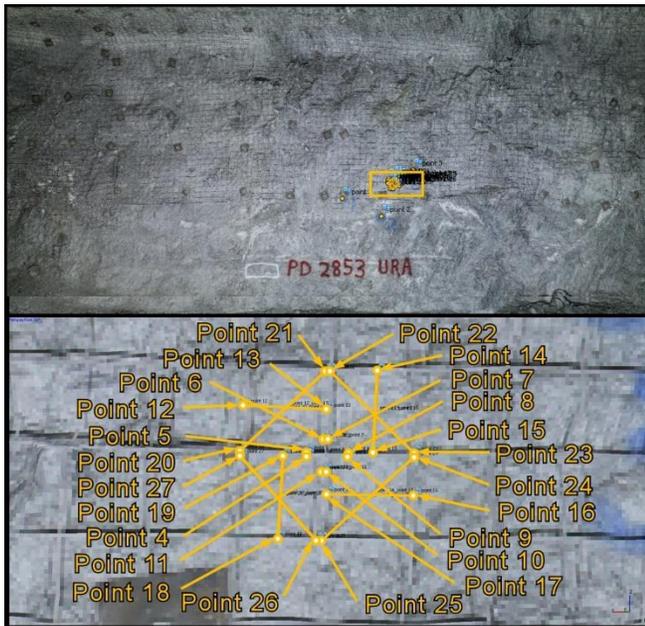
Figure 7. Corrosion control site at Green's Creek Mine (top), zoomed in to the area selected for photogrammetric measurement (bottom).

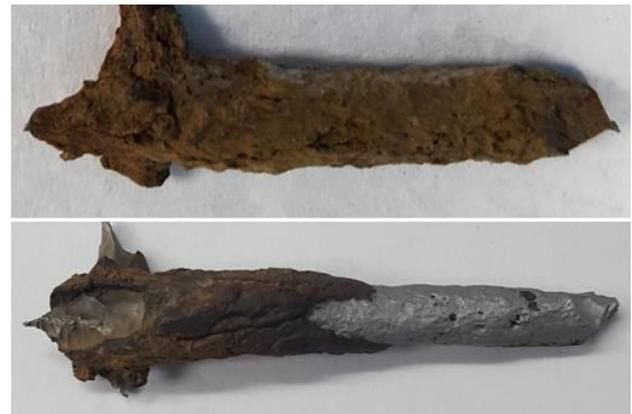
Figure 8. Top: before cleaning the sample measured 7.27 mm. Bottom: after cleaning the sample measured 4.20 mm.

At the onset of corrosion the metal appears to expand or bulk as the corrosion product forms. In the case of welded-wire mesh the effective diameter of the wire may be much less than it appears. Figure 8 shows a sample before and after removal of the corrosion product. The sample experienced total removal on only half of the sample to show the bulking due to buildup of corrosion product.

The diameter of the sample shown in Figure 8 was measured in the laboratory prior to and after multiple cleaning cycles following ASTM G1-03 [6]. The final cleaning cycle was performed with sandblasting (Figure 9).

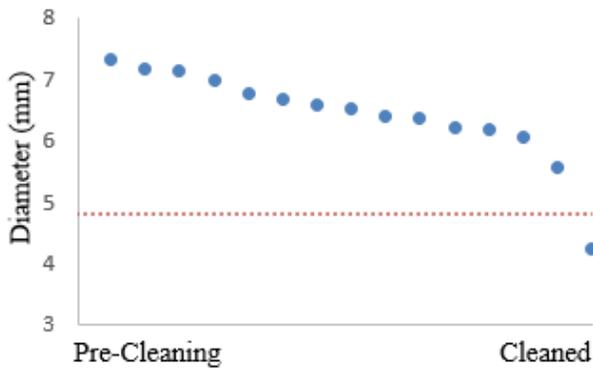
Figure 9. Change in diameter with multiple cleaning cycles – final cleaning cycle was sand blasted. The dashed line represents the original diameter of the sample.

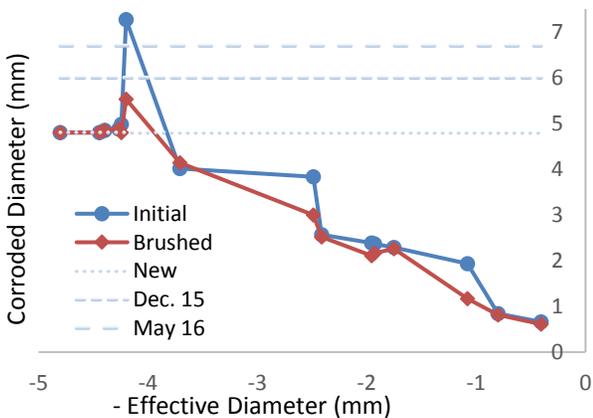
Figure 10. Corroded wire diameter as a function of wire diameter (sign changed). Lines represent the diameter of new mesh and the diameters estimated using photogrammetry in December 2015 and May 2016.

Apparent bulking has been estimated by photogrammetric measurements in the range of 25 – 40% greater than the original diameter. Continued corrosion may result in weakly attached product which begins to flake off. Maximum bulking is determined, in part, by any vibrations, abrasions, etc. that the wire is subjected to. Initial observations in the laboratory suggest bulking of as much as 73%. Flaking, or cleaning with a wire brush, were observed to reduce total diameter to metal and corrosion products which are well attached to the metal. These can be removed by acid washing, leaving an un-corroded wire which provides the effective strength of the corroded mesh. Figure 10 demonstrates the relationship of corroded wire diameter to the wire diameter under the layer of corrosion product for the initial set of samples taken from a small test section. This observation applies to this small sample set and may be different for samples exposed to differing types of corrosion.

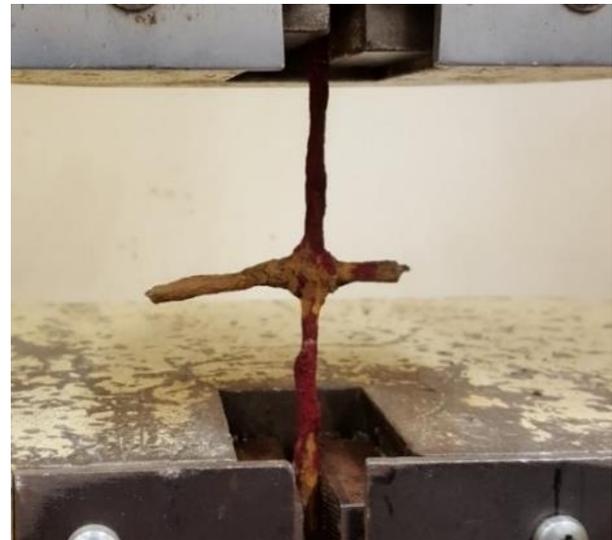
Figure 11. A welded-wire mesh sample being pulled at 150 lbs/sec until breaking.

Tension pull tests of the welded-wire mesh samples were conducted using a 12 kip Tinius Universal Testing Machine following ASTM E8/E8M-11 [7]. A section of the welded-wire mesh was cut, then the minimum diameter was measured to achieve statistical average. The minimum diameter was recorded because this is where the mesh is expected to break [8]. The testing zone of the sample was in the center of the wire; in this zone the sample was marked at two sites two inches apart. The samples were secured in the Tinius instrument using pull claw attachments and subjected to a load rate of 150 lbs/sec (Figure 11). After the sample failed, elongation was found by fitting the broken pieces together and measuring the final distance between the two marked sites. The elongation measurement was used to calculate the nominal strain of the sample.

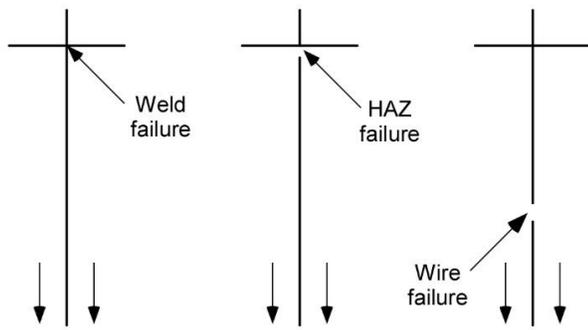
Figure 12. Mode of failure in the weld, the heat affected zone (HAZ), and the wire after [9].

Weld tension tests were conducted to compare the strength of the weld, the wire, and the heat affected zone (HAZ) [9] (Figure 12). A perfect weld should be stronger than the wire itself. These tests were carried out according to ASTM A497/A497-07 [10].

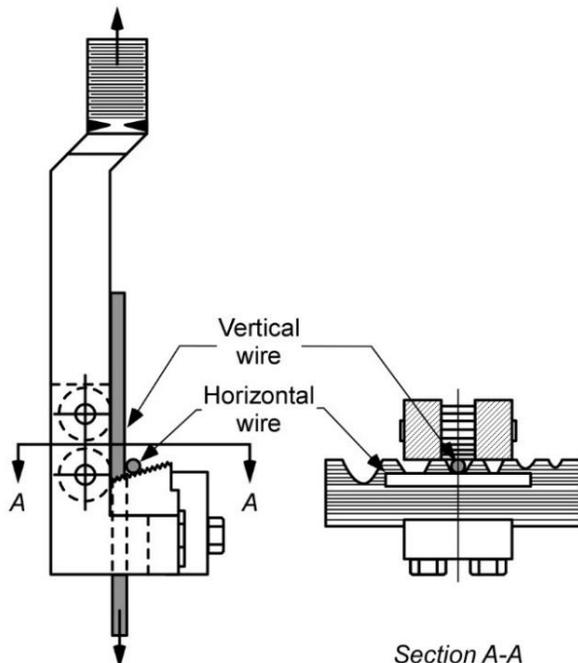
Figure 13. Welded-wire reinforcement weld tester after ASTM A497/A497M-07 [10].

Sections of wire were again cut from the samples provided by the Greens Creek Mine. Villaescusa [9] reported a slight difference in failure mode in the longitudinal wire compared to the cross wire in weld, therefore, in this study two samples with different orientation were cut and both were tested. Again the thinnest part of the sample was chosen for testing because this is the most likely location of failure. Some samples included welds that had already separated due to corrosion, in these instances the thinnest section that could be fit into the test apparatus was chosen. Orientation is not noted in the sample pairs because the samples from the mine do not indicate orientation. The same 12 kip Tinius Universal Testing Machine was used with a different attachment. Figure 13 shows a schematic of the apparatus and its main functional components. The sample is pulled from the bottom, putting stress on the weld at 150 lbs/sec until failure occurs. Samples that failed in the wire rather than the weld were included in the data of the wire tension tests.

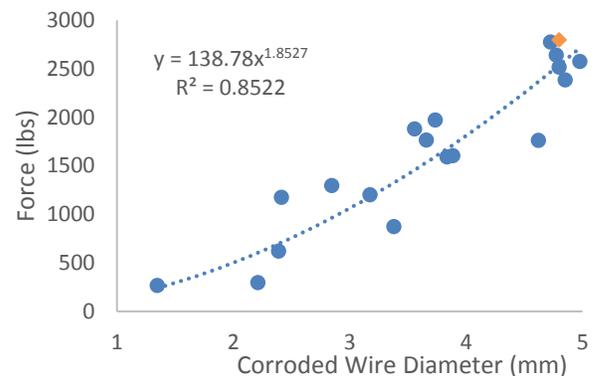
Figure 14. Welded-wire mesh failure load as a function of diameter in wire tension testing with the new welded-wire mesh represented by an orange diamond marker.

A positive exponential relationship was observed between the maximum load before failure and the measured diameter of the welded-wire mesh (Figure 8). Dorion, et al. [8] observed a similar exponential relationship with welded-wire mesh samples also obtained from a mining environment. The differences in the mathematical relationship observed by Dorion, et al. ($Failure\ Load\ (kN) = 0.38 \times d^{2.2}$) and this study (Figure 14) could be due to the differences in number of samples or variations in the metallic properties of the welded-wire mesh. Analysis by Dorion et al. and SMRD both come close to the diameter squared relationship that results from a change in strand diameter. Samples around 3.5 mm diameter have lost roughly half their strength, this could be a valuable threshold for significant strength loss. In Figure 10, 3.5 mm diameter correlates to samples that are no longer bulked and would appear in a mining environment to have a slightly smaller diameter than new welded-wire mesh.

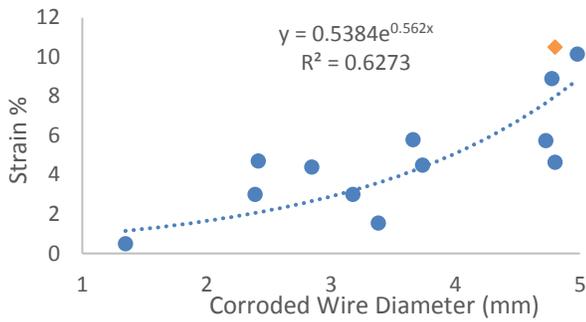
Figure 15. Nominal strain is lower in samples that have experienced a loss in diameter due to corrosion - the new welded-wire mesh is represented by an orange diamond marker.

Nominal strain was calculated (equation 3) and compared to the diameter of the samples tested (Figure 15). Data indicates that there is a relationship between nominal strain and diameter for this sample set. The relationship indicates that loss in diameter due to corrosion causes embrittlement of the welded-wire mesh, that is, the material is less prone to stretch as load is applied. This is important as it reduces the robustness of the support (ability to maintain support safety through ground deformations).

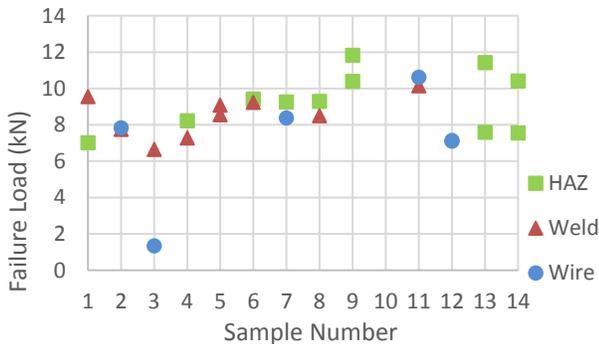
Figure 16. Mode of failure for the heat effected zone (HAZ), weld, and wire for each sample pair. Sample 14 is the new welded-wire mesh.

The variability of mode of failure in the sample pairs is shown in Figure 16. From the tested samples, 57% of sample pairs failed in different ways depending on the orientation. The new welded-wire mesh sample failed in the HAZ for both orientations (Figure 16, sample number 14).
