Evaluating the stability of a freestanding Mast Climbing Work Platform

Mast Climbing Work Platform

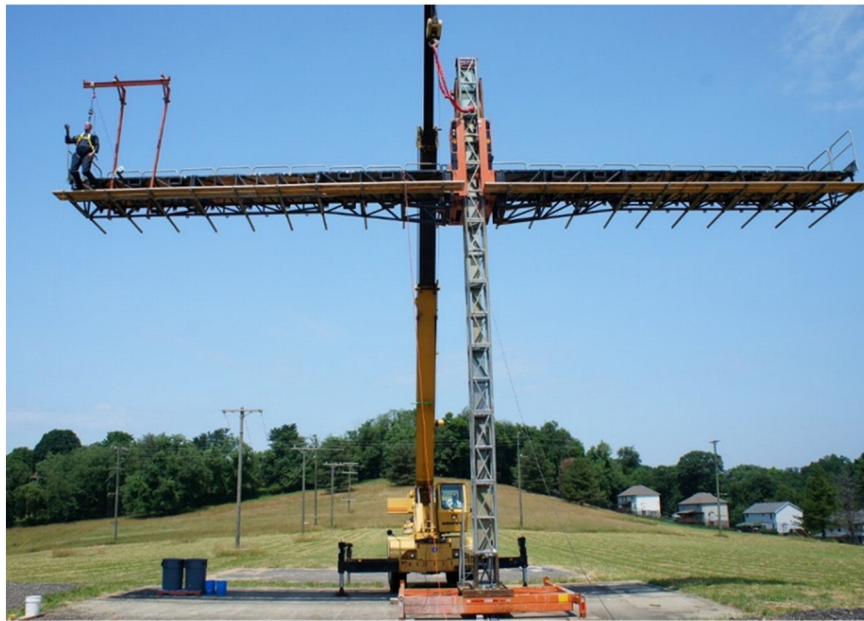
Fig. 1. Fraco ACT8 Mast Climbing Work Platform.

A freestanding Fraco ACT8 mast climber was used for all testing. The Fraco ACT8 consisted of the following:

- Freestanding ground base with outriggers placed according to manufacturer recommendations,
- 45-foot mast height with no anchor point,
- Diesel drive unit,
- Six 10-foot (3.05-m) sections of platform for a total of 30 ft (9.14 m) on each side of the drive unit with platform outriggers to form a lower working platform (step deck) created with planking, and
- One section of I-beam Monorail system used for tying off at the end of the platform.

The six platform sections that were fixed to the drive unit also included movable outriggers located 2 ft below the height of the main working deck. These outriggers can be pulled out and planking can be affixed to them to create a lower working deck on which workers commonly stand to perform tasks. This lower working deck configuration was also used for the study. An overview of the MCWP test configuration used is shown in Fig. 2.

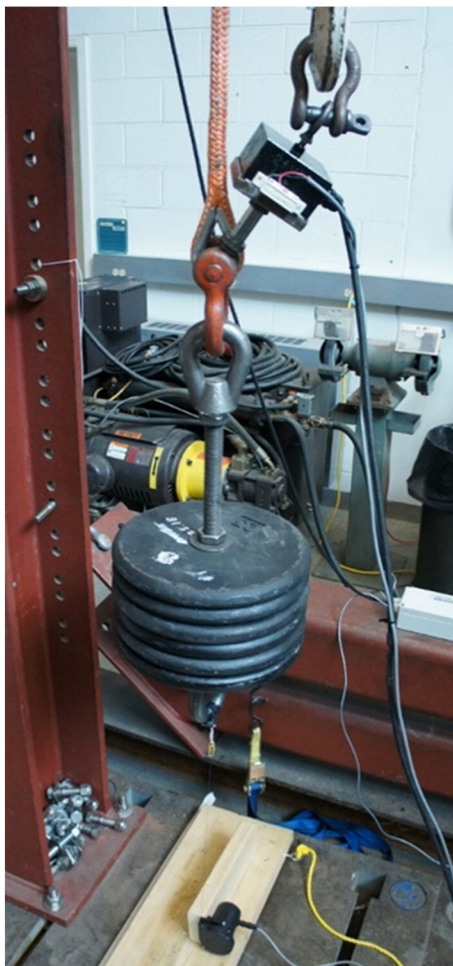
Fig. 2. Nystron rope "break-in" configuration.

Nystron rope consists of a polyester jacket with a double-braided nylon core. To break in the rope and eliminate the construction stretch, a procedure similar to the one utilized by Harris was used (Harris et al., 2010). A 6-foot (1.83-m) Nystron rope, 5/8 in. (0.127 m) in diameter with split thimble ends, was affixed to a set of rigid weights on a threaded rod with locking hardware. The Nystron rope break-in configuration can be seen in Fig. 1.

The rope length was measured with a string potentiometer [Celesco model SP2-50, Chatsworth, CA] to ensure that all the stretch was removed. The string potentiometer was then used to detect the vertical linear position from which the weights needed to be dropped to achieve the desired 1800-pound (8000-N) and 2400-pound (10,675-N) impact forces. The weight and drop height configurations needed to achieve these forces were calculated at 118 lb (53.5 kg) at 30.5 in. (0.77 m), and 168 lb (76.2 kg) at 30.5 in. (0.77 m) respectively.

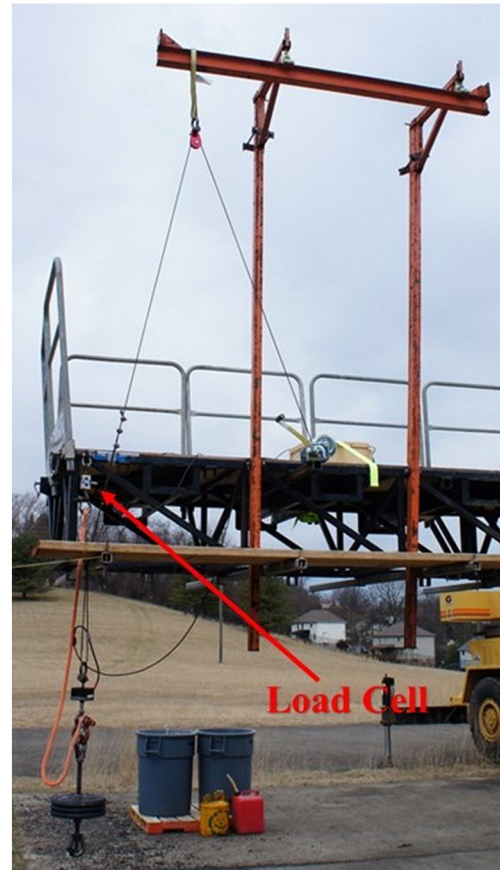
Fig. 3. Dead-weight drop test configuration.

The configuration consisted of a Fraco ACT8 (described in Section 2.1.) with dead weights attached to the end anchor point of the platform. A 3000-pound (13,400 N) Interface (Interface Inc., Scottsdale, AZ) S-type load cell was used to record the force transmitted between the Nystron rope eyelet and the last anchor point. Shackles and eye bolts were used to make the connection. The load cell signal was passed through a signal conditioner and connected to a National Instruments 9191 wireless data acquisition device (National Instruments Corporation, Austin, TX) that was connected to a laptop.

winch connected to the platform by the I-beam Monorail system. An electromagnetic disconnect was used to hold the weights at the desired height. The ACT8 drive unit was raised by remote control to its maximum allowable freestanding height of approximately 38 ft (11.58 m). The electromagnet was then deactivated by a remote control to release the weights that create the desired forces. Data recording began before the start of the weights' free-fall and continued until the platform rocking motion had stopped (approximately 15 s). The dead-weight testing configuration is shown in Fig. 3.

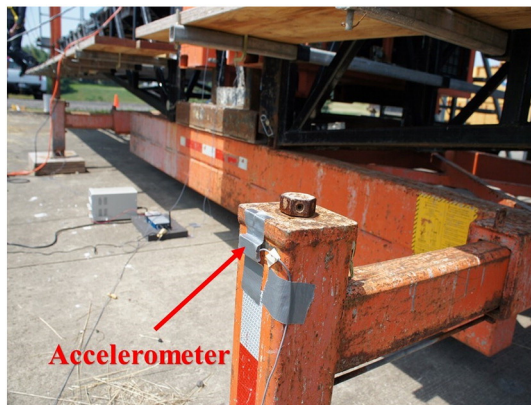
Fig. 4. Accelerometer on the outrigger pad column.

The Interface S-type load cell was used to record the force transmitted between the snap hook eyelets and the last anchor point. The load cell signal was passed through a signal conditioner and connected to a National Instruments 9191 wireless data acquisition device (National Instruments Corporation, Austin, TX) connected to a laptop. Five in-house packaged tri-axial accelerometers (Kionix, Model KXR85, Ithaca, NY) were attached to the MCWP for vibration measurement. They were placed on the main platform section of the steel truss structure at evenly spaced 5-foot (1.53-m) increments from the end going inwards on the platform on one side of the drive unit. Two accelerometers were also placed on the outrigger pad columns at the base of the MCWP for measurement, one on the top section of each leg and secured with double sided tape, as shown in Fig. 4.

The accelerometers operated at 3.3 V and measured accelerations with values at ± 6 G with the sensitivity of 220 mV/G. The signals from the accelerometers were input to the wireless data acquisition system (National Instrument Analogue Input Module 9205 with Compact DAQ chassis 9191) and a LabVIEW program was developed to record, store, and display the acceleration time history data in real time.

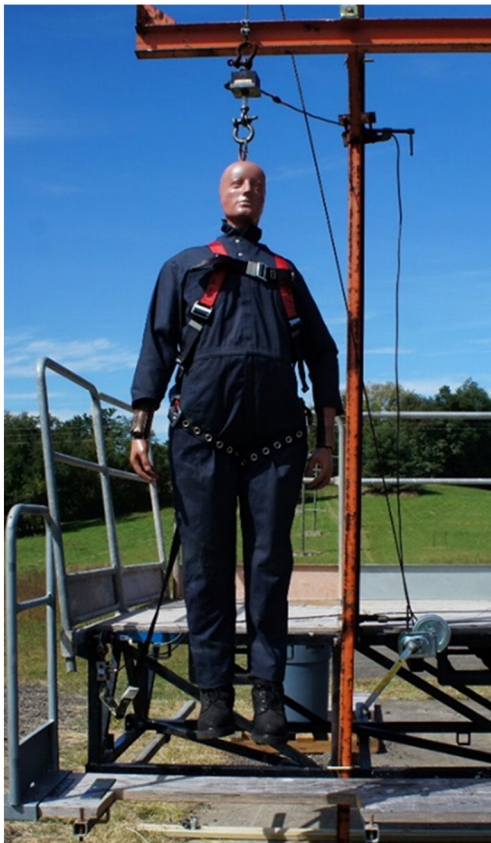
Fig. 5. Fall-arrest scenario configuration.

To re-create a fall-arrest scenario using the MCWP, the ADAM manikin was dropped from the far end of the main working platform. The platform weights for the specific testing configuration—unloaded, fully loaded, and overloaded—were put into place before each test. The ADAM manikin was outfitted with a randomly selected PFAS that included a harness and 6-foot (1.83-m) energy-absorbing lanyard. The lanyard snap hook was tied to the D-ring of the harness on one end, and an eye bolt that was attached to the force gauge on the other end. The force gauge was hooked by another eye bolt to the last anchor point on the platform's end that was furthest from the drive unit. The total force gauge configuration was approximately 12 in. (0.305 m) in length. The data recorded during the experiment included the arrest forces measured by the force gauge, vertical platform displacement measured by the string potentiometers, and the overall stability of the MCWP system as per visual observation, photos and videos.

The ADAM manikin was hooked to the I-beam Monorail tie-off system via a winch and pulley and was raised into position. ADAM was held to the cable by the electromagnetic disconnect system. A small section of the second step-down planking was removed to allow ADAM to free fall without interference. All data, photo, and video recordings began prior to the first drop. The ACT8 drive unit was raised to its maximum allowable freestanding height, and once stabilized, the ADAM manikin was released and allowed to free fall. Once the mast climber (entire structure) stopped moving, the drive unit was lowered and reset. The fall-arrest scenario test configuration is shown in Fig. 5.

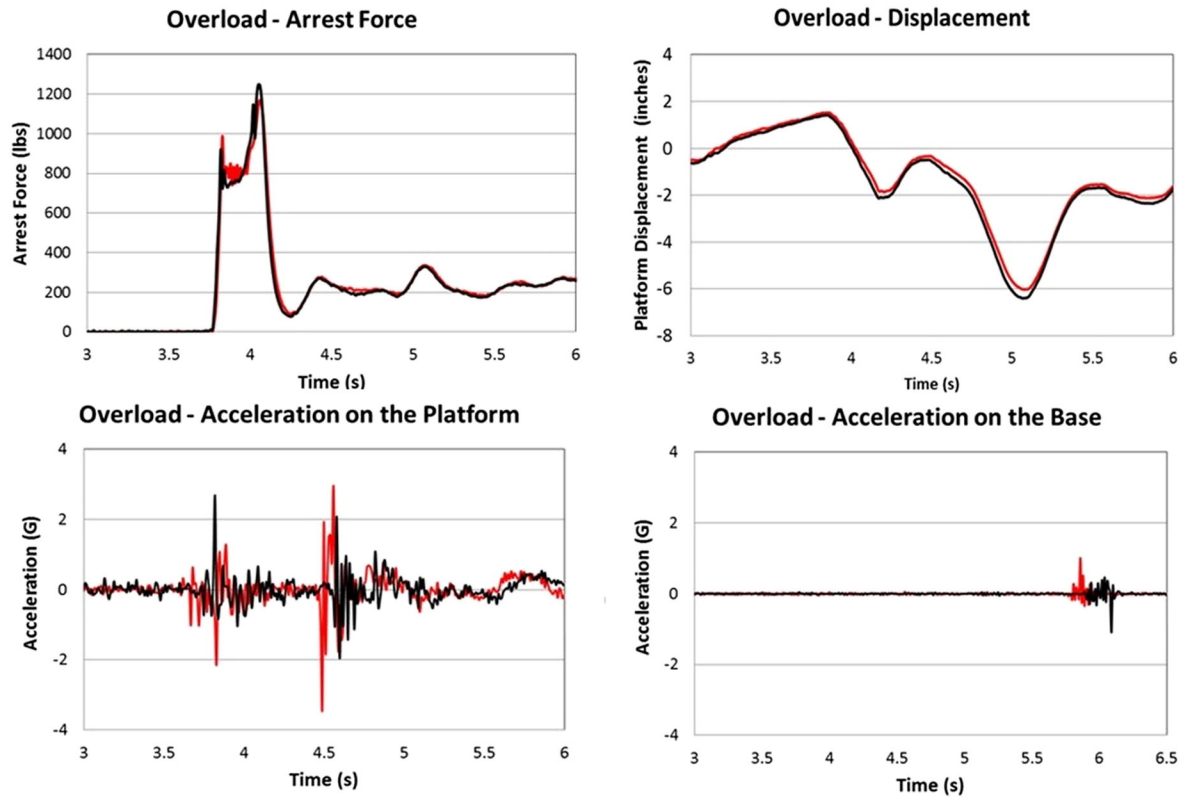
Fig. 8. MCWP measurements for the platform overload condition.

The most interesting results were ones that created the most unstable platform. The following figures illustrate the greatest platform displacements and accelerations recorded at the furthest end of the platform. Each figure contains the two repeated trials for each condition - shown in red and black, respectively. Figs. 8–10 contain the graphs of the fall-arrest force, platform displacement, acceleration at the end of the platform, and acceleration at the outrigger arm base for the various platform conditions.

Also of note, as shown in the aforementioned figures, an initial vertical rise was shown in the platform displacement at the release of ADAM as expected. Upon the lanyard deployment, there was an initial downward displacement of the platform approximately 4 in. (0.102 m) for each scenario, followed by a brief rise of the platform of

The first acceleration peak on graphs 8, 9, and 10 correspond to the initial force placed on the lanyard and its full impact force after the energy-absorbing portion had fully deployed. The overloaded platform scenario found both peaks were approximately 2 G (19.6 m/s^2) to 3 G (29.4 m/s^2). The maximum loaded and unloaded platform scenarios found the first peak to be near 1 G (9.8 m/s^2) and the second peak to be approximately 3 G (29.42 m/s^2).

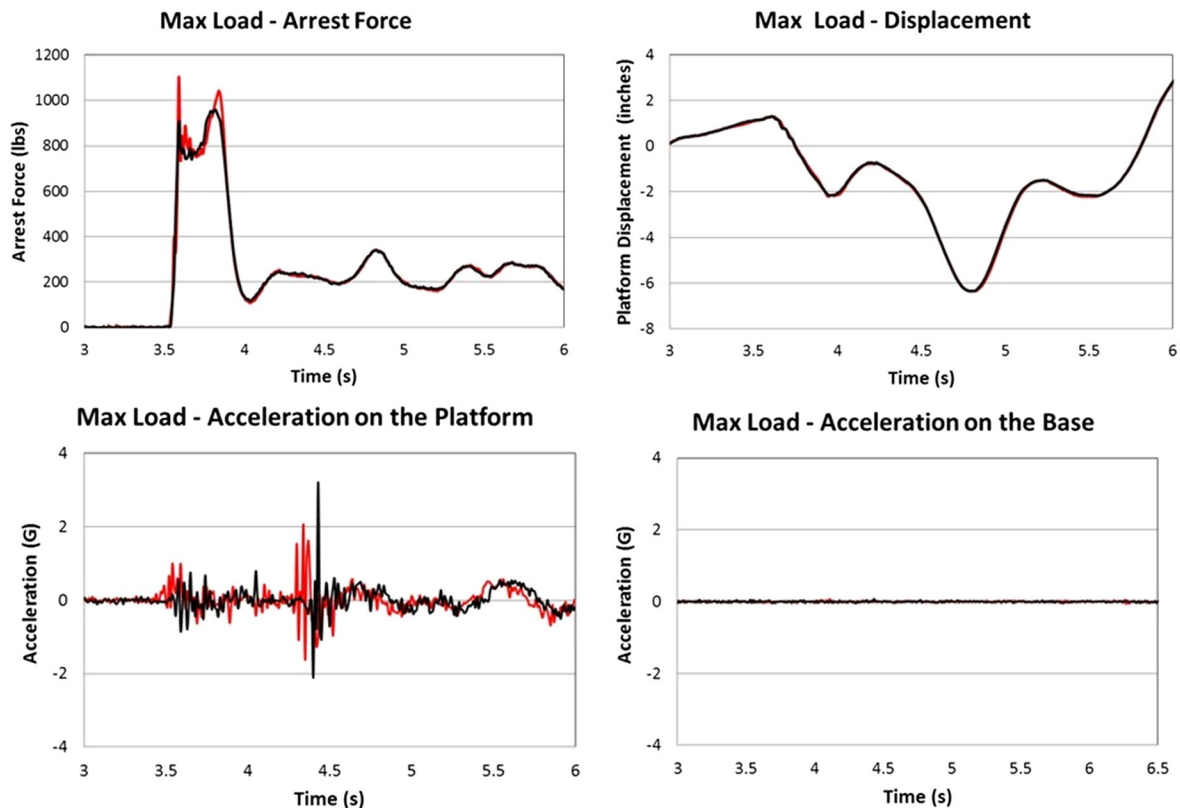
Fig. 9. MCWP measurements for the maximum loaded condition.

Fig. 9 shows the corresponding graphs of the maximum loaded platform condition.

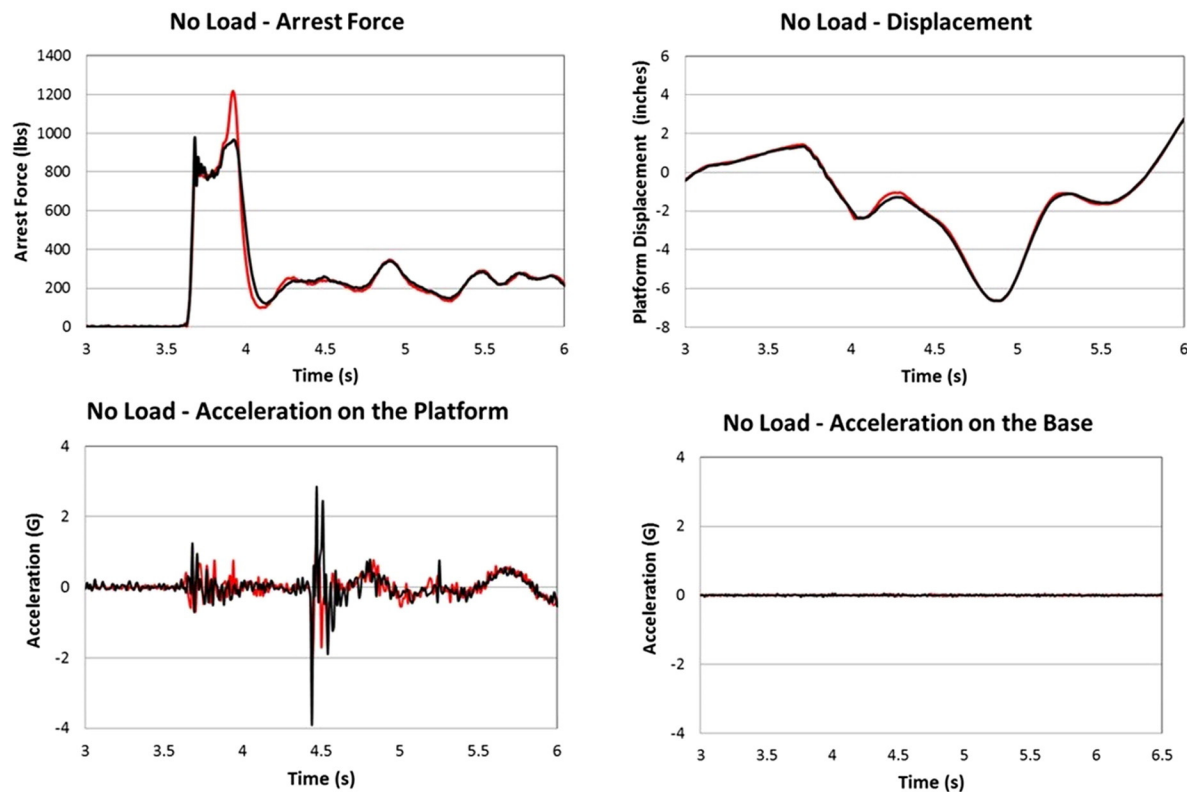
Fig. 10. MCWP measurements for the unloaded platform condition.

Fig. 10 shows the corresponding graphs of the unloaded platform condition.
