# Evaluation and mapping of corrosion in a western USA underground metal mine — year one preliminary results

*Corrosion of ground support can lead to falls of ground, posing a significant risk to miner safety. To address this problem, the Spokane Mining Research Division of the National Institute for Occupational Safety and Health is investigating ground support corrosion at the Greens Creek mine, located near Juneau, Alaska, United States of America. Field and laboratory studies include surveys of weld-wire mesh corrosion, rock mass conductivity measurements, and sample analyses using a scanning electron microscope, energy dispersive spectrometry, and Fourier transform infrared spectrometry. Current field studies demonstrate a correlation of rock mass conductivity to the degree of weld-wire mesh corrosion and the relationship of ground conductivity surveys to support corrosion potential. Laboratory analyses of mine samples identify the presence of sulphate, which is a determinant for sulphate reducing bacteria activity. Identification of sulphate reducing bacteria (SRB) would provide evidence for microbial influenced corrosion in this mine. Ongoing research is evaluating methods

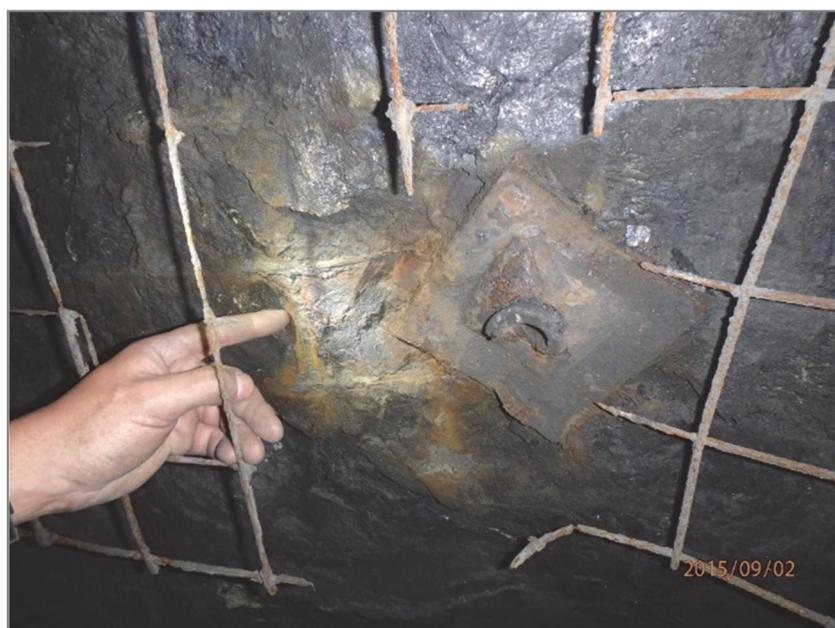
Galvanic corrosion also occurs when two metals are in direct contact (NACE 2012), where the more electronegative metal becomes anodic while the more electropositive metal becomes cathodic. This scenario has been observed at the Greens Creek mine where the rock support is in direct contact with the more electropositive dark argillite rock mass (Figure 1). The ground support acts as the anode while the rock mass acts as the cathode, representing the combination of 'rusted carbon steel' and 'carbon, graphite' in Table 1. Oxidation has effectively dissolved the support in these locations, necessitating a rehabilitation plan to replace any ground control found to be ineffective or highly corroded.

Figure 1 Galvanic corrosion of welded wire mesh in contact with dark graphitic argillite

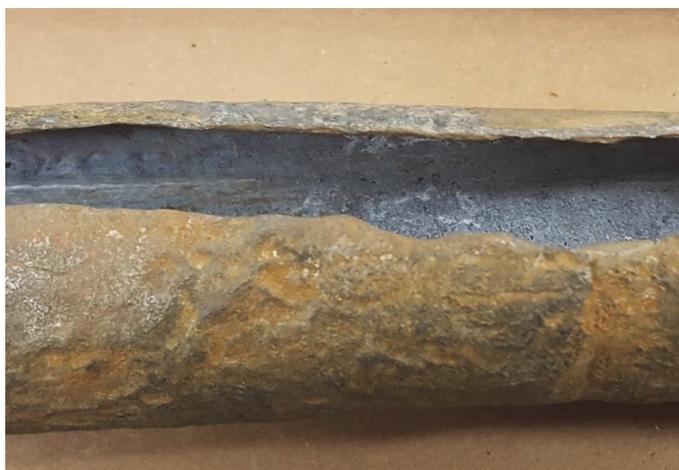
Heavy corrosion was found on the outside surface of galvanised friction rockbolts and polymer-coated Omega rockbolts extracted by over-core drilling (Figure 2). Scratching was noted on galvanised friction rockbolts as well as polymer-coated Omega bolts. Scratching of the bolt appeared to be a key starting point for pitting corrosion in Omega bolts. Scratching of galvanised friction rockbolts also led to general and pitting corrosion, however, there were scratches noted where corrosion had not yet occurred. This could be due to the galvanising process yielding protection deeper into the metal while a polymer-coating only protects the surface of the metal. The inside surfaces of the galvanised friction rockbolts show almost no corrosion, supporting the hypothesis that an outside influence, such as the rock mass, is attacking the bolts. Pitting observed in the bolt samples could be due to microbial influenced corrosion (MIC) playing a part in corrosion (Mattsson 1989). These early observations defined the specific research topics for SMRD researchers and the Hecla Mining Company.

**Figure 2 Friction rockbolt displaying heavy corrosion on the outside with very little corrosion in the interior, suggesting that corrosion is caused by outside influences such as the rock mass**

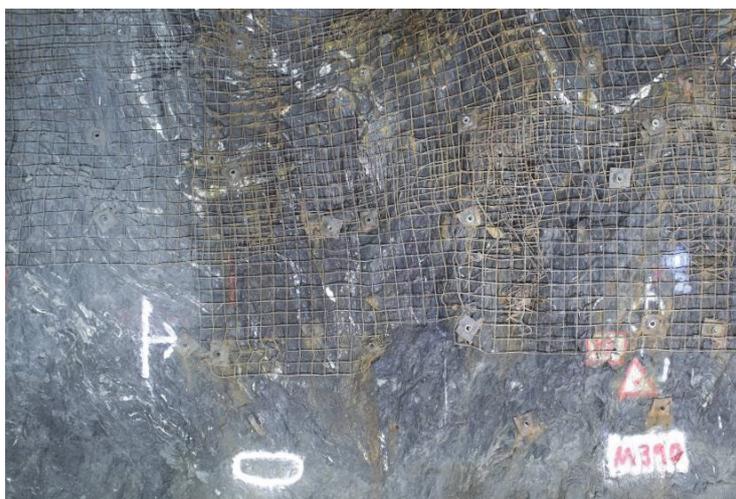
Atmospheric conditions at high-corrosion site M 390, a large ventilation and exploration drift, were measured at 24°C with 77.8% humidity. RMR ranged from approximately 35 to 45, but joint spacing generally (< 50 mm) and condition (slightly rough and hard) were noted, along with minimal, but present groundwater. The site is located 120 m below sea level. The original rib bolts were 1.8 m long galvanised steel friction and Omega bolts, with 2.4 m long galvanised friction bolts in the back. The original bolting pattern was 1.2 × 1.2 m, with slight overbolting, and 5 mm galvanised weld-wire mesh. Between the December 2015 and May 2016 visits, the area was rehabilitated with 5 mm polymer coated welded wire mesh and 1.8 m and 2.4 m coated friction and Omega rockbolts. This site also featured a visible boundary between corroded and non-corroded material, represented by the right-pointing arrow in Figure 3.

Figure 3 M 390 represents an area with high visual corrosion in dark argillite rock mass

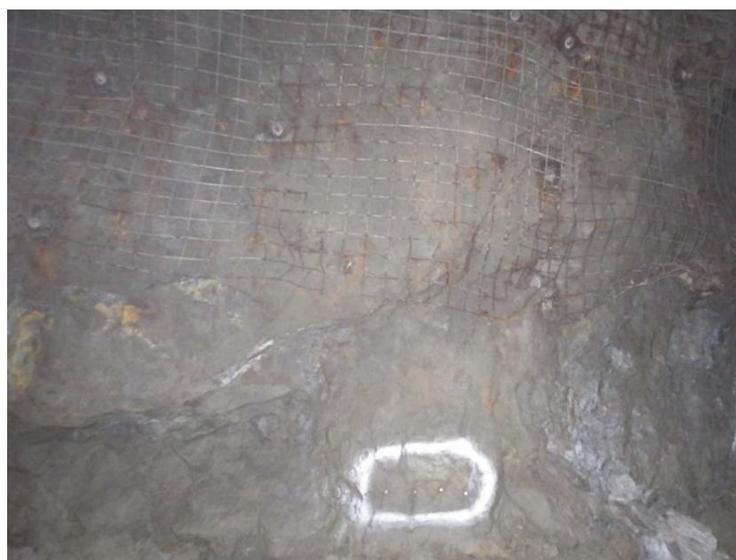
Another heading called the 29 L represented the moderate corrosion location (Figure 4). The argillite rock mass was slightly red in colour, with pyrite visible. The site is located near the top of the mine, 412 m above sea level. The air temperature was 17.2°C, and at 89.2% humidity, this was the most humid site studied. Water was noted in puddles in the road but not seeping through the rock mass. RMR ranged from 35 to 45. Support characteristics were similar to M 390, though rehabilitation was not deemed necessary.

Figure 4 29 L represents an area with moderate visual corrosion in light red argillite rock mass

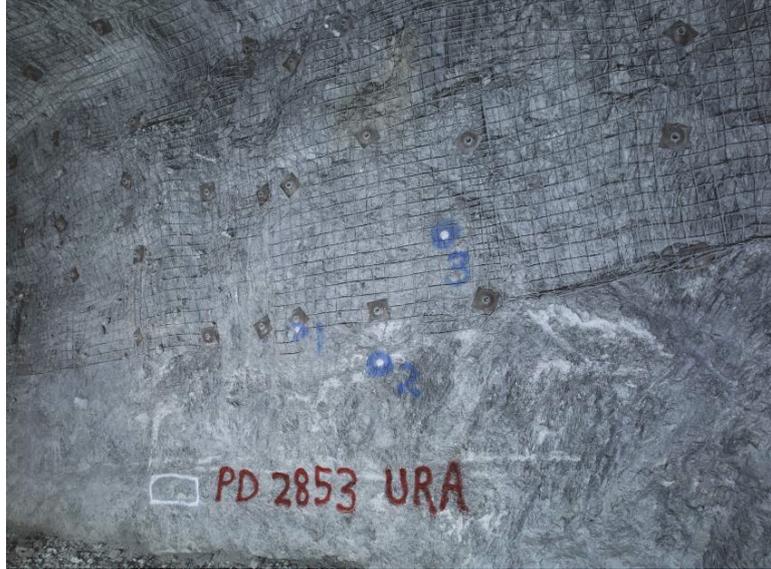
Raise access PD 2853 represented the low corrosion area (Figure 5). PD 2853 was observed to be dry, with light grey coloured phyllite. The air temperature was 13.2°C with 77% humidity, at an elevation of 140 m above sea level. RMR ranged from approximately 45 to 56, joint spacing and condition were noted to be

similar to those at M 390. The ground support consists of 1.8 m long galvanised friction rockbolts with a slightly overbolted 1.2 × 1.2 m pattern and 5 mm welded wire mesh. No rehabilitation has been necessary up to this time. Overall, this site was in near original condition, with essentially no evidence of support corrosion. Together with sites M 390 and 29 L, three distinct levels of corrosion could be studied by SMRD researchers and Hecla Mining Company.

Figure 5 PD 2853 URA represents an area with low visual corrosion in phyllite rock mass

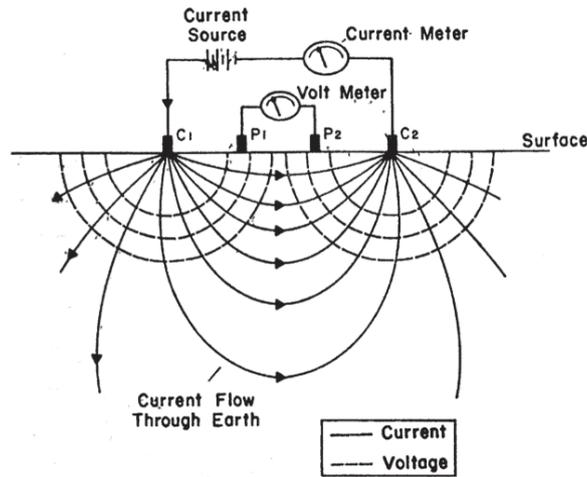
To determine the rock mass conductivity and its possible correlation with corrosion, measurements were taken using a small-scale Wenner array (ASTM International 2005). The Wenner array (Figure 6), consists of four equally spaced in-line electrodes. Nodes  $C_1$  and  $C_2$  are the current electrodes, while nodes  $P_1$  and  $P_2$  are potential electrodes. The spacing of the electrodes determines how far the current will penetrate, with larger spacing achieving greater depth and volume of earth. The bulk average resistivity is calculated by measuring the difference of the potential electrodes when a low frequency alternating current is passed into the rock through the current electrodes. The resistivity is calculated with Equation (3). The conductivity is the inverse of resistivity.

Figure 6 A Wenner array was used to measure the conductivity of the rock mass (ASTM 2005)

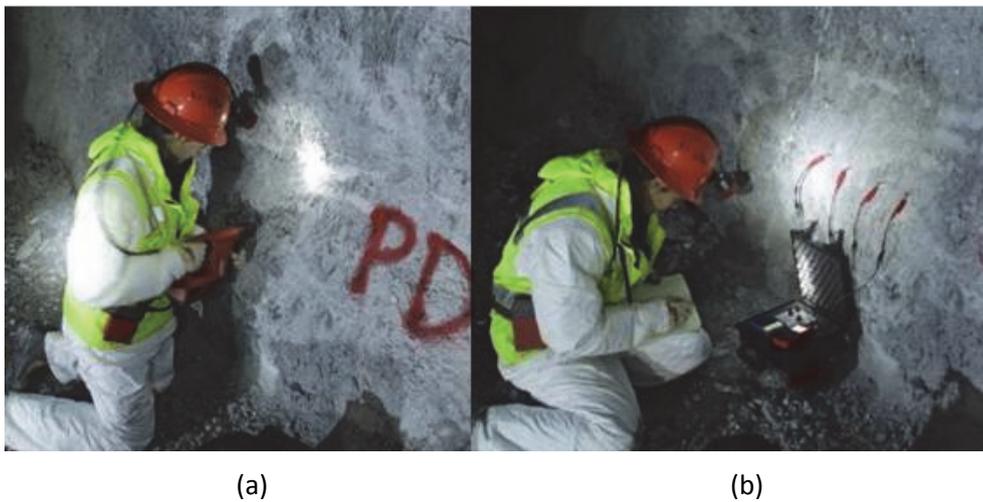
The electrodes were installed at the pre-selected sites in the ribs of excavation by drilling four holes 10.16 cm apart (Figure 7) and inserting 7.62 cm stainless steel construction screws as electrodes. With the electrodes in place, an instrument designed by SMRD researchers (Figure 8) was used to measure the current and voltage. These values were recorded and used to calculate the conductivity of the rock mass in each of the three areas.

Figure 7 (a) Drilling holes for electrode insertion; and, (b) measuring the current and voltage used to calculate conductivity of the rock mass

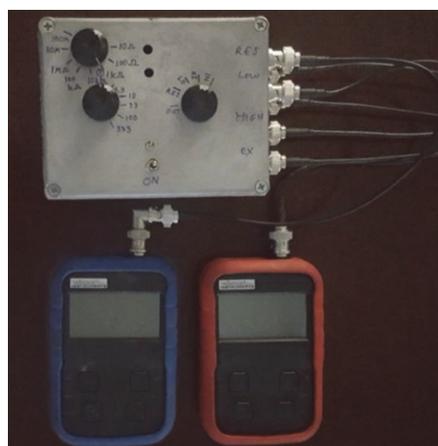
Figure 8 Instrument for measuring current and voltage

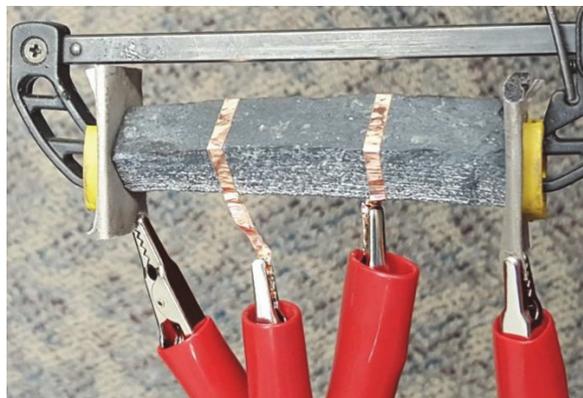
The conductivity of rock samples was measured following the procedure described by Telford et al. (1990); the principles are the same as the Werner method. Rock samples were first cut to give flat edges for good connectivity with the current electrodes. Current was applied through conductive foam held tight to the ends of the sample with a rubber C-clamp, and 3.175 mm thick copper tape made contact with all faces as potential electrodes (Figure 9). The same instrument used to measure rock mass conductivity in the mine was used to measure rock sample conductivity.

**Figure 9** Rock sample conductivity measurement using conductive foam as current electrodes and copper tape as potential electrodes

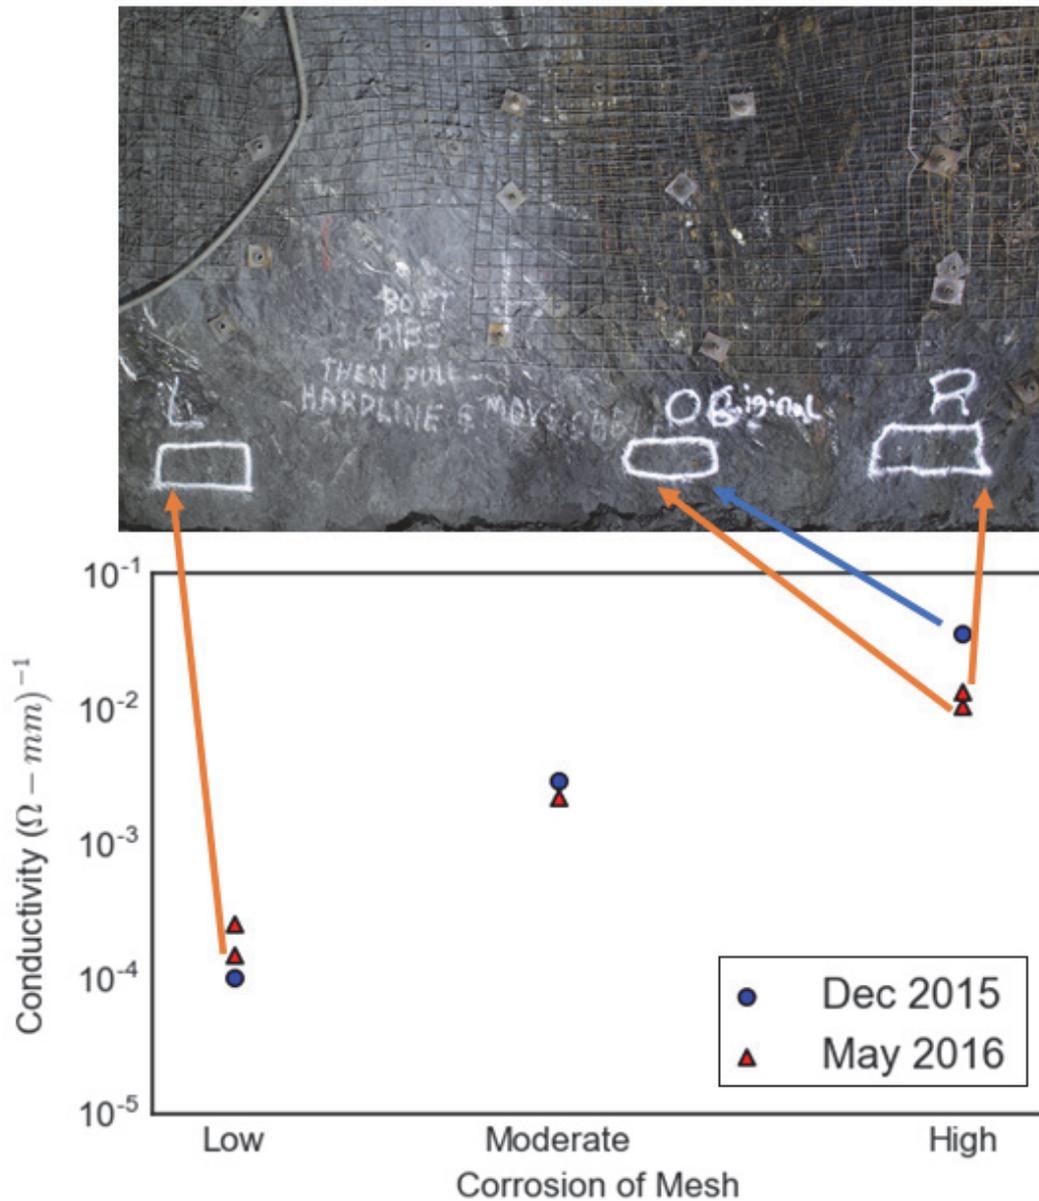
Rock mass conductivity data from field investigations at the Greens Creek mine indicate that rock with higher conductivity is facilitating higher levels of corrosion. It has previously been noted that soil conductivities greater than  $1.0 \times 10^{-4} (\Omega \text{ mm})^{-1}$  are considered highly corrosive (Peabody 2001). Figure 10 outlines how the lowest conductivity recorded exceeds this threshold. The circles on the graph correlate to the measurements taken in December 2015, while the triangles indicate the measurements taken in May 2016. Moderate corrosion data was measured at the 29 L site and two of the low corrosion data were measured at PD 2853. All other data was measured at M 390 as indicated in Figure 10.

Figure 10 Conductivity measurements of rock mass and support at the Greens Creek mine. Moderate data was measured at the 29 L site, two of the low corrosion data were measured at PD 2853, and all other data was measured at M 390 as indicated

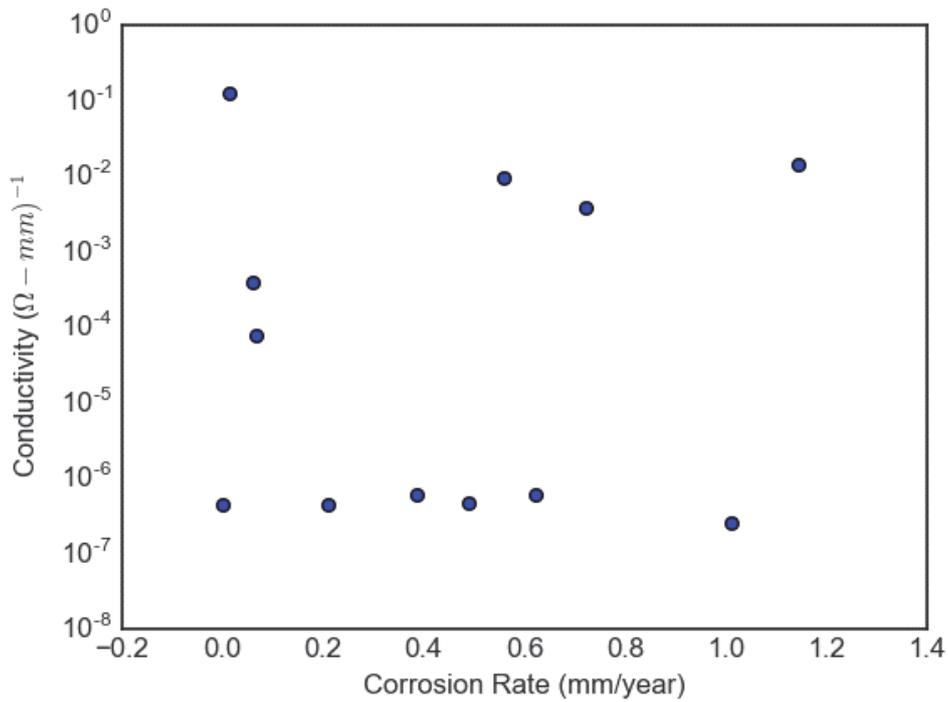
The measured conductivity of rock samples was correlated to the corrosion rate calculated from corresponding weld-wire mesh samples (Figure 11). There is a lot of variability in the data, this may be improved by making more rock sample conductivity measurements or by using more uniform samples such as diamond drill core samples. Carmichael (1982) suggests that for greater accuracy electrical properties should be measured in the rock mass rather than samples because of the strong dependence on environmental factors such as moisture content, temperature and vapour pressure.

Figure 11 Corrosion rate of weld-wire mesh samples versus conductivity of corresponding rock samples

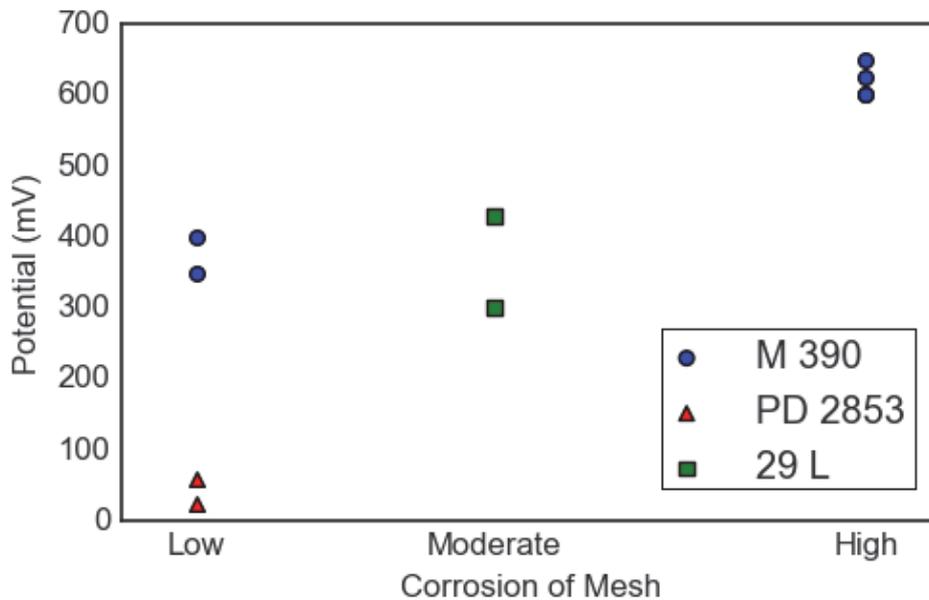
Voltage measurements between the rock mass and welded wire mesh followed a pattern similar to the rock conductivity data, except in the case of the low corrosion area of M 390 (Figure 12). Nonetheless, the difference in potential is still closer to the 29 L (mid-level corrosion) rather than the PD 2853 (low-corrosion) area. This unexpected result could be due to stray currents in the mesh matrix or differences in the rock type.

Figure 12 Difference in potential measured between the rock mass and the wire mesh correlate to amount of corrosion, except in the low corrosion area very close to the high corrosion area (M 390)

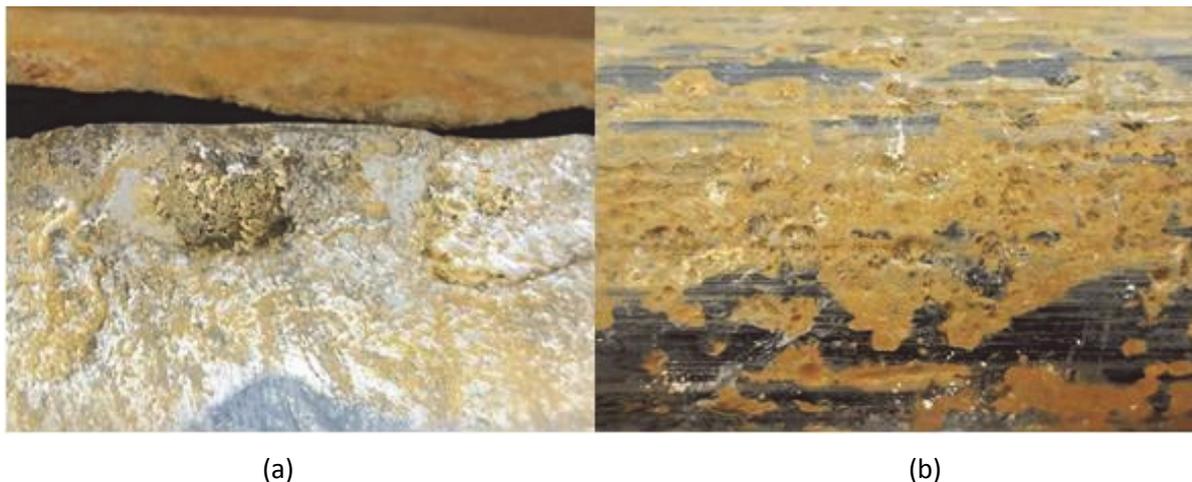
Pitting corrosion found on rockbolts retrieved from the Greens Creek mine (Figure 13) may be characteristic of the contribution of MIC to accelerated corrosion, chloride ions (McCafferty 2010), or sulphide minerals creating localised acidic conditions (Hassell et al. 2004). Because pitting may be due to a variety of environmental conditions, further investigation is required to positively identify MIC. SEM and EDS analyses confirmed the presence of sulphur in the corrosion product separated from the highly corroded weld-wire mesh. Iron was found on the fresh steel surface, but only small amounts of sulphur. The high amount of sulphur in the corrosion product, when compared to the lack of sulphur found on the metal surface, may suggest SRB activity. The continued presence of iron found on the corrosion product could indicate the production of iron sulphide (Figure 14).

Figure 13 (a) Large pits in four year old friction bolt; and, (b) small pits on 10 month old coated Omega bolt

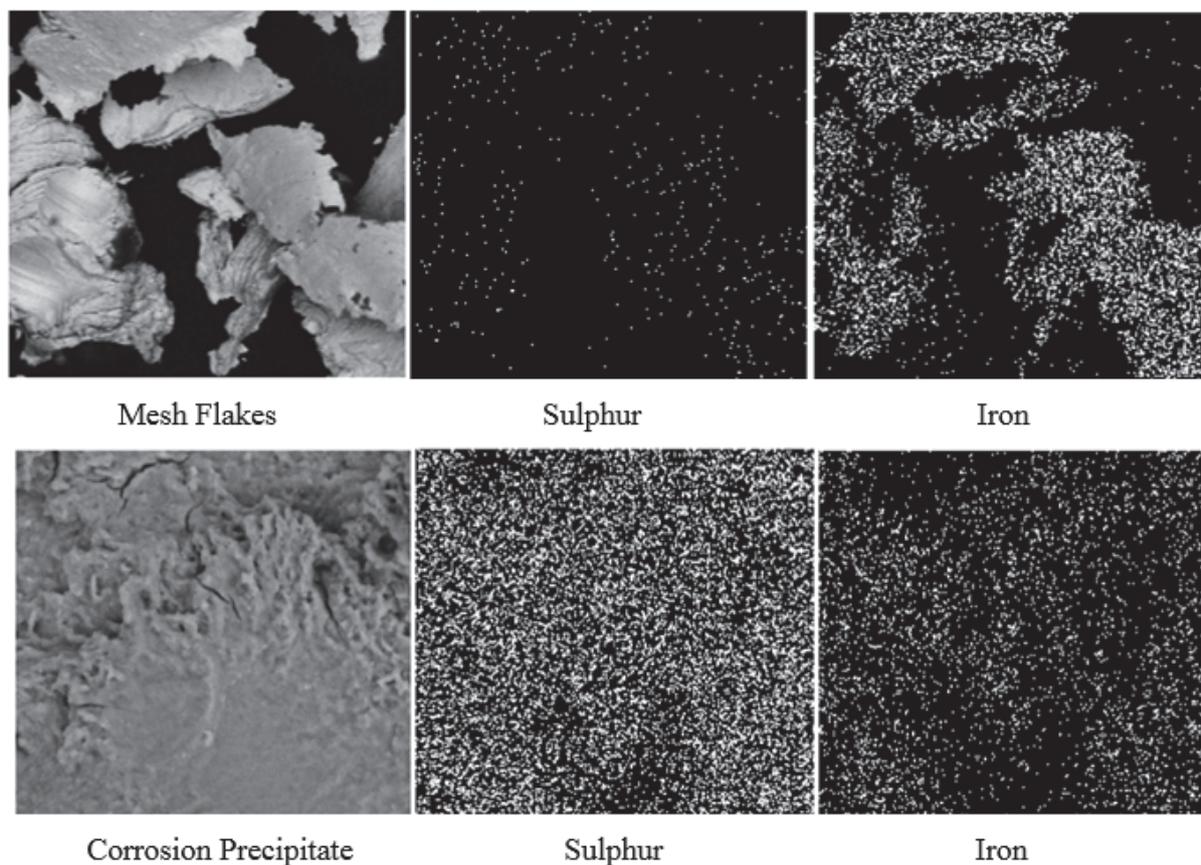
Figure 14 SEM and EDS images (each row is one sample) of the surfaces of flakes from a new wire mesh (top row); and corrosion precipitate (bottom row)

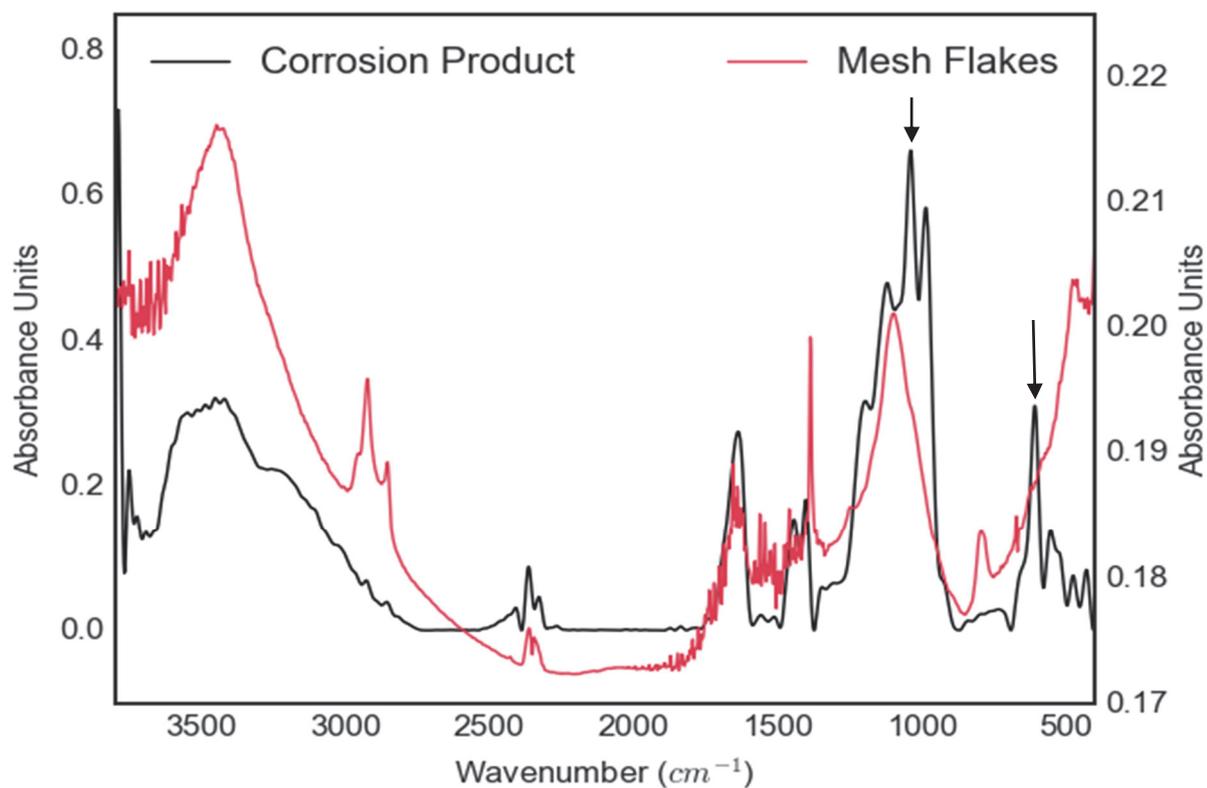
FTIR analysis may support the findings of the SEM and EDS analysis. While multiple aliquots of the corrosion precipitate sample were analysed on the FTIR, the spectra varied only in peak height, so only the spectrum representative of the average was selected for use in this paper. The peaks between  $3,000$  and  $2,800 \text{ cm}^{-1}$  indicate carbon hydrogen bonding (C-H), revealing the presence of a small amount of organic material, while the strength of the band in the spectra near  $1,450 \text{ cm}^{-1}$  indicates the presence of carbonate (Figure 12). The strong peaks seen in Figure 15 at  $606 \text{ cm}^{-1}$  and between  $1,100$  and  $1,000 \text{ cm}^{-1}$  are of particular interest in detecting sulphate and sulphite (Nakamoto 1997, in Rubio et al. 2006). The presence of carbonate, along with no detection of silicon, indicates that the broad band absorption between  $1,000$  and  $1,100 \text{ cm}^{-1}$  is potentially due to a sulphur oxygen bond (S-O) in sulphate or sulphite (Griffiths, personal communication, 10 July 2016). Regarding the spectra of weld-wire mesh flakes, the lack of strong peaks between  $1,000$  and  $1,100 \text{ cm}^{-1}$  and at  $600 \text{ cm}^{-1}$  indicates an absence of sulphur ions in the wire mesh that are present in the corrosion product.

Figure 15 Average corrosion precipitate spectrum (left hand y axis) with wire mesh flakes spectrum (right hand y axis); arrows indicate peaks at 600  $cm^{-1}$  and between 1,100 and 1,000  $cm^{-1}$

Taken together, SEM, EDS, and FTIR observations of corrosive product compared to non-corroded samples may indicate SRB activity in the 627 access of the Greens Creek mine. Therefore, it may be concluded that MIC is also occurring. Further investigation will determine whether this conclusion is correct, and if so, what corrective actions may be taken.
