# LINE OF DUTY DEATH REPORT

REPORT 2021-10 • December 2024

## ***Volunteer Firefighter Killed after Becoming Trapped at an Assisted Living Facility Fire and Two Firefighters Injured – New York***

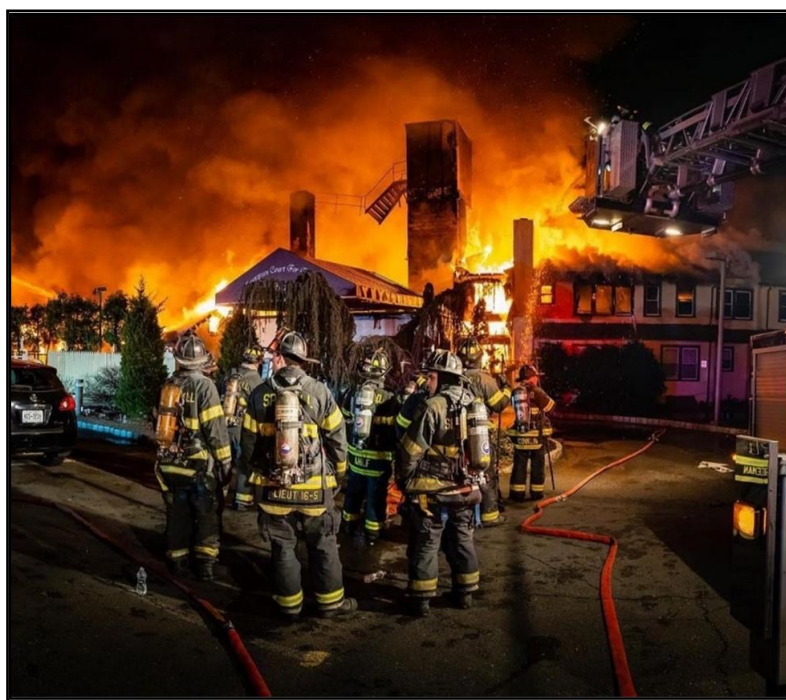
**The collapse of Side Alpha/Side Bravo corner at 03:01 hours of the assisted living facility.  
(Photo courtesy of Kenneth Flynn)**

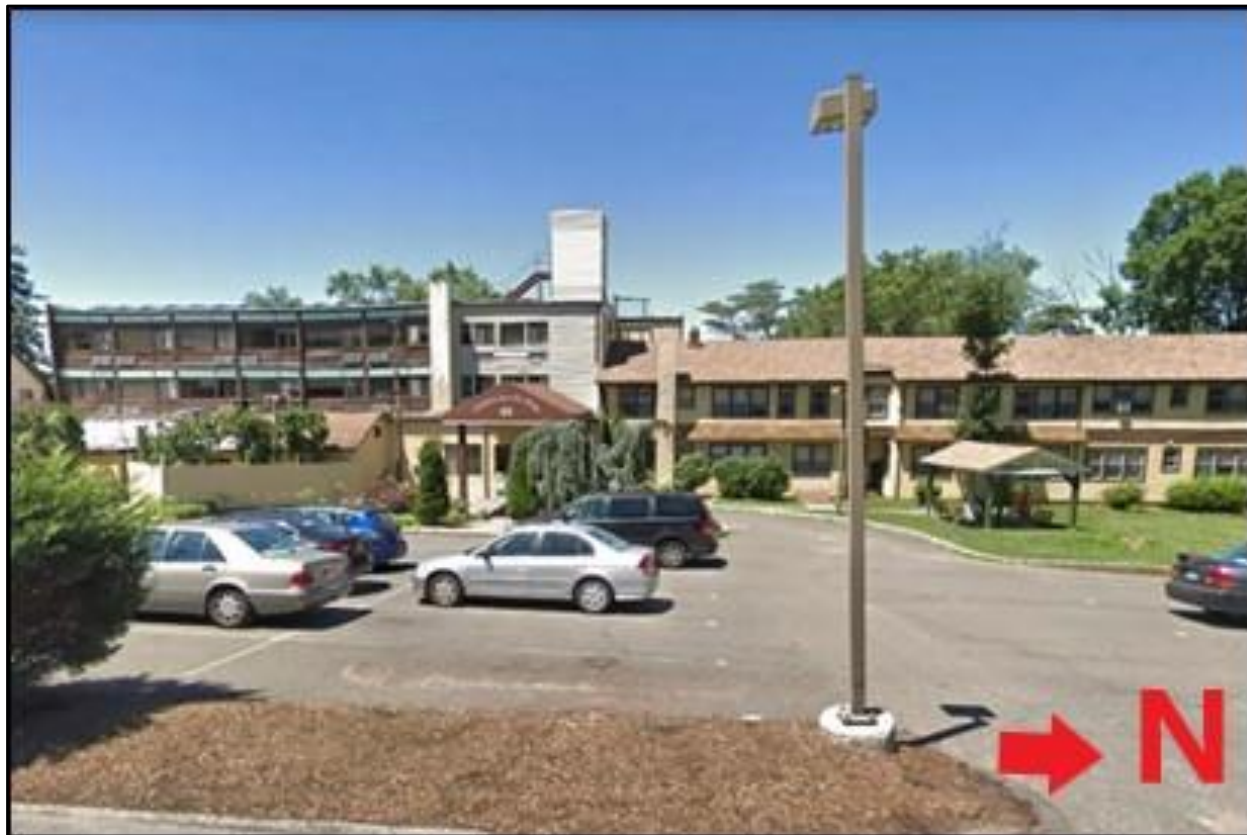
**Photo 2. Side Alpha of the assisted living facility.**  
*(Photo courtesy of the New York Post)*

building construction were limited or non-existent. This includes the overall plot plan of the facility and dimensions of the buildings. The original set of buildings were wood frame (Type V) building construction (See **Photo 2** and **Photo 3**).

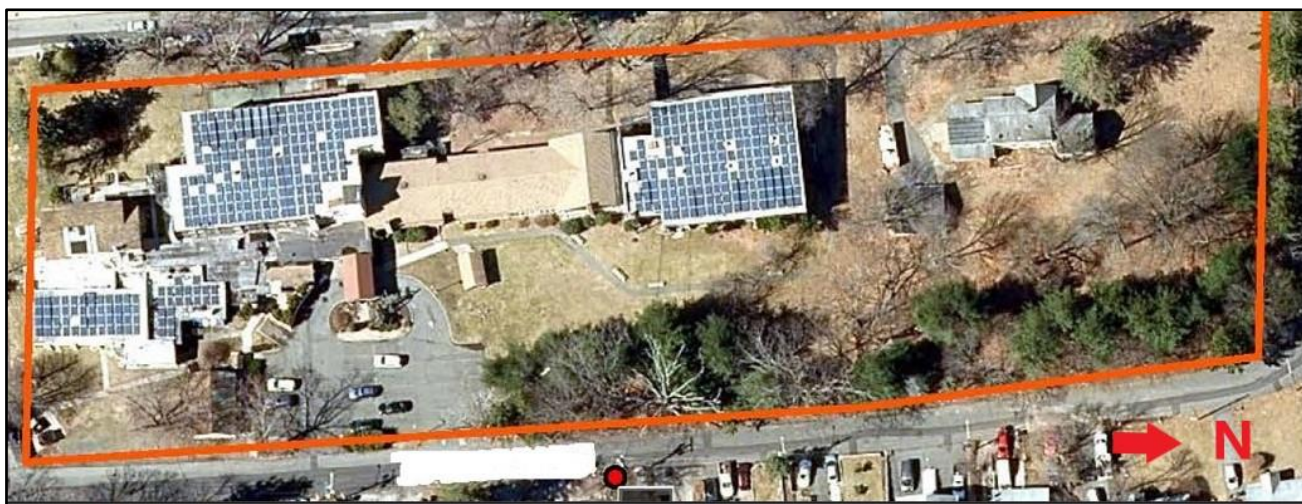
**Photo 3. An aerial photograph of the assisted living facility. The red dot at the bottom of the picture indicates the closest fire hydrant.**  
*(Photo courtesy of the county Fire Academy)*

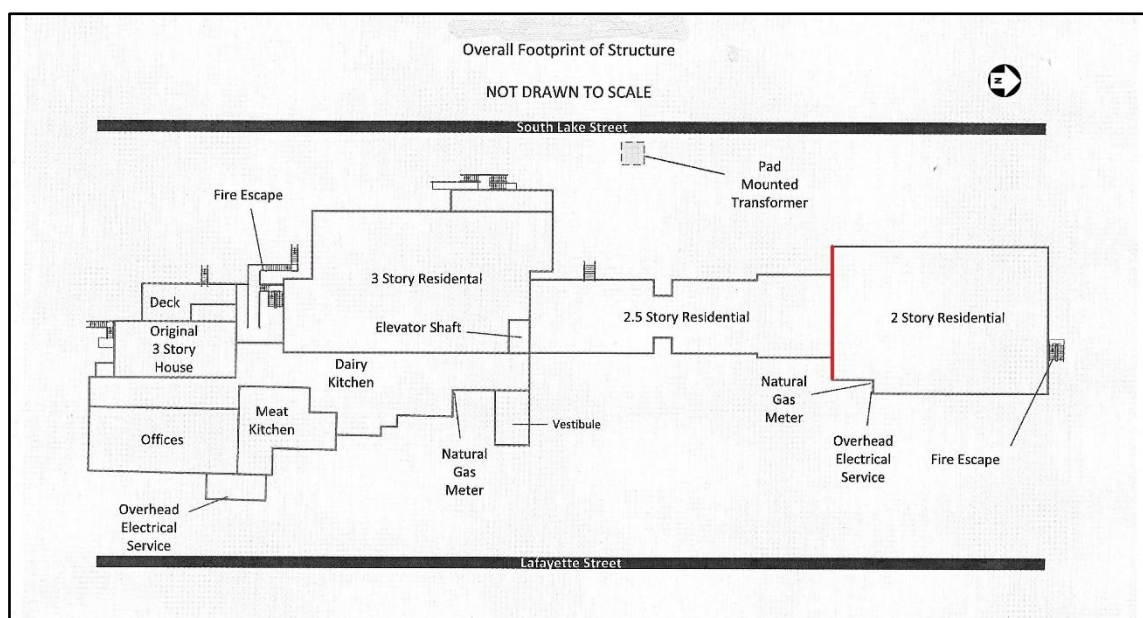
**Diagram 1.** The site plan of the assisted living facility. The **red** line indicates the firewall between the 2½-story and 2-story buildings which prevented fire spread.  
(Photo courtesy of the NY Office of the State Fire Marshal)

The original facility consisted of a 3-story residential building, kitchens, offices, and dining room (**See Diagram 1**). There was a swimming pool in the basement of the 3-story residential building, but it was non-functional. It is unknown when the hotel and resort closed and the assisted living facility became operational. The 2½-story and 2-story buildings were added later. There was a firewall between the 2½-story and 2-story buildings which prevented fire spread during this incident. According to state investigation documents and interviews, the 3-story residential building maintained a fire suppression sprinkler system in the kitchens and dining area/hallway. During the incident, the sprinkler system was activated but ineffective because the fire extended up the wall behind appliances, into the ceiling and roof of the dairy kitchen, and above the sprinkler systems.

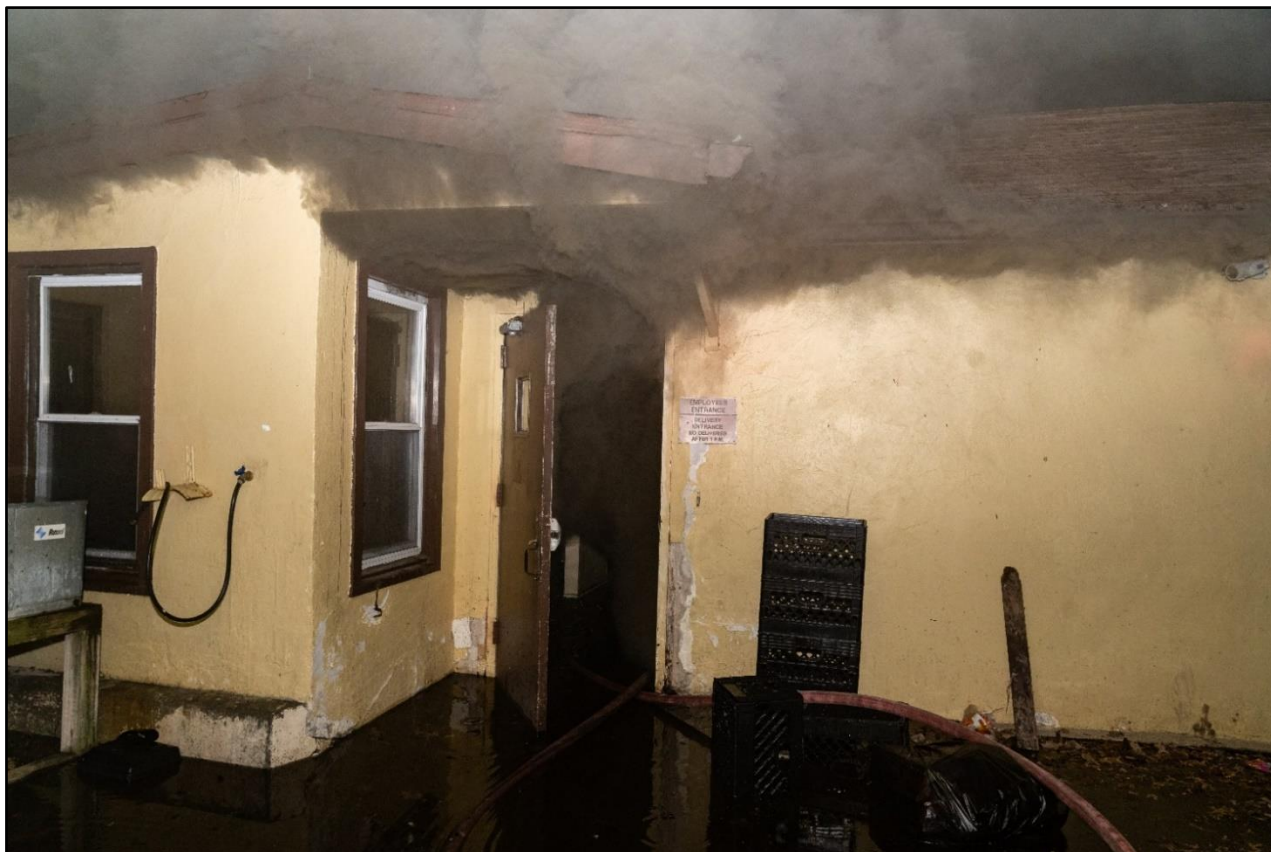
**Photo 5. The smoke conditions from the exterior dairy kitchen door on Side Alpha. The 1¾-inch hoseline was from Tanker 17. The time is approximately 01:40 hours.**  
*(Photo courtesy of Kenneth Flynn)*

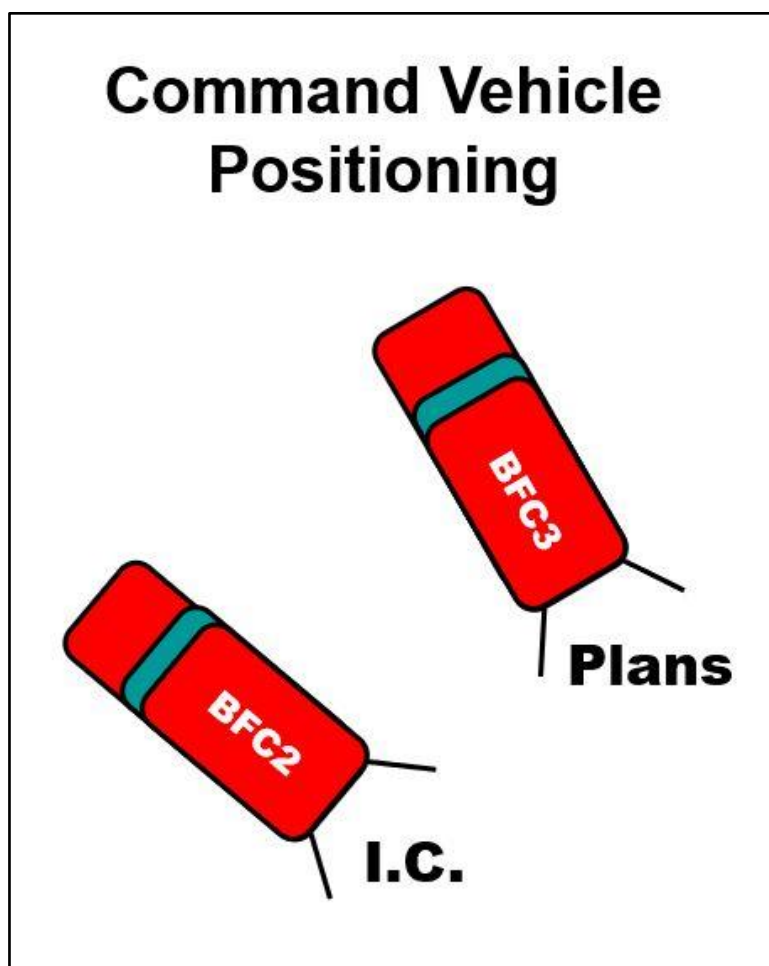
**Figure 1. An example of utilizing a Planning Section Chief who is working in proximity with the IC at a Type IV incident. Also, another command vehicle can be added for the Logistics Section Chief.**

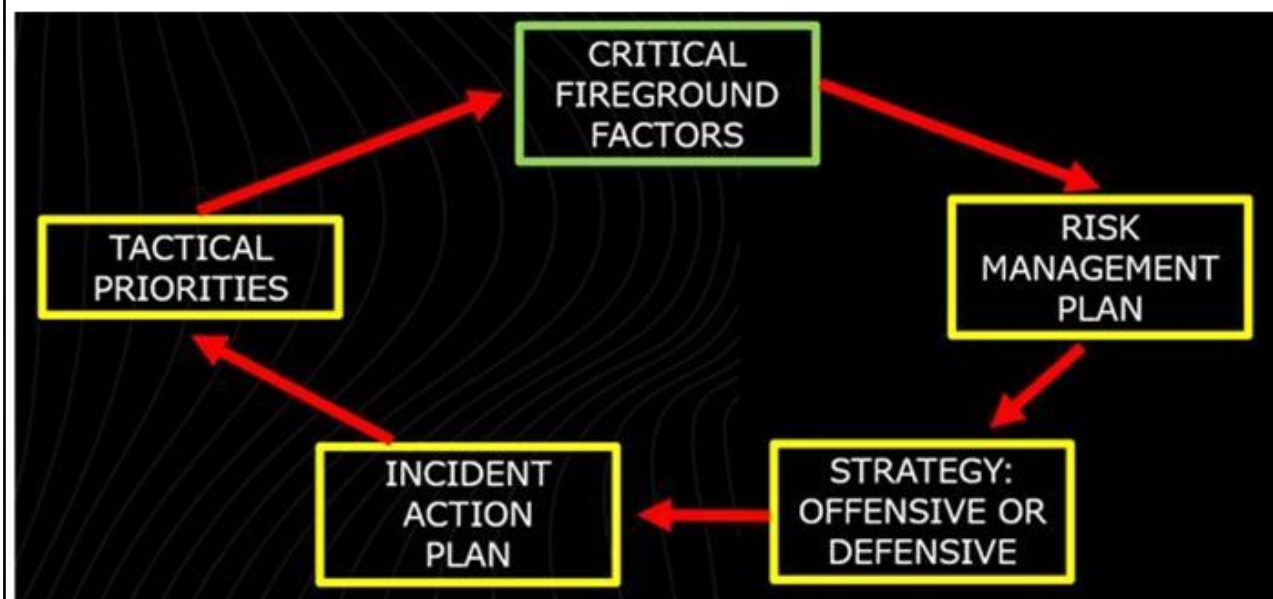
**Diagram 2. This model displays the decision-making process into a standard sequence.**  
(Courtesy of South King County Fire Training Consortium)

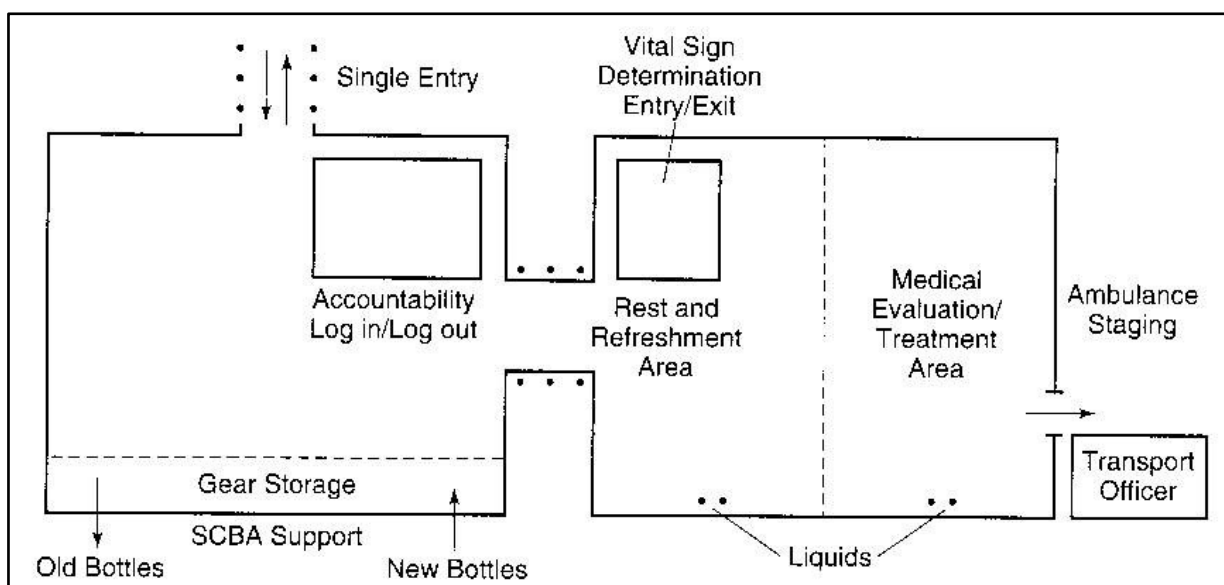
**Diagram 3. An example of how a Rehab area should be organized. This is just one of many ways to establish an effective Rehab area.**  
(Courtesy of U.S. Fire Administration)

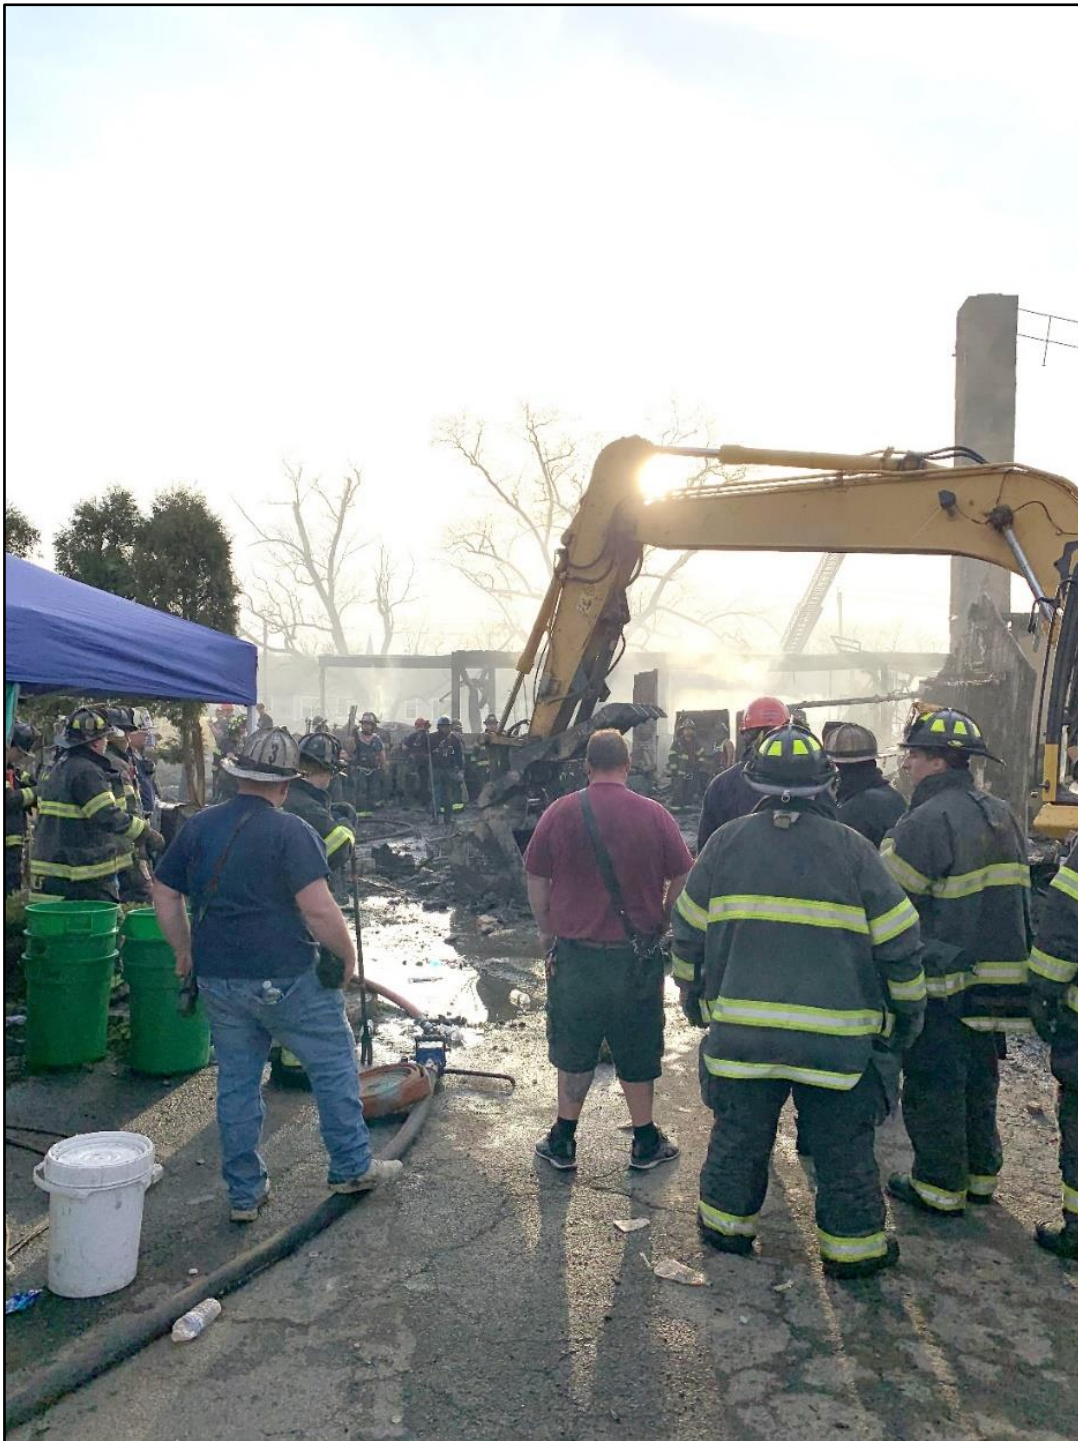
**Photo 9. A photograph of firefighters surrounding heavy equipment working to locate Tanker 17D in the remains of the assisted living facility.**  
*(Photo courtesy of the county Fire Academy)*
