# BALING FATAL INJURY FACTS

**In upstate New York, 2 workers died while operating balers and compactors between 2004 and 2005. Below are descriptions of how the workers were killed on the job.**

### New York Fatality Assessment & Control Evaluation (FACE)

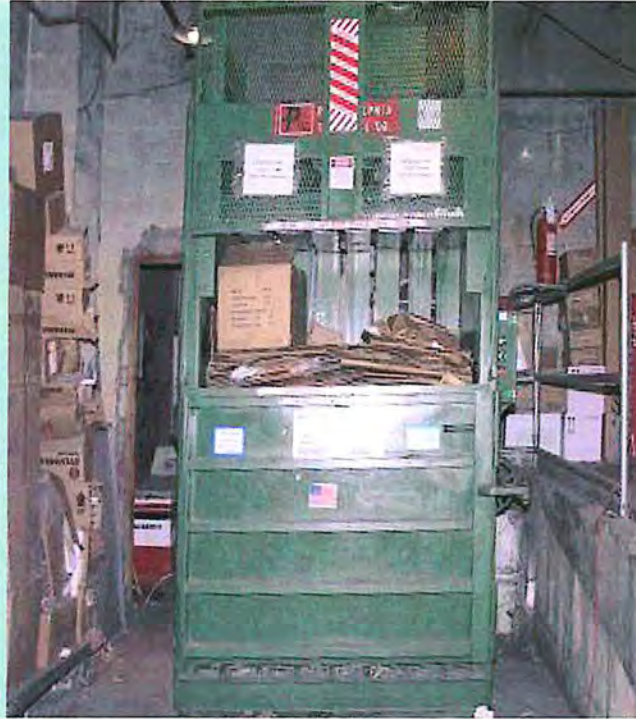
A department store manager was killed when he was crushed in a cardboard baling machine. The safety gate was not closed during baling and the victim climbed into the baling chamber and was crushed by the hydraulic ram. The electrical wiring on the machine had been altered to bypass the "on/off" switch and the safety gate had been short-circuited.

A recycling company employee was killed when he fell into a compactor while trying to clear a jam. The chute opening lacked fall protection and there was no emergency stopping device to prevent him from being pulled into the machine.

- ✦ Develop and implement a lockout/tagout program to ensure workers' safety during troubleshooting and machine maintenance.
- ✦ Train workers in proper baler operation and ensure employees know the importance of baler safety features, such as the safety gate and lockout/tagout program.
- ✦ Implement standard procedures for clearing material jams and provide safe access to feed chutes.
- ✦ Ensure only properly trained employees use baling equipment.
- ✦ Follow the manufacturer's recommended schedule for baling machine maintenance and inspection of machine safety features to ensure machines are working properly.
- ✦ Do not assign workers under age 18 to service, load, operate, or assist in the operation of baling equipment. New York State Labor Law prohibits workers under 18 from any occupation involving baler operation.
