REPORT #:

71-183-2019

Spotter Crushed between Excavator Bucket and Trench Box

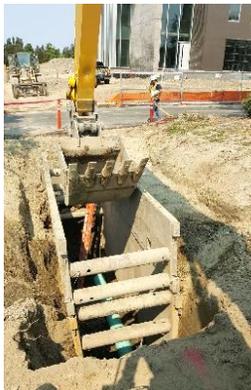
View from excavator cab. The spotter was in the trench to the right in the operator's blind spot.

State investigators found that the victim was standing in the area of the excavator bucket's swing and that he was in the operator's blind spot behind the bucket. The normal practice for this company was to remove the bucket when hoisting loads. In addition, the crew reported there was sense of urgency to get the job done quickly.

- Pre-plan a job task to ensure safety of the crew. For example, in this case the task could have been accomplished by having only one spotter/signal person and no one in the trench.
- Ensure all ground workers are aware of the excavator's swing areas and blind spots when hoisting materials and stay outside of these areas.
- Before hoisting materials, review and confirm communication signals between the equipment operator and workers on foot.

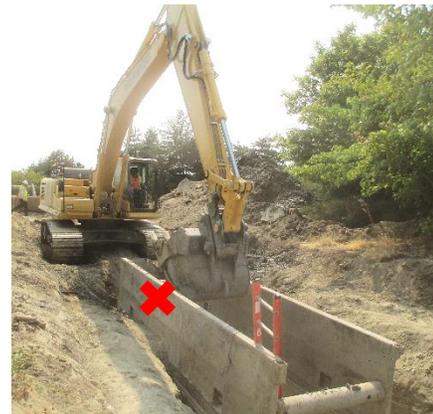
When the suspended pipe was over the trench, the two spotters steadied it. As the operator began to lower the pipe, the victim was standing next to the box watching the pipe descend. As he was doing his, the bucket pinned the middle of his body against the top of the box. He suffered severe crushing injuries to his abdomen.

The "x" indicates the location of the victim.
