71-188-2019

Commercial warehouse roof

## Rofer Falls 30 Feet through Skylight

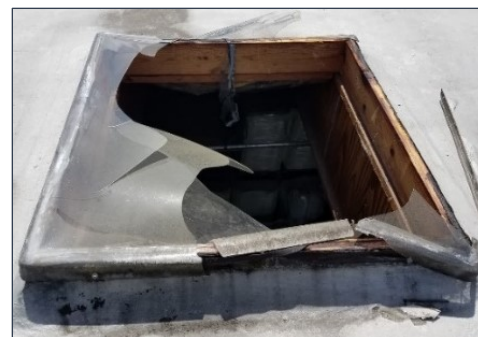
The arrow shows the skylight the roofer fell through. The warning line system used is shown to the left of the skylight.

The supervisor, who was also the safety monitor, was standing about 20 feet from the victim when he saw him stepping backward toward a skylight. The supervisor yelled "skylight!" to warn him. The victim, who had been talking with a coworker, caught his foot on the skylight frame and stumbled backward. The coworker reached out to grab him, but was unable to. The victim fell onto the unprotected plastic dome skylight cover, which broke, and he fell through the skylight. He landed 30 feet below on a concrete floor.

**Skylight the roofer fell through.**

Investigators found: **1)** Inappropriate fall protection was used. Safety monitor and warning line systems should not be used when unprotected skylights are present. Though warning lines must be used around unprotected sides and edges of a low pitch roof work area. **2)** The employer did not protect skylights. **3)** The building owner did not protect skylights.

- Building owners should install protective guards or screens over skylights or install guardrails to prevent falls through skylights by maintenance or other personnel who may enter the roof.
- Employers should provide skylight safety nets and train employees how to use them.
- State building code officials should consider including a provision in the building code that would require all skylights in new or renovated buildings to either have a protective cover or be of sufficient strength to prevent a worker from falling through.
