## INCIDENT FACTS

71-196-2020

## Laborer Partially Buried when Trench Wall Collapses

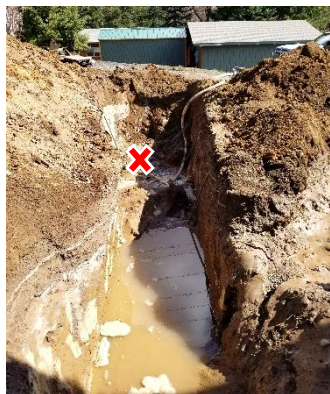
Unprotected trench after its sidewall collapsed, partially burying the laborer. The "x" indicates the laborer's location.

Investigators found: **1)** The trench was not protected from cave-ins by an adequate protective system. **2)** Spoil piles three feet high of type C soil were placed within two feet of the trench edge. **3)** Spoil piles were positioned on the uphill side of the trench creating a surcharge towards the trench opening. **4)** It is possible that the excavators created vibration in the ground and caused the trench side to sluff.

- Never enter an unprotected or uninspected trench, even for a short task.
- Do not assume that there will be a warning sign to alert you before a cave-in, or that you will have time to move out of the way.
- Be aware that heavy equipment operating nearby a trench may cause soil distress.

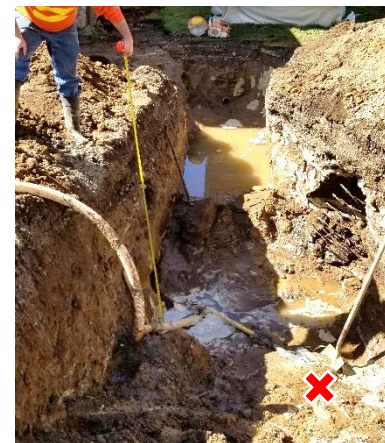
Unprotected trench after its sidewall collapsed. The "x" indicates the laborer's location.
