INCIDENT FACTS

71-218-2022

Hop Combine Harvester

Hop Farm Harvester Operator Struck By Steel Cable

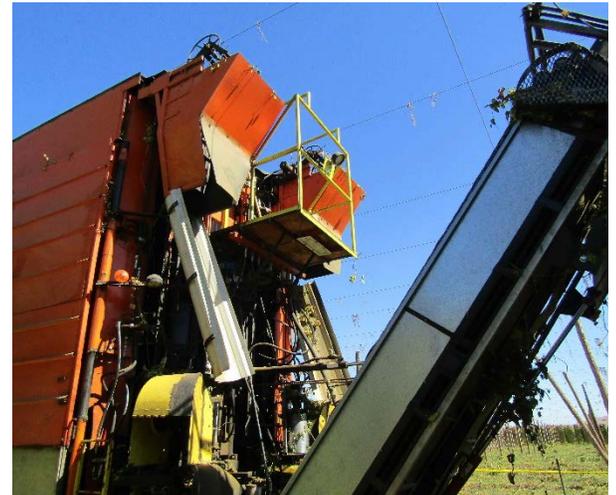
- The hydraulic systems on the harvester were functioning properly when examined.
- The steel cable and a bolt on the top of the harvester showed signs of damage, possibly due to the cable being caught on the bolt.
- A few poles that suspended the cables were leaning in the direction of the harvester, possibly due to the harvester striking and tensioning the cable.
- Another operator reported that he had also experienced the cables getting caught and dangerously releasing while working at the rear of the harvester. He said he had learned to stoop to avoid them.

Rear of harvester with elevated platform where worker was located. Cross-cables are overhead and leaning poles are in the background.

- Design hop growing trellises in a way that eliminates or reduces the hazard of overhead cross cables when harvesting.
- Add guarding to the front of rear platforms to protect operators.
- Reduce snag hazards on the top of machinery by using round socket-head bolts or domed bolt covers.
- Train harvester drivers to maintain safe distances between harvesters and overhead cables.
- Train and encourage workers to report hazardous conditions so they can be corrected before an injury occurs.
