INCIDENT FACTS

71-224-2022

A framer was seriously injured after falling 25 feet from a sheathed low-pitched roof of a house being constructed.

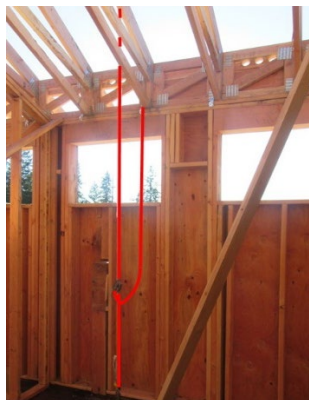
Lifeline that was available to the framer. The roof he fell from is located on the other side of the wall.

- Employers should
 - Conduct pre-shift safety meetings to determine if workers will be doing tasks that put them at risk of falls and reinforce the need for fall protection.
 - Perform unannounced fall protection spot checks to ensure workers maintain 100% tie-off.
 - Effectively enforce their written safety program.
- Workers should use employer provided fall protection.

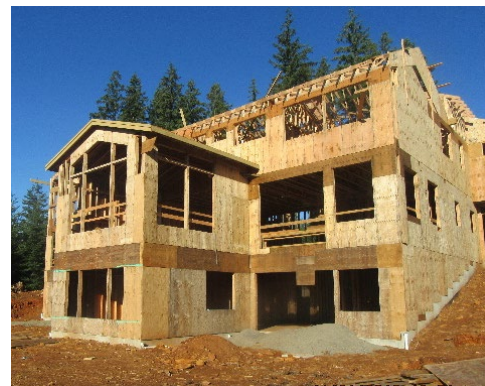
House where framer fell 25 feet from the lower back sheathed roof. He was not using fall protection.
