INCIDENT FACTS

71-227-2022

Siding Installer Falls 23 Feet from Pump Jack Scaffold

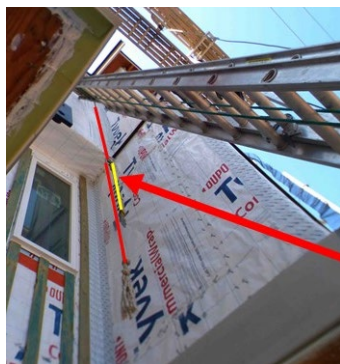
Rope grab lifeline with connector that installer did not use, as he was not wearing his full body harness.

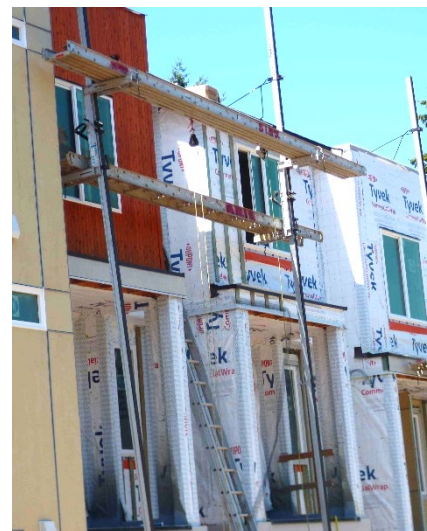
A 38-year-old siding installer died when he fell 23 feet from a pump jack scaffold. The siding installer, who owned his own construction company, was working for a subcontractor to install siding at a new construction apartment complex. On the day of the incident, the installer accessed the scaffold platform at the building's third floor level by climbing an extension ladder. The scaffold was not equipped with a guardrail system; it only had a workbench, which alone does not meet the requirement of a guardrail system. The installer provided his own full body harness, but he was not wearing it. The subcontractor provided the pump jack scaffolds and the rest of the personal fall arrest system consisting of a vertical rope lifeline with a rope grab and connector. The subcontractor required that site workers use the personal fall arrest system. As the installer was working from the scaffold platform, he fell 23 feet, landing on a pile of construction materials on the ground. He died of multiple blunt force injuries due to the fall.

Unguarded pump jack scaffold from which the siding installer fell 23 feet.

- Use guardrails on scaffolds whenever practical instead of or in addition to personal fall protection.
- Emphasize the requirement that workers maintain 100% tie off. This should be written in the work contract.
- Inspect scaffold operations at the start of each day before work begins and periodically throughout the day to ensure workers use fall protection.
